Civil Engineering and Development Department

**Agreement No. CE 59/2015 (EP)
Environmental Team for
Tseung Kwan O – Lam Tin Tunnel
Design and Construction**

**Monthly Environmental Monitoring and
Audit Report for
May 2020
(version 1.0)**

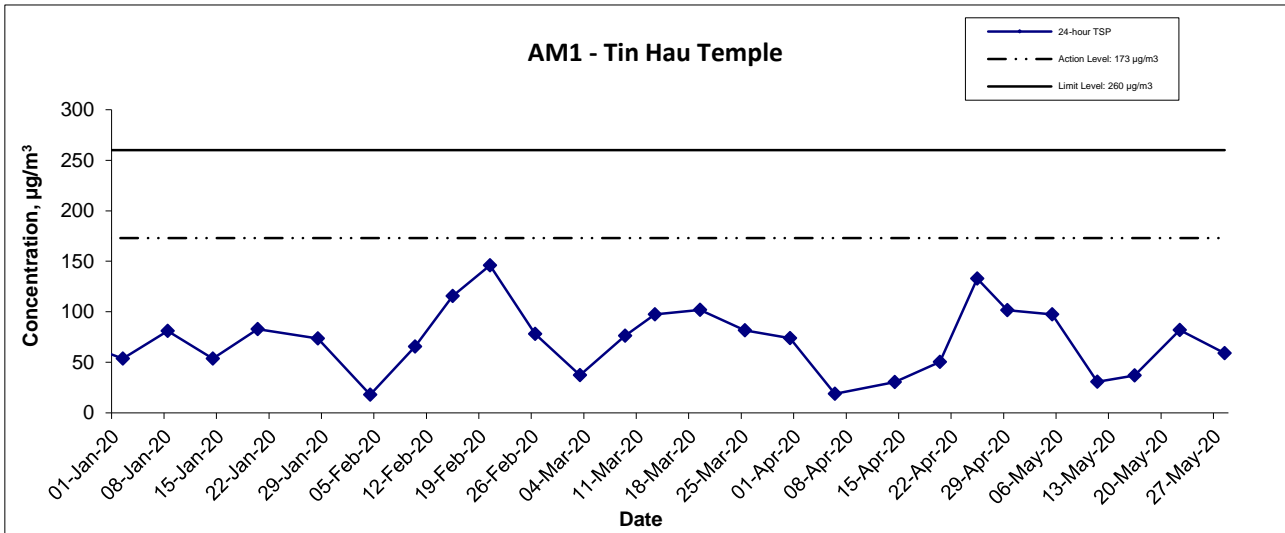
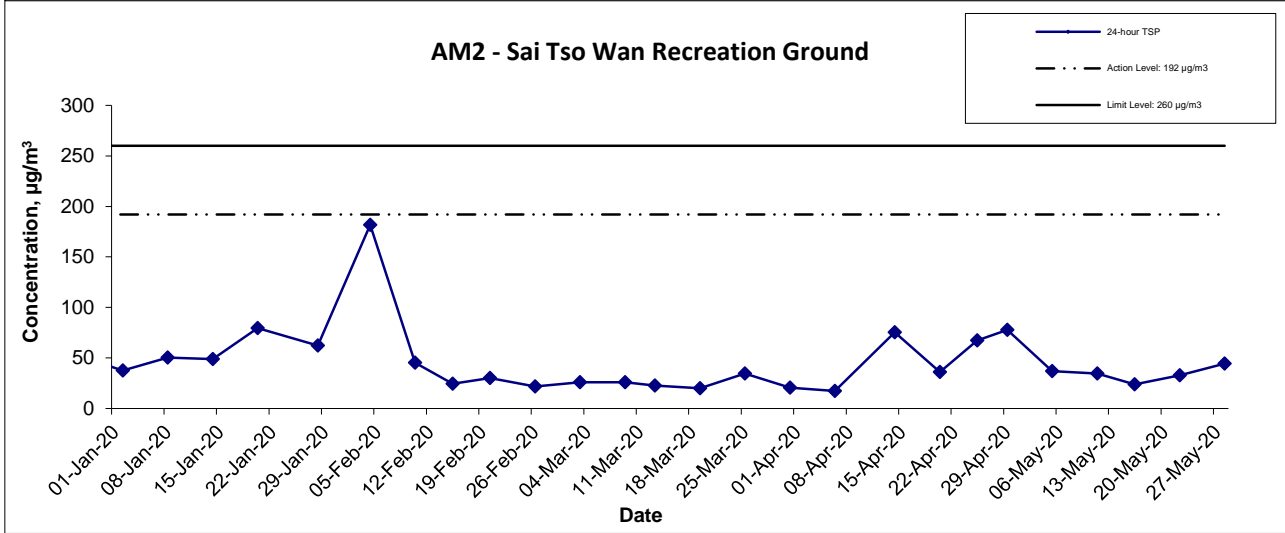
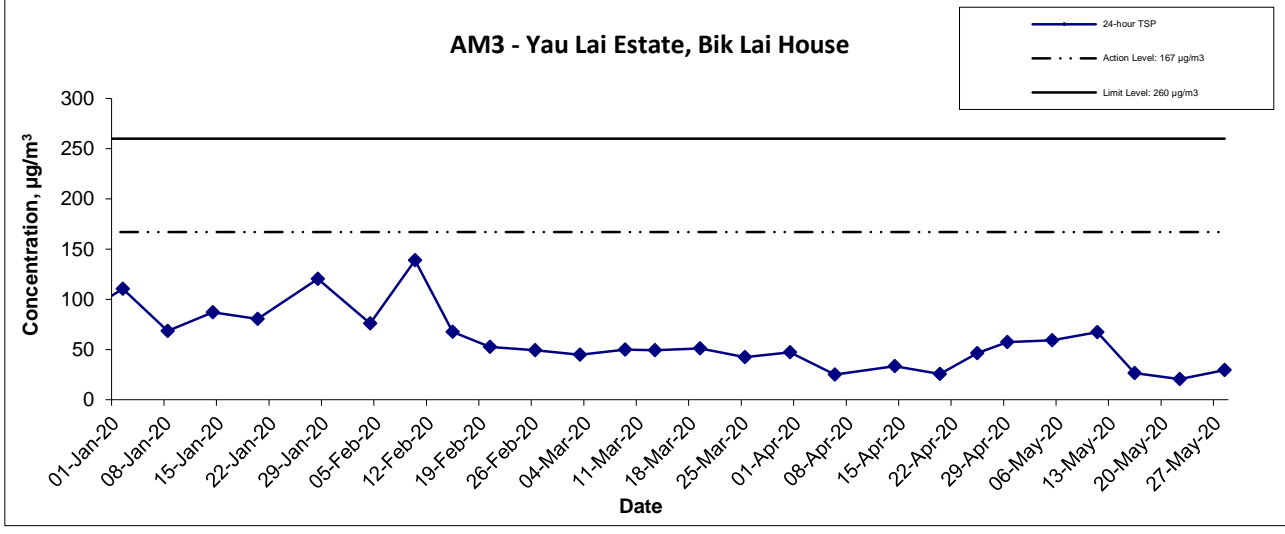
24-hr TSP Concentration Levels

Agreement No. CE/59/2015 (EP) Environmental Team for Tseung Kwan O - Lam Tin Tunnel - Design and Construction Graphical Presentation of 24-hour TSP Monitoring Results	Scale N.T.S	Project No. MA16034	
	Date May-20	Appendix F

- 3.21 No Action/Limit Level exceedance was recorded for both 1-hour TSP and 24-hour TSP monitoring respectively.
- 3.22 The air temperature, precipitation and the relative humidity data was obtained from Hong Kong Observatory where the wind speed and wind direction were recorded by the installed Wind Anemometer at rooftop of Yau Lai Estate Bik Lai House (41/F). The location is shown in **Figure 2**. This weather information for the reporting month is summarized in **Appendix C**.
- 3.23 The monitoring data and graphical presentations of 1-hour and 24-hour TSP monitoring results are shown in **Appendix E** and **Appendix F** respectively.
- 3.24 According to our field observations, the major dust source identified at the designated air quality monitoring stations are as follows:

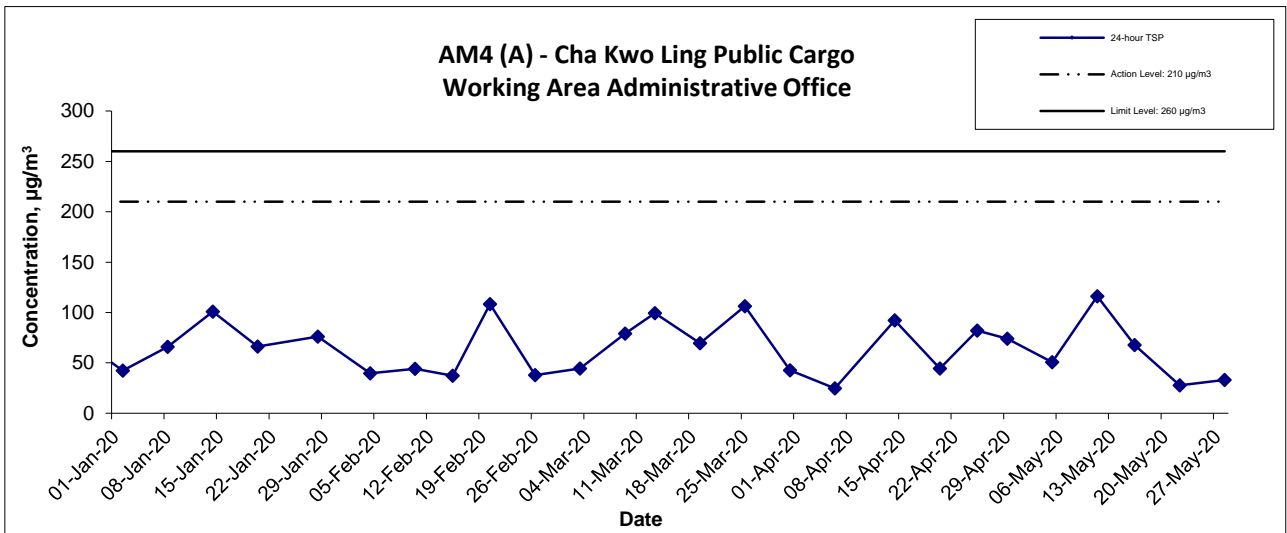
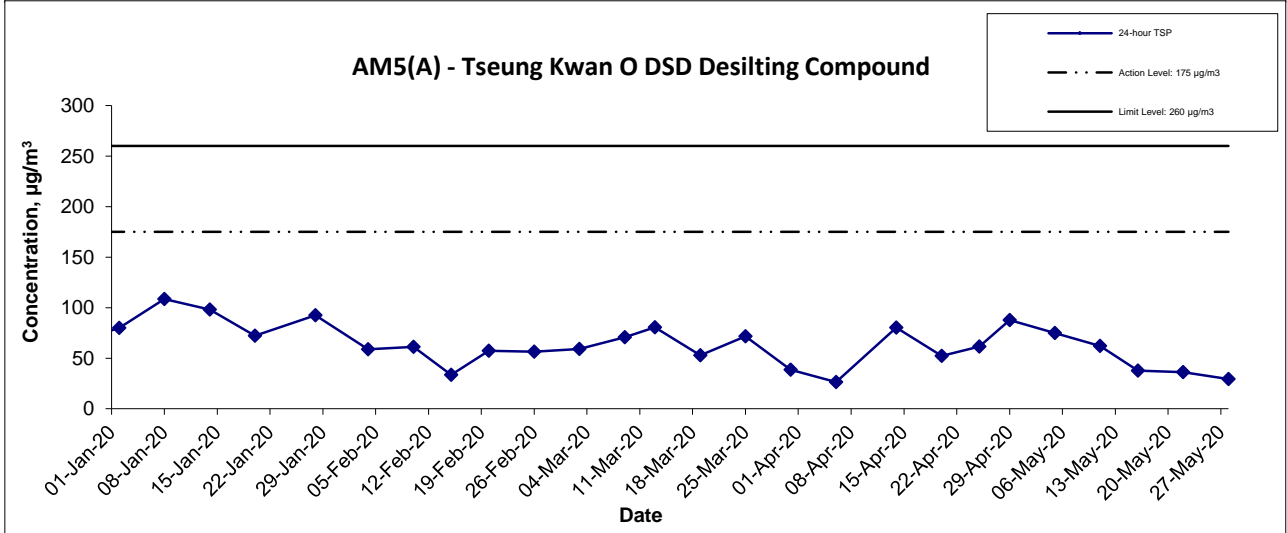
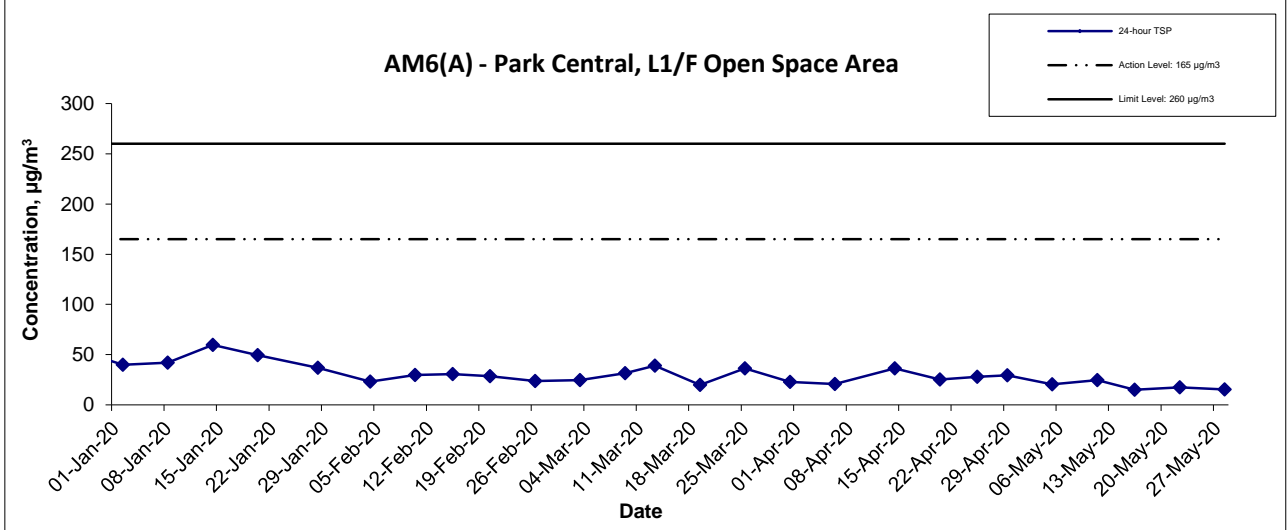
24-hr TSP Concentration Levels

Agreement No. CE/59/2015 (EP) Environmental Team for Tseung Kwan O - Lam Tin Tunnel - Design and Construction Graphical Presentation of 24-hour TSP Monitoring Results	Scale N.T.S	Project No. MA16034	
	Date May-20	Appendix F

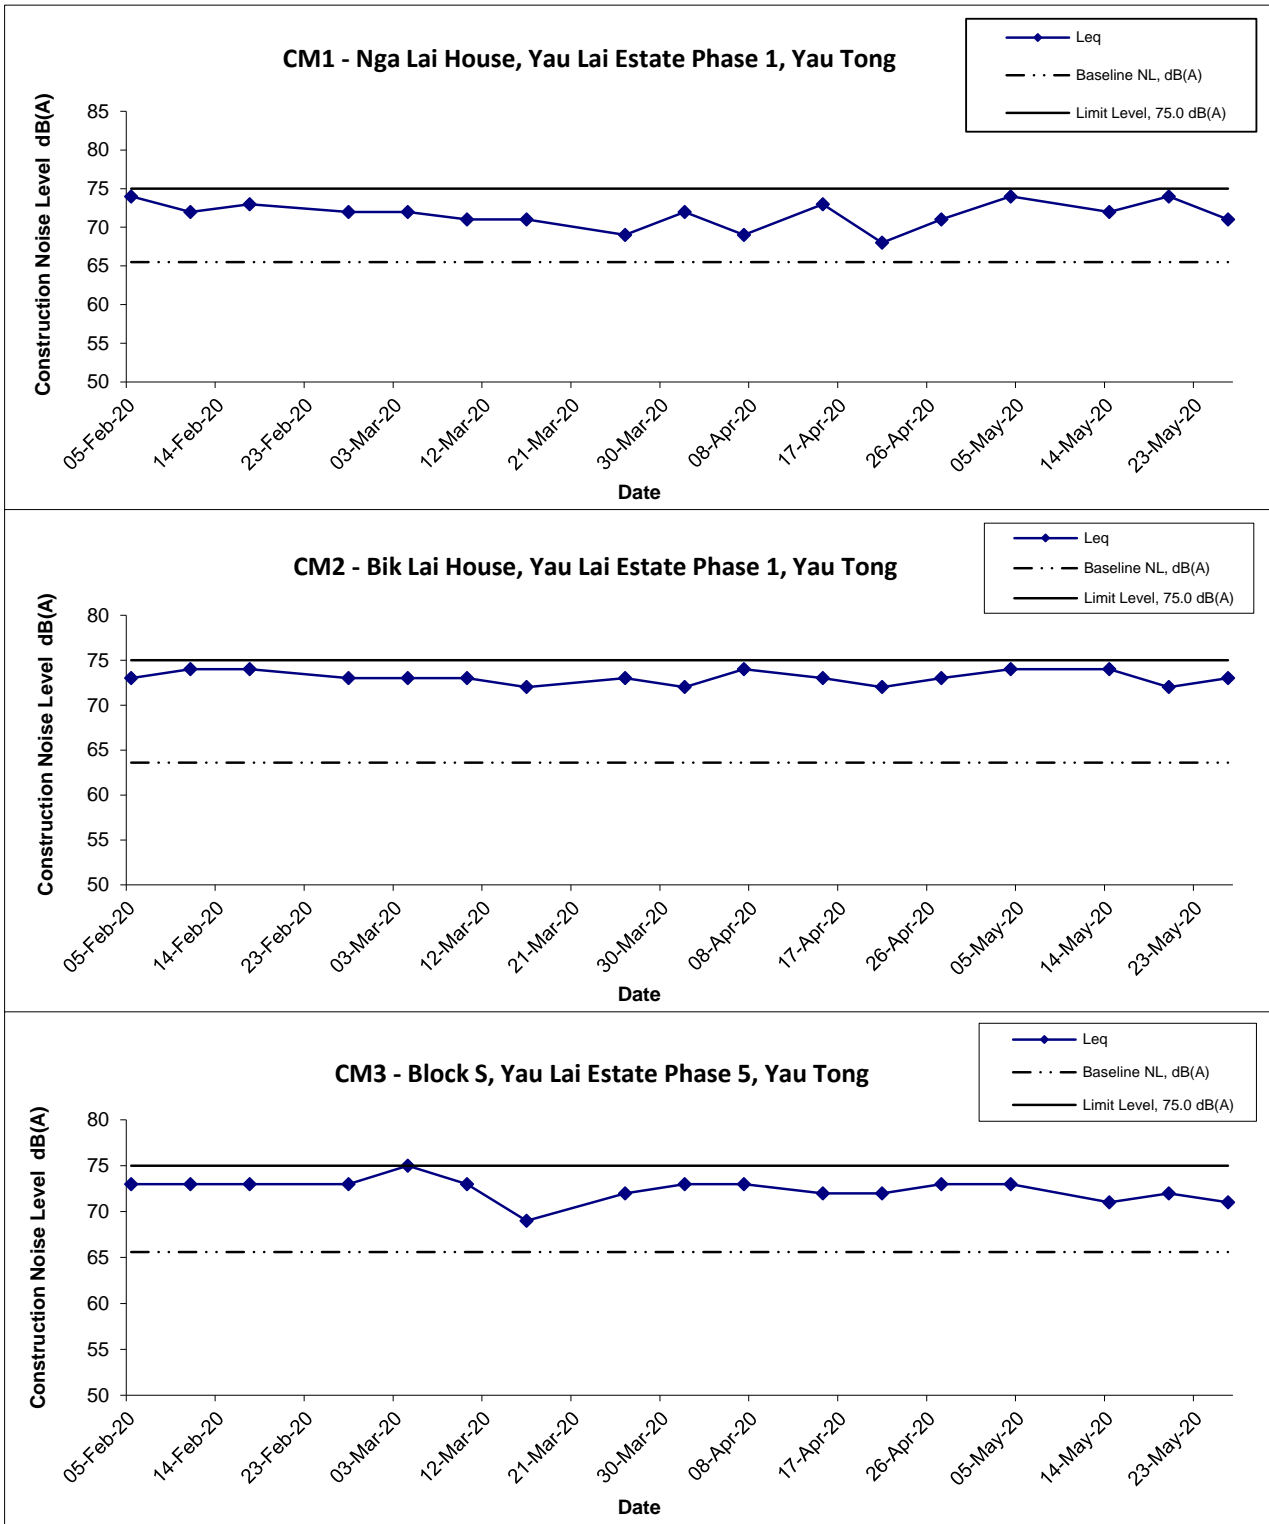
Noise Levels

Title Agreement No. CE/59/2015 (EP) Environmental Team for Tseung Kwan O - Lam Tin Tunnel - Design and Construction Graphical Presentation of Construction Noise Monitoring Results	Scale	Project	CINOTECH
	N.T.S	No. MA16034	
	Date May 20	Appendix G
