**Agreement No. CE 59/2015 (EP)
Environmental Team for
Tseung Kwan O – Lam Tin Tunnel
Design and Construction**

**Monthly Environmental Monitoring and
Audit Report for
June 2020
(version 1.0)**

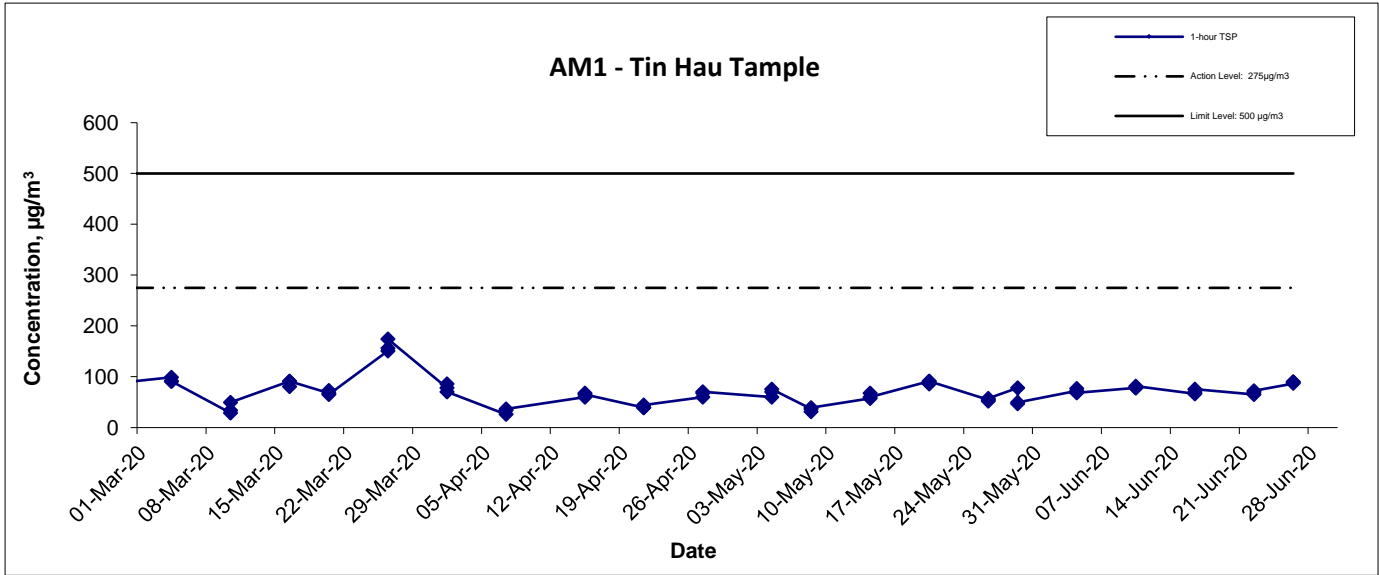
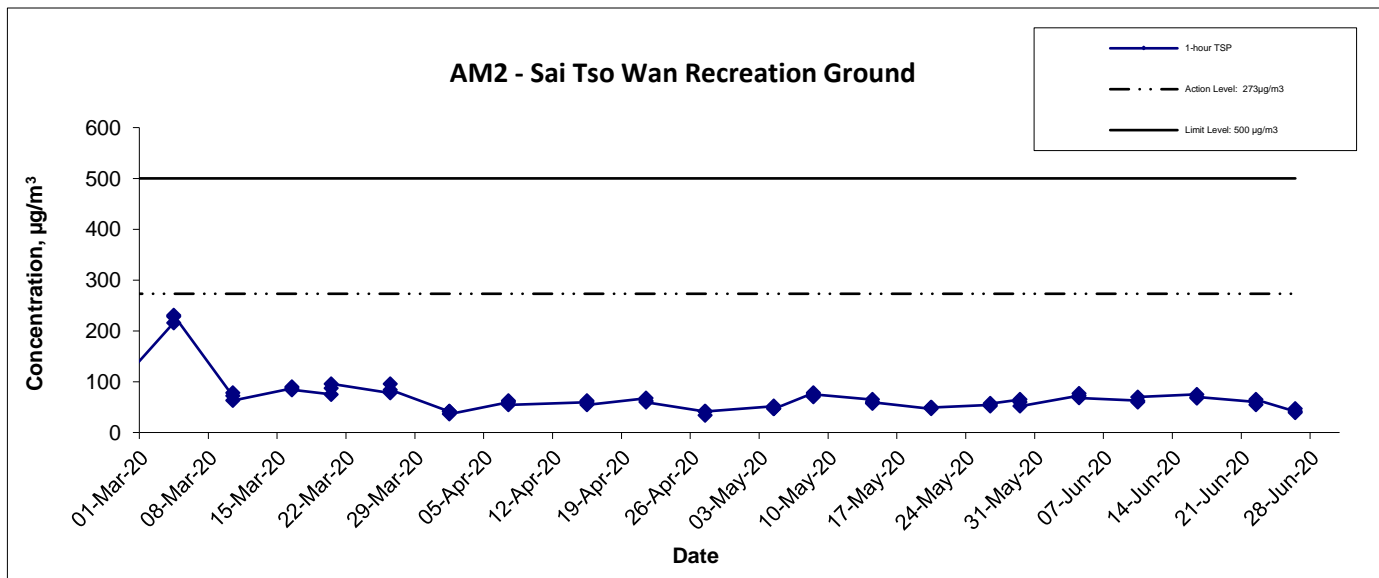
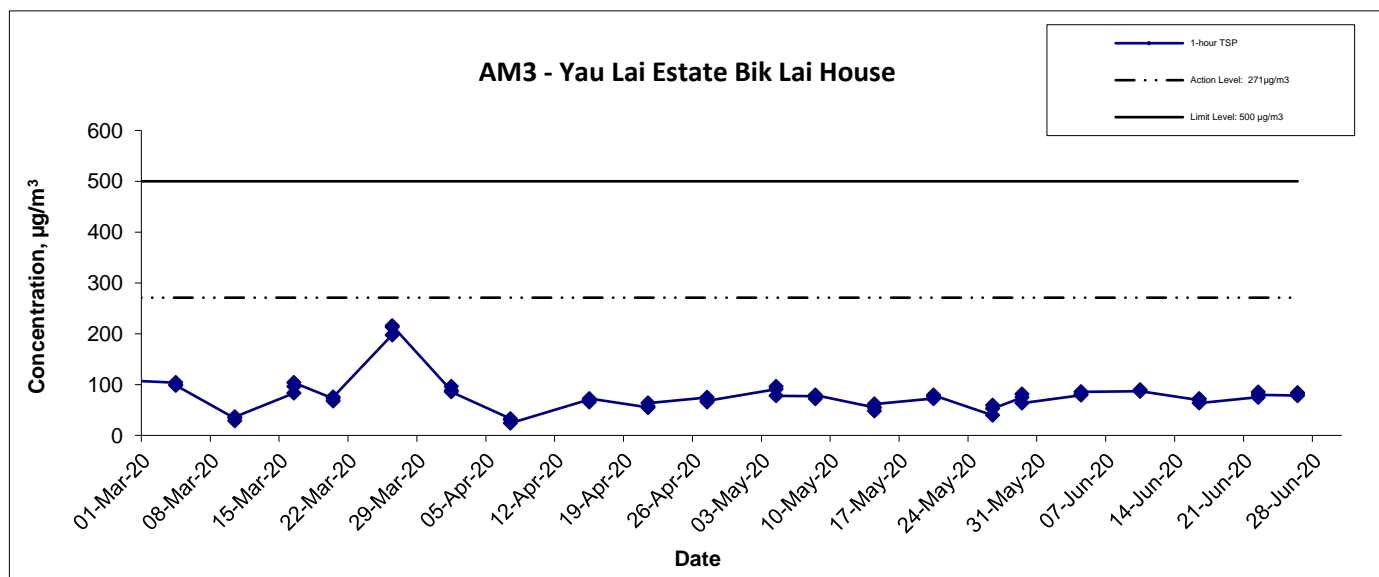
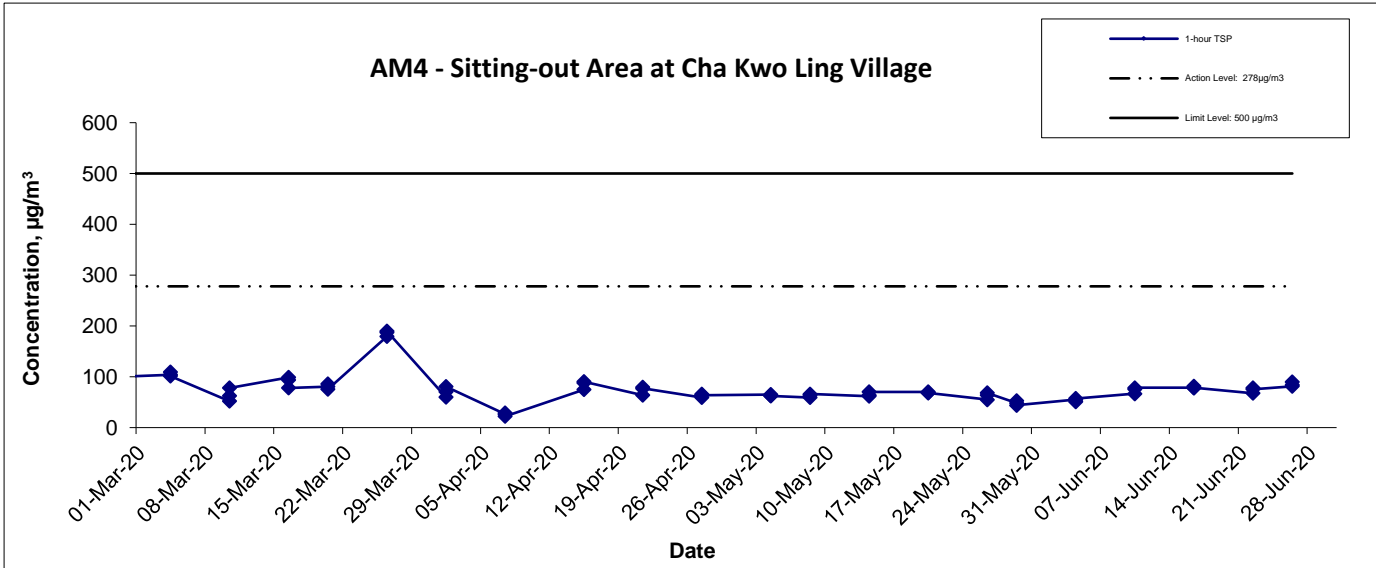
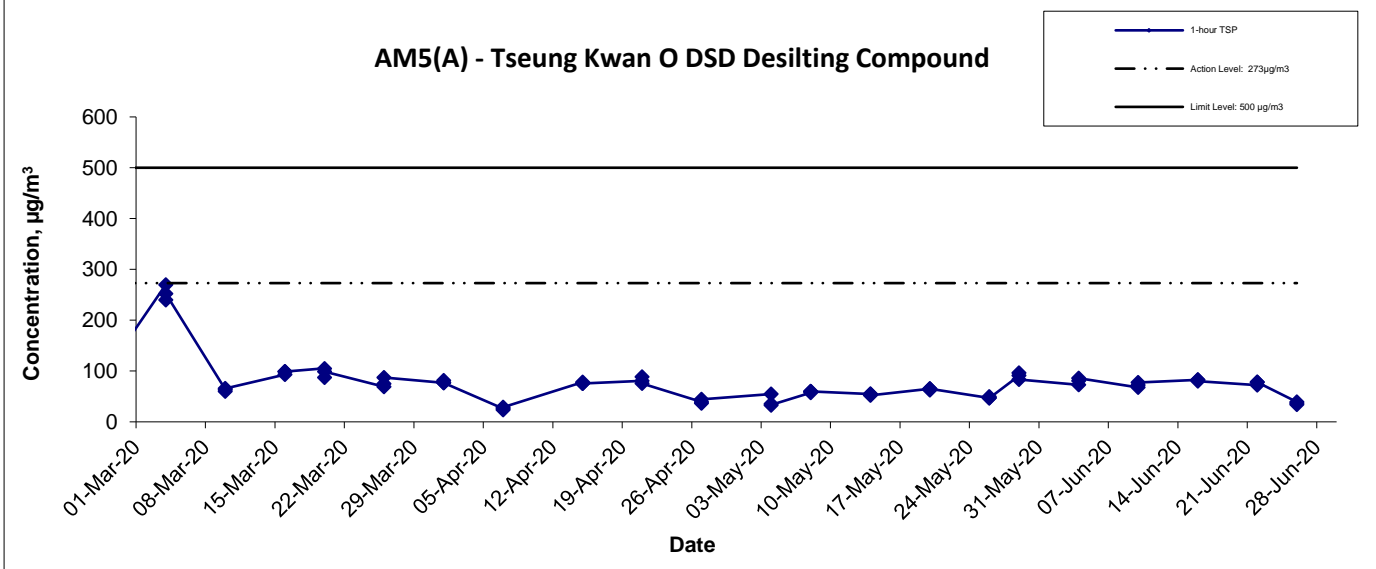
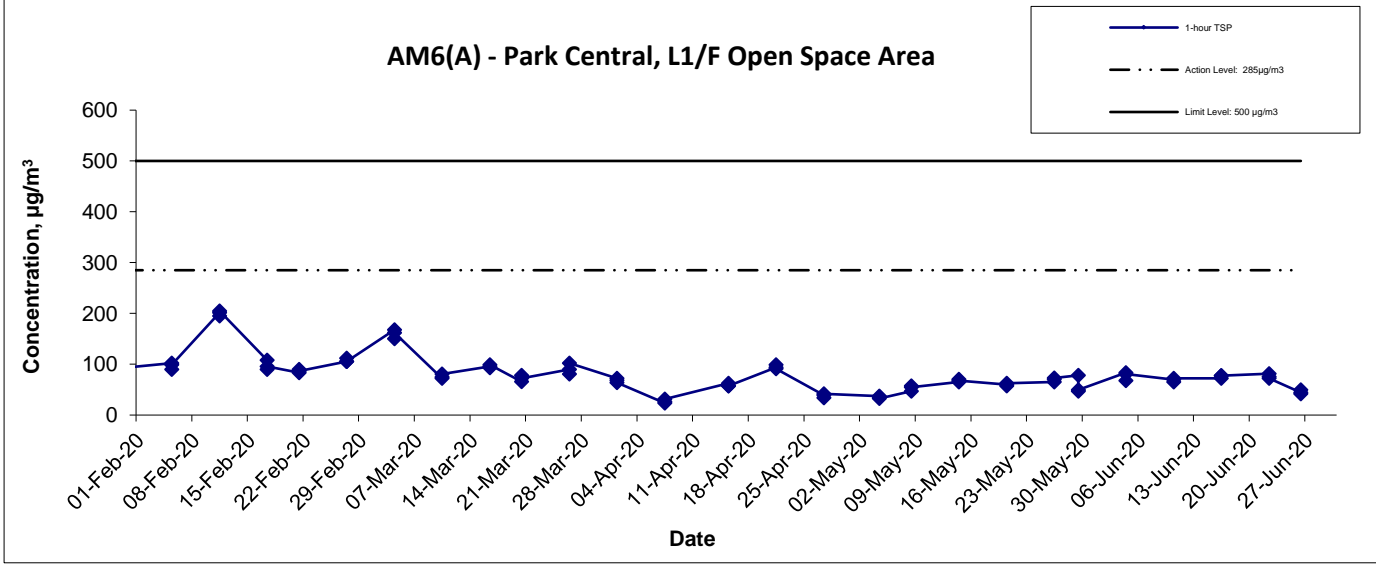
Agreement No. CE/59/2015 (EP) Environmental Team for Tseung Kwan O - Lam Tin Tunnel - Design and Construction	Scale	N.T.S	Project No.	MA16034	CINOTECH
Graphical Presentation of 1-hour TSP Monitoring Results	Date	Jun-20	Appendix	E

1-hr TSP Concentration Levels

- 3.21 No Action/Limit Level exceedance was recorded for both 1-hour TSP and 24-hour TSP monitoring respectively.
- 3.22 The air temperature, precipitation and the relative humidity data was obtained from Hong Kong Observatory where the wind speed and wind direction were recorded by the installed Wind Anemometer at rooftop of Yau Lai Estate Bik Lai House (41/F). The location is shown in **Figure 2**. This weather information for the reporting month is summarized in **Appendix C**.
- 3.23 The monitoring data and graphical presentations of 1-hour and 24-hour TSP monitoring results are shown in **Appendix E** and **Appendix F** respectively.
- 3.24 According to our field observations, the major dust source identified at the designated air quality monitoring stations are as follows:

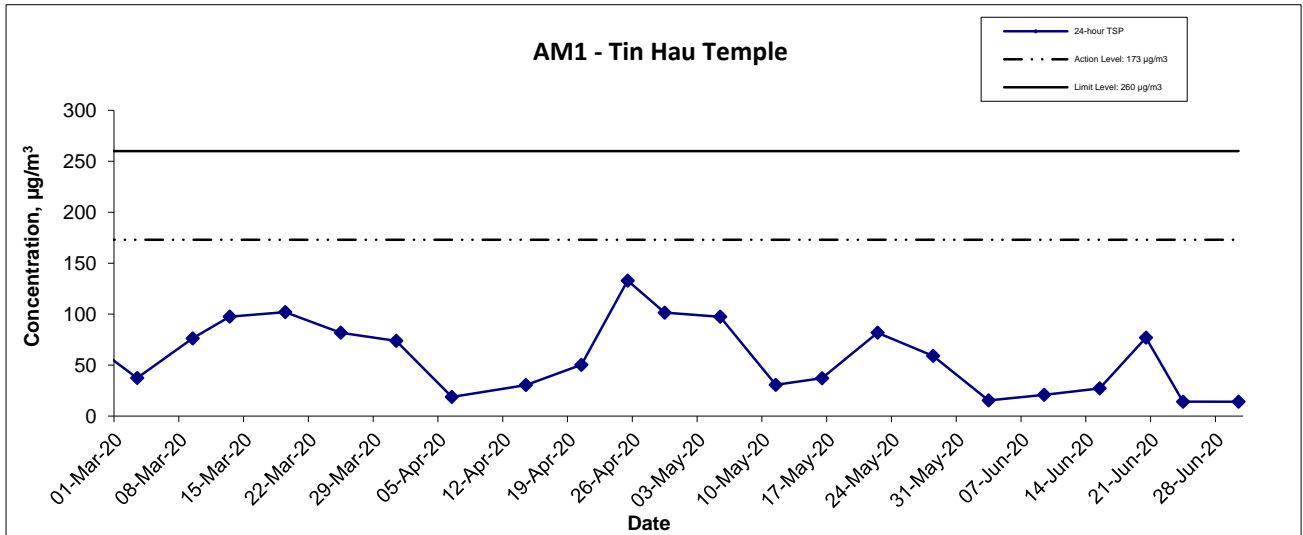
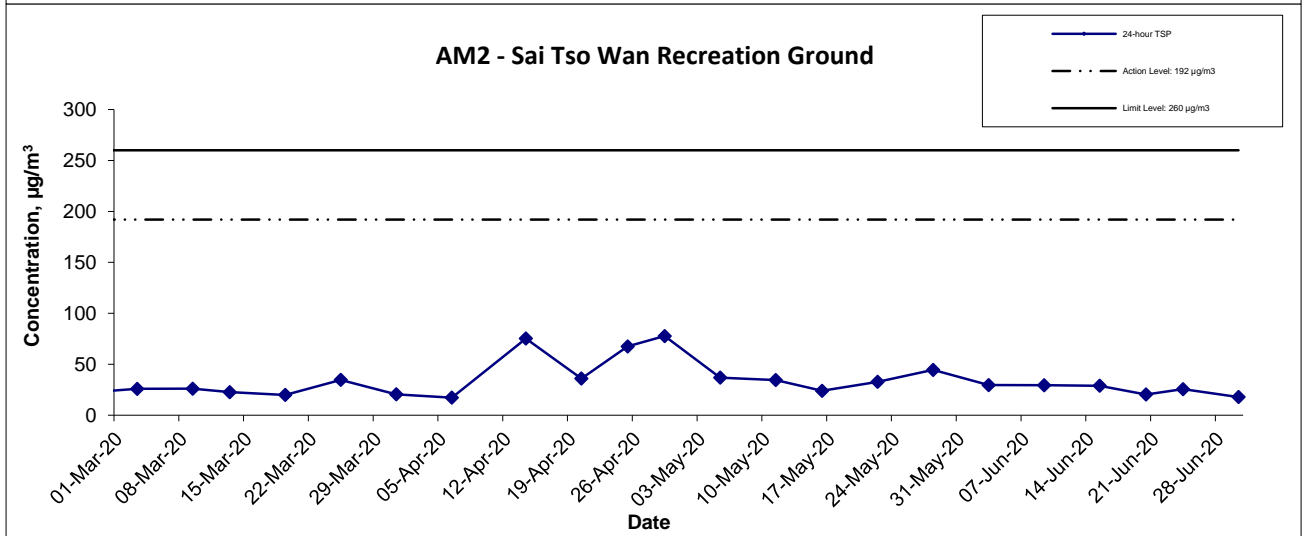
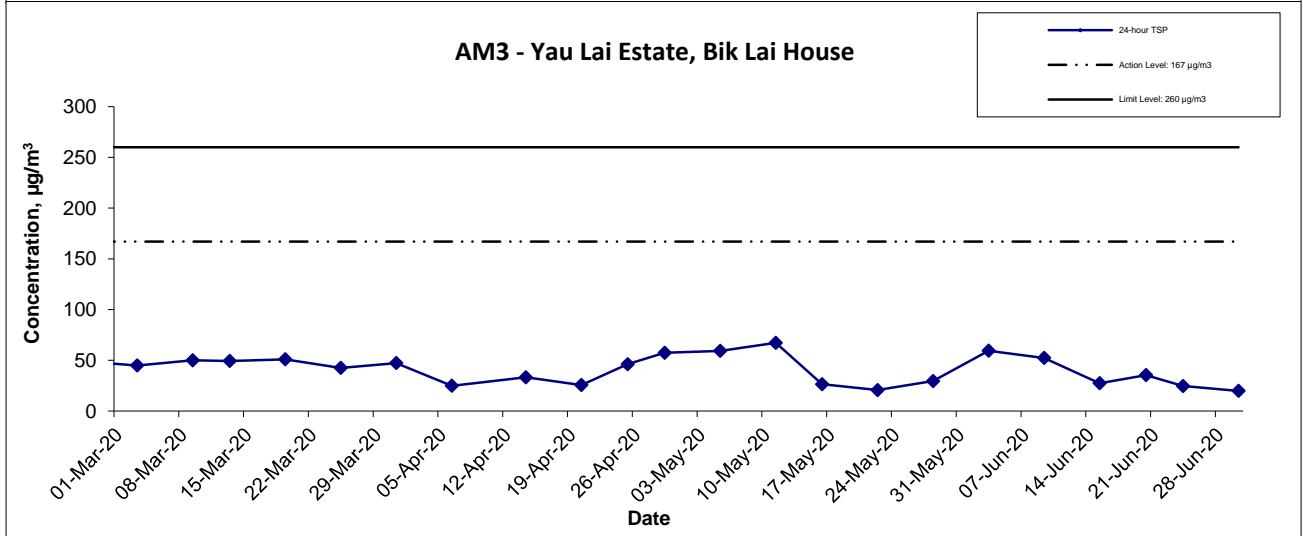
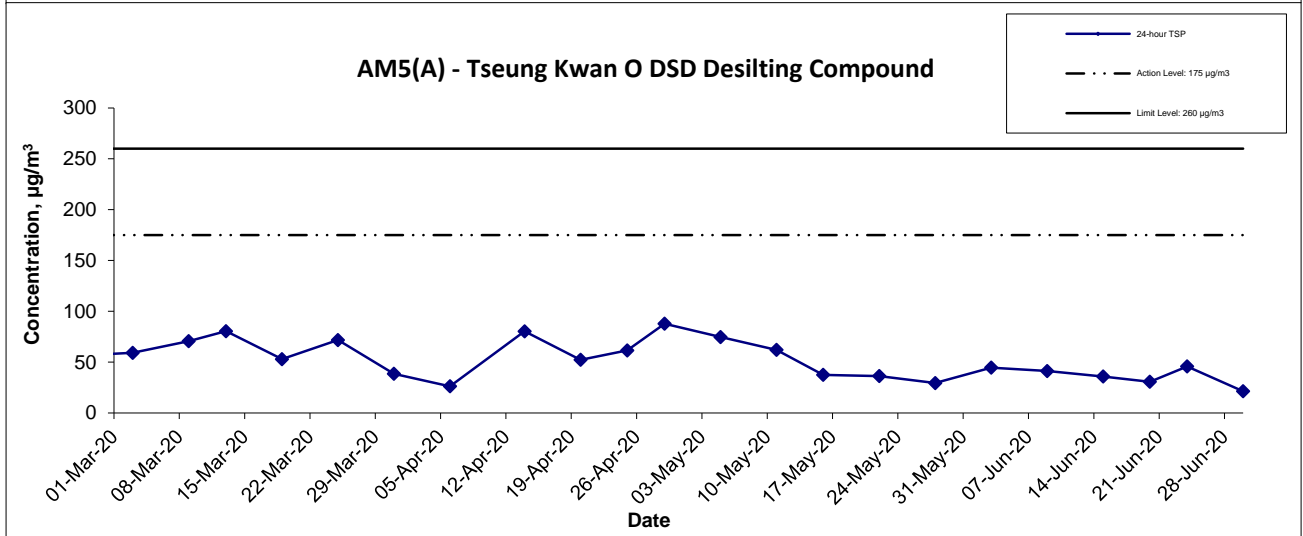
24-hr TSP Concentration Levels

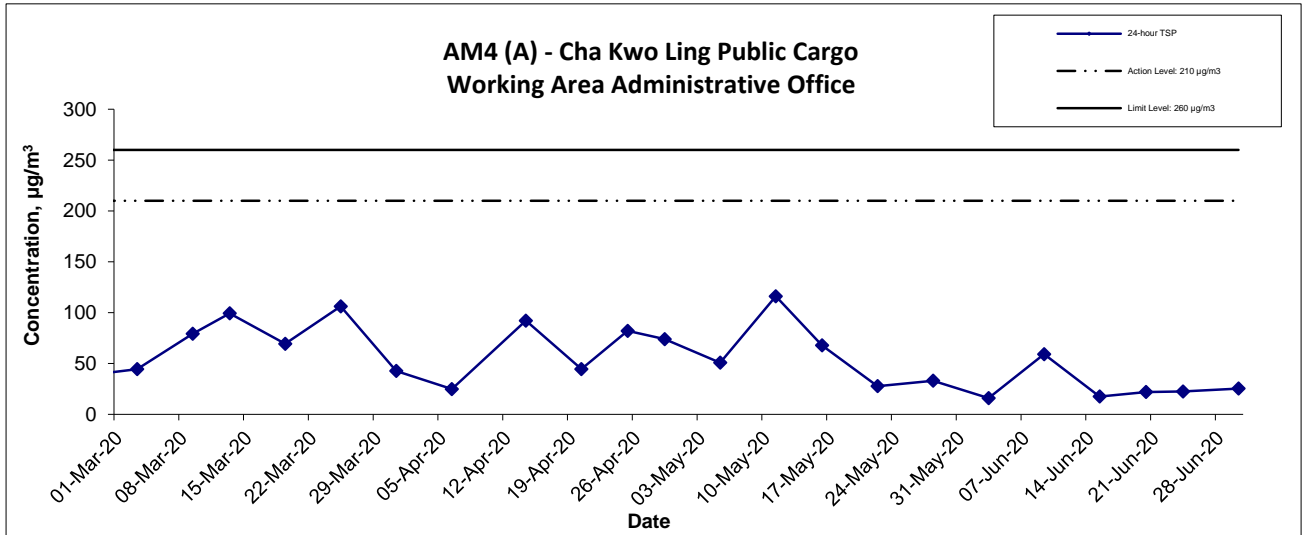
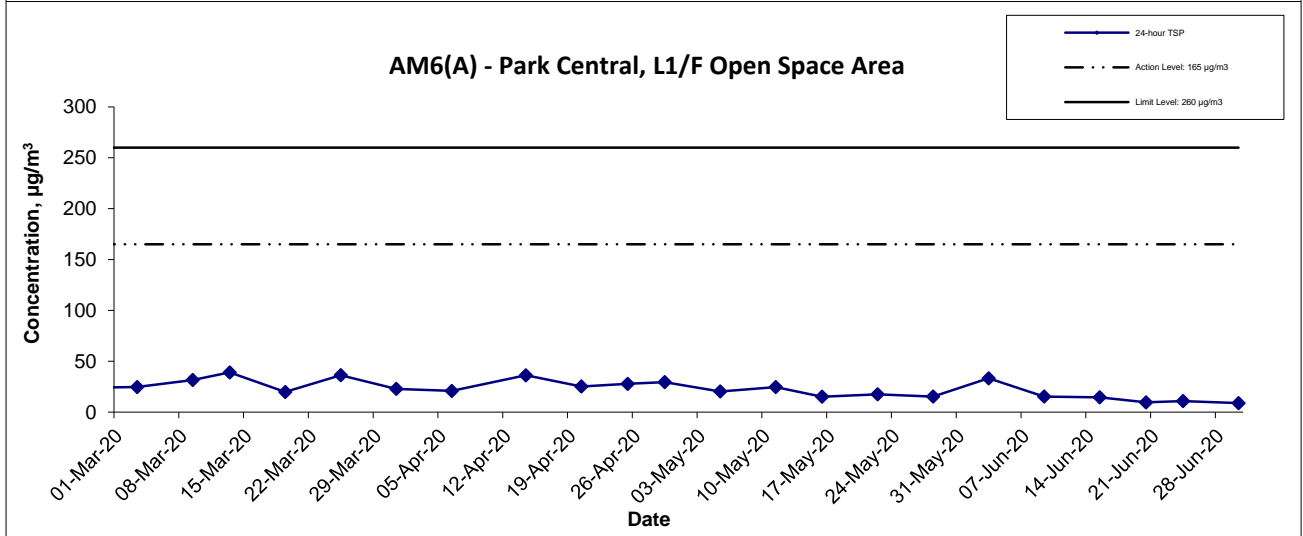
Graphical Presentation of 24-hour TSP Monitoring Results

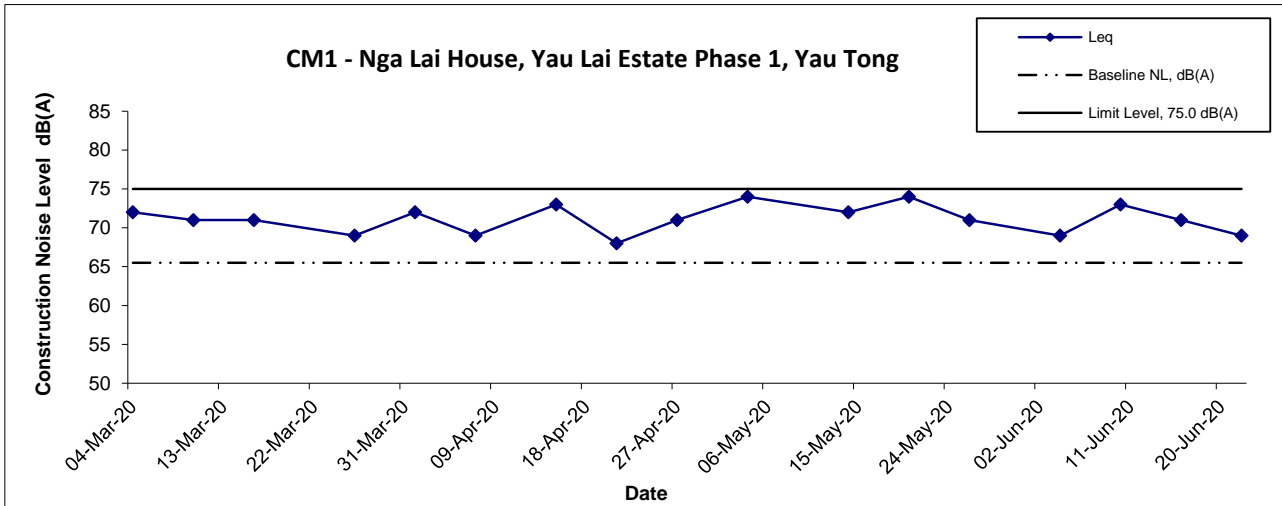
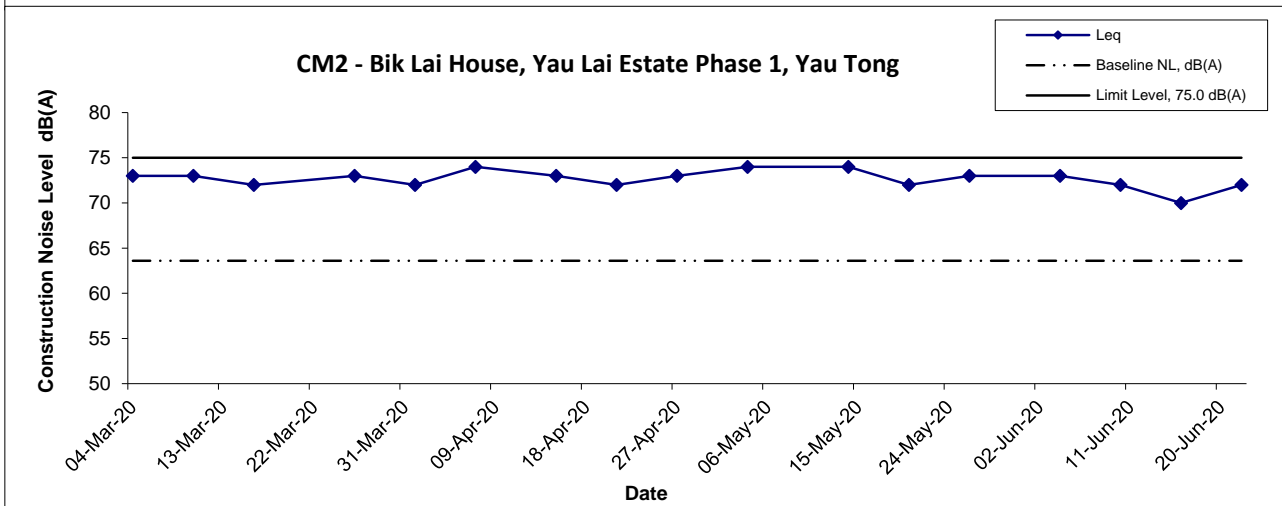
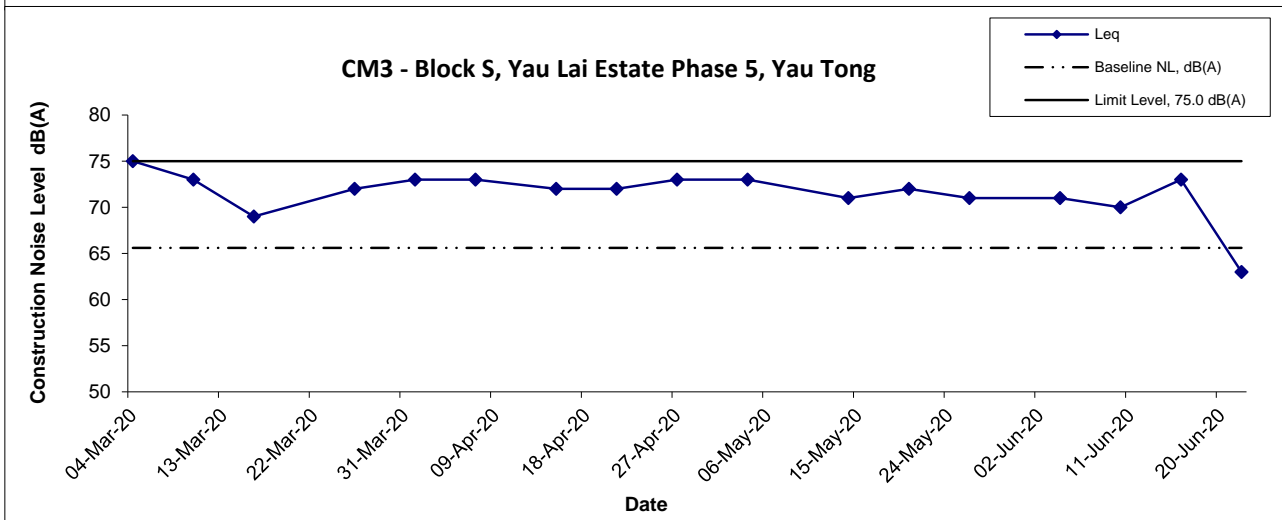
Noise Levels

Title Agreement No. CE/59/2015 (EP) Environmental Team for Tseung Kwan O - Lam Tin Tunnel - Design and Construction Graphical Presentation of Construction Noise Monitoring Results	Scale	Project	CINOTECH
	N.T.S	No. MA16034	
	Date	Appendix	
	Jun 20	G

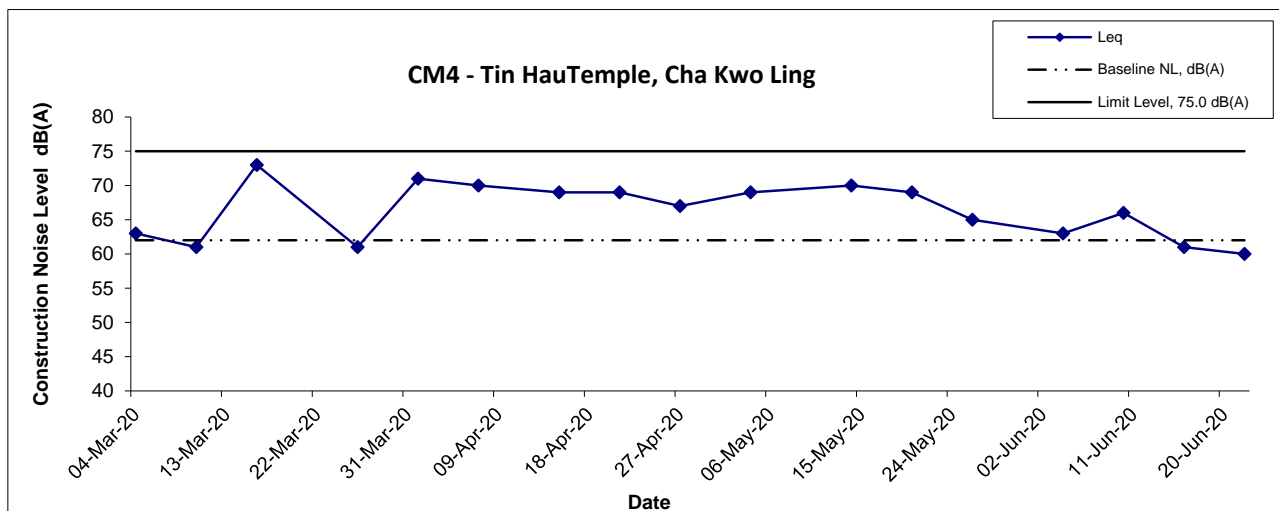
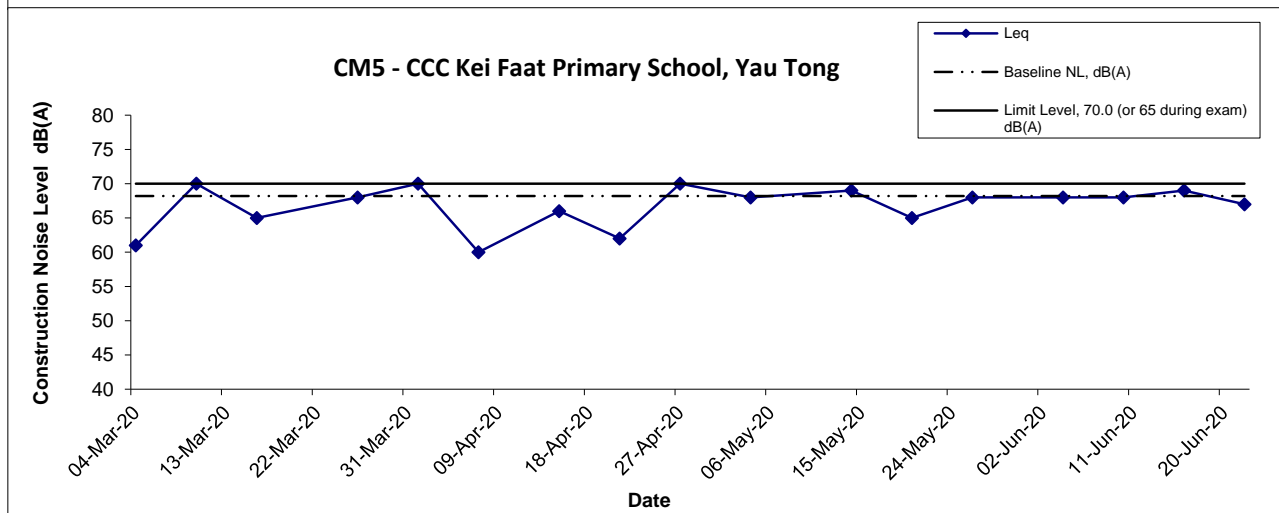
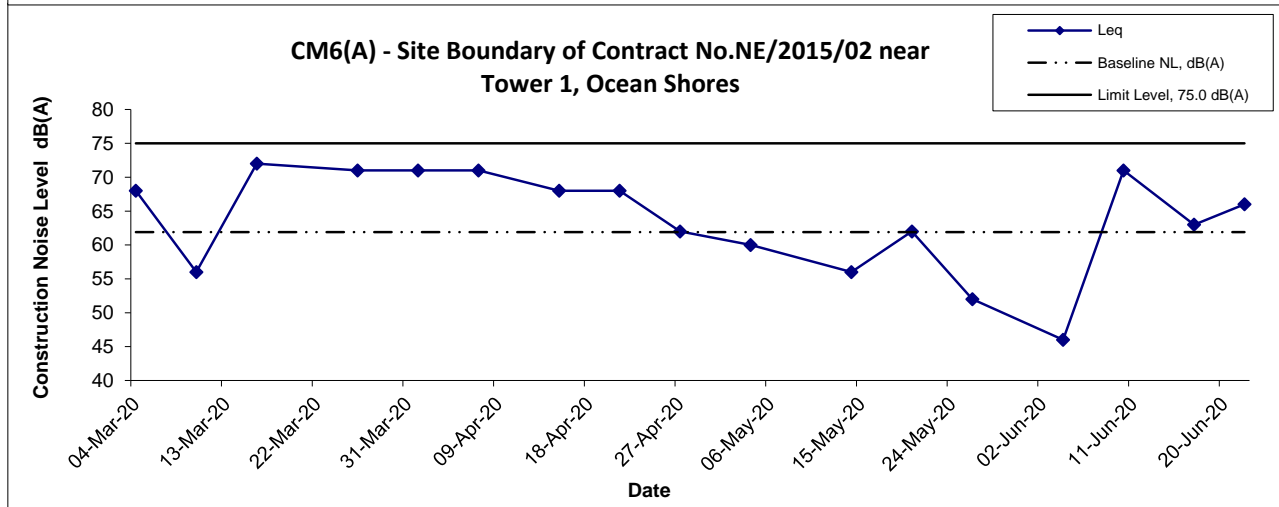
Noise Levels

Title Agreement No. CE/59/2015 (EP) Environmental Team for Tseung Kwan O - Lam Tin Tunnel - Design and Construction Graphical Presentation of Construction Noise Monitoring Results	Scale	N.T.S	Project	No. MA16034	CINOTECH
	Date	Jun 20	Appendix	G

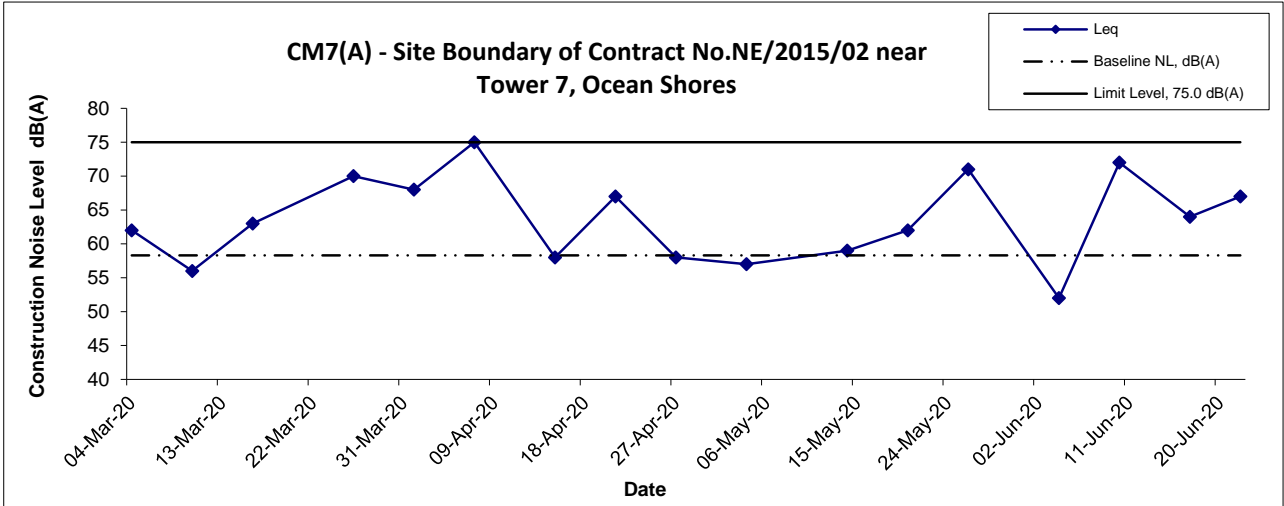
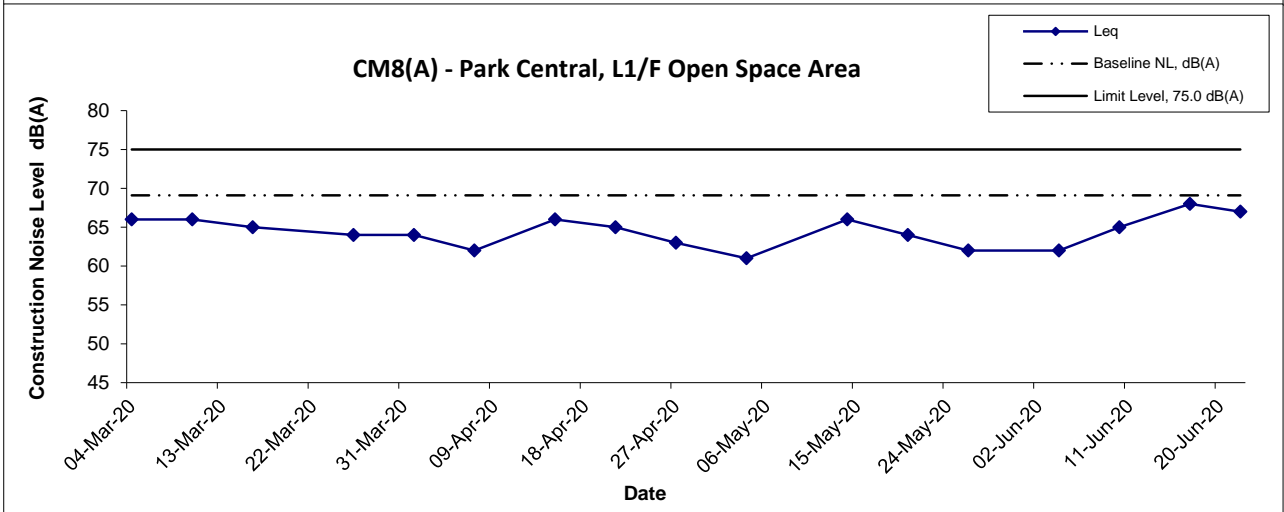
Noise Levels

Title Agreement No. CE/59/2015 (EP) Environmental Team for Tseung Kwan O - Lam Tin Tunnel - Design and Construction Graphical Presentation of Construction Noise Monitoring Results	Scale	N.T.S	Project No. MA16034	CINOTECH
	Date	Jun 20	Appendix G

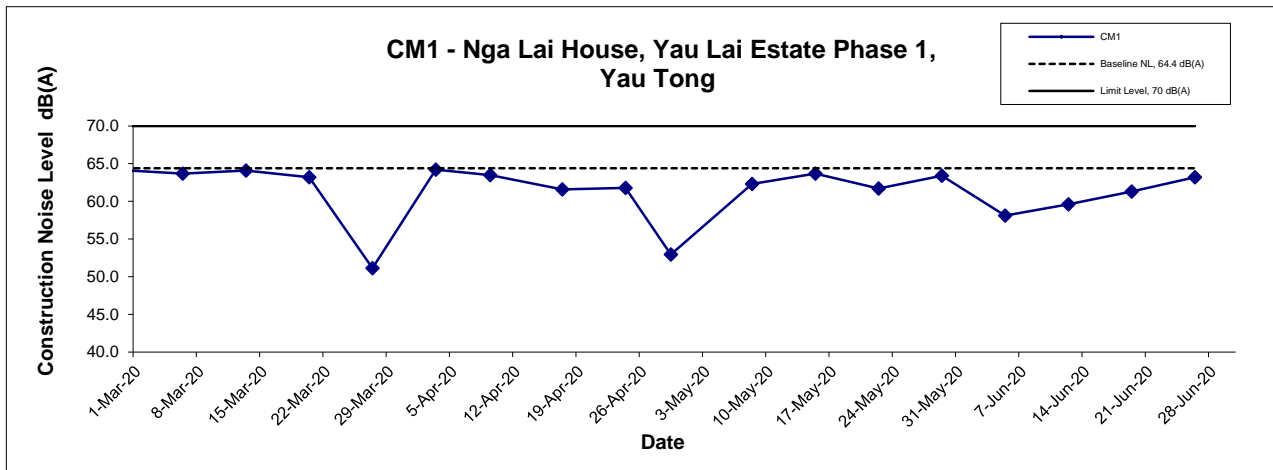
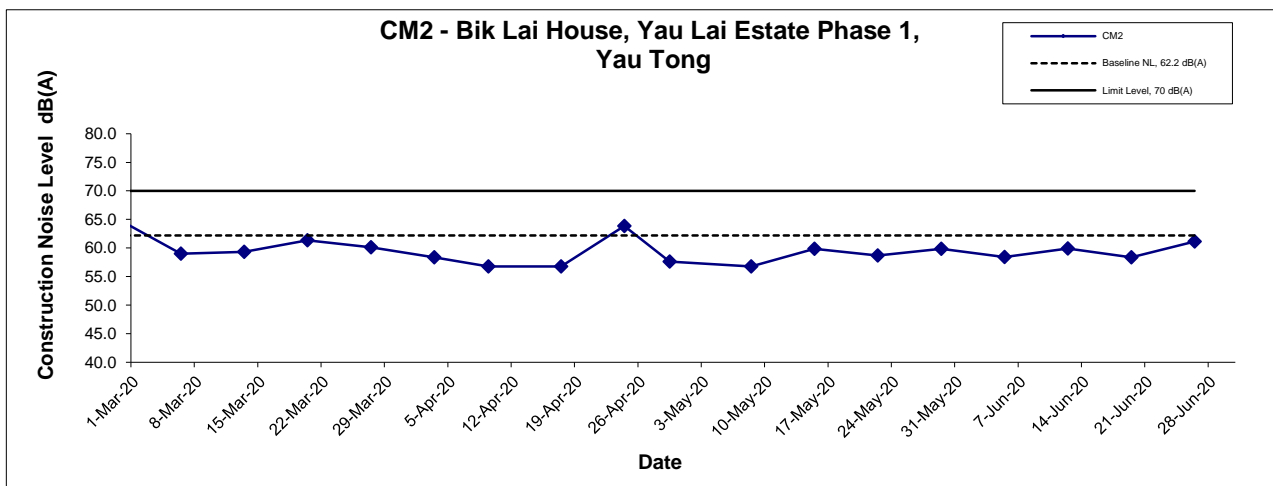
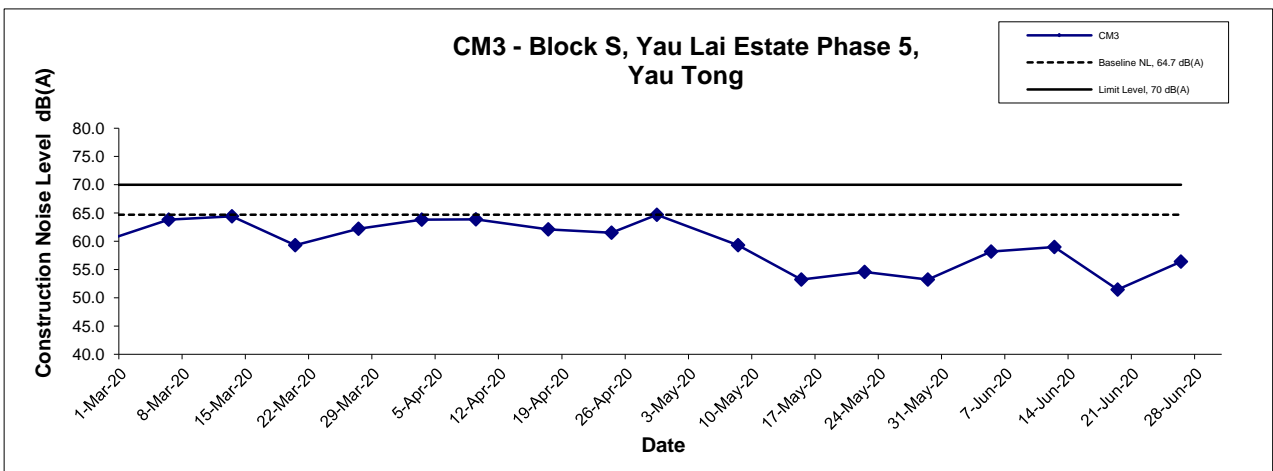
Noise Levels (Restricted Hours - 19:00 - 23:00 on normal weekdays)

Title Agreement No. CE/59/2015 (EP) Environmental Team for Tseung Kwan O - Lam Tin Tunnel - Design and Construction	Scale N.T.S	Project No. MA16034	
	Graphical Presentation of Restricted Noise Monitoring Results	Date Jun 20

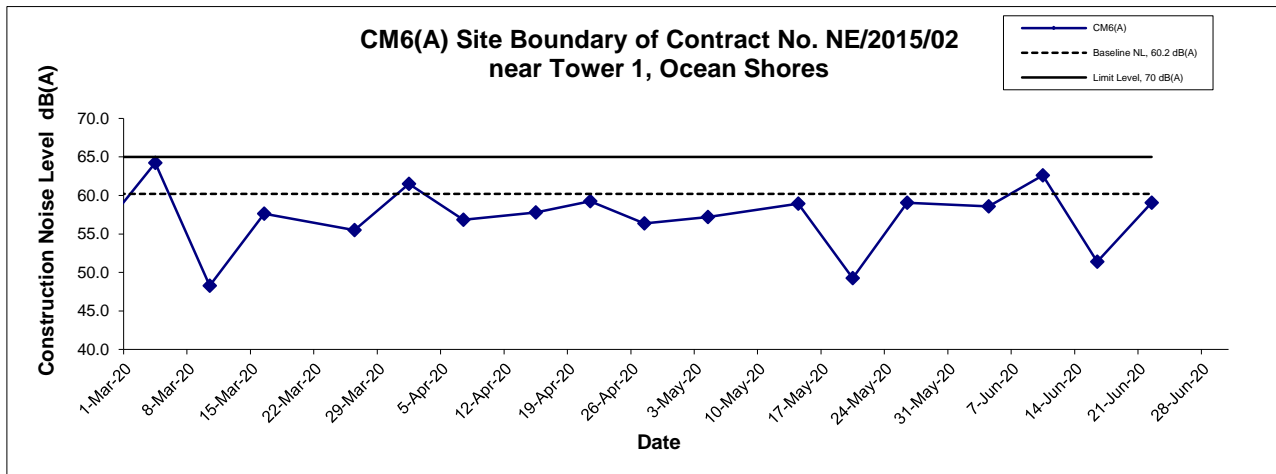
Noise Levels
(Restricted Hours - 19:00 - 23:00 on normal weekdays)

Title Agreement No. CE/59/2015 (EP) Environmental Team for Tseung Kwan O - Lam Tin Tunnel - Design and Construction Graphical Presentation of Restricted Noise Monitoring Results	Scale N.T.S	Project No. MA16034	CINOTECH
	Date Jun 20	Appendix G

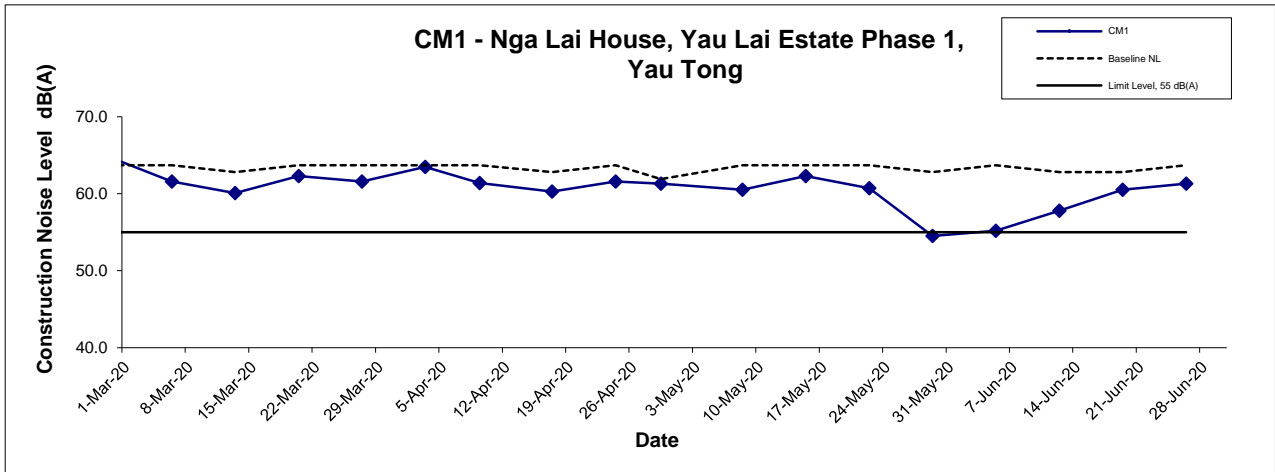
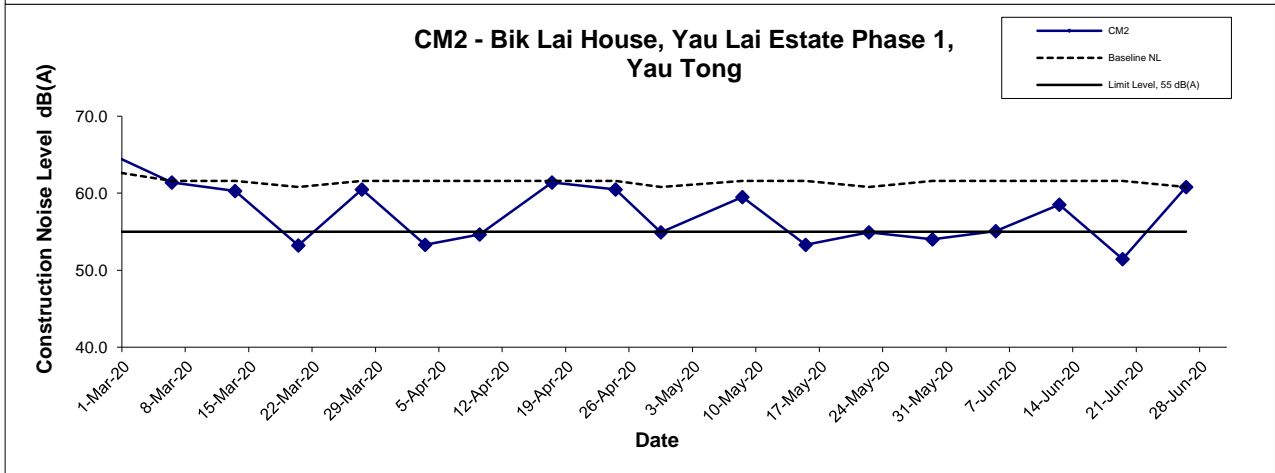
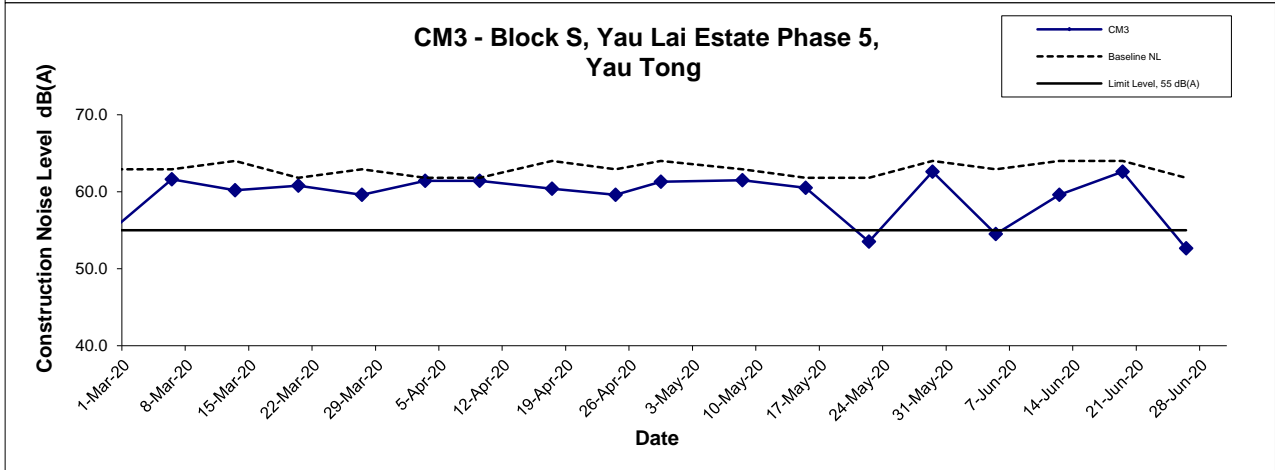
Noise Levels (Restricted Hours - 2300-0700 on normal weekdays)

Title Agreement No. CE/59/2015 (EP) Environmental Team for Tseung Kwan O - Lam Tin Tunnel - Design and Construction Graphical Presentation of Restricted Noise Monitoring Results	Scale	N.T.S	Project No.	MA16034	CINOTECH
	Date	Jun 20	Appendix	G

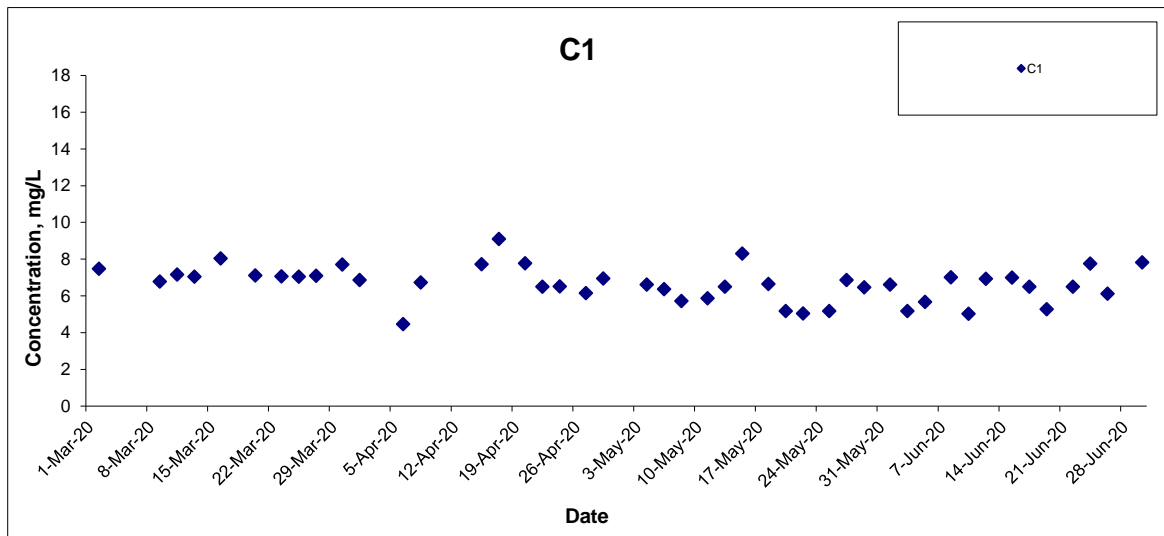
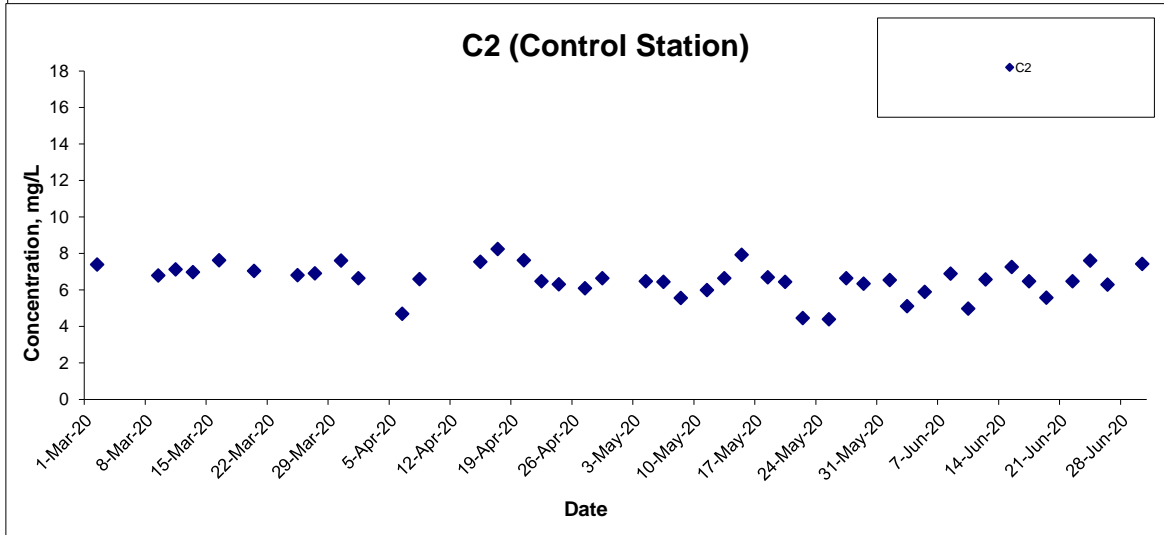
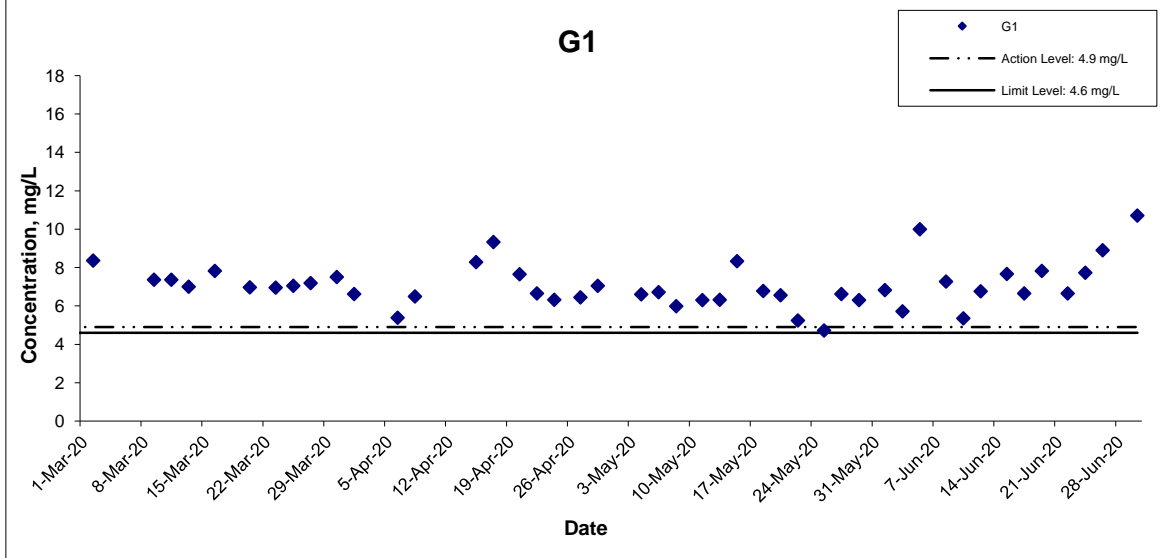
Dissolved Oxygen (Depth-averaged) at Mid-Ebb Tide

Title Agreement No. CE 59/2015(EP) Environmental Team for Tseung Kwan O - Lam Tin Tunnel Design and Construction Graphical Presentation of Water Quality Monitoring Results	Scale N.T.S	Project No. MA16034	
	Date June 20	Appendix I

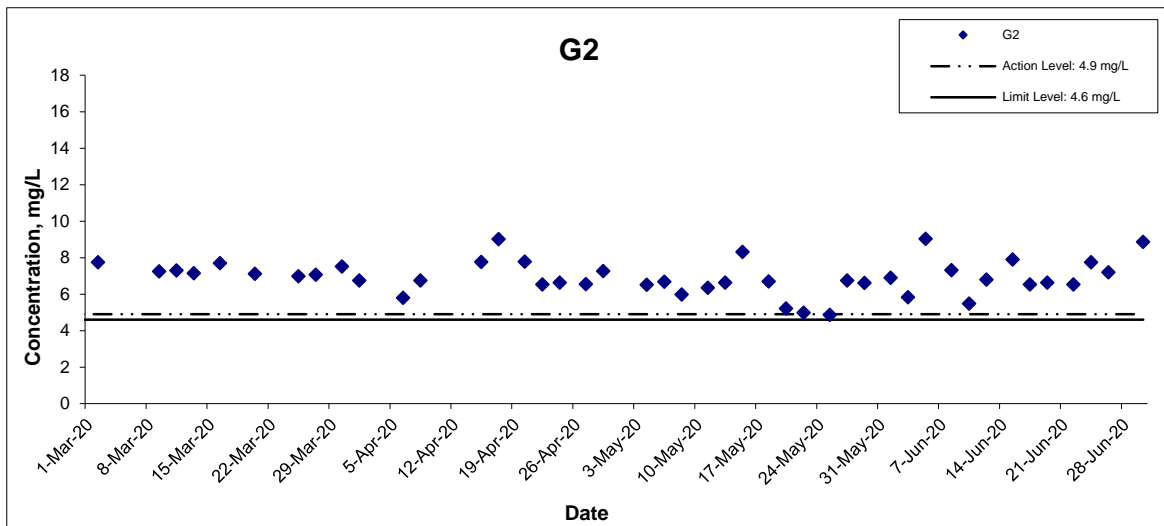
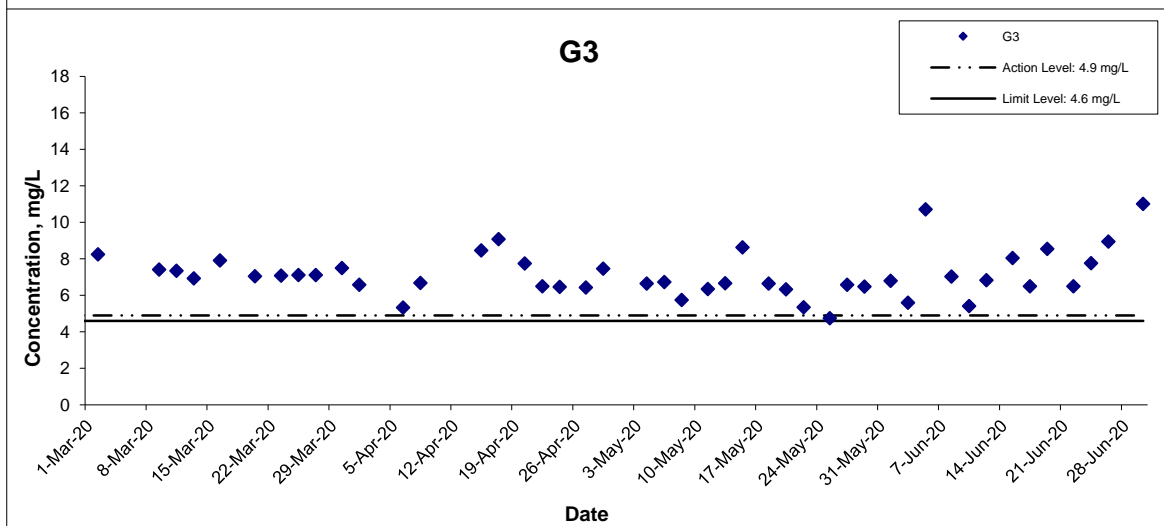
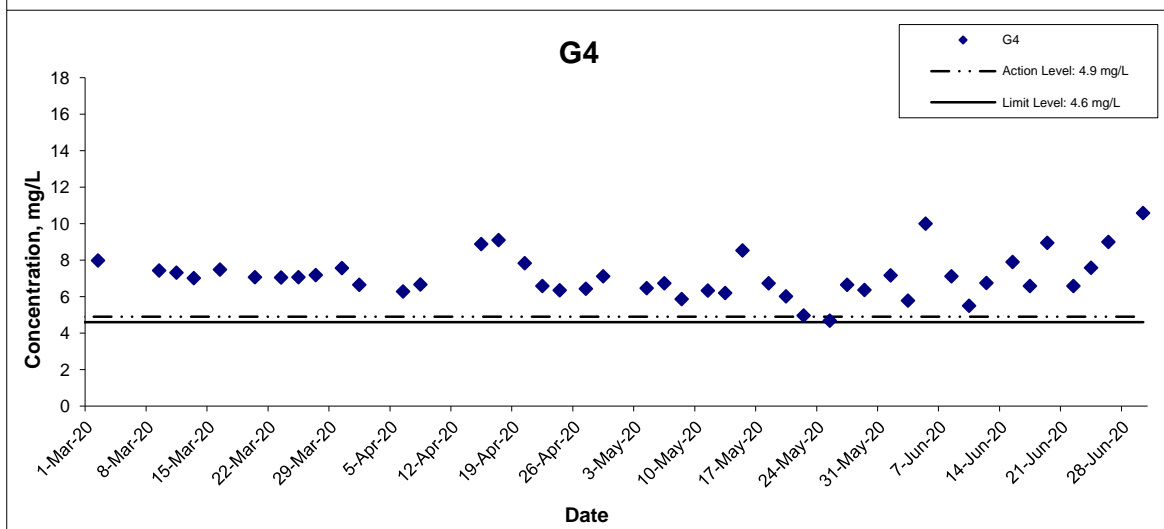
Dissolved Oxygen (Depth-averaged) at Mid-Ebb Tide

Title Agreement No. CE 59/2015(EP) Environmental Team for Tseung Kwan O - Lam Tin Tunnel Design and Construction Graphical Presentation of Water Quality Monitoring Results	Scale N.T.S	Project No. MA16034	
	Date June 20	Appendix I
