**Agreement No. CE 59/2015 (EP)
Environmental Team for
Tseung Kwan O – Lam Tin Tunnel
Design and Construction**

**Monthly Environmental Monitoring and
Audit Report for
June 2020
(version 1.0)**

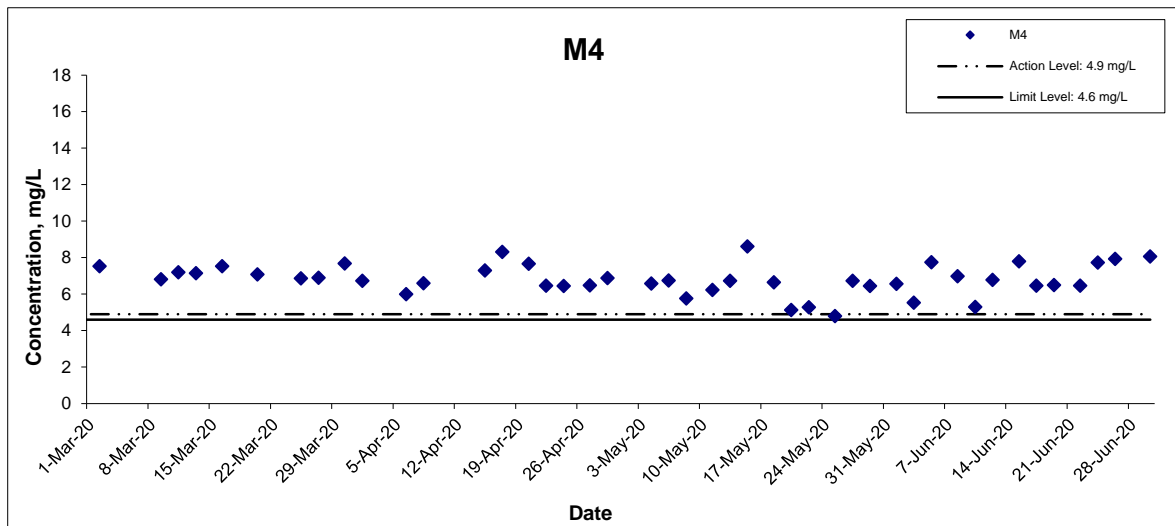
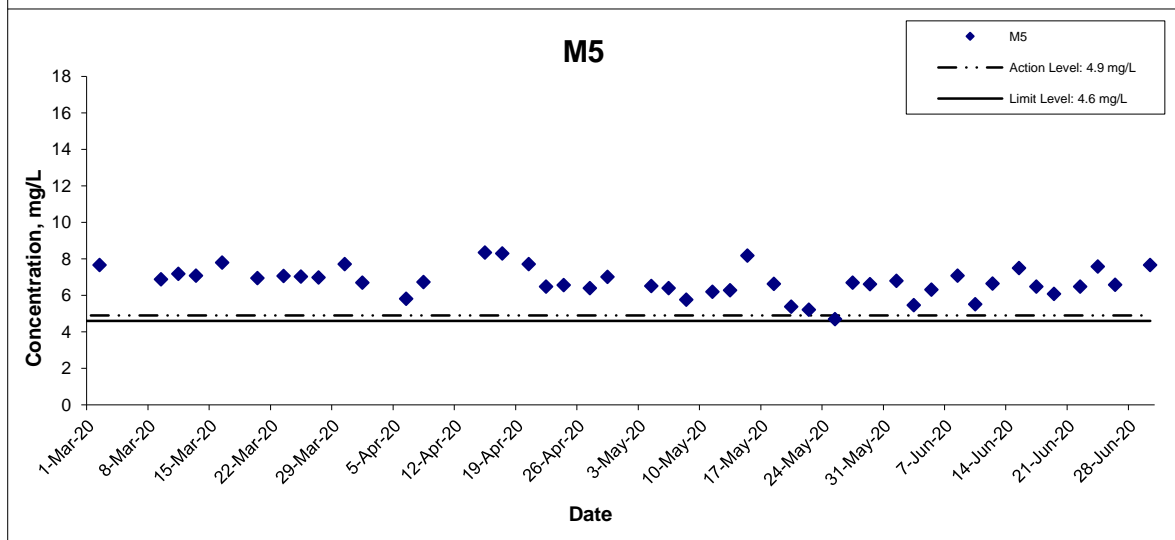
Dissolved Oxygen (Depth-averaged) at Mid-Ebb Tide

Title Agreement No. CE 59/2015(EP) Environmental Team for Tseung Kwan O - Lam Tin Tunnel Design and Construction Graphical Presentation of Water Quality Monitoring Results	Scale N.T.S	Project No. MA16034	
	Date June 20	Appendix I

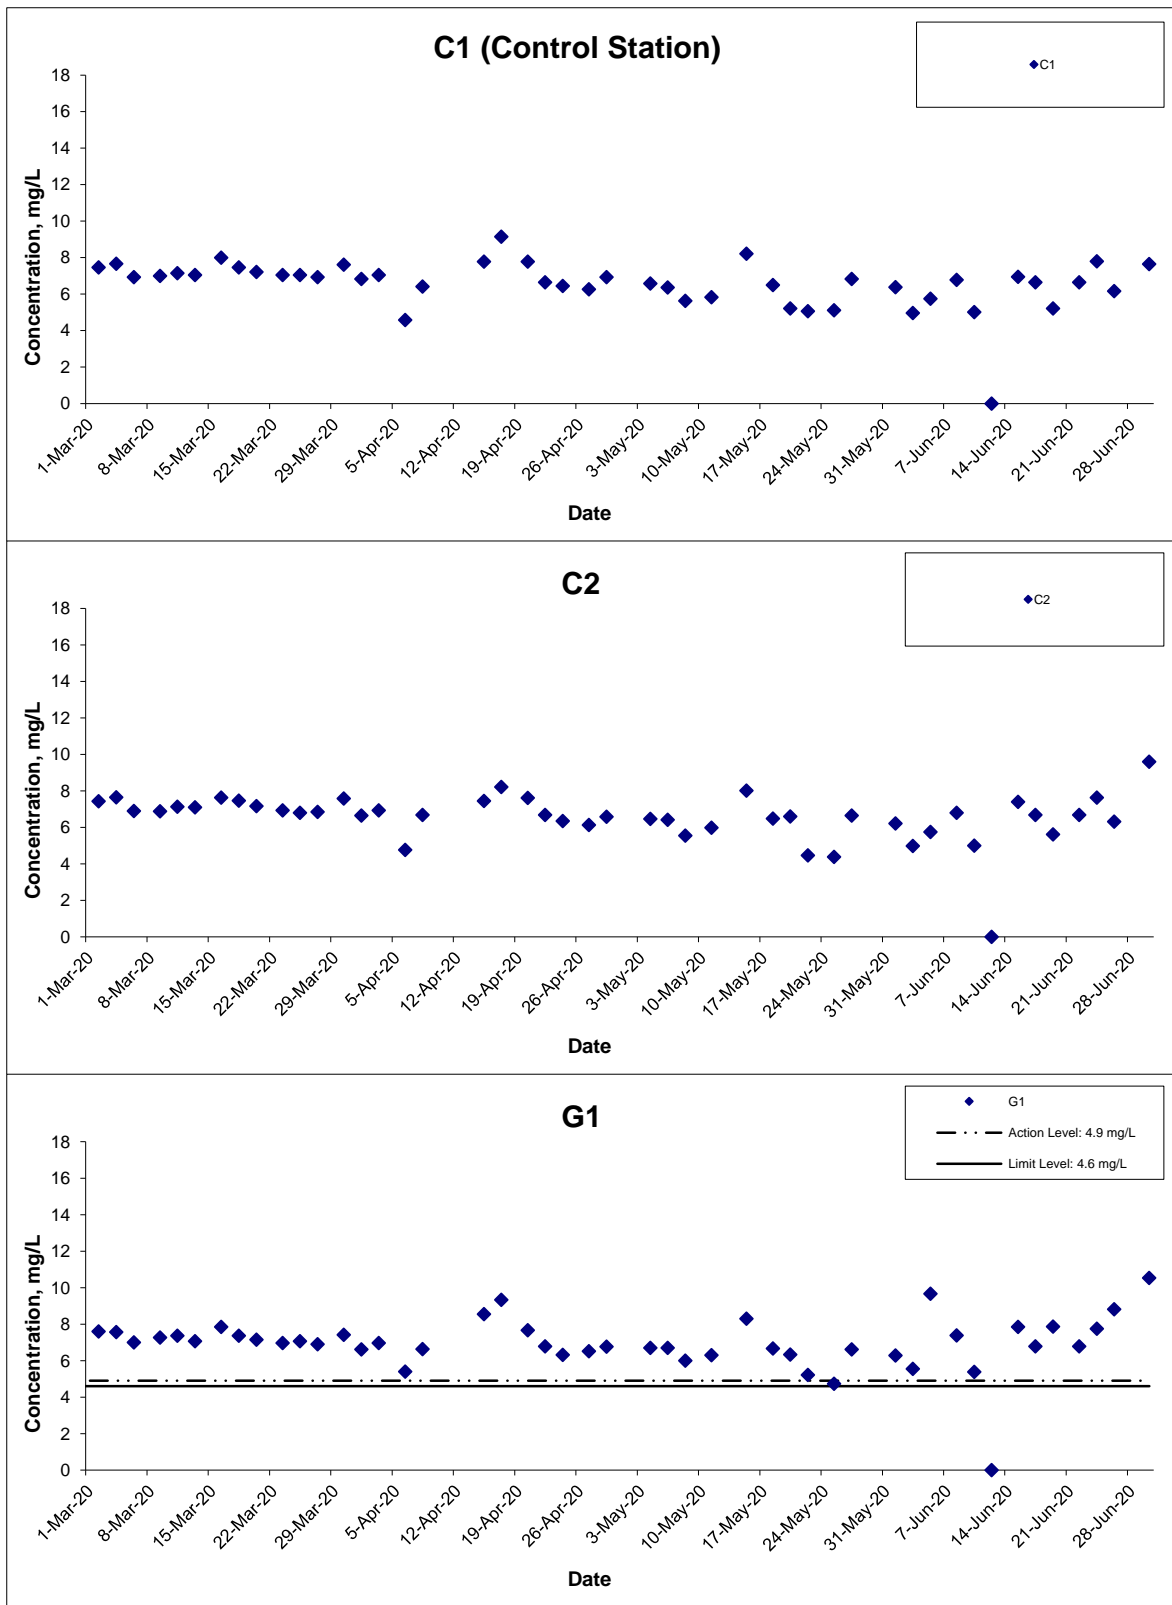
Dissolved Oxygen (Depth-averaged) at Mid-Flood Tide

Title Agreement No. CE 59/2015(EP) Environmental Team for Tseung Kwan O - Lam Tin Tunnel Design and Construction Graphical Presentation of Water Quality Monitoring Results	Scale N.T.S	Project No. MA16034	
	Date June 20	Appendix I

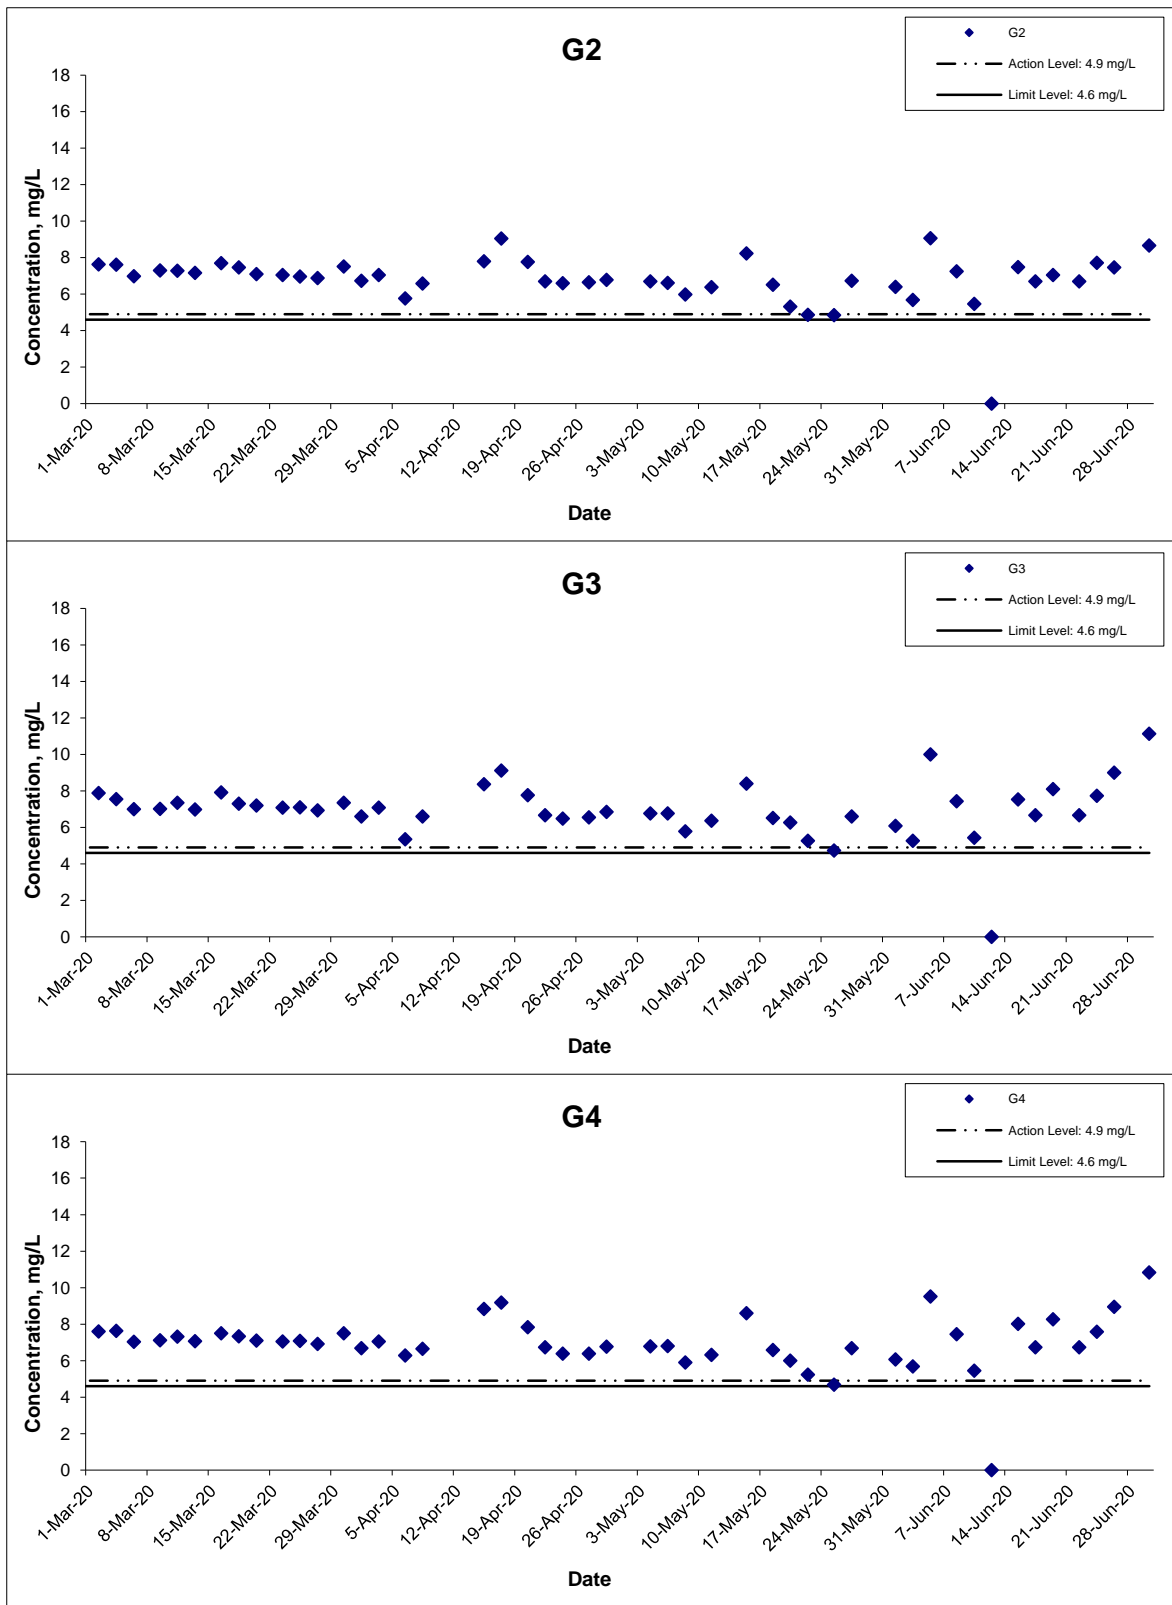
Dissolved Oxygen (Depth-averaged) at Mid-Flood Tide

Title Agreement No. CE 59/2015(EP) Environmental Team for Tseung Kwan O - Lam Tin Tunnel Design and Construction Graphical Presentation of Water Quality Monitoring Results	Scale N.T.S	Project No. MA16034	
	Date June 20	Appendix I

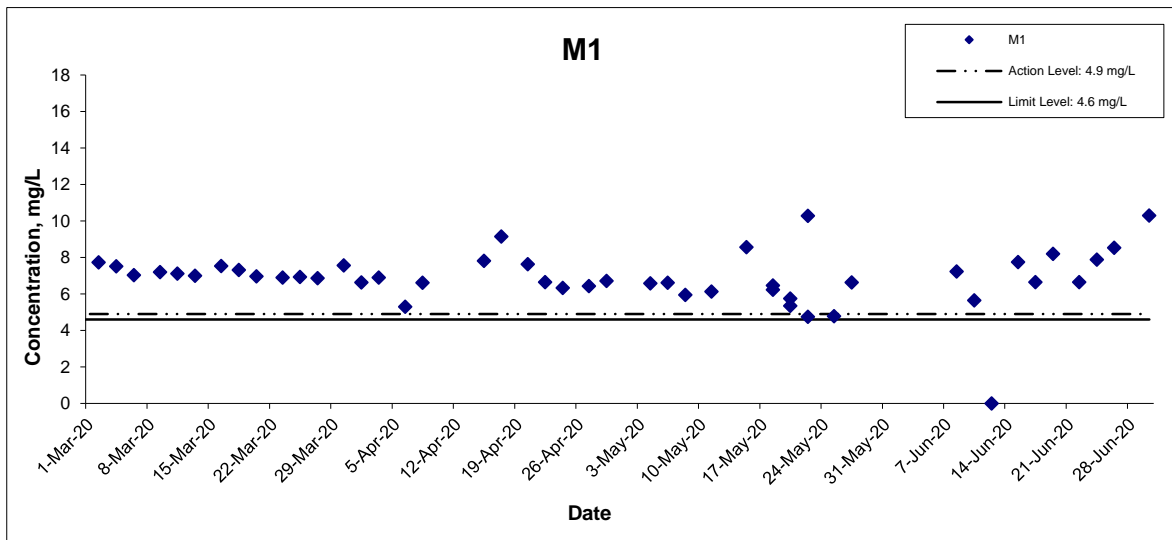
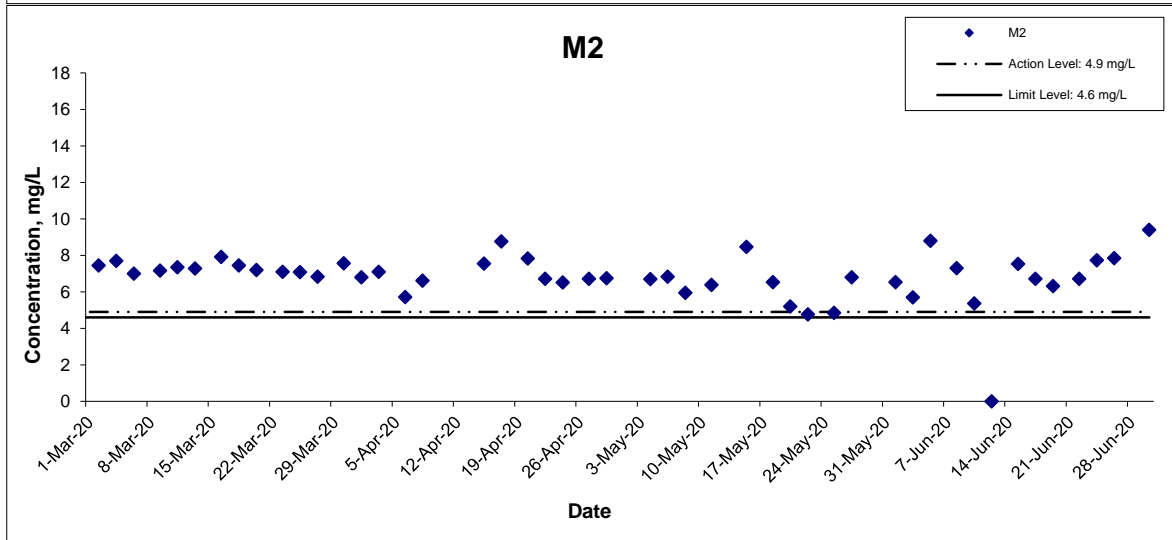
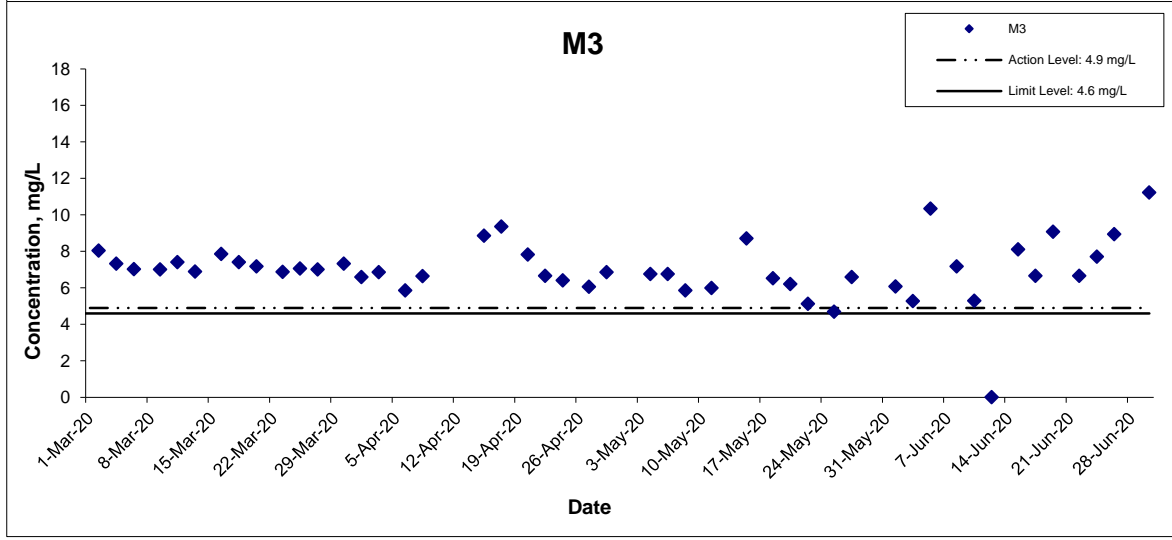
Dissolved Oxygen (Depth-averaged) at Mid-Flood Tide

Title Agreement No. CE 59/2015(EP) Environmental Team for Tseung Kwan O - Lam Tin Tunnel Design and Construction Graphical Presentation of Water Quality Monitoring Results	Scale N.T.S	Project No. MA16034	
	Date June 20	Appendix I

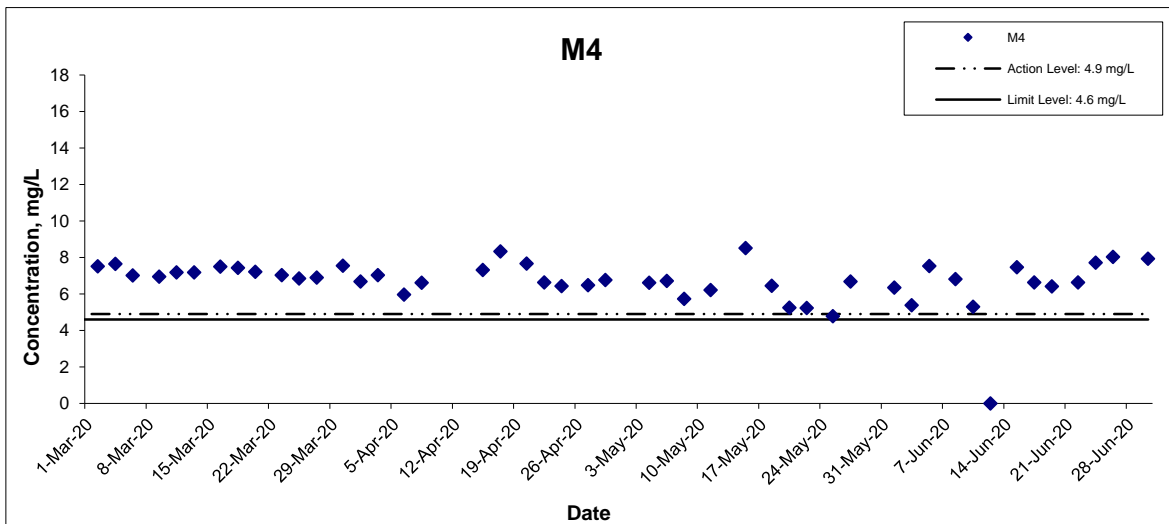
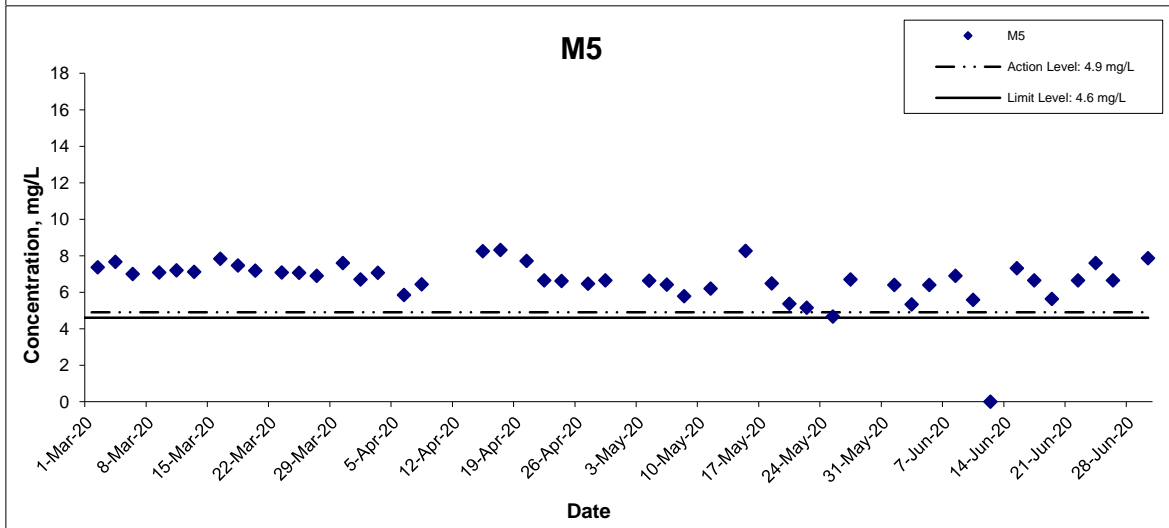
Dissolved Oxygen (Depth-averaged) at Mid-Flood Tide

Title Agreement No. CE 59/2015(EP) Environmental Team for Tseung Kwan O - Lam Tin Tunnel Design and Construction Graphical Presentation of Water Quality Monitoring Results	Scale N.T.S	Project No. MA16034	
	Date June 20	Appendix I

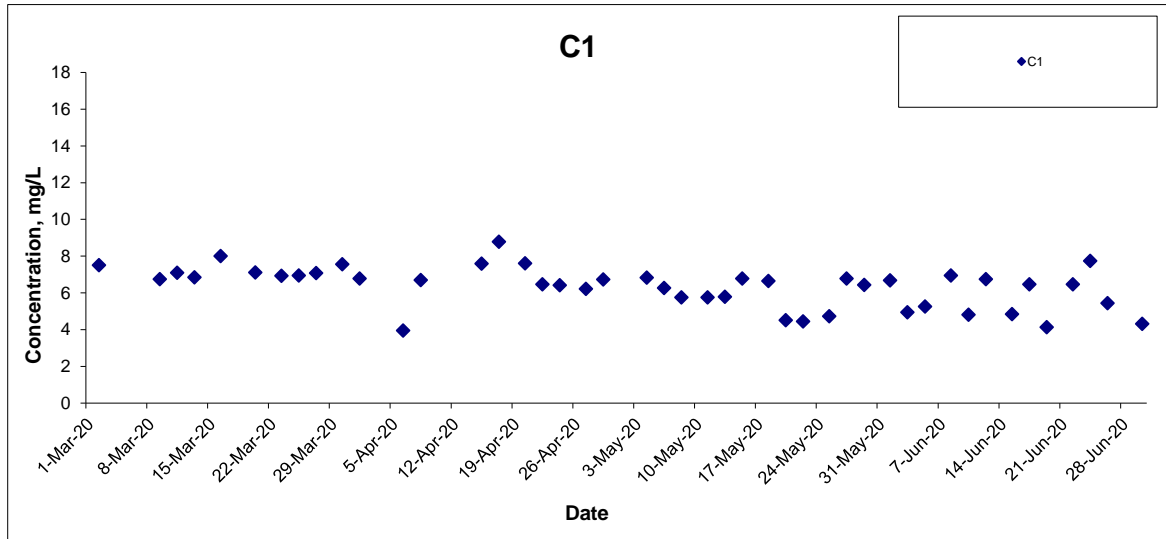
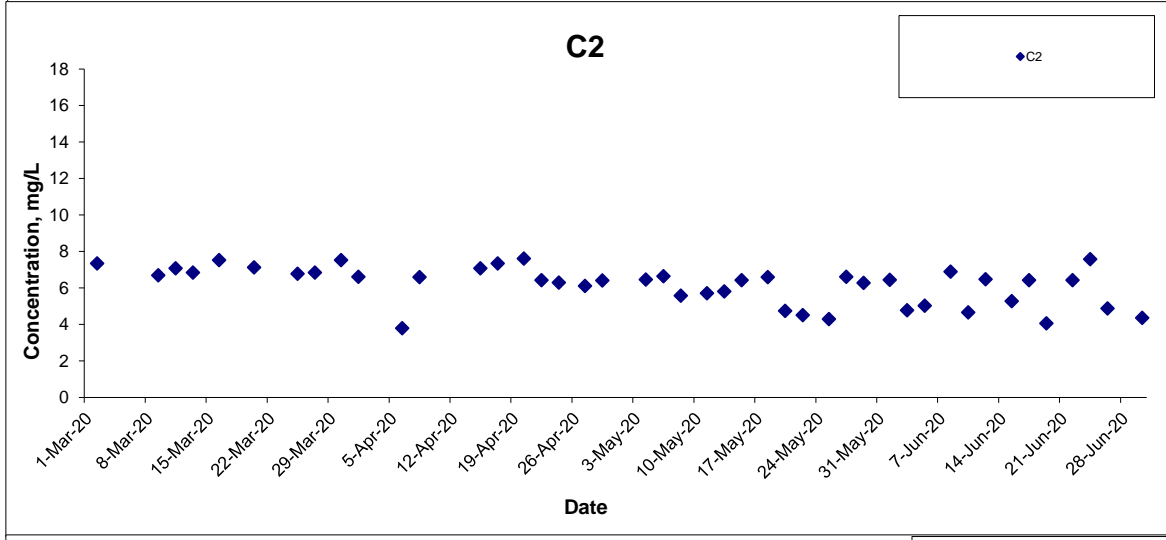
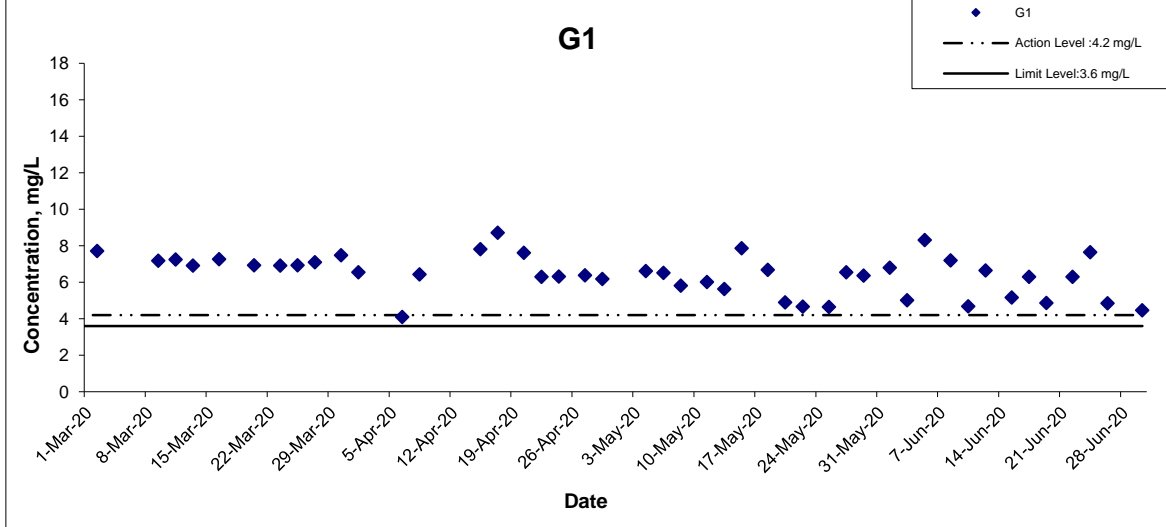
Dissolved Oxygen (Bottom) at Mid-Ebb Tide

Title Agreement No. CE 59/2015(EP) Environmental Team for Tseung Kwan O - Lam Tin Tunnel Design and Construction Graphical Presentation of Water Quality Monitoring Results	Scale N.T.S	Project No. MA16034	
	Date June 20	Appendix I

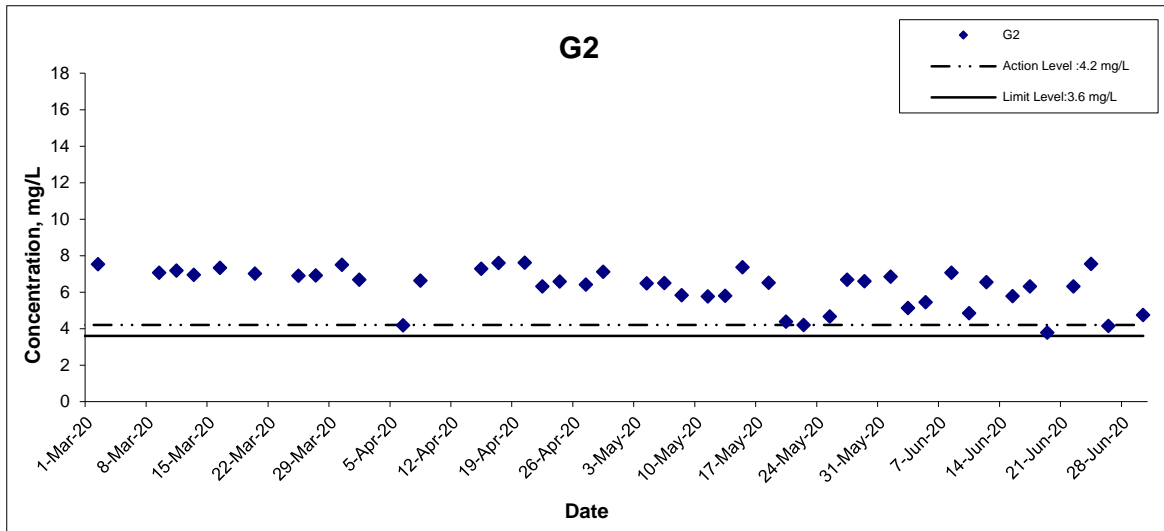
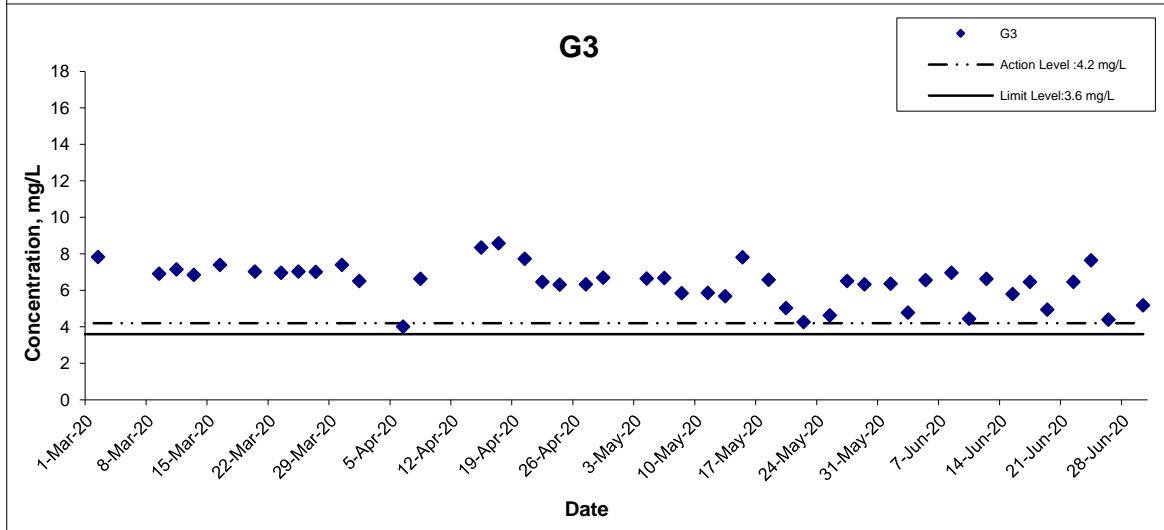
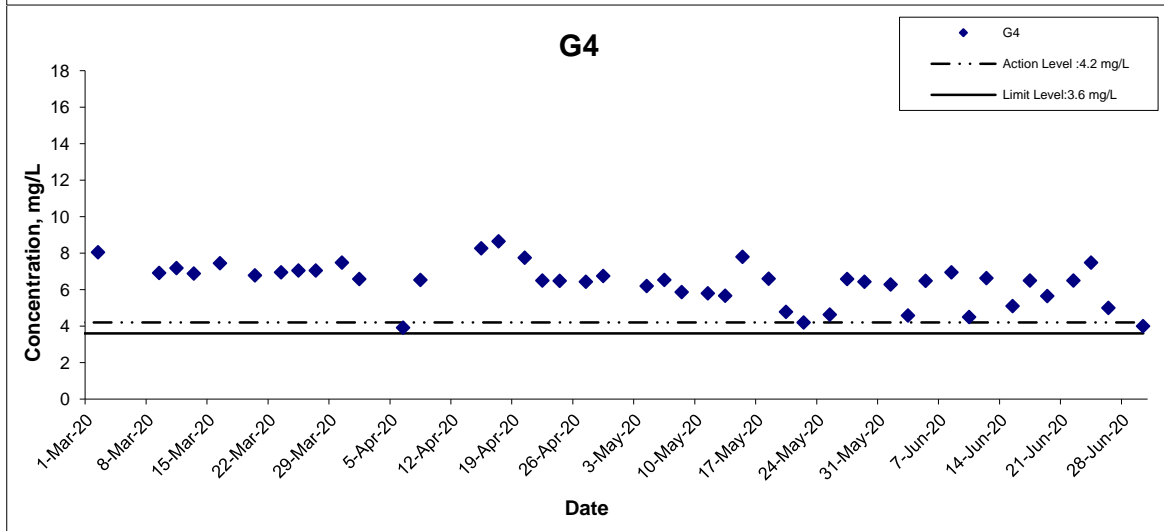
Dissolved Oxygen (Bottom) at Mid-Ebb Tide

Title Agreement No. CE 59/2015(EP) Environmental Team for Tseung Kwan O - Lam Tin Tunnel Design and Construction Graphical Presentation of Water Quality Monitoring Results	Scale N.T.S	Project No. MA16034	
	Date June 20	Appendix I

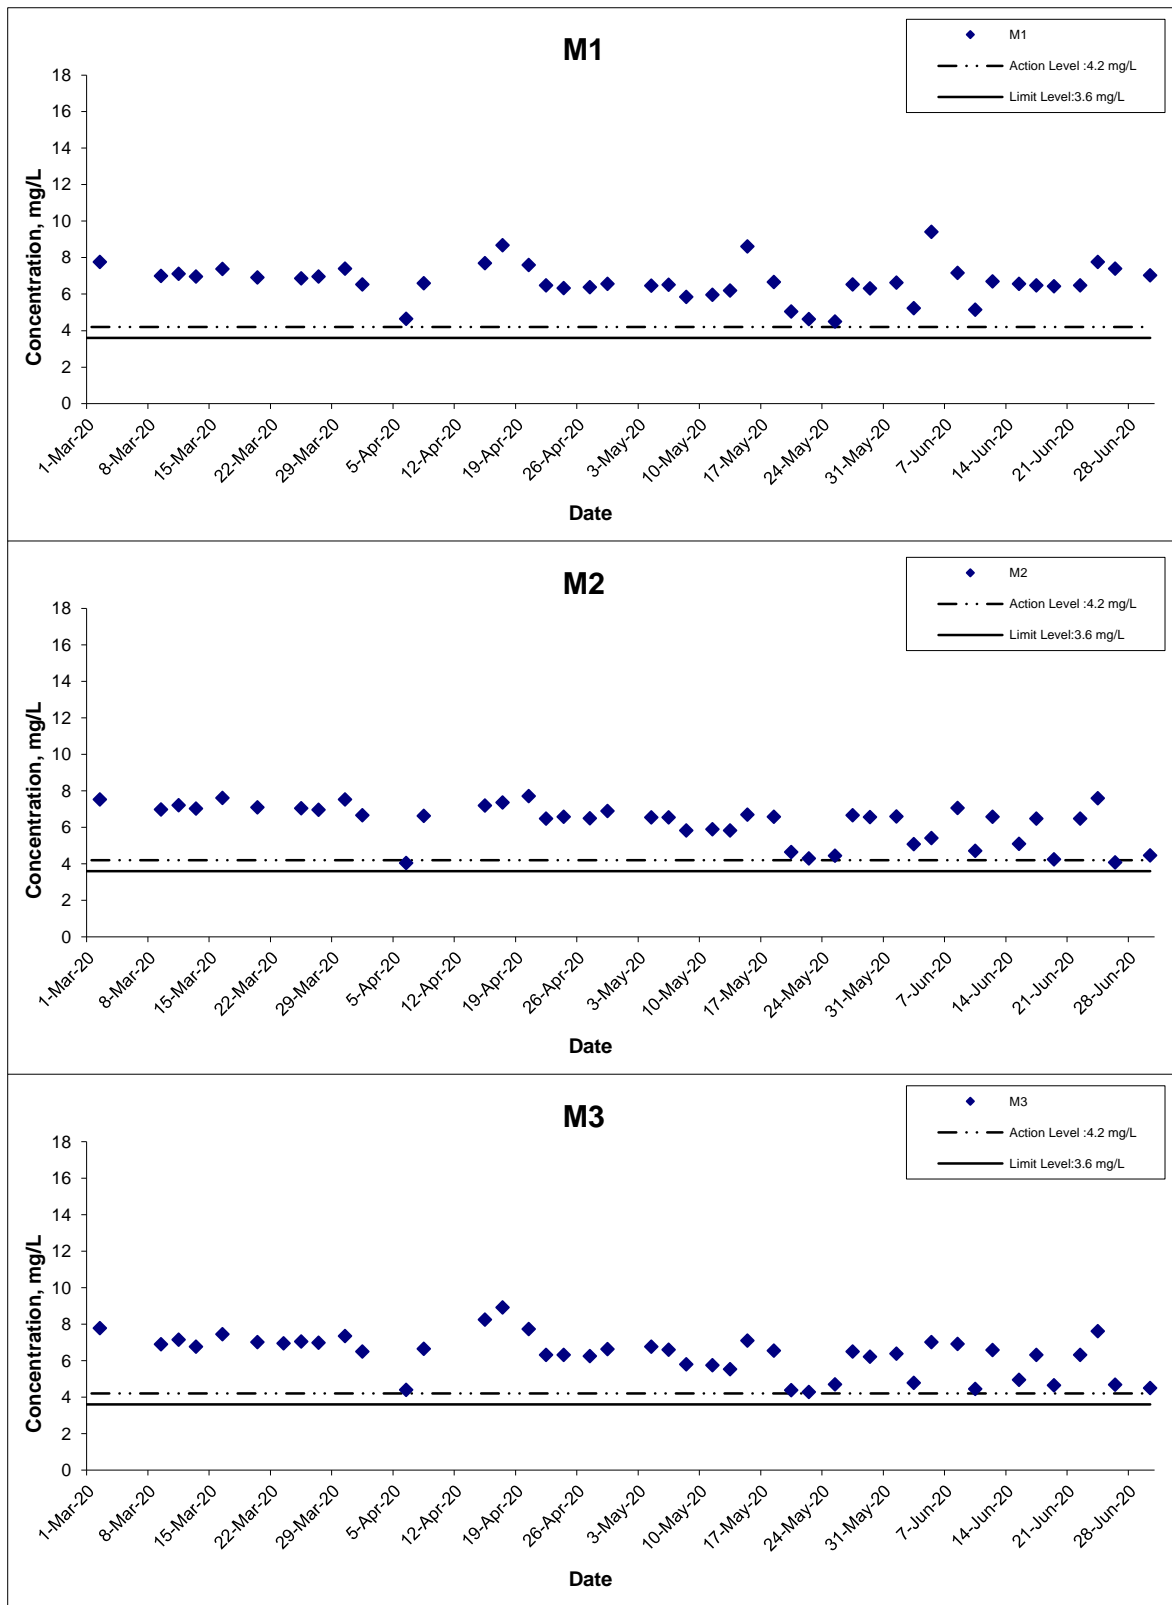
Dissolved Oxygen (Bottom) at Mid-Ebb Tide

Title Agreement No. CE 59/2015(EP) Environmental Team for Tseung Kwan O - Lam Tin Tunnel Design and Construction Graphical Presentation of Water Quality Monitoring Results	Scale N.T.S	Project No. MA16034	
	Date June 20	Appendix I

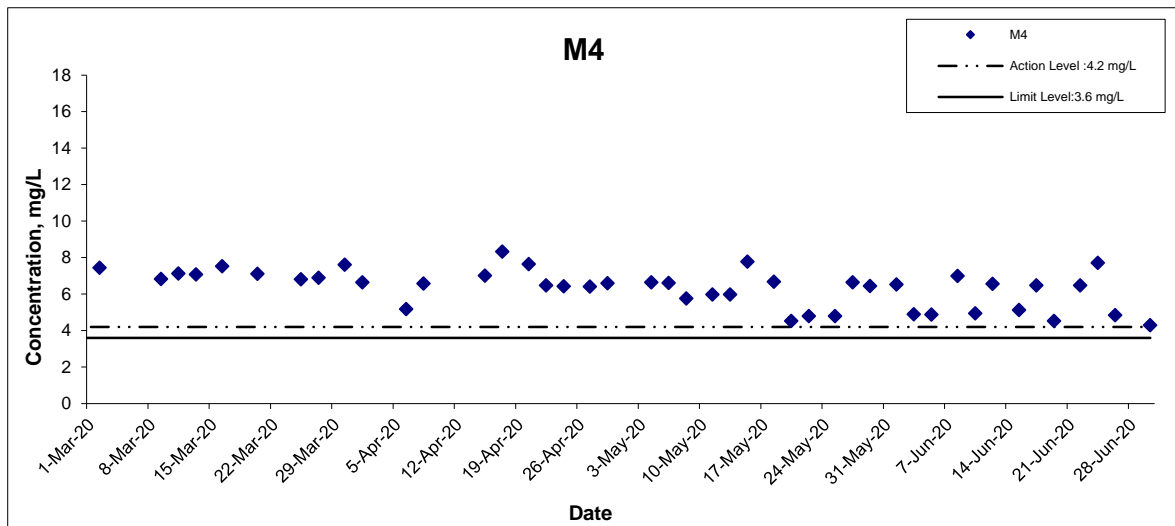
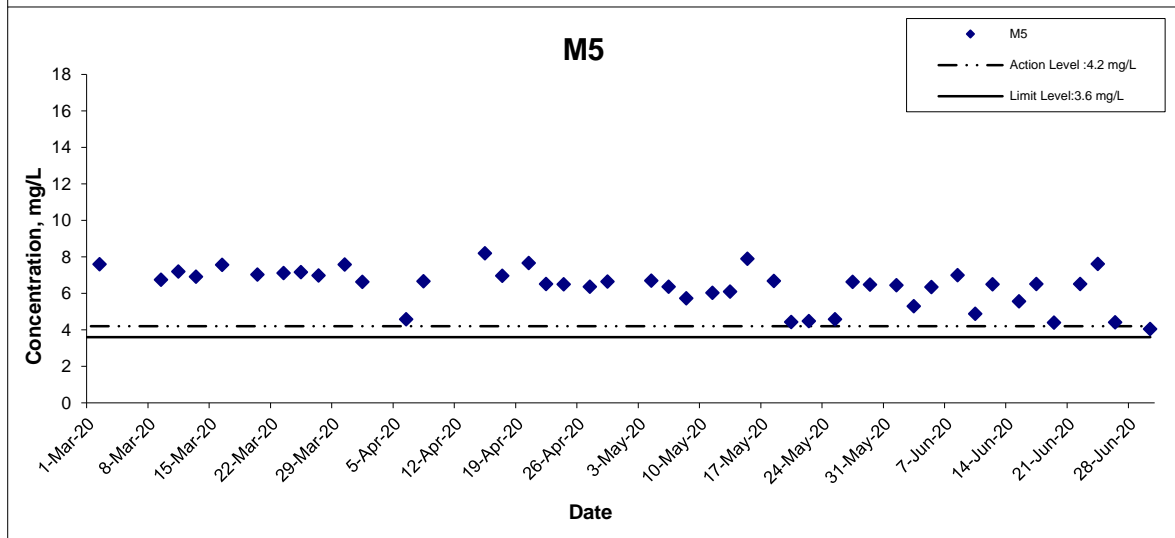
Dissolved Oxygen (Bottom) at Mid-Ebb Tide

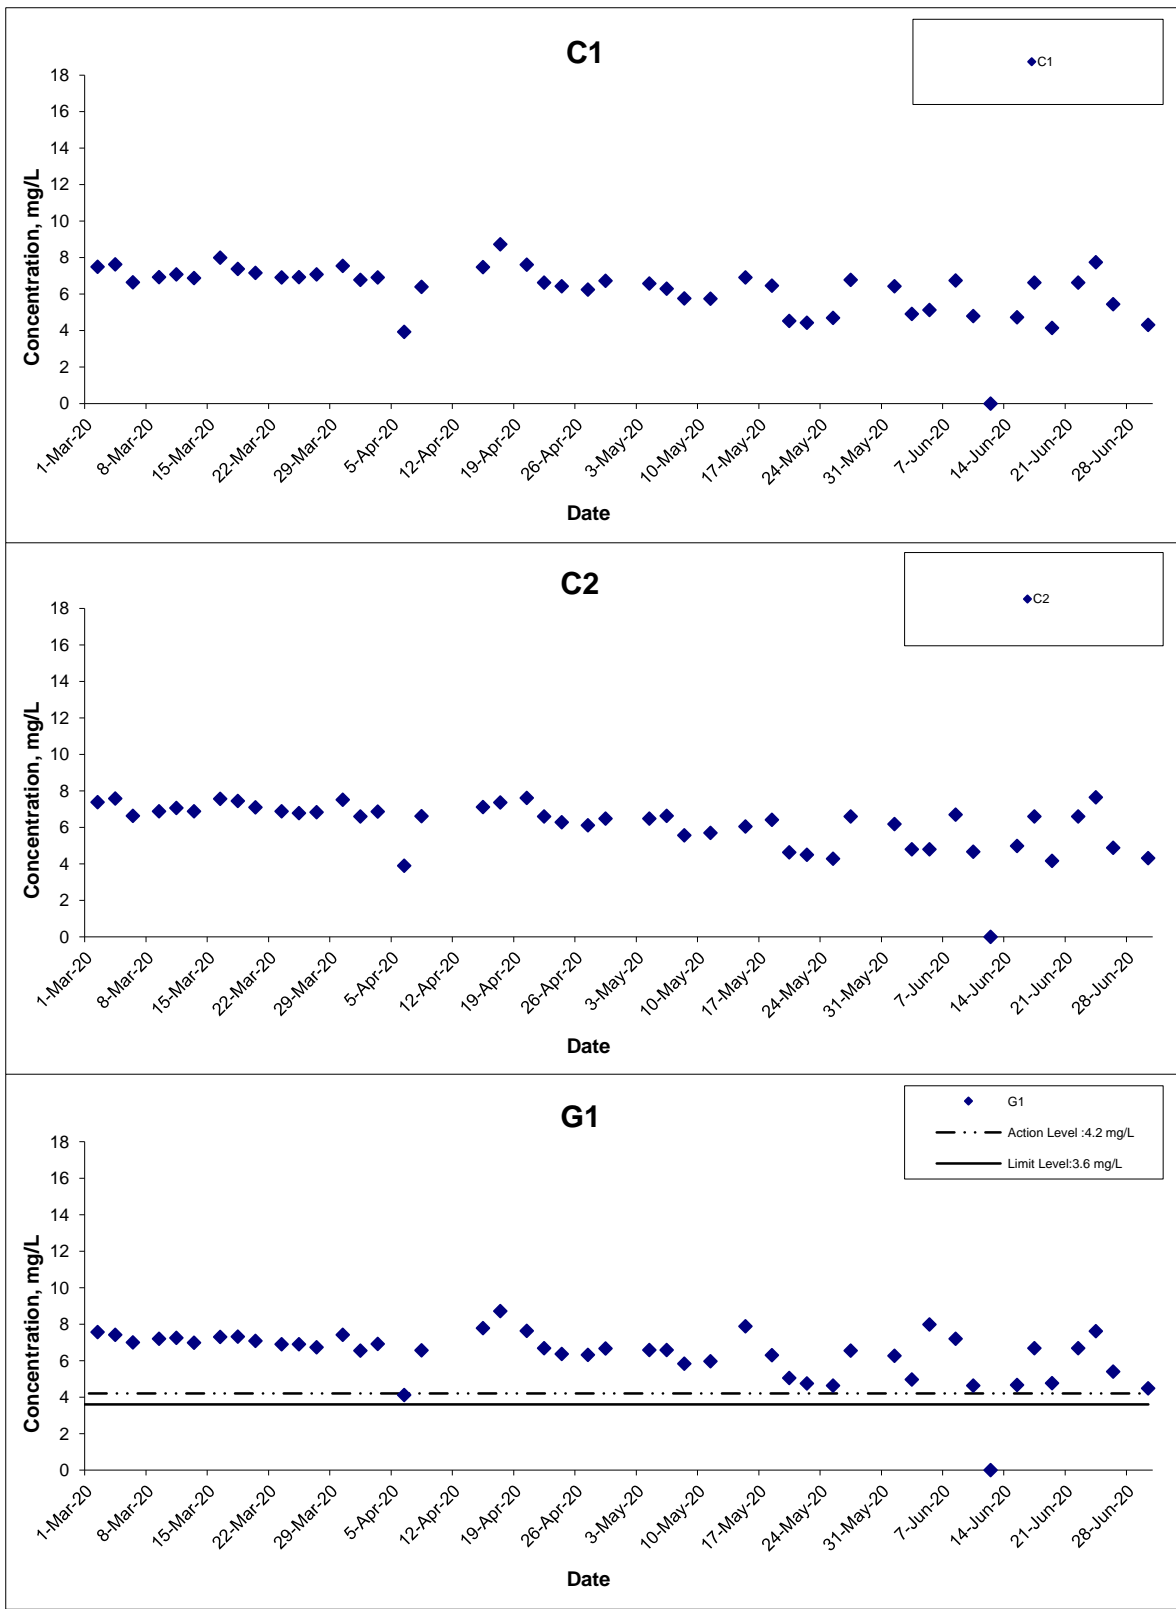
Title Agreement No. CE 59/2015(EP) Environmental Team for Tseung Kwan O - Lam Tin Tunnel Design and Construction Graphical Presentation of Water Quality Monitoring Results	Scale N.T.S	Project No. MA16034	
	Date June 20	Appendix I

Dissolved Oxygen (Bottom) at Mid-Flood Tide

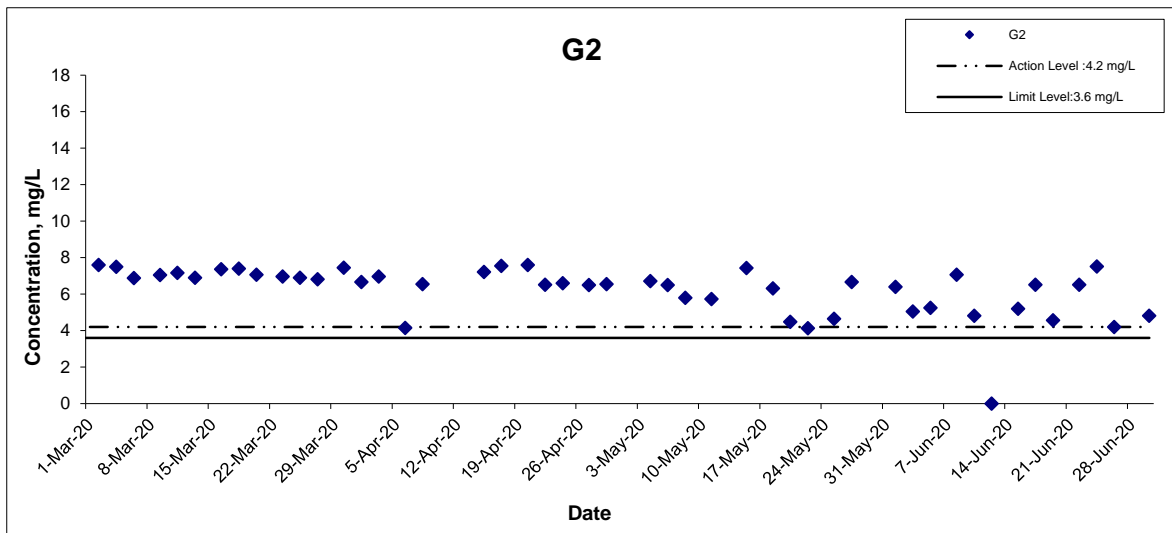
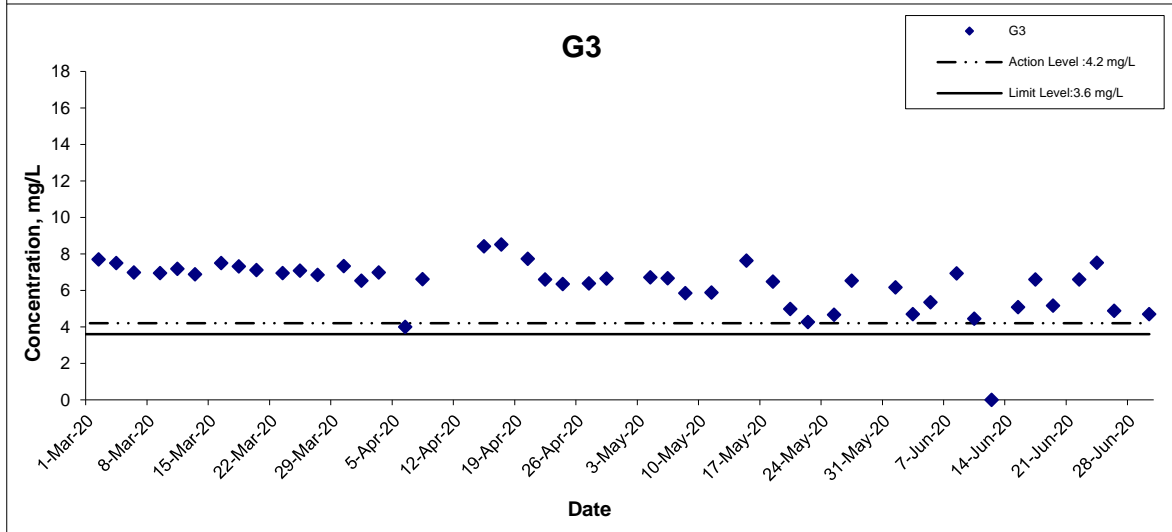
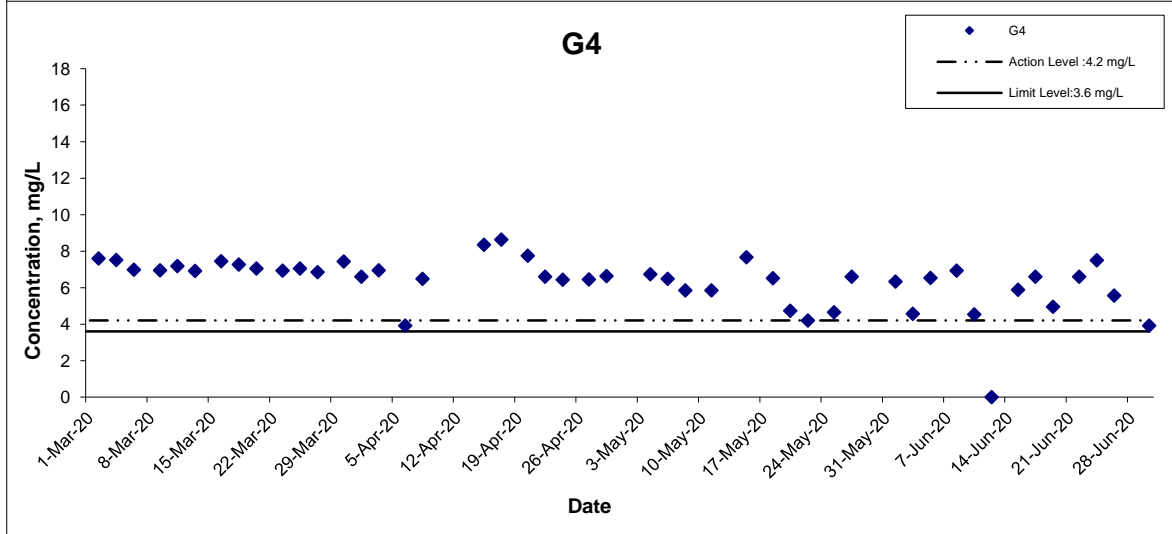
Title Agreement No. CE 59/2015(EP) Environmental Team for Tseung Kwan O - Lam Tin Tunnel Design and Construction
Graphical Presentation of Water Quality Monitoring Results

Dissolved Oxygen (Bottom) at Mid-Flood Tide

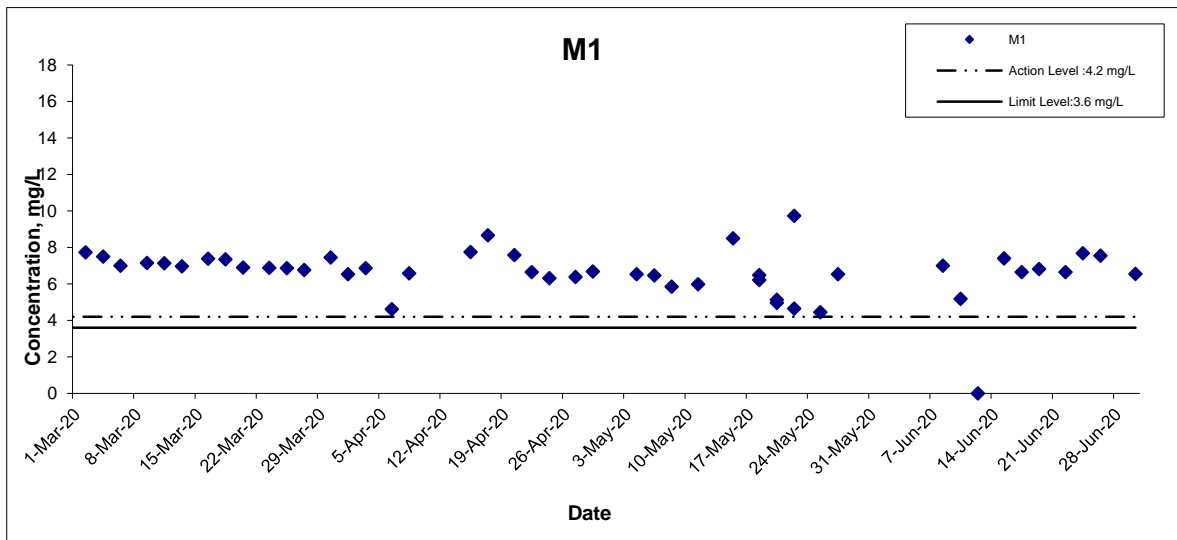
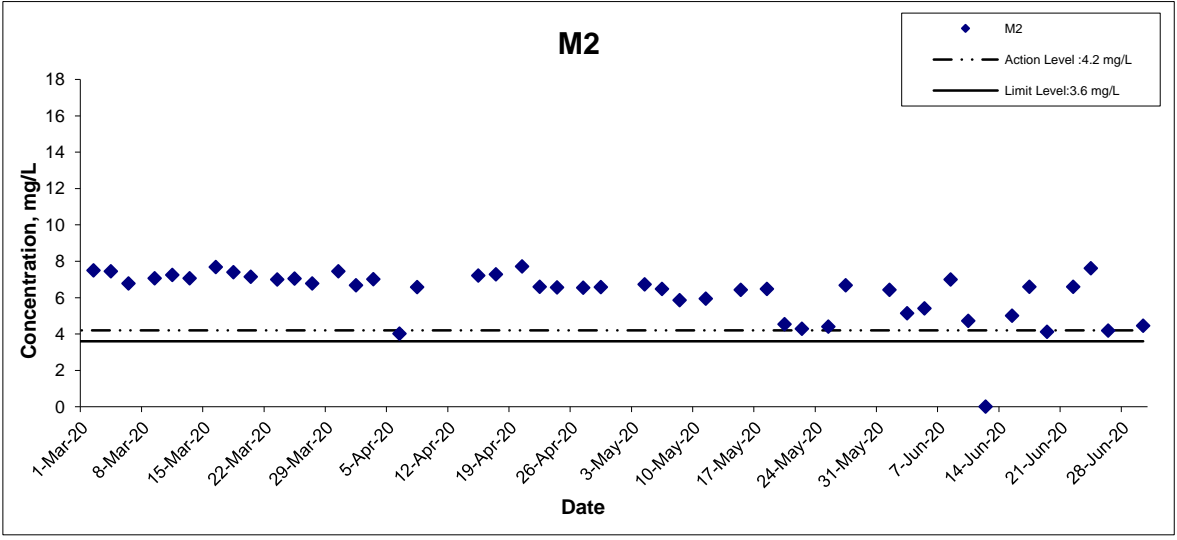
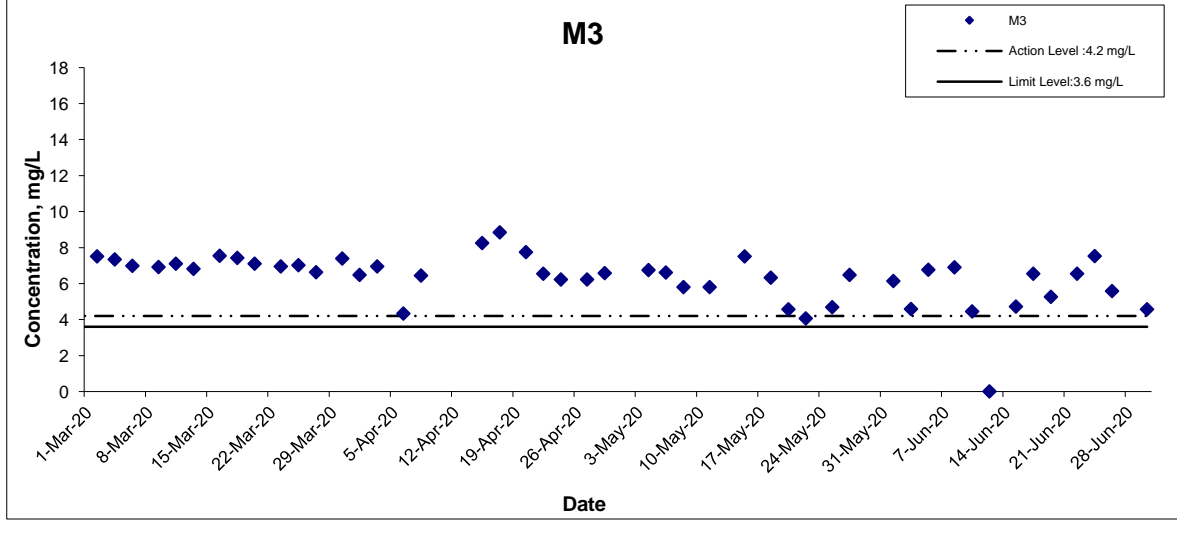
Title Agreement No. CE 59/2015(EP) Environmental Team for Tseung Kwan O - Lam Tin Tunnel Design and Construction Graphical Presentation of Water Quality Monitoring Results	Scale N.T.S	Project No. MA16034	
	Date June 20	Appendix I

Dissolved Oxygen (Bottom) at Mid-Flood Tide

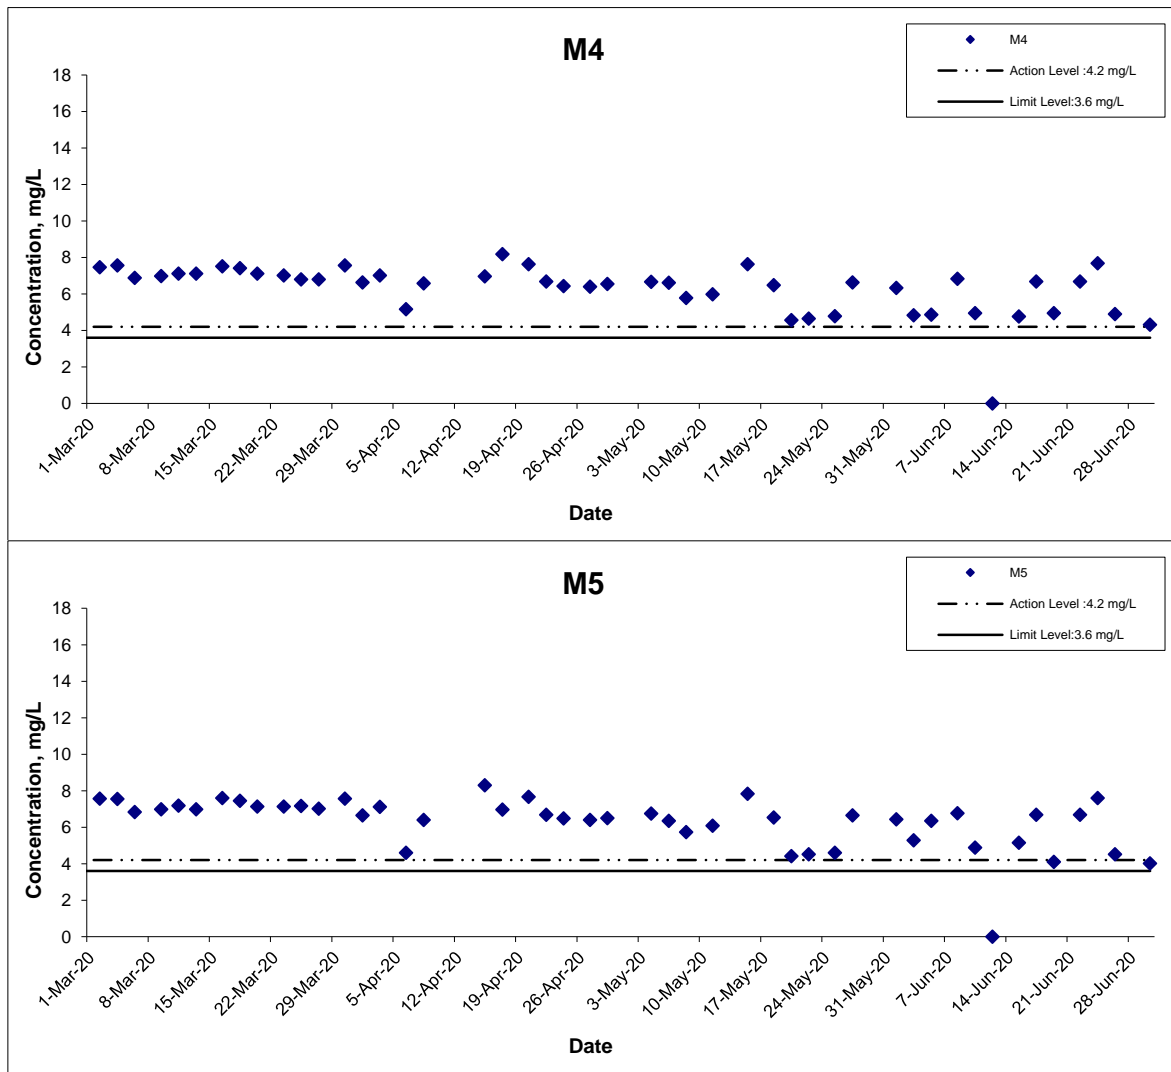
Title Agreement No. CE 59/2015(EP) Environmental Team for Tseung Kwan O - Lam Tin Tunnel Design and Construction Graphical Presentation of Water Quality Monitoring Results	Scale N.T.S	Project No. MA16034	
	Date June 20	Appendix I

Dissolved Oxygen (Bottom) at Mid-Flood Tide
