**Agreement No. CE 59/2015 (EP)
Environmental Team for
Tseung Kwan O – Lam Tin Tunnel
Design and Construction**

**Monthly Environmental Monitoring and
Audit Report for
June 2020
(version 1.0)**

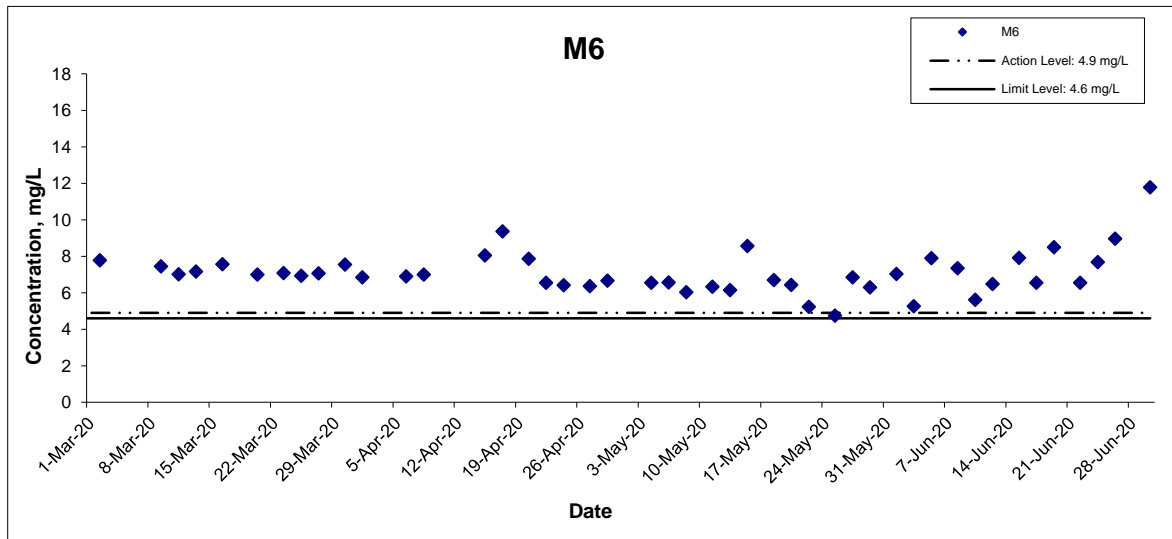
Title Agreement No. CE 59/2015(EP) Environmental Team for Tseung Kwan O - Lam Tin Tunnel Design and Construction Graphical Presentation of Water Quality Monitoring Results	Scale N.T.S	Project No. MA16034	
	Date June 20	Appendix I

Dissolved Oxygen (Intake Level of WSD Salt Water Intake) at Mid-Ebb Tide

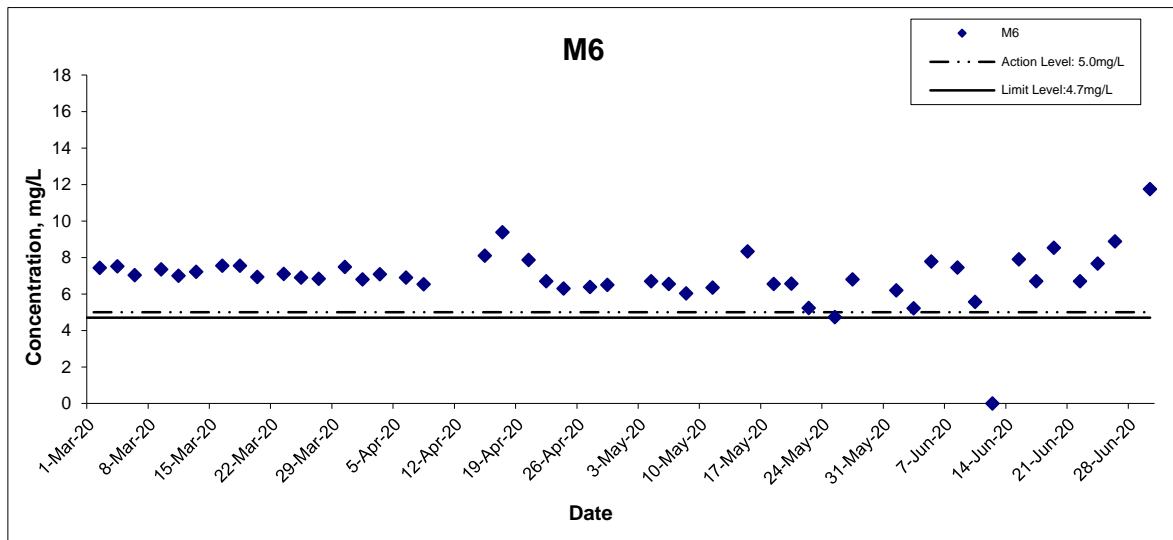
Title Agreement No. CE 59/2015(EP) Environmental Team for Tseung Kwan O - Lam Tin Tunnel Design and Construction Graphical Presentation of Water Quality Monitoring Results	Scale N.T.S	Project No. MA16034	
	Date June 20	Appendix I

Dissolved Oxygen (Intake Level of WSD Salt Water Intake) at Mid-Flood Tide

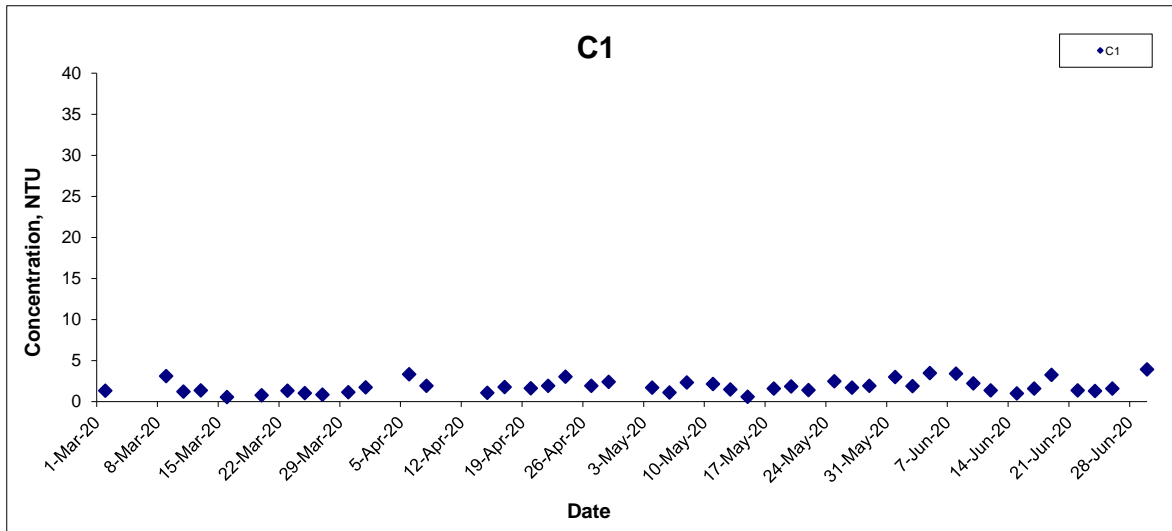
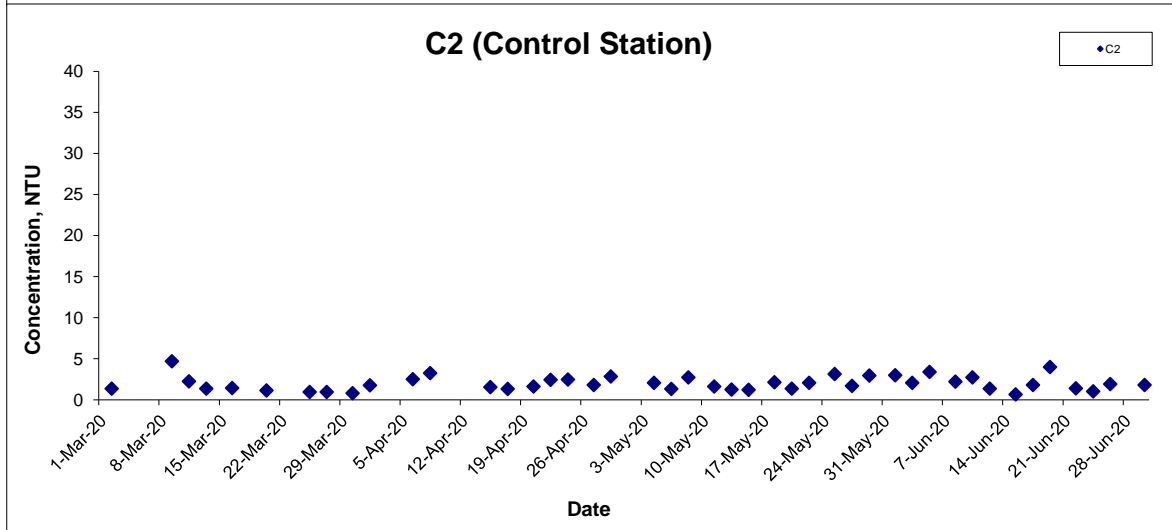
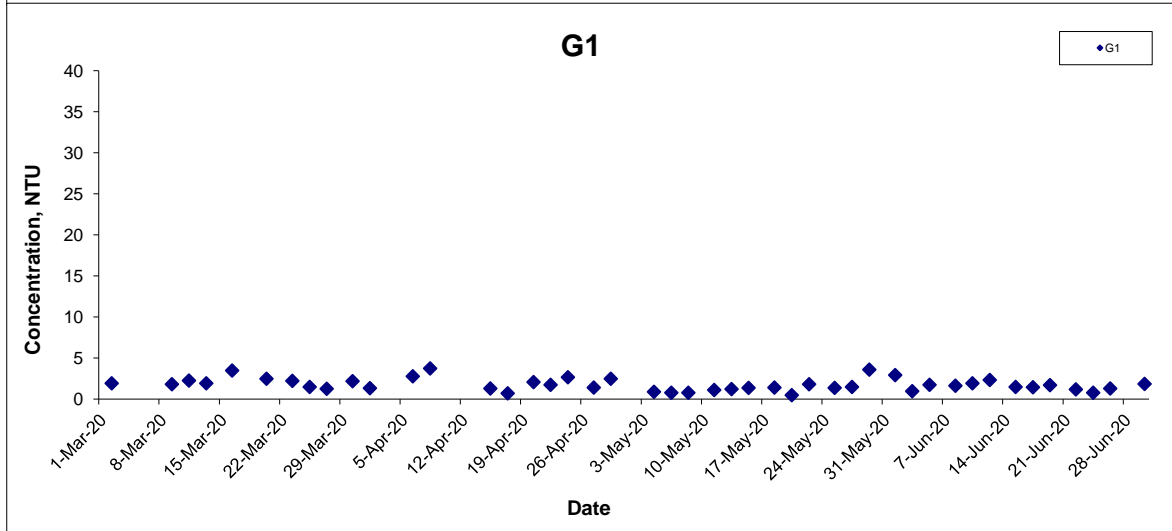
Title Agreement No. CE 59/2015(EP) Environmental Team for Tseung Kwan O - Lam Tin Tunnel Design and Construction Graphical Presentation of Water Quality Monitoring Results	Scale N.T.S	Project No. MA16034	
	Date June 20	Appendix I

Turbidity (Depth-averaged) at Mid-Ebb Tide

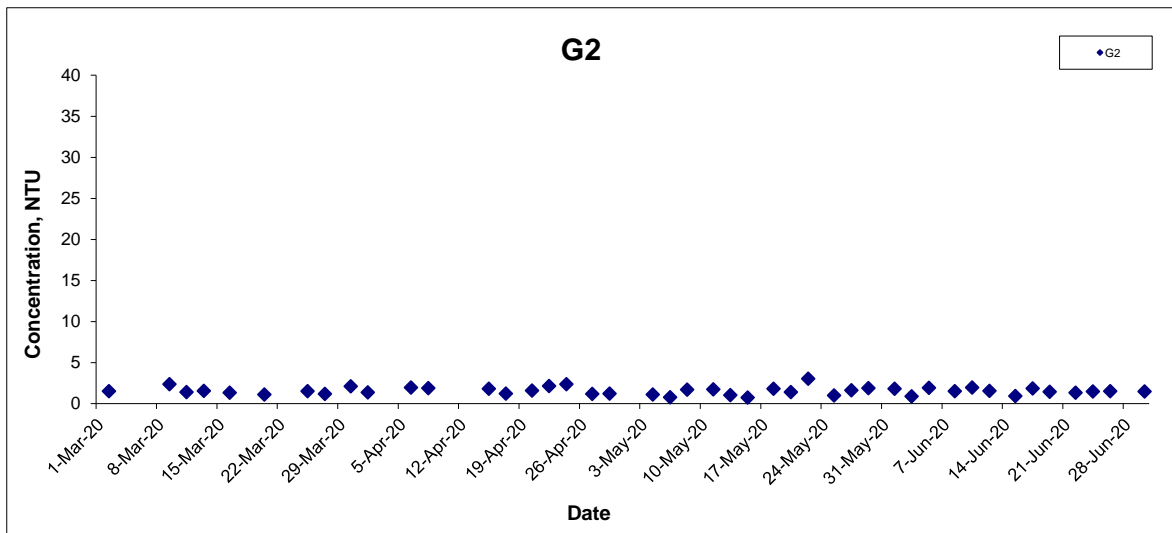
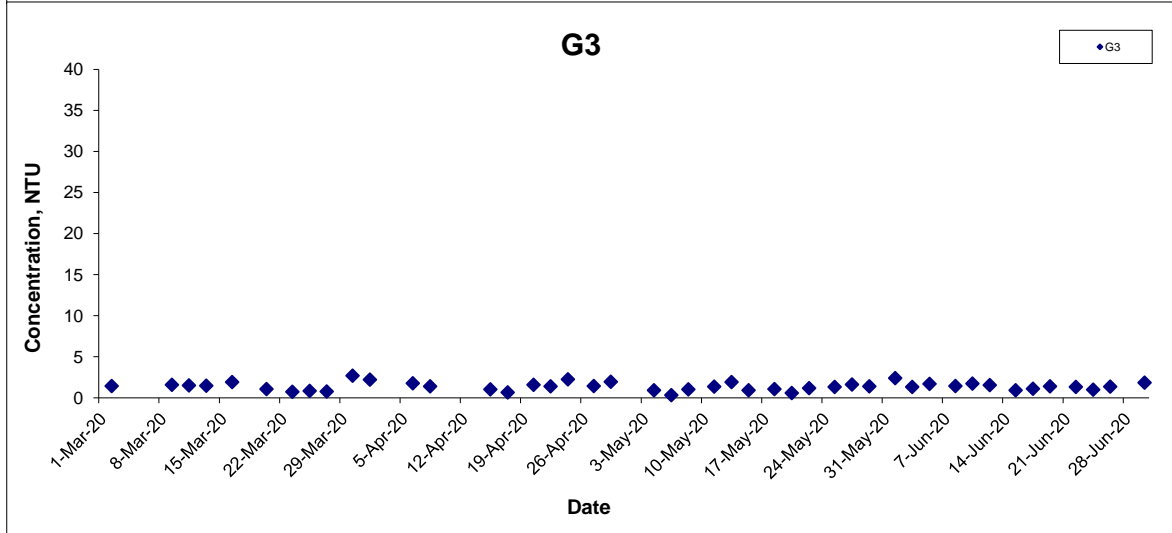
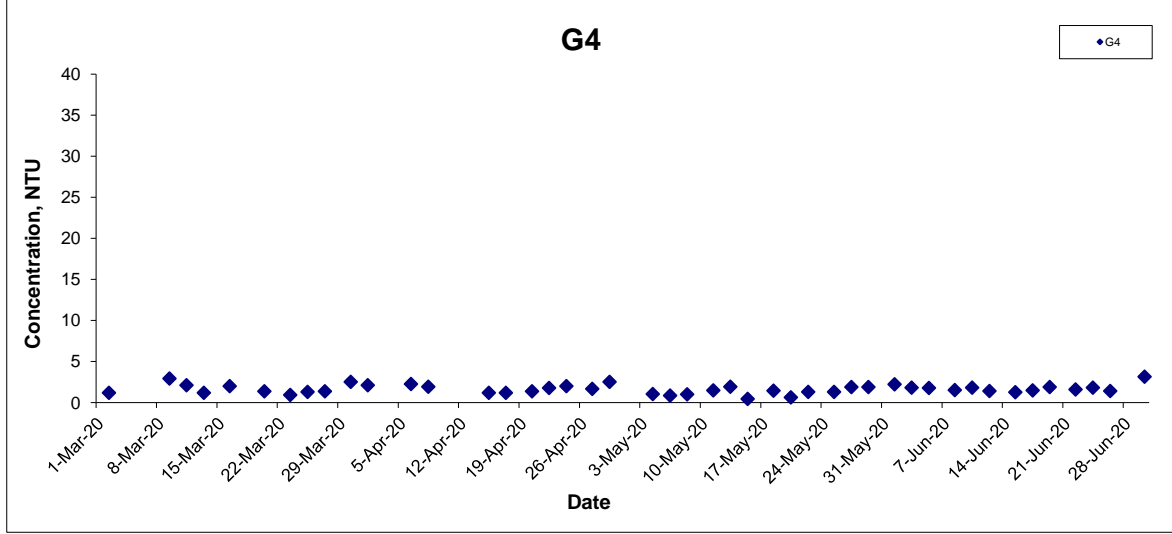
Title Agreement No. CE 59/2015(EP) Environmental Team for Tseung Kwan O - Lam Tin Tunnel Design and Construction Graphical Presentation of Water Quality Monitoring Results	Scale N.T.S	Project No. MA16034	
	Date Jun 20	Appendix I

Turbidity (Depth-averaged) at Mid-Ebb Tide

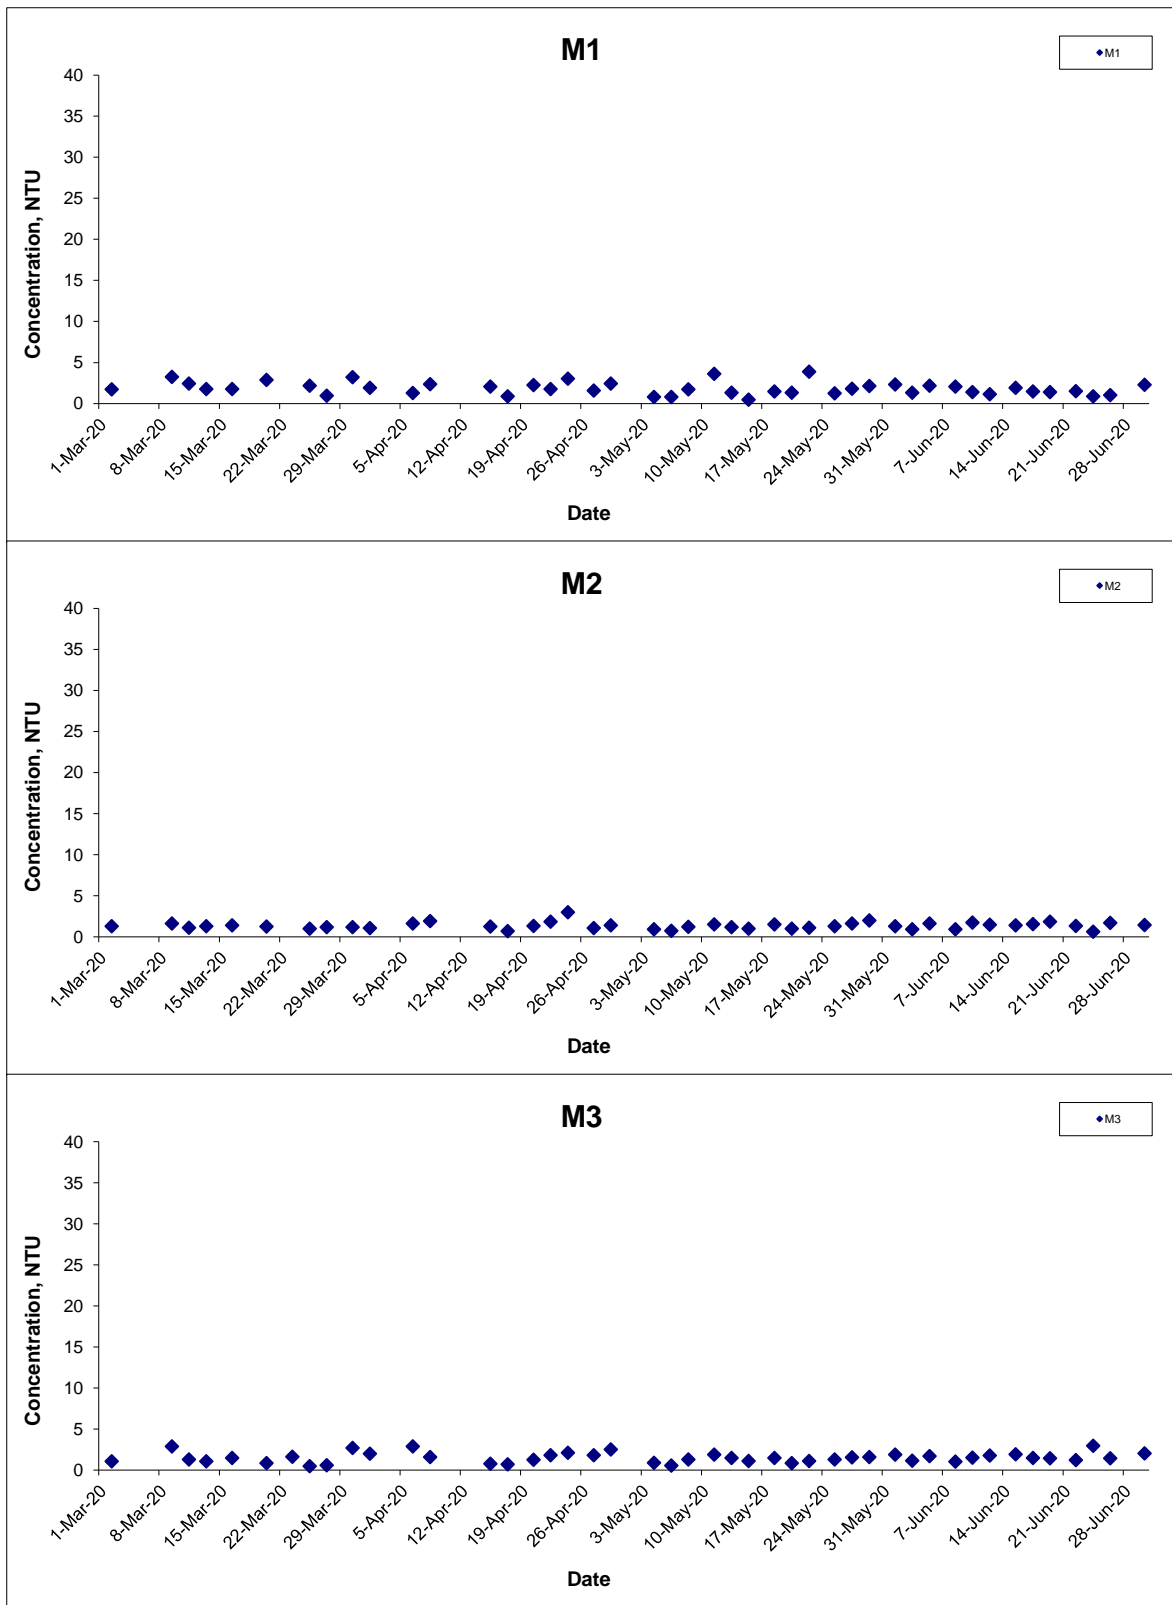
Title Agreement No. CE 59/2015(EP) Environmental Team for Tseung Kwan O - Lam Tin Tunnel Design and Construction Graphical Presentation of Water Quality Monitoring Results	Scale N.T.S	Project No. MA16034	
	Date Jun 20	Appendix I

Turbidity (Depth-averaged) at Mid-Ebb Tide

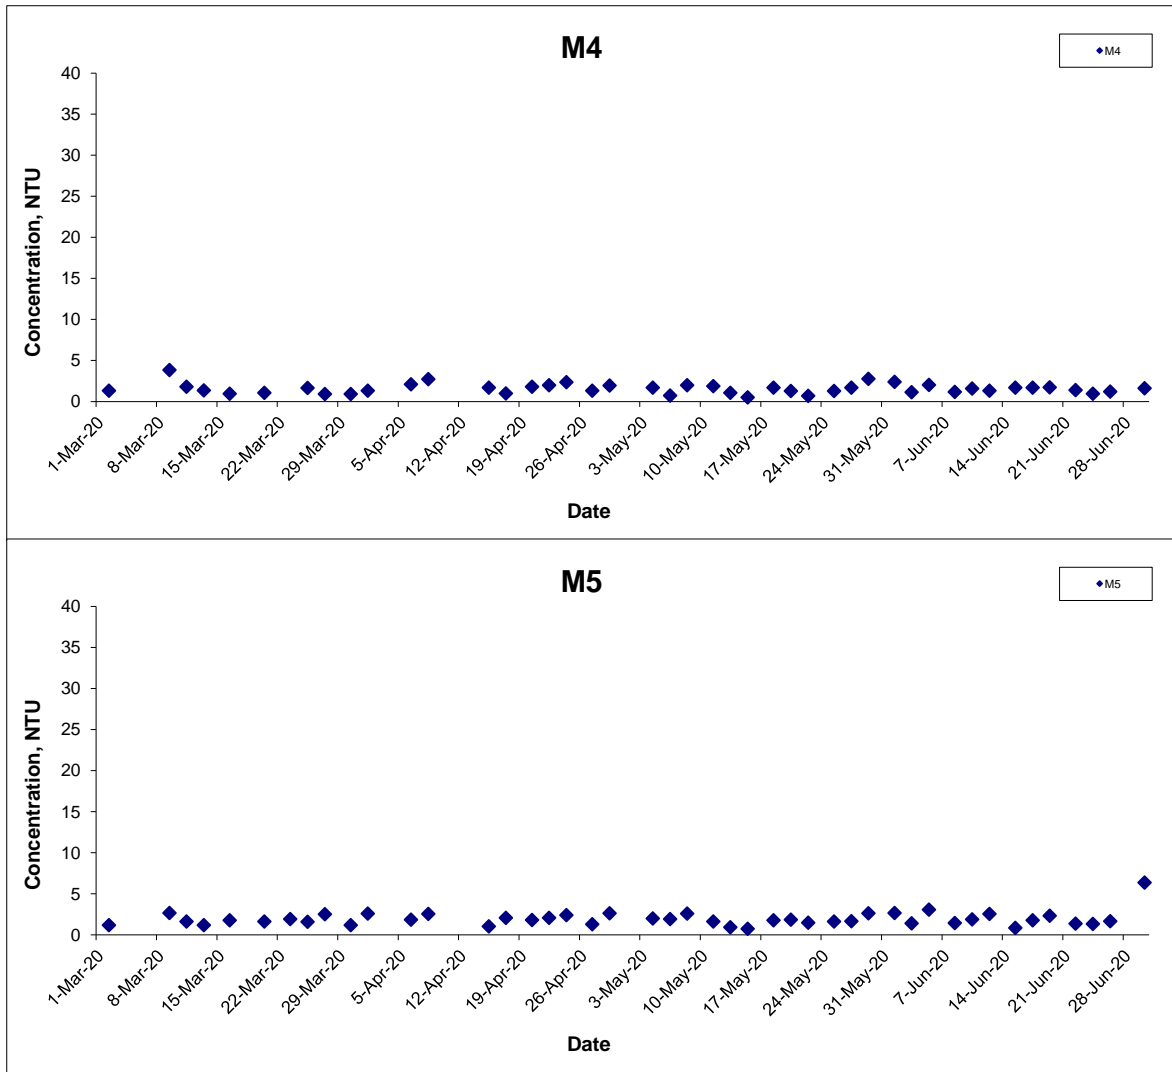
Title Agreement No. CE 59/2015(EP) Environmental Team for Tseung Kwan O - Lam Tin Tunnel Design and Construction Graphical Presentation of Water Quality Monitoring Results	Scale N.T.S	Project No. MA16034	
	Date Jun 20	Appendix I

Turbidity (Depth-averaged) at Mid-Ebb Tide

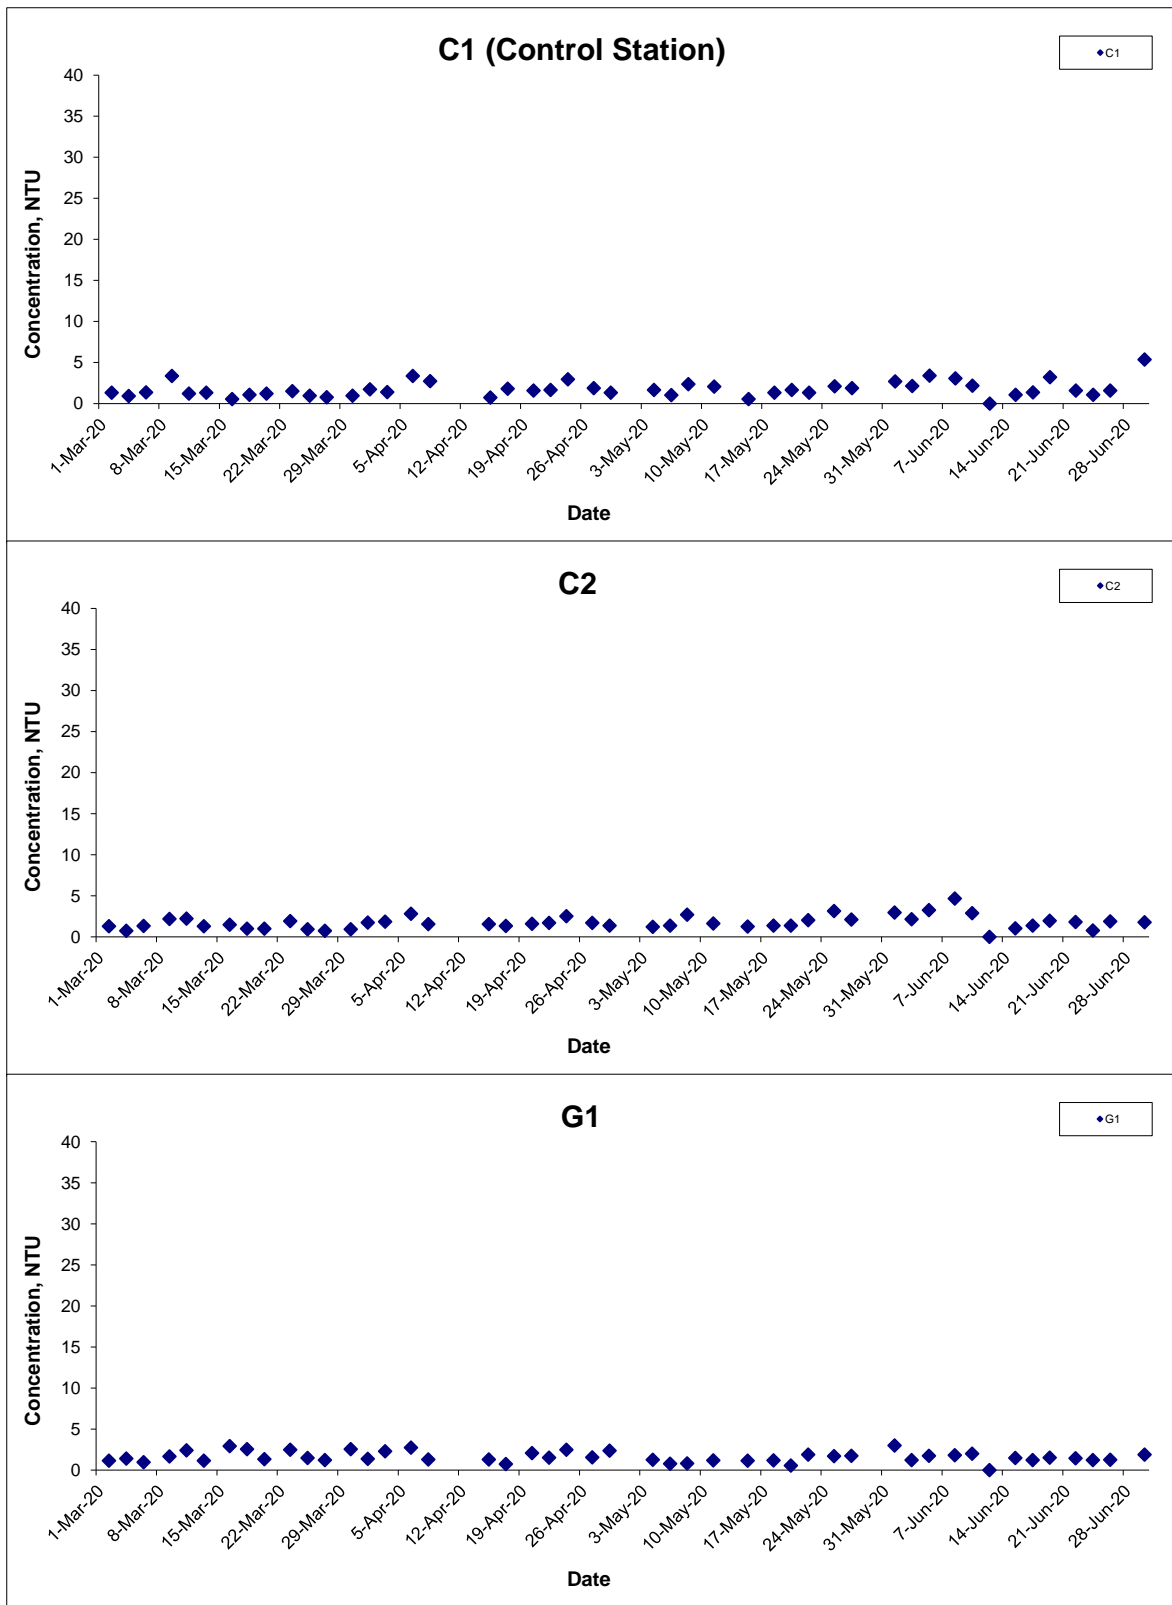
Title Agreement No. CE 59/2015(EP) Environmental Team for Tseung Kwan O - Lam Tin Tunnel Design and Construction Graphical Presentation of Water Quality Monitoring Results	Scale N.T.S	Project No. MA16034	
	Date Jun 20	Appendix I

Turbidity (Depth-averaged) at Mid-Flood Tide

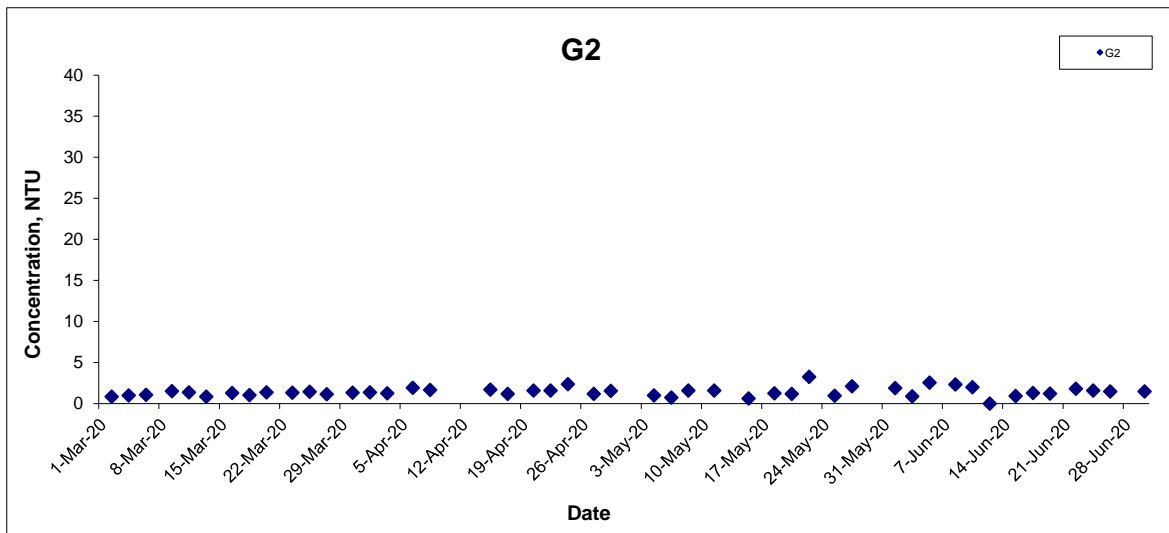
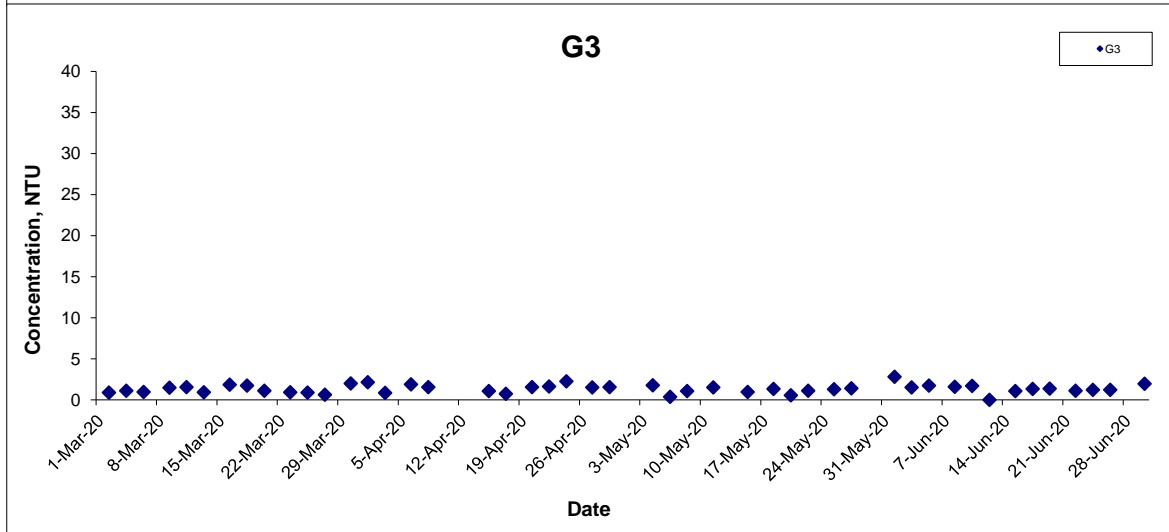
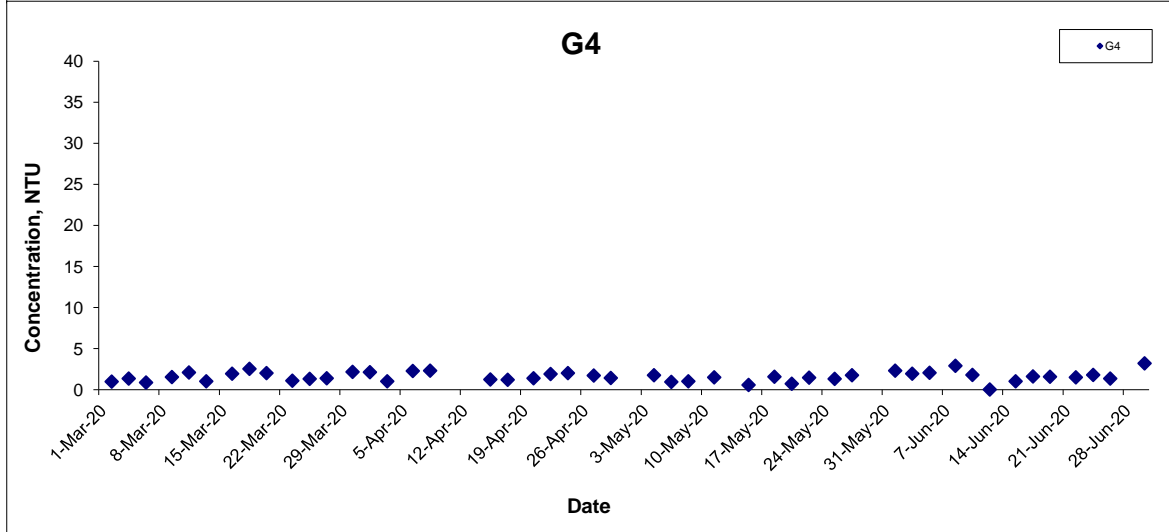
Title Agreement No. CE 59/2015(EP) Environmental Team for Tseung Kwan O - Lam Tin Tunnel Design and Construction Graphical Presentation of Water Quality Monitoring Results	Scale N.T.S	Project No. MA16034	
	Date Jun 20	Appendix I

Turbidity (Depth-averaged) at Mid-Flood Tide

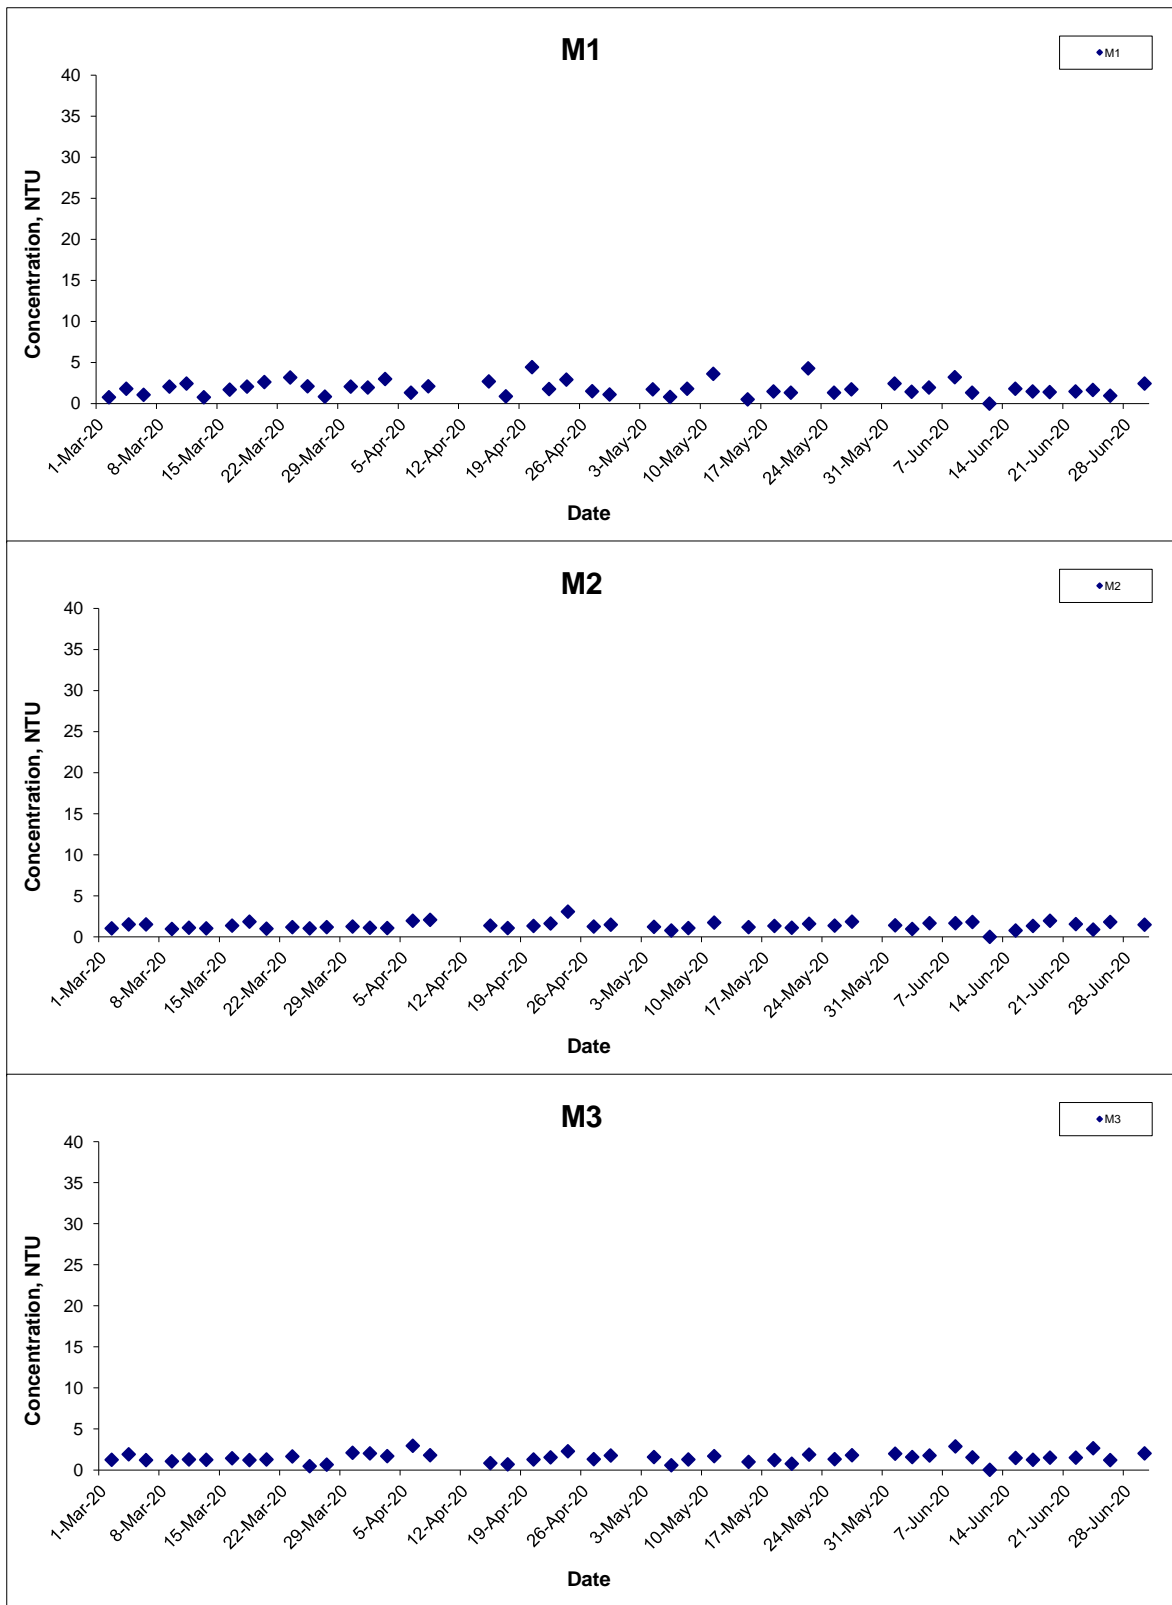
Title Agreement No. CE 59/2015(EP) Environmental Team for Tseung Kwan O - Lam Tin Tunnel Design and Construction Graphical Presentation of Water Quality Monitoring Results	Scale N.T.S	Project No. MA16034	
	Date Jun 20	Appendix I

Turbidity (Depth-averaged) at Mid-Flood Tide

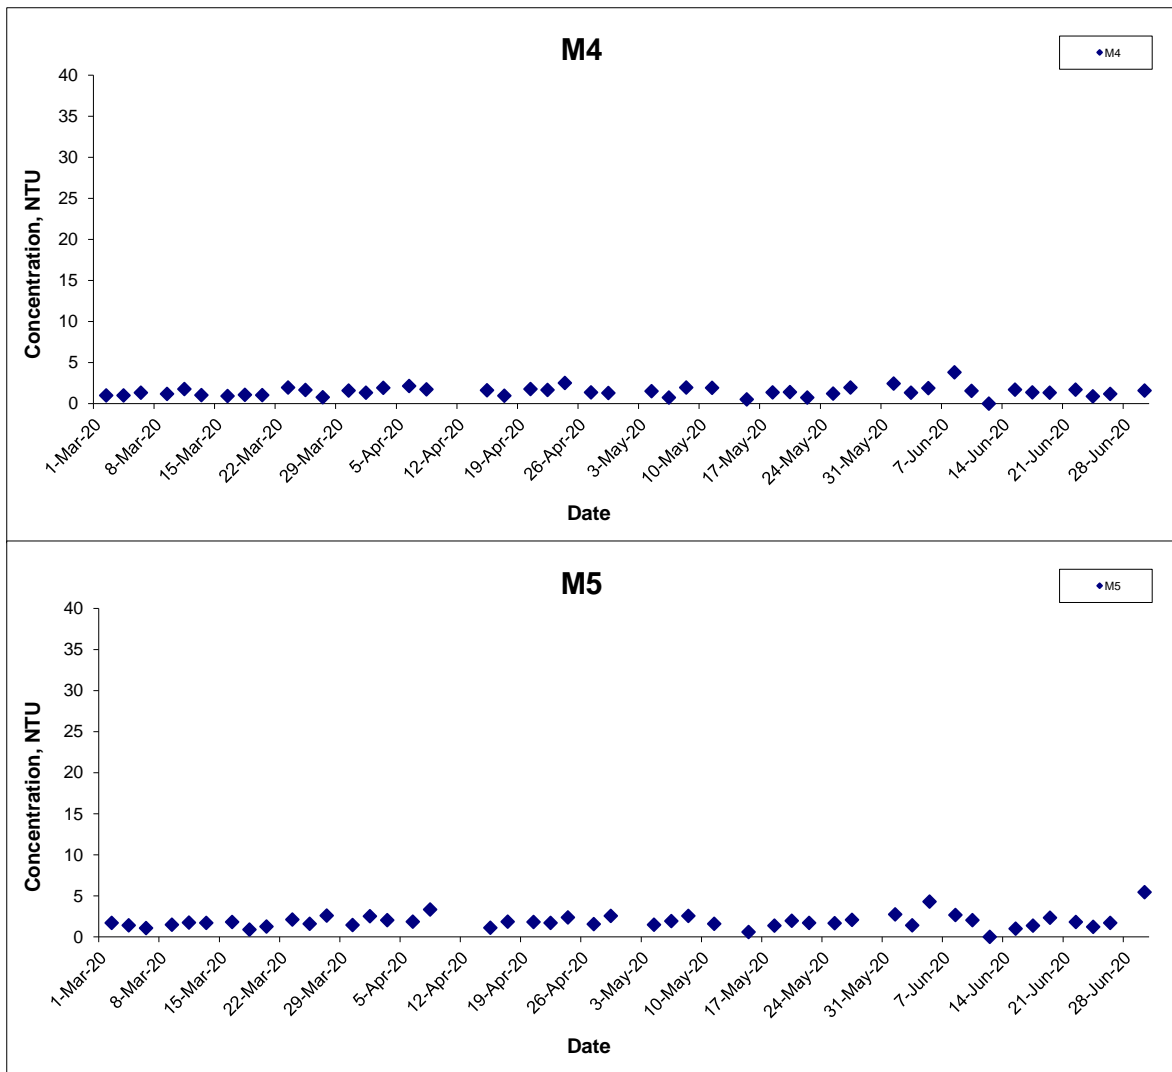
Title Agreement No. CE 59/2015(EP) Environmental Team for Tseung Kwan O - Lam Tin Tunnel Design and Construction Graphical Presentation of Water Quality Monitoring Results	Scale N.T.S	Project No. MA16034	
	Date Jun 20	Appendix I

Turbidity (Depth-averaged) at Mid-Flood Tide

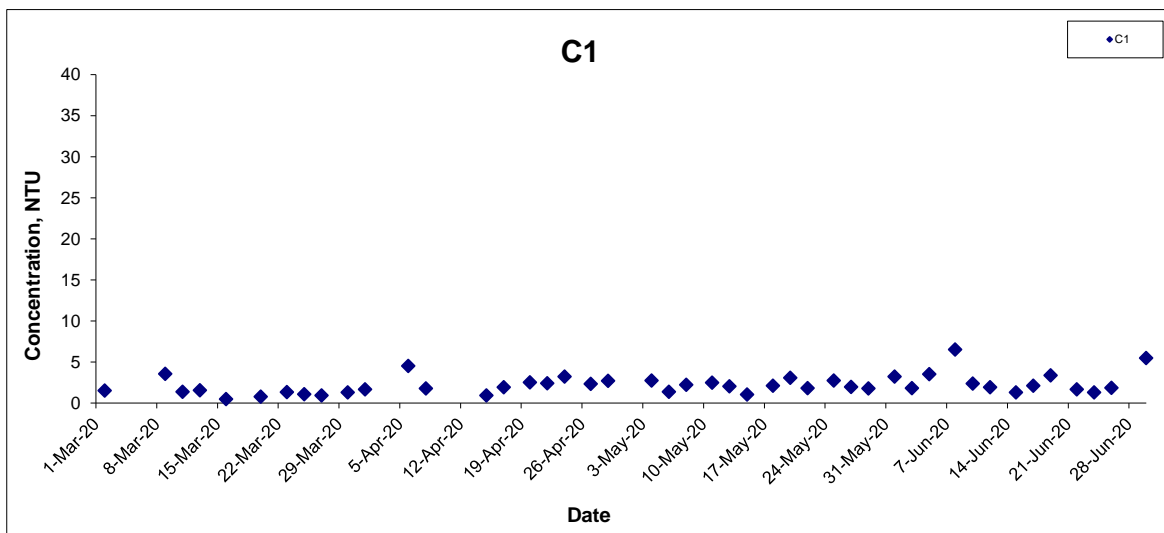
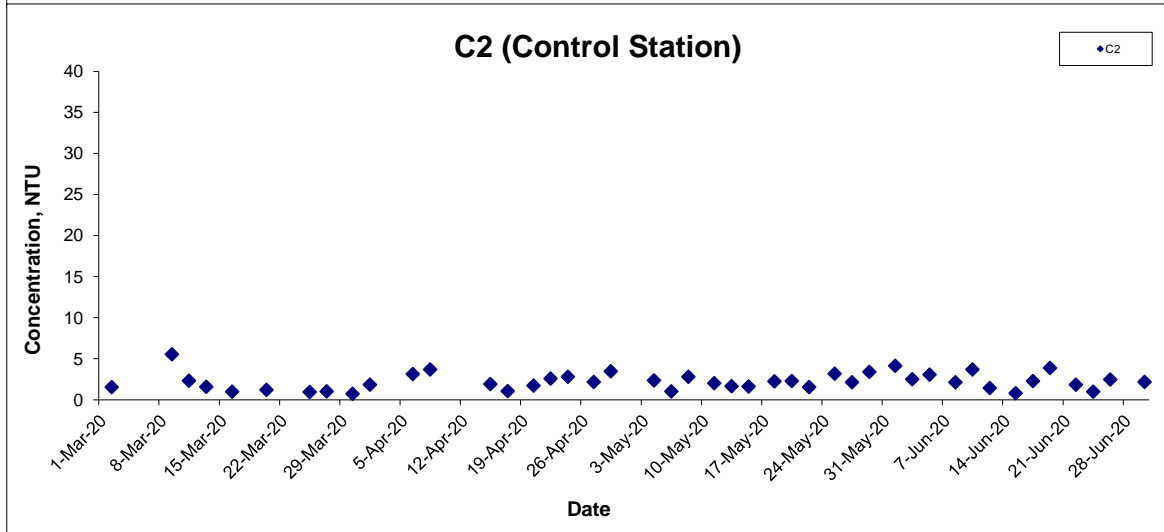
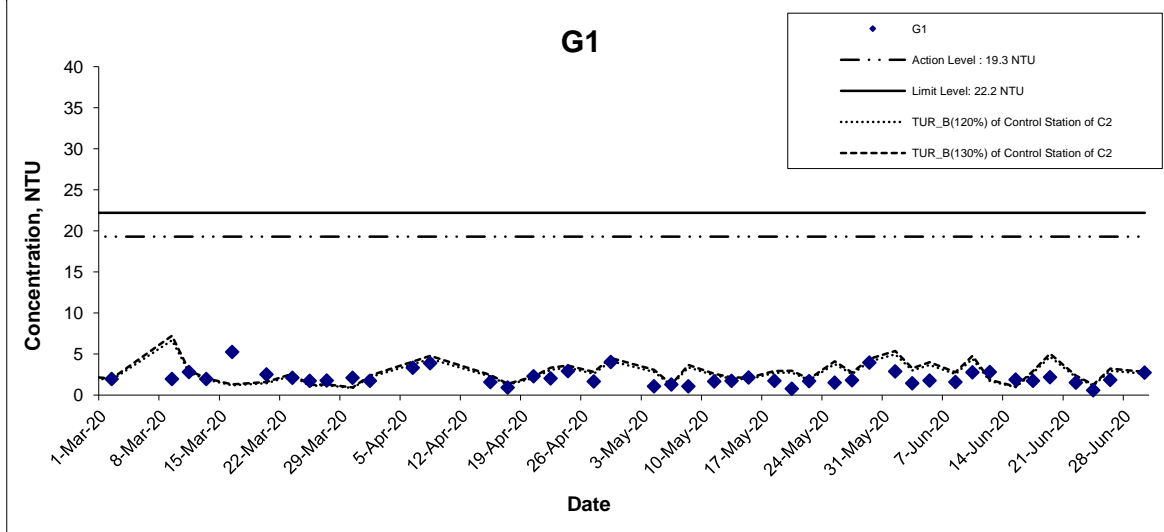
Title Agreement No. CE 59/2015(EP) Environmental Team for Tseung Kwan O - Lam Tin Tunnel Design and Construction Graphical Presentation of Water Quality Monitoring Results	Scale N.T.S	Project No. MA16034	
	Date Jun 20	Appendix I

Turbidity (Bottom) at Mid-Ebb Tide

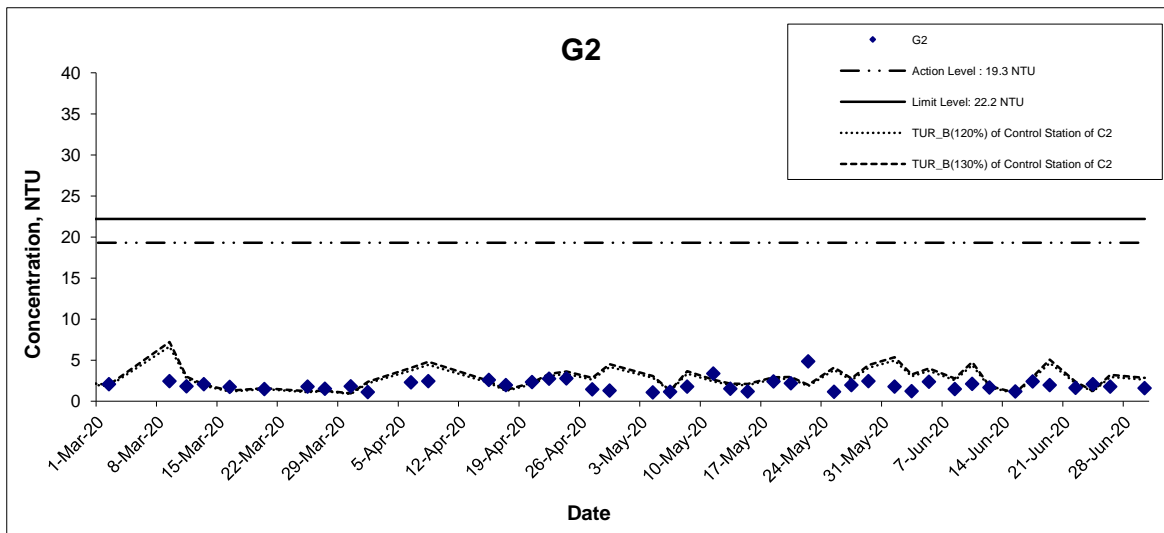
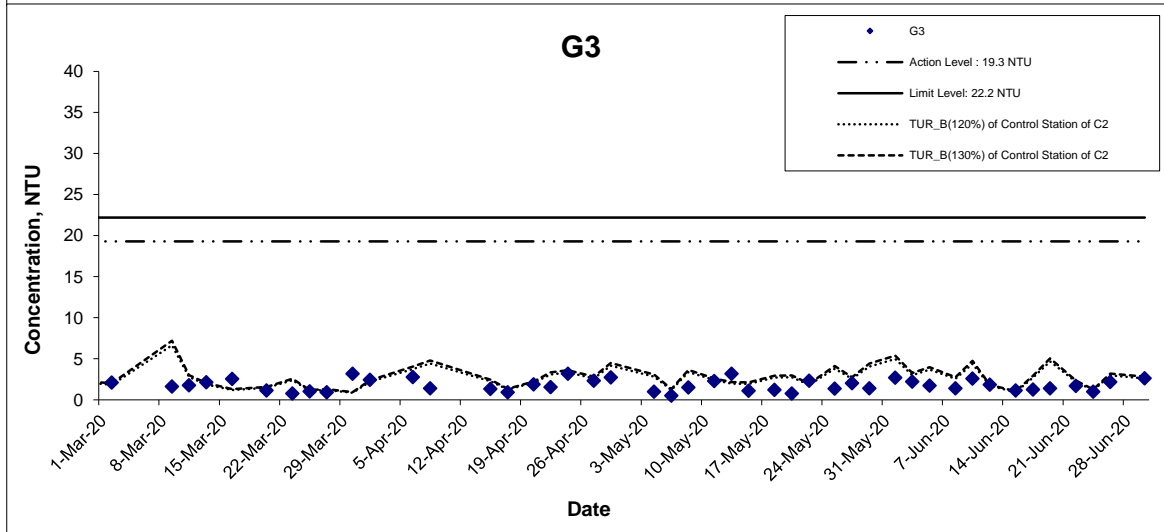
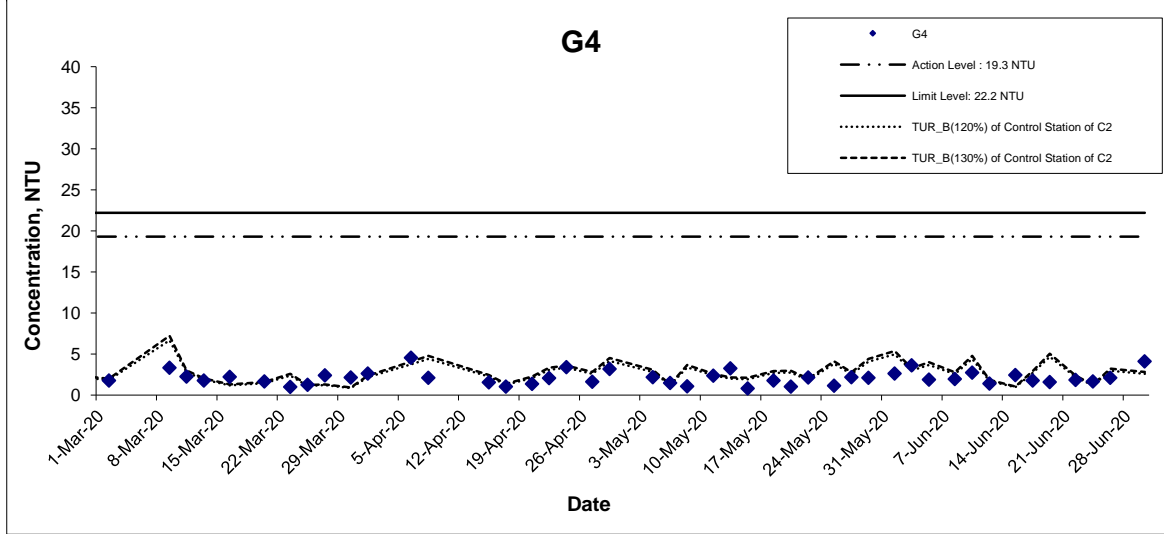
Title Agreement No. CE 59/2015(EP) Environmental Team for Tseung Kwan O - Lam Tin Tunnel Design and Construction

Turbidity (Bottom) at Mid-Ebb Tide

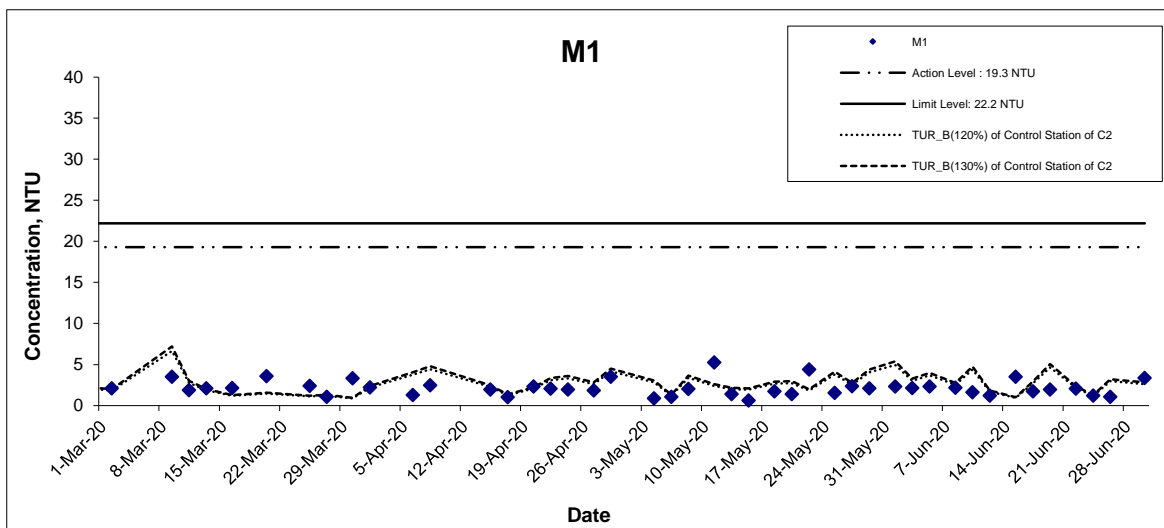
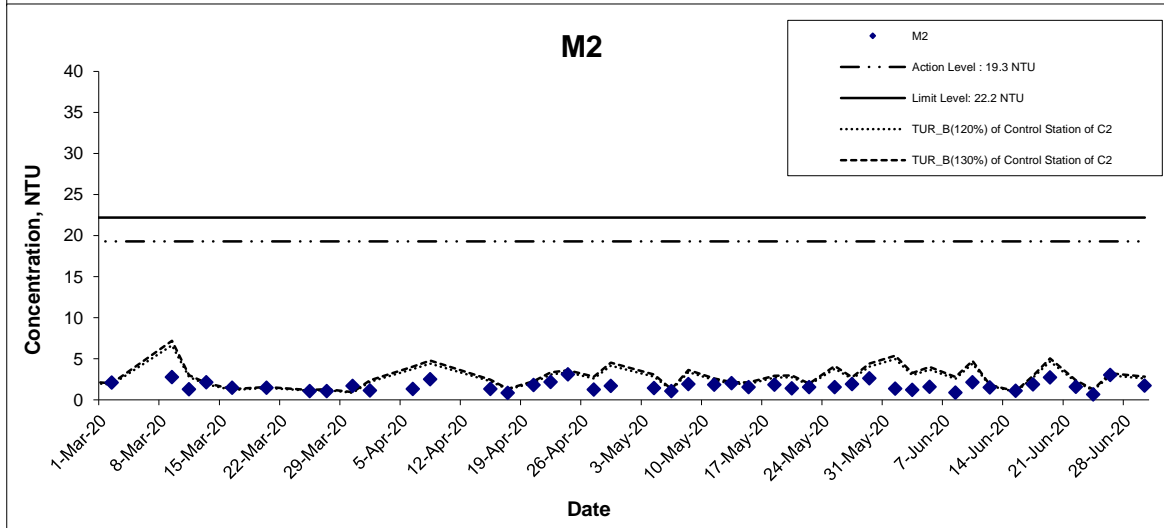
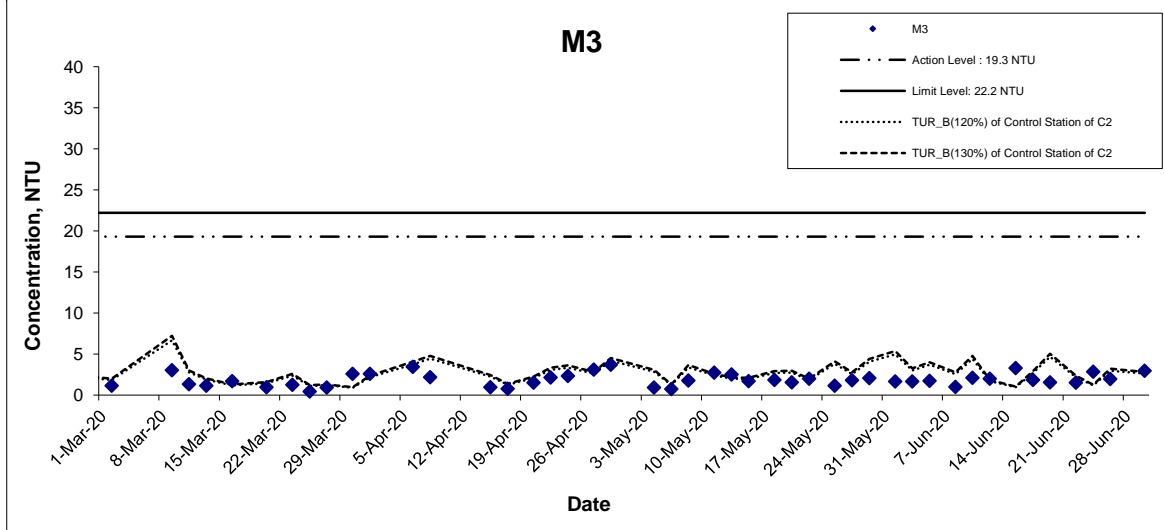
Title Agreement No. CE 59/2015(EP) Environmental Team for Tseung Kwan O - Lam Tin Tunnel Design and Construction

Turbidity (Bottom) at Mid-Ebb Tide

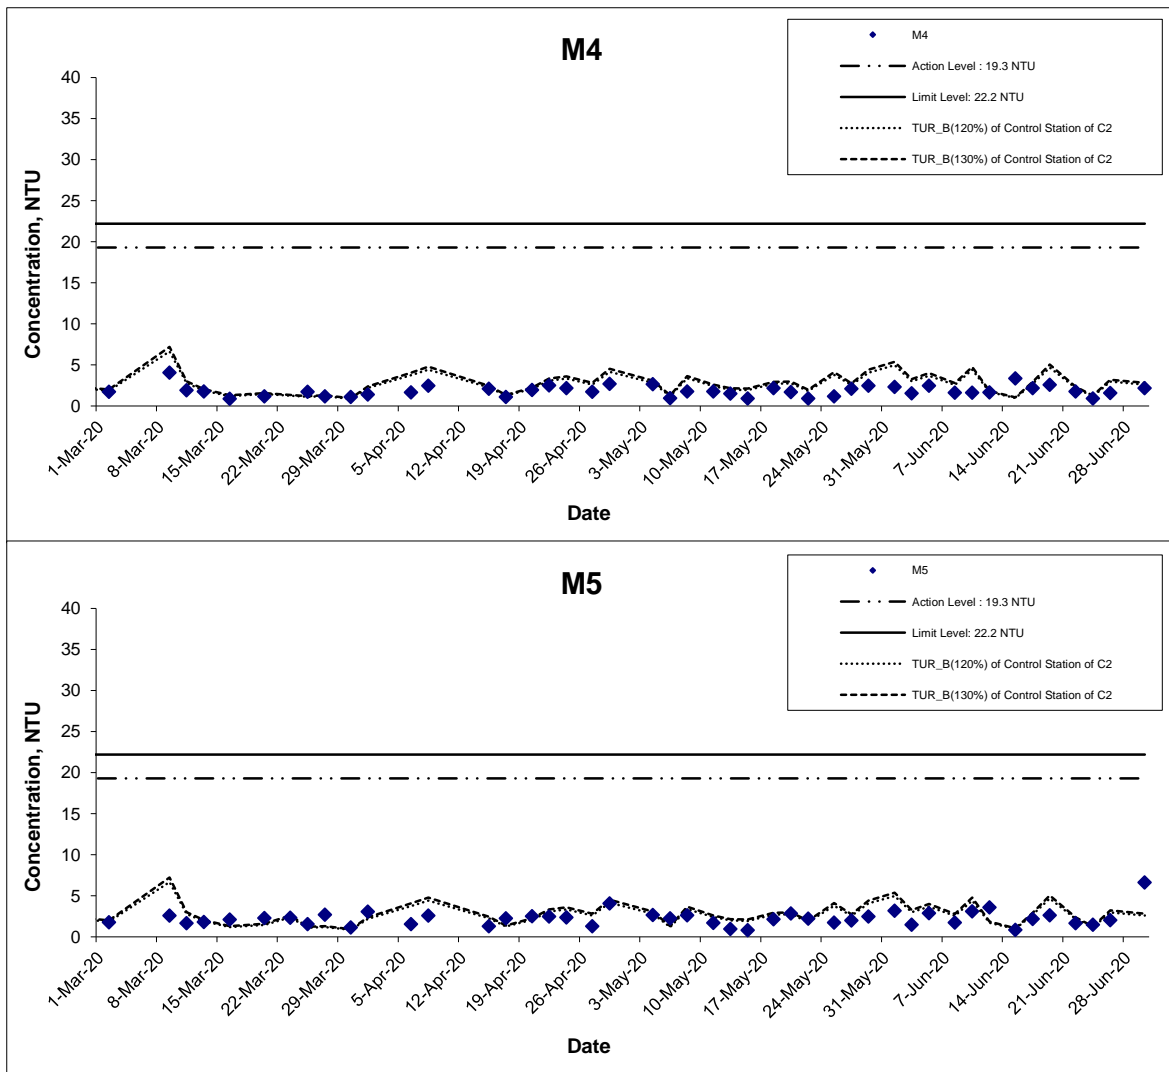
Title Agreement No. CE 59/2015(EP) Environmental Team for Tseung Kwan O - Lam Tin Tunnel Design and Construction Graphical Presentation of Water Quality Monitoring Results	Scale	N.T.S	Project No.	MA16034	CINOTECH
	Date	Jun 20	Appendix	I

Turbidity (Bottom) at Mid-Ebb Tide
