**Agreement No. CE 59/2015 (EP)
Environmental Team for
Tseung Kwan O – Lam Tin Tunnel
Design and Construction**

**Monthly Environmental Monitoring and
Audit Report for
June 2020
(version 1.0)**

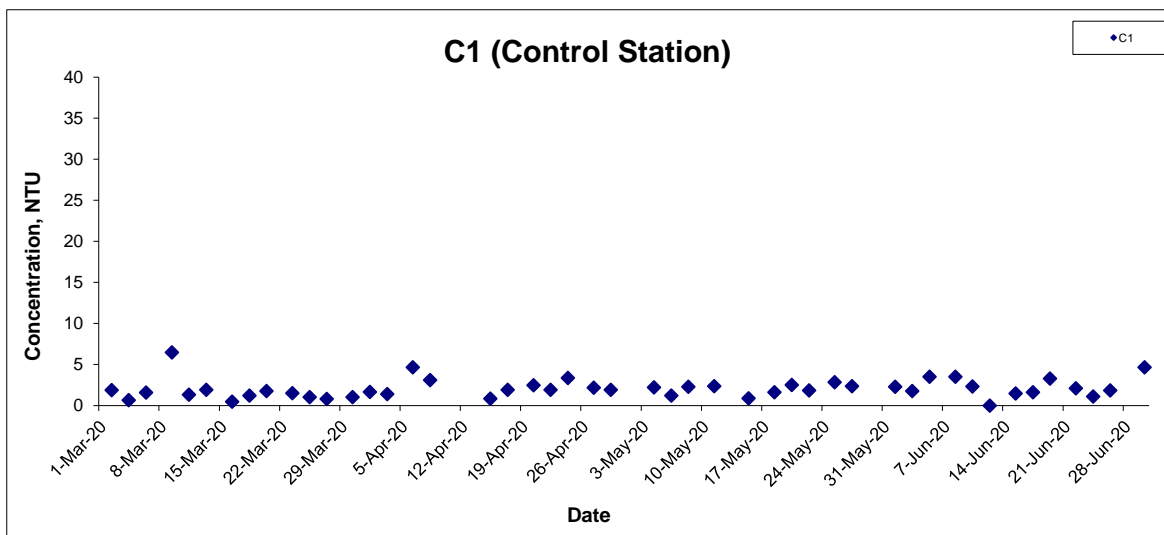
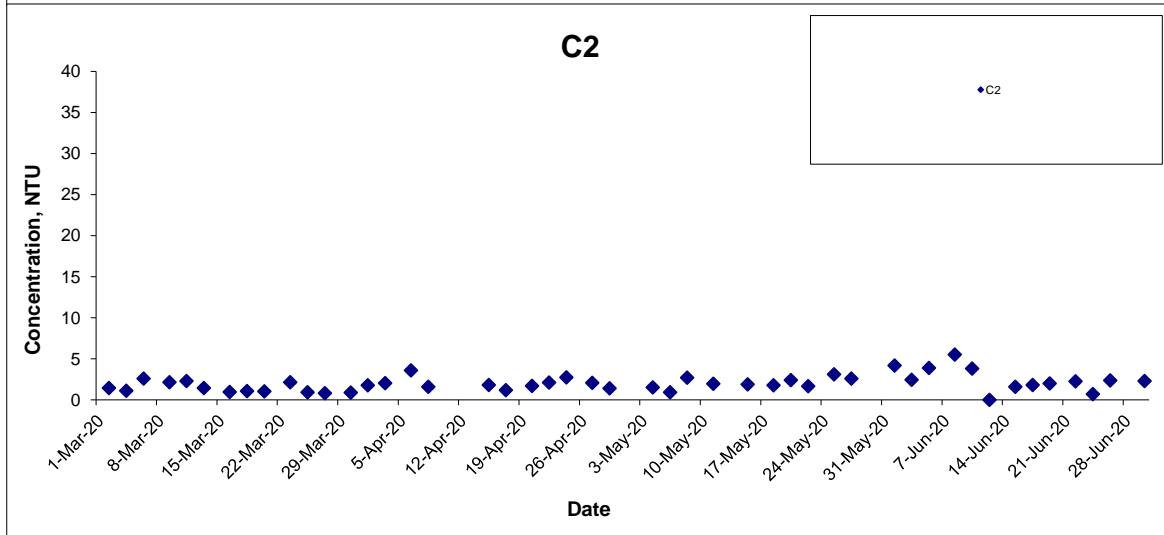
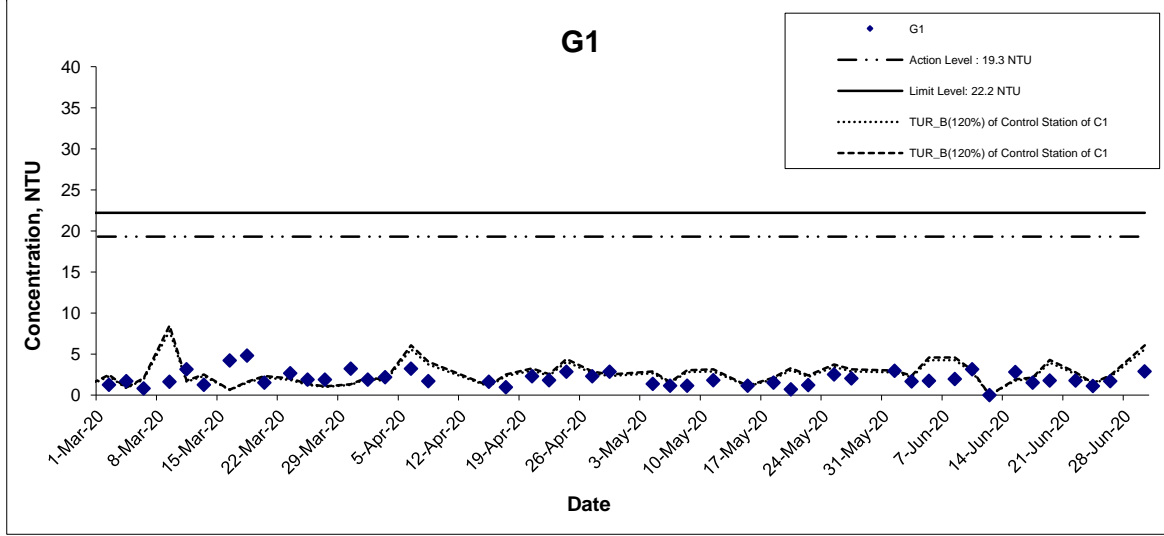
Title Agreement No. CE 59/2015(EP) Environmental Team for Tseung Kwan O - Lam Tin Tunnel Design and Construction Graphical Presentation of Water Quality Monitoring Results	Scale N.T.S	Project No. MA16034	
	Date Jun 20	Appendix I

Turbidity (Bottom) at Mid-Flood Tide

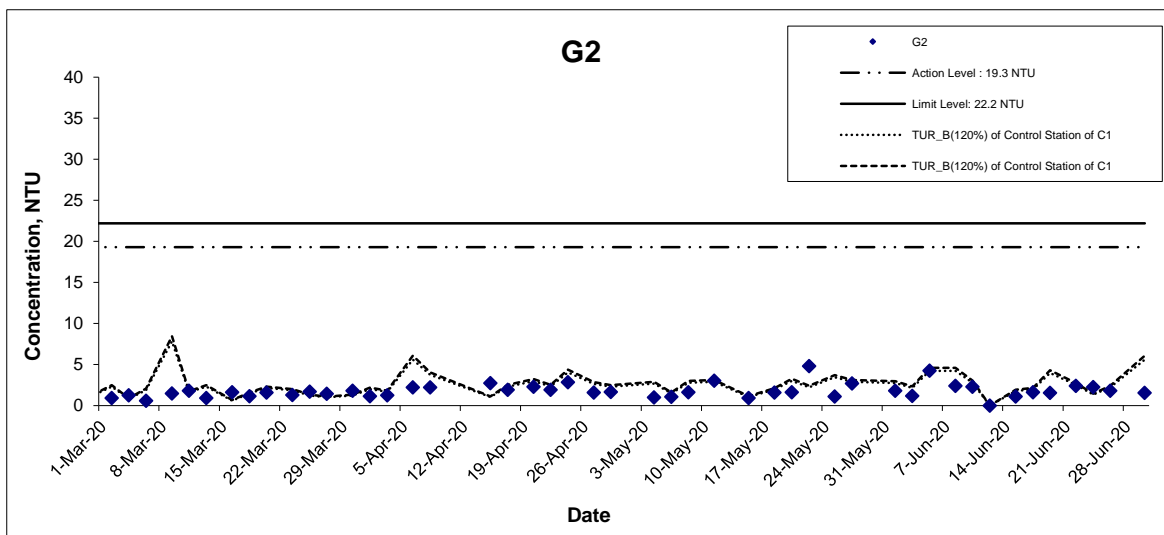
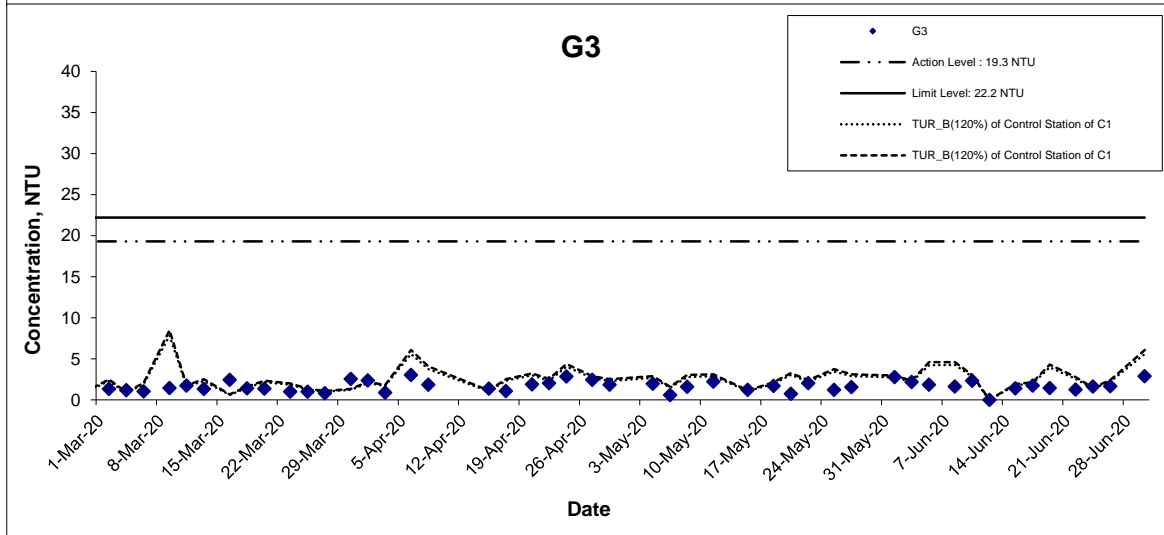
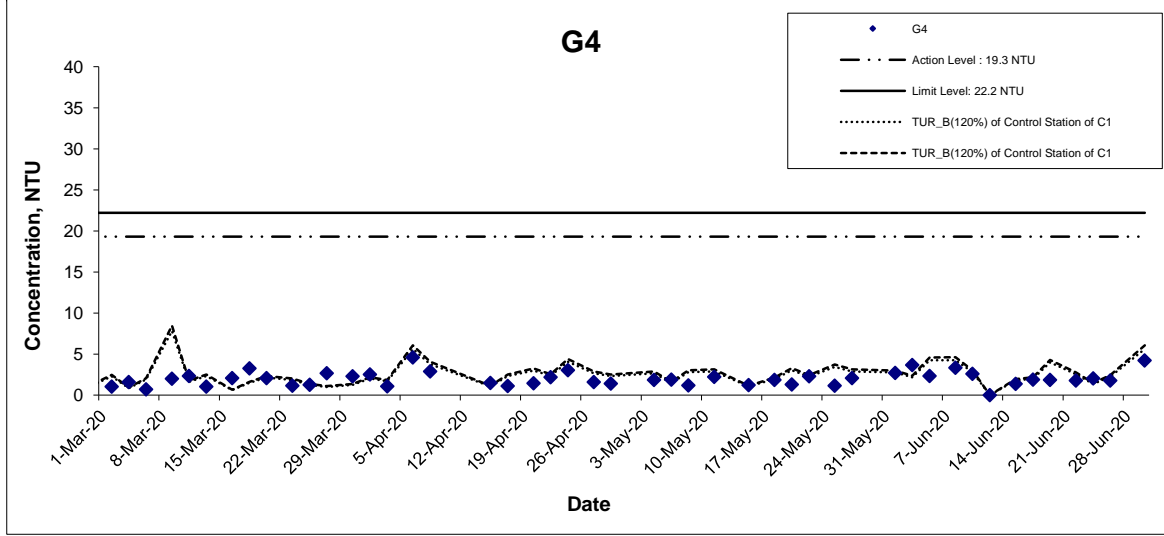
Turbidity (Bottom) at Mid-Flood Tide

Title Agreement No. CE 59/2015(EP) Environmental Team for Tseung Kwan O - Lam Tin Tunnel Design and Construction Graphical Presentation of Water Quality Monitoring Results	Scale	N.T.S	Project No.	MA16034	CINOTECH
	Date	Jun 20	Appendix	I

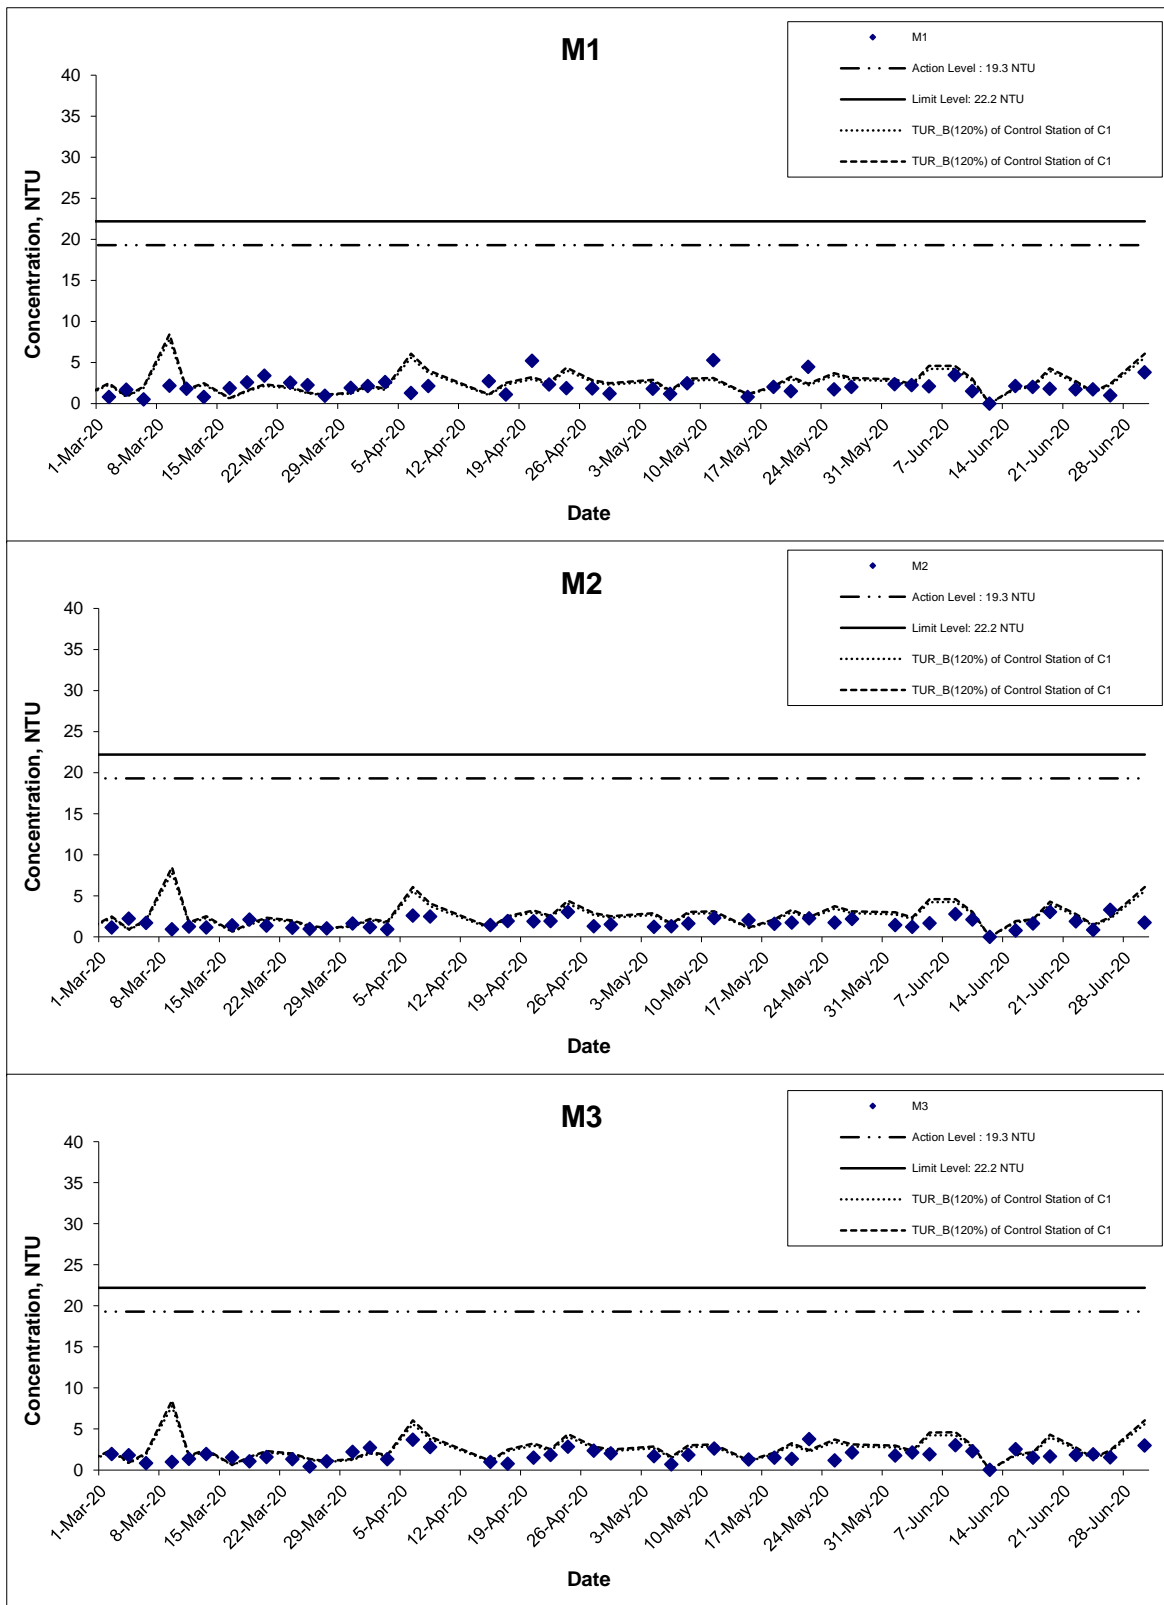
Turbidity (Bottom) at Mid-Flood Tide

Title Agreement No. CE 59/2015(EP) Environmental Team for Tseung Kwan O - Lam Tin Tunnel Design and Construction Graphical Presentation of Water Quality Monitoring Results	Scale N.T.S	Project No. MA16034	
	Date Jun 20	Appendix I

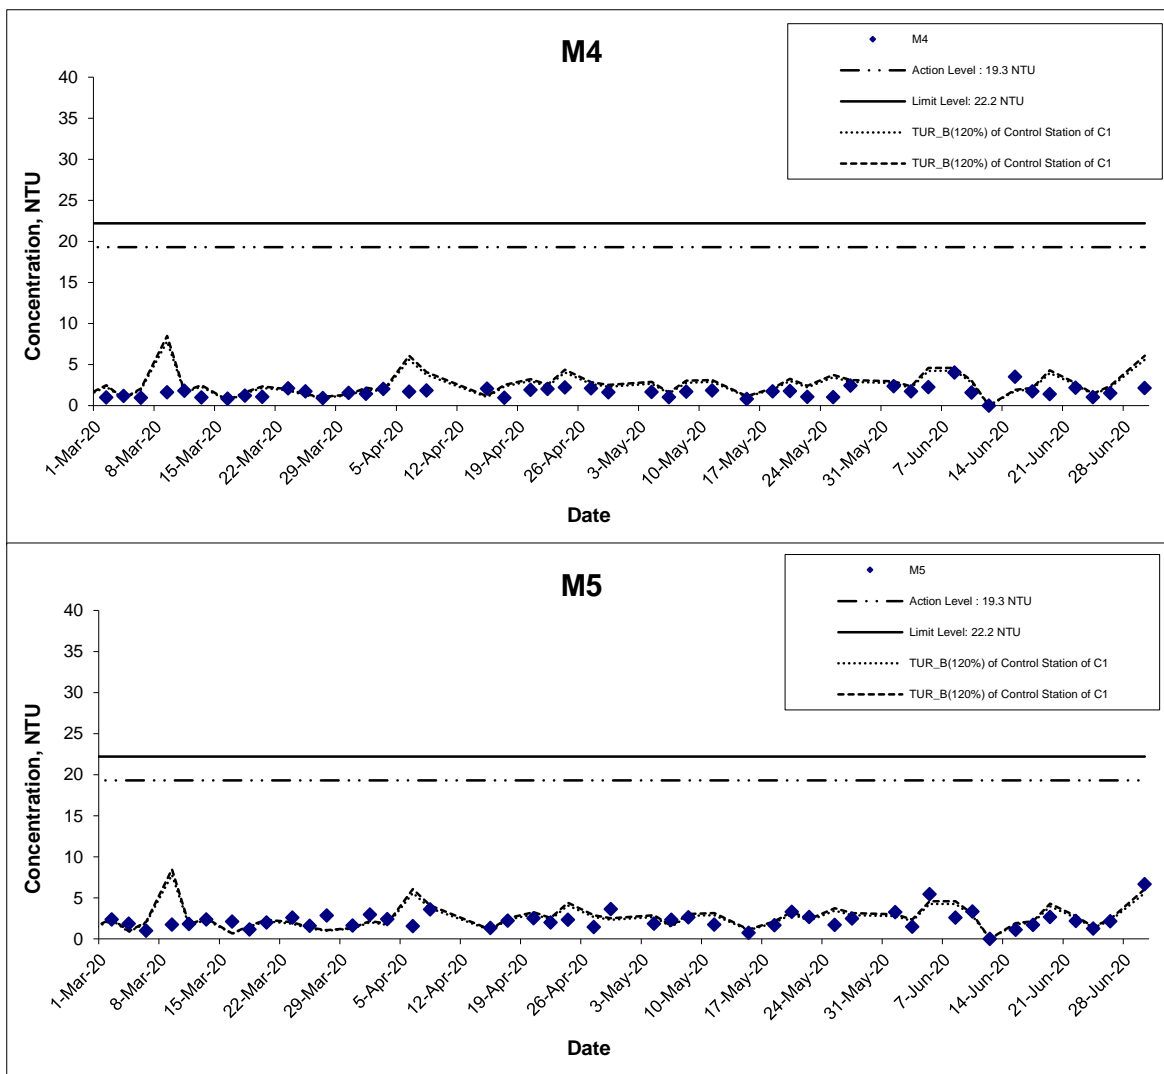
Turbidity (Bottom) at Mid-Flood Tide

Graphical Presentation of Water Quality Monitoring Results

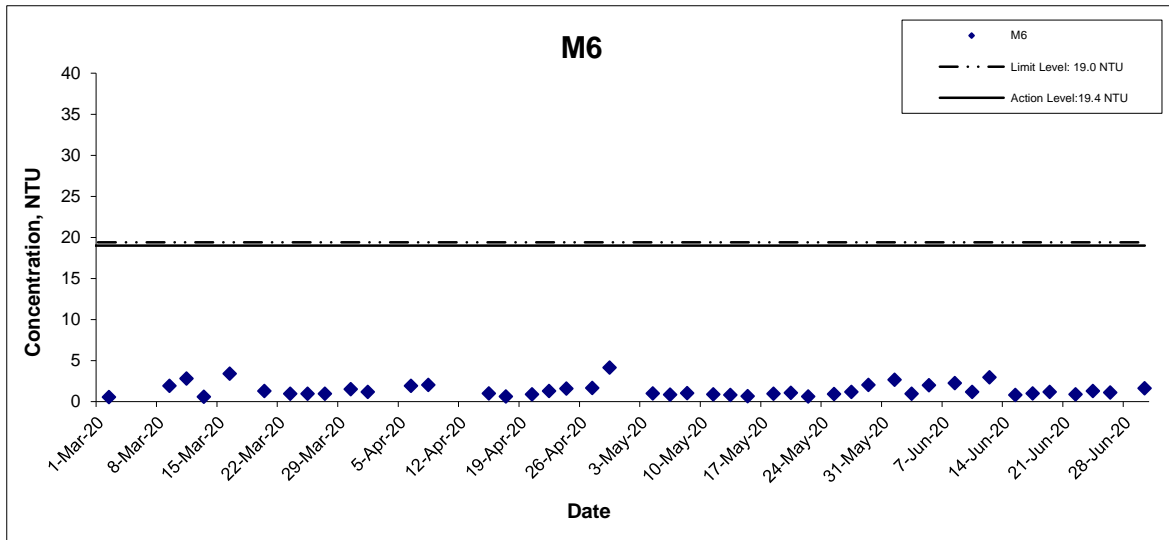
Turbidity (Intake Level of WSD Salt Water Intake) at Mid-Ebb Tide

Title Agreement No. CE 59/2015(EP) Environmental Team for Tseung Kwan O - Lam Tin Tunnel Design and Construction Graphical Presentation of Water Quality Monitoring Results	Scale N.T.S	Project No. MA16034	
	Date Jun 20	Appendix I

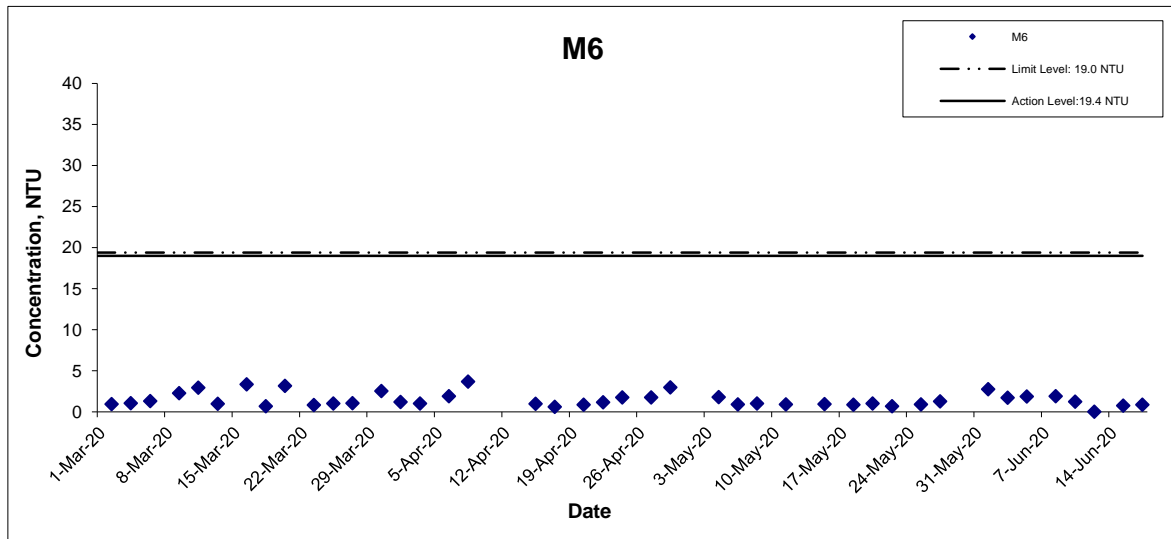
Turbidity (Intake Level of WSD Salt Water Intake) at Mid-Flood Tide

Title Agreement No. CE 59/2015(EP) Environmental Team for Tseung Kwan O - Lam Tin Tunnel Design and Construction Graphical Presentation of Water Quality Monitoring Results	Scale N.T.S	Project No. MA16034	CINOTECH
	Date Jun 20	Appendix I

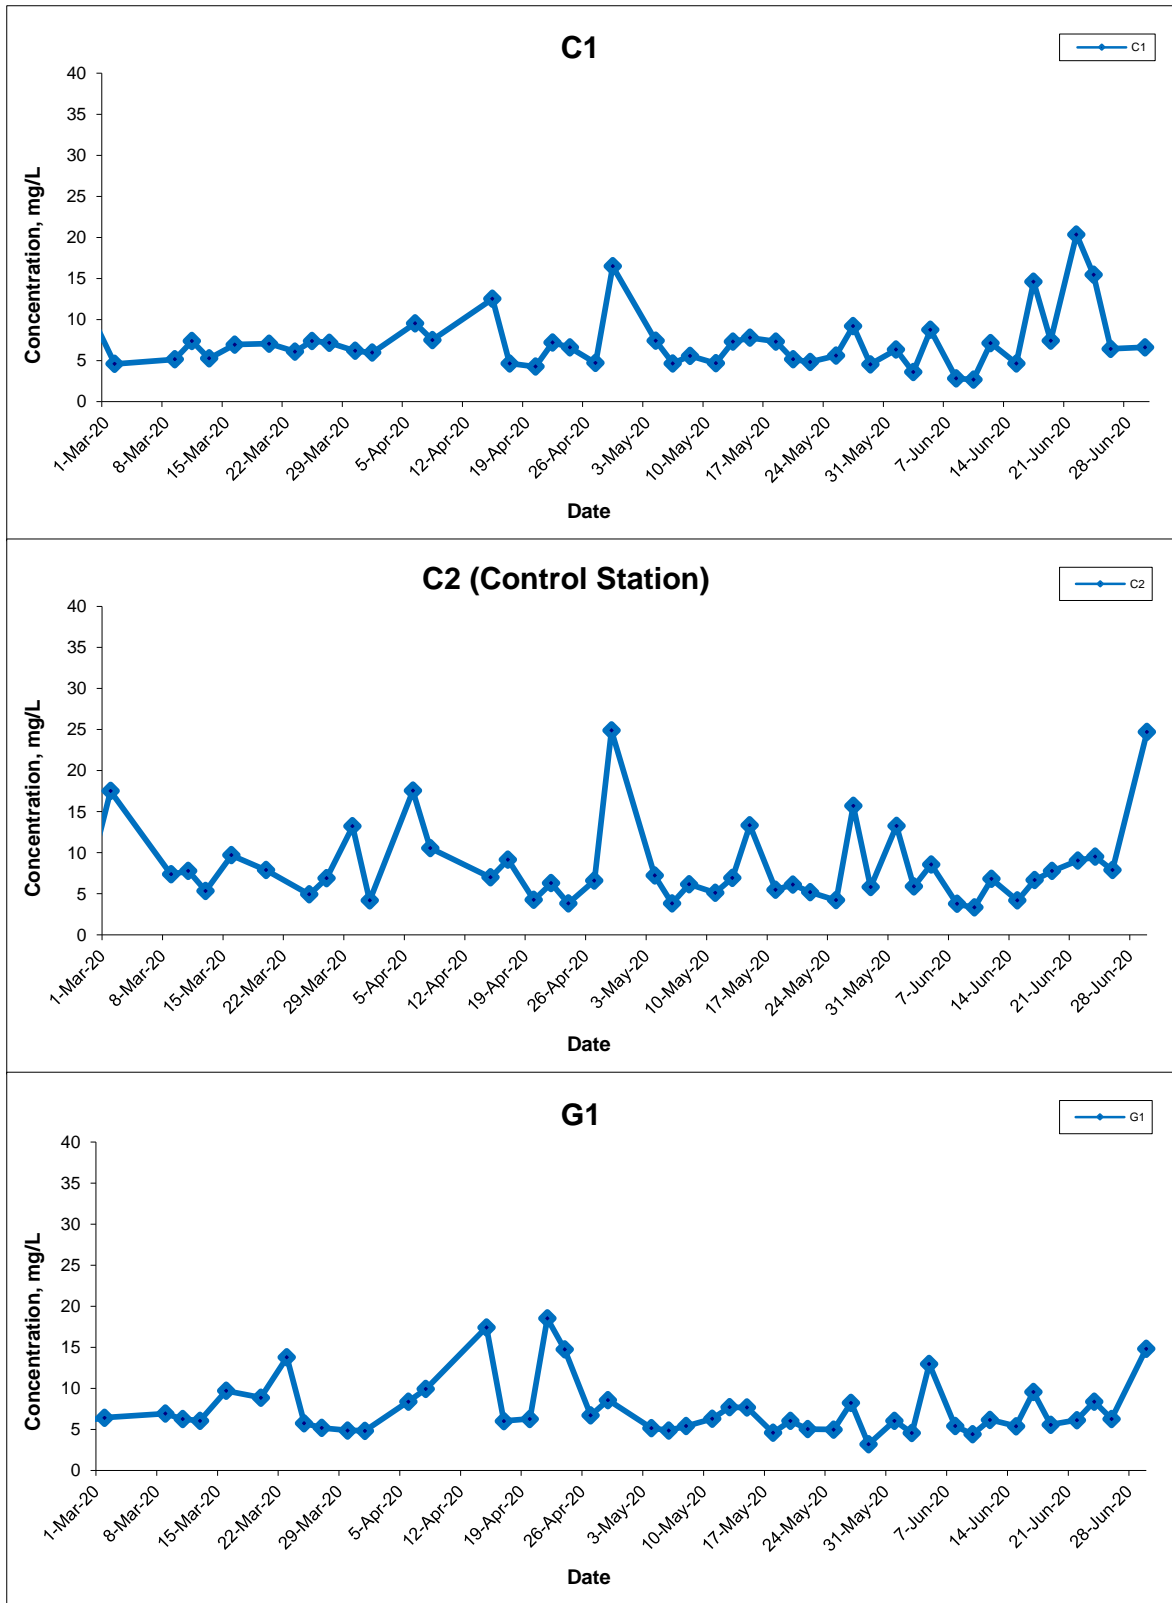
Suspended Solids (Depth-averaged) at Mid-Ebb Tide

Title Agreement No. CE 59/2015(EP) Environmental Team for Tseung Kwan O - Lam Tin Tunnel Design and Construction Graphical Presentation of Water Quality Monitoring Results	Scale N.T.S	Project No. MA16034	
	Date Jun 20	Appendix I

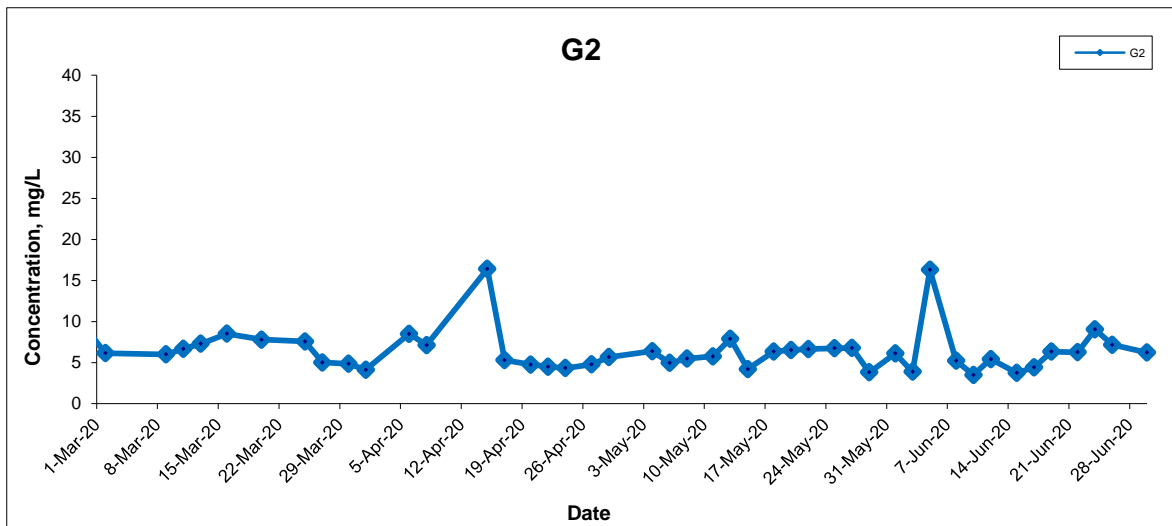
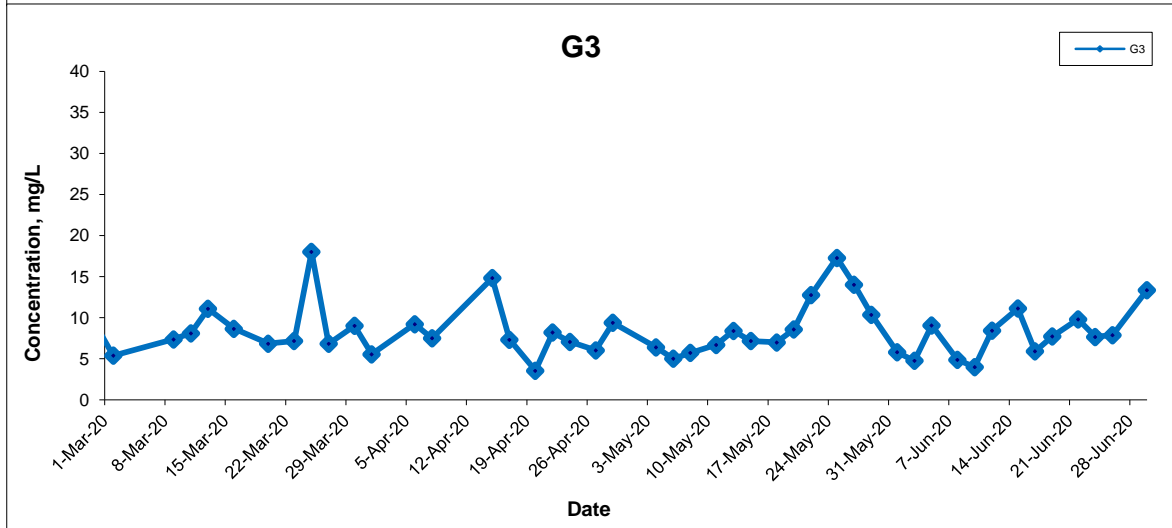
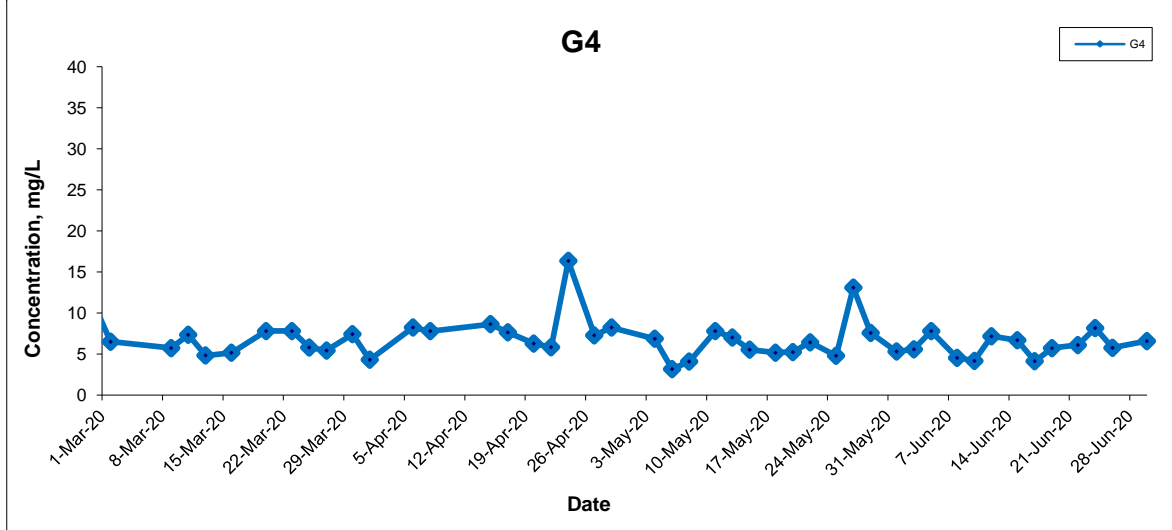
Suspended Solids (Depth-averaged) at Mid-Ebb Tide

Title Agreement No. CE 59/2015(EP) Environmental Team for Tseung Kwan O - Lam Tin Tunnel Design and Construction Graphical Presentation of Water Quality Monitoring Results	Scale N.T.S	Project No. MA16034	
	Date Jun 20	Appendix I

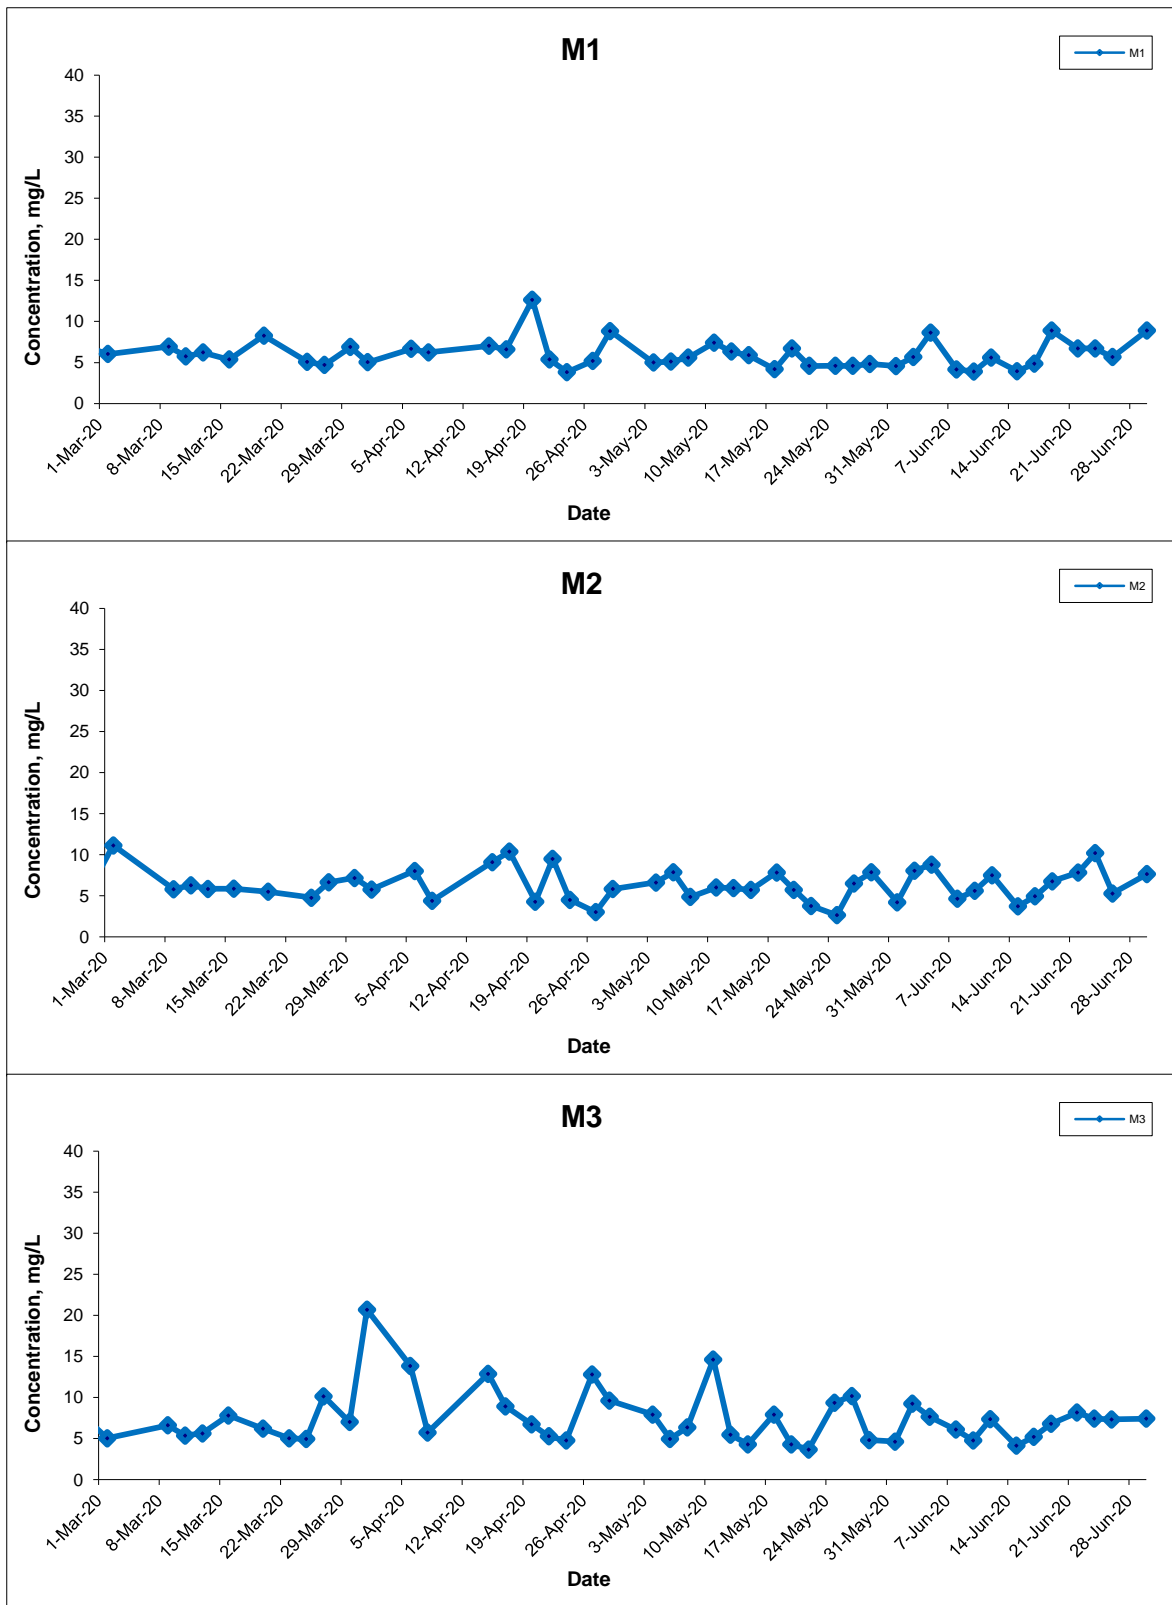
Suspended Solids (Depth-averaged) at Mid-Ebb Tide

Title Agreement No. CE 59/2015(EP) Environmental Team for Tseung Kwan O - Lam Tin Tunnel Design and Construction Graphical Presentation of Water Quality Monitoring Results	Scale N.T.S	Project No. MA16034	
	Date Jun 20	Appendix I

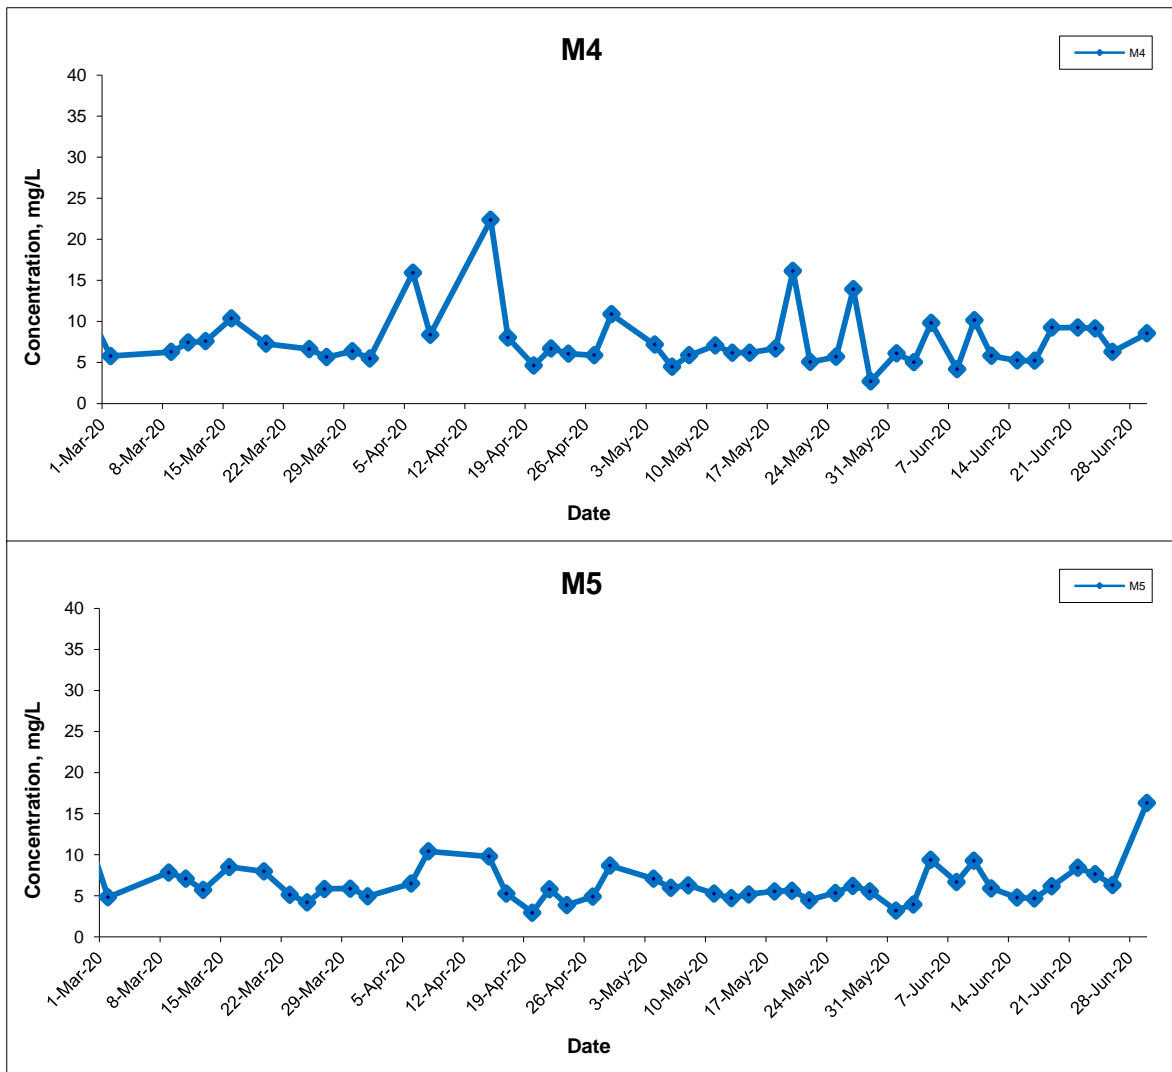
Suspended Solids (Depth-averaged) at Mid-Ebb Tide

Title Agreement No. CE 59/2015(EP) Environmental Team for Tseung Kwan O - Lam Tin Tunnel Design and Construction Graphical Presentation of Water Quality Monitoring Results	Scale N.T.S	Project No. MA16034	
	Date Jun 20	Appendix I

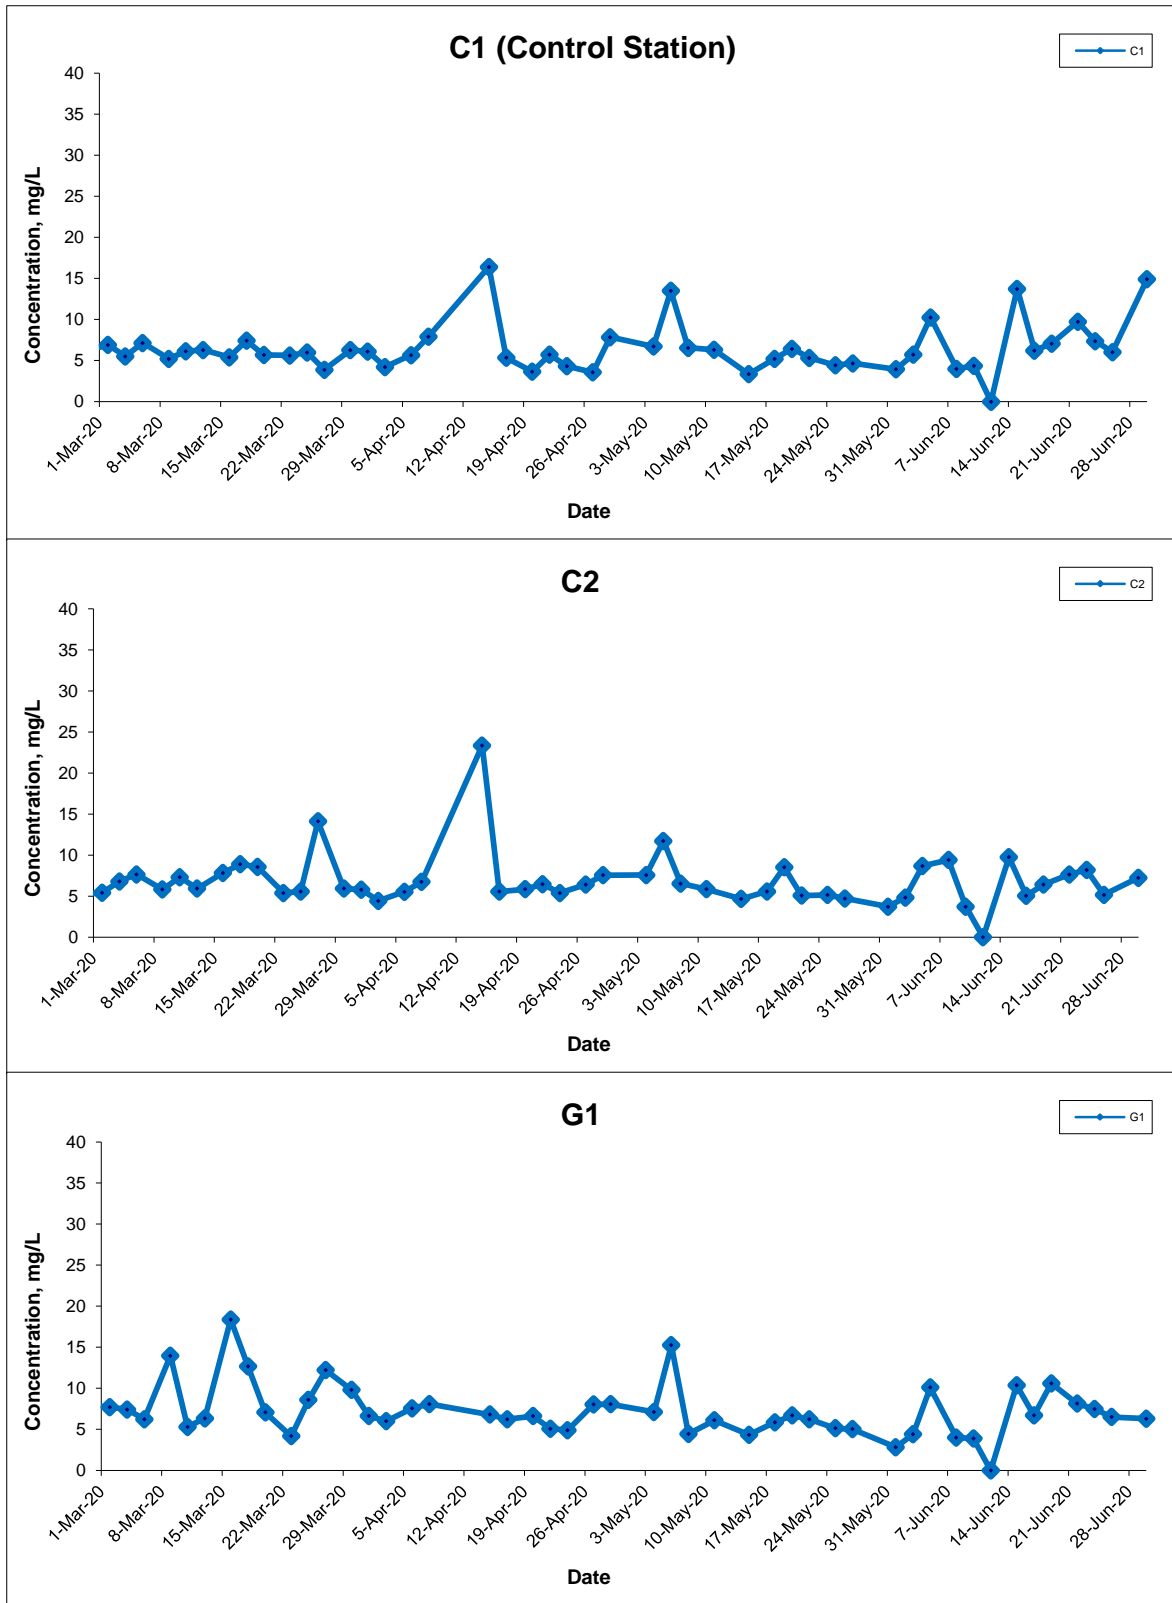
Suspended Solids (Depth-averaged) at Mid-Flood Tide

Title Agreement No. CE 59/2015(EP) Environmental Team for Tseung Kwan O - Lam Tin Tunnel Design and Construction Graphical Presentation of Water Quality Monitoring Results	Scale N.T.S	Project No. MA16034	
	Date Jun 20	Appendix I

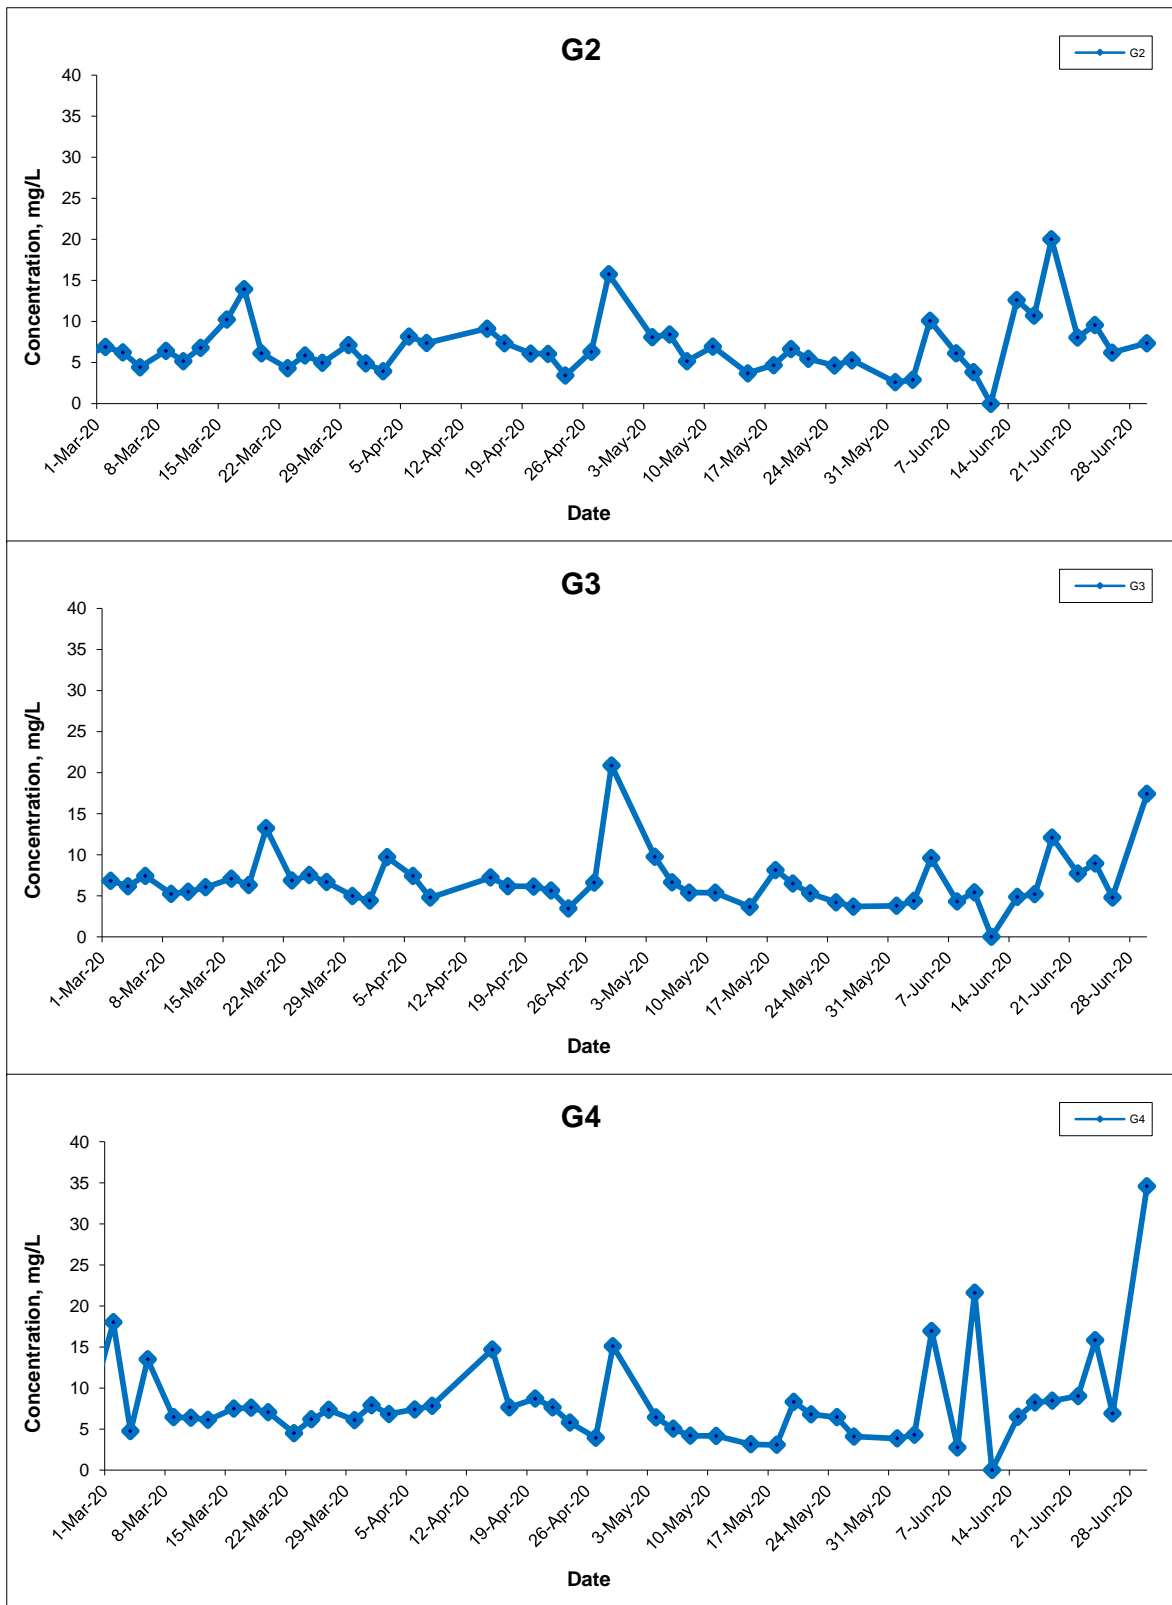
Suspended Solids (Depth-averaged) at Mid-Flood Tide

Title Agreement No. CE 59/2015(EP) Environmental Team for Tseung Kwan O - Lam Tin Tunnel Design and Construction Graphical Presentation of Water Quality Monitoring Results	Scale N.T.S	Project No. MA16034	
	Date Jun 20	Appendix I

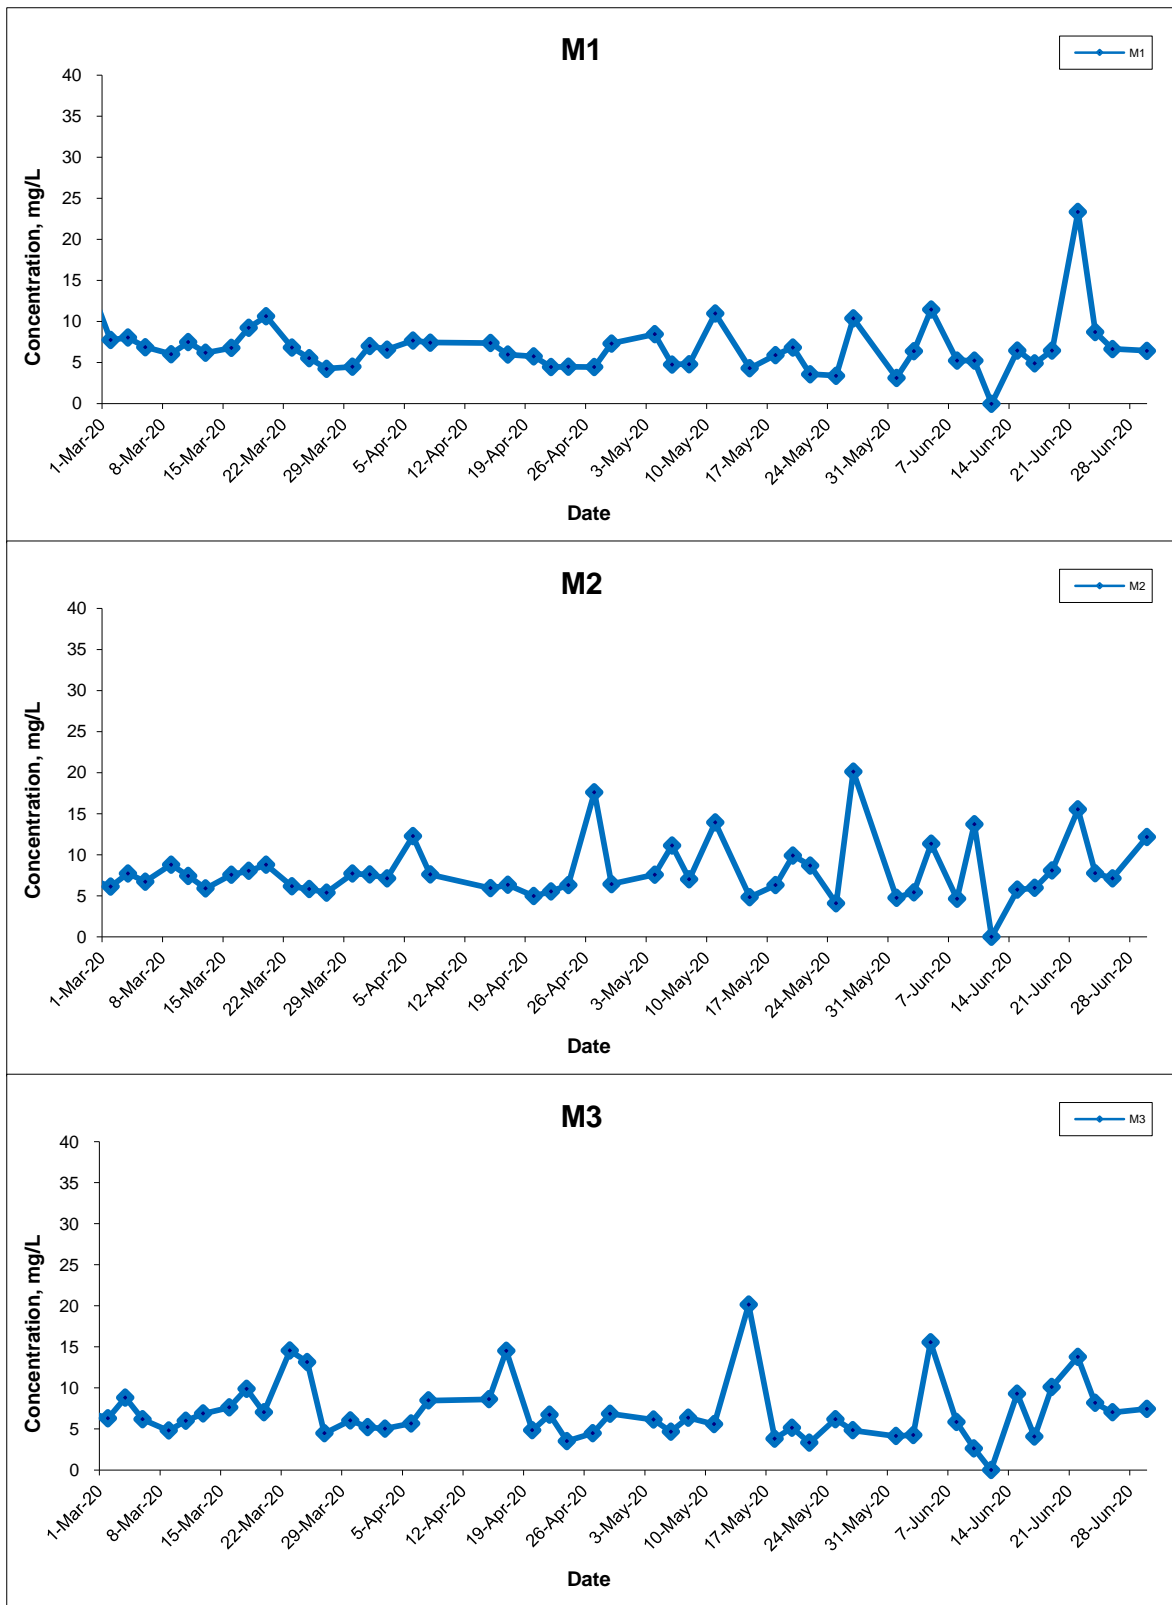
Suspended Solids (Depth-averaged) at Mid-Flood Tide

Title Agreement No. CE 59/2015(EP) Environmental Team for Tseung Kwan O - Lam Tin Tunnel Design and Construction Graphical Presentation of Water Quality Monitoring Results	Scale N.T.S	Project No. MA16034	
	Date Jun 20	Appendix I

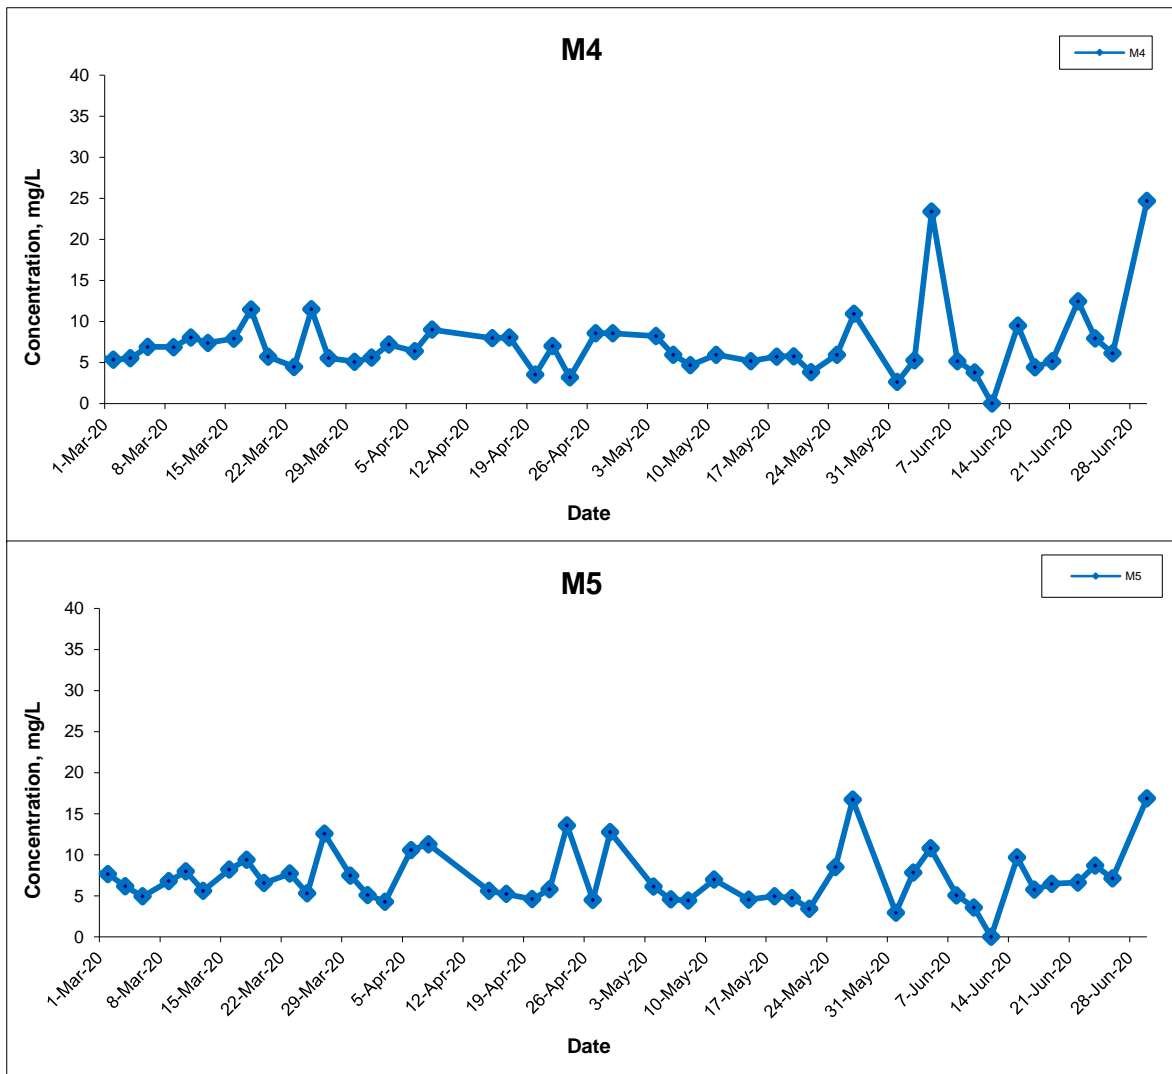
Suspended Solids (Depth-averaged) at Mid-Flood Tide

Title Agreement No. CE 59/2015(EP) Environmental Team for Tseung Kwan O - Lam Tin Tunnel Design and Construction Graphical Presentation of Water Quality Monitoring Results	Scale N.T.S	Project No. MA16034	
	Date Jun 20	Appendix I
