**Agreement No. CE 59/2015 (EP)
Environmental Team for
Tseung Kwan O – Lam Tin Tunnel
Design and Construction**

**Monthly Environmental Monitoring and
Audit Report for
June 2020
(version 1.0)**

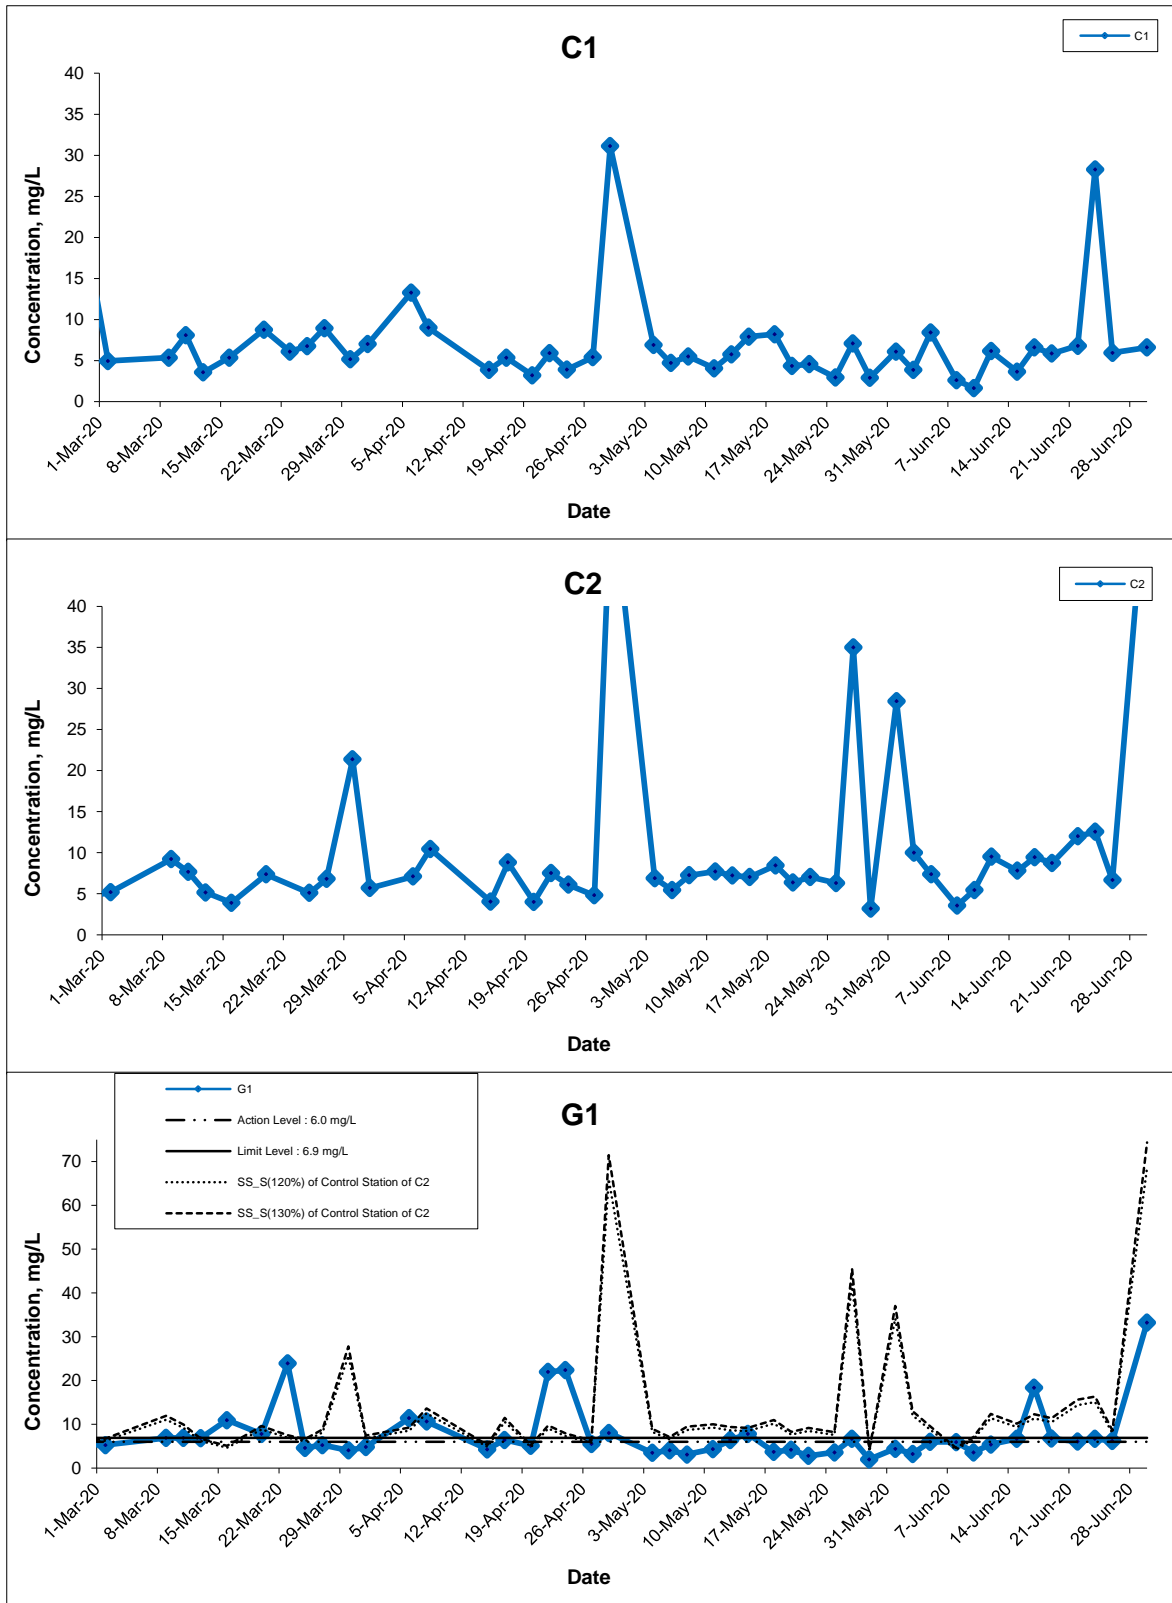
Suspended Solids (Surface) at Mid-Ebb Tide

Title Agreement No. CE 59/2015(EP) Environmental Team for Tseung Kwan O - Lam Tin Tunnel Design and Construction Graphical Presentation of Water Quality Monitoring Results	Scale N.T.S	Project No. MA16034	
	Date Jun 20	Appendix I

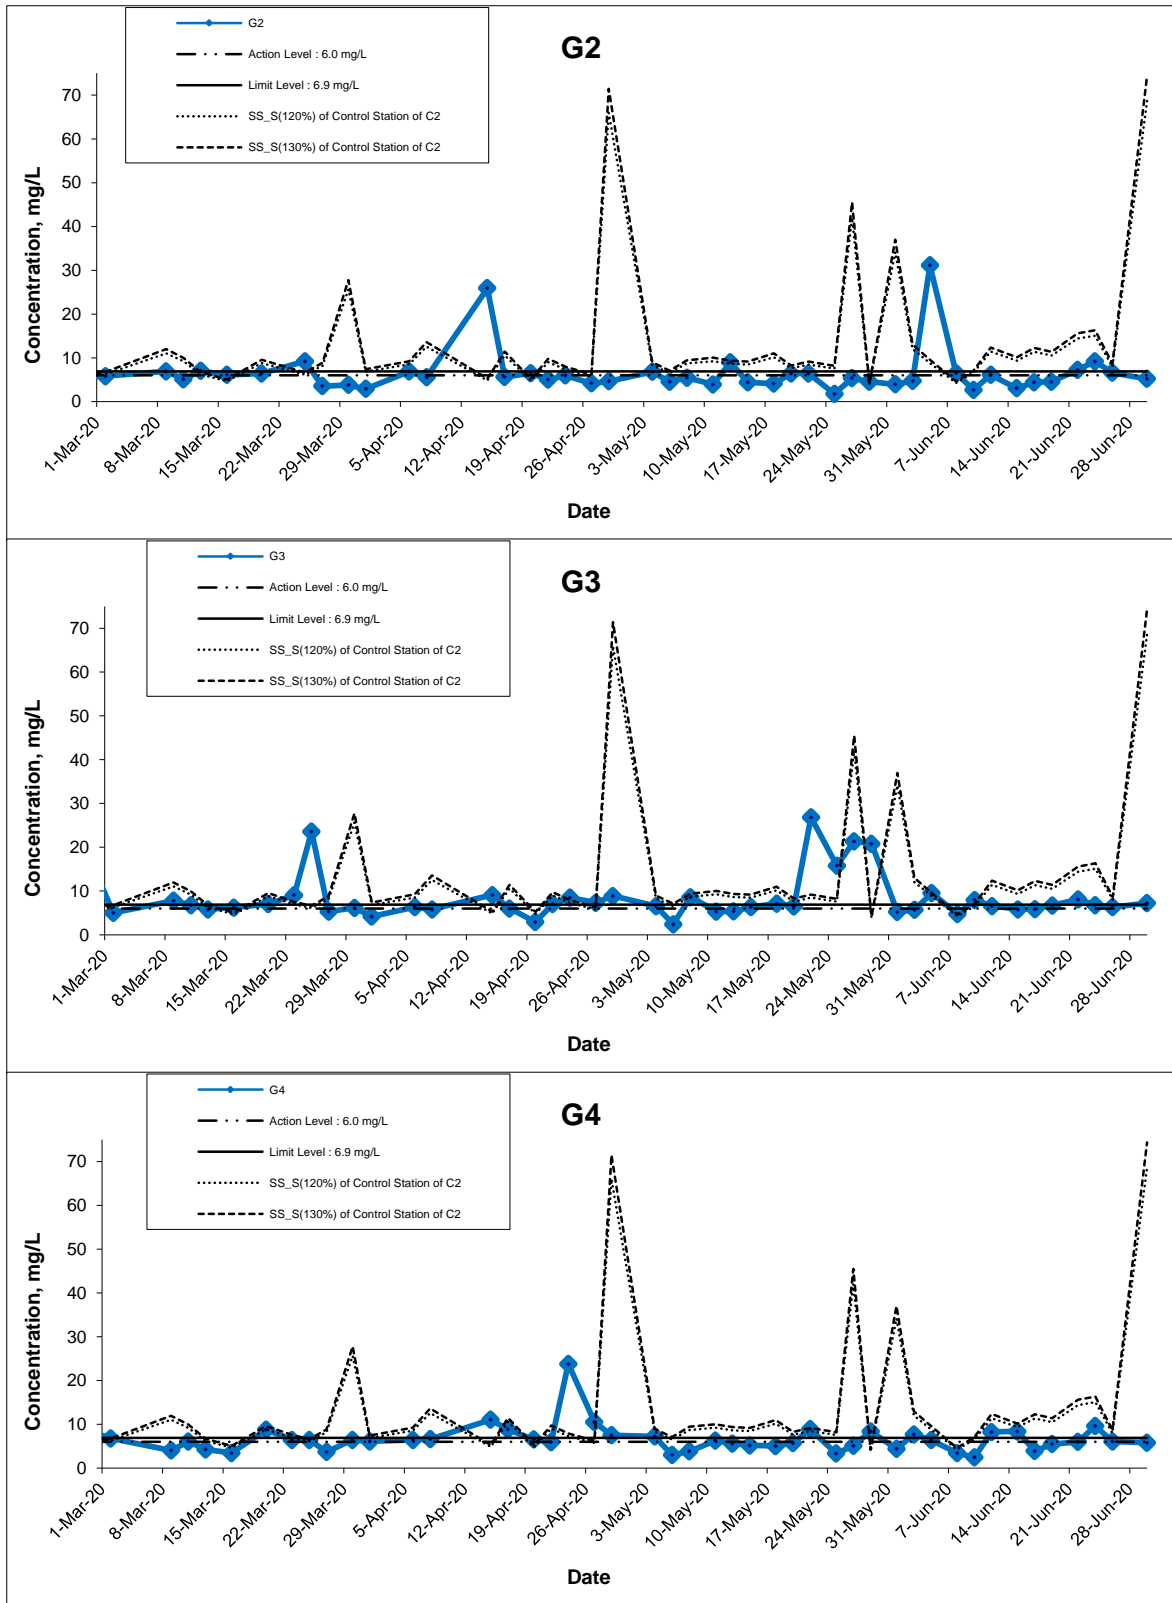
Suspended Solids (Surface) at Mid-Ebb Tide

Graphical Presentation of Water Quality Monitoring Results

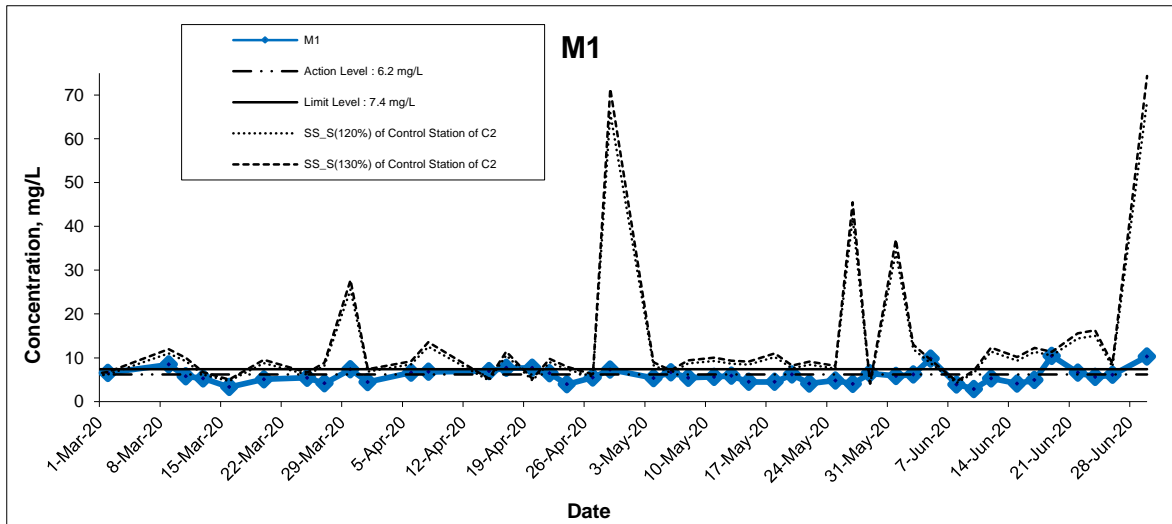
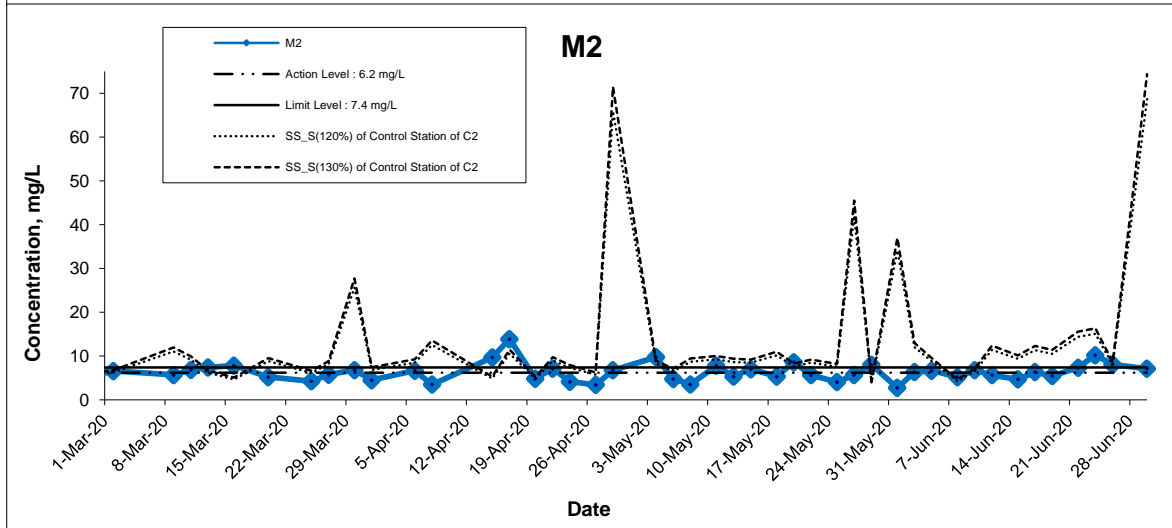
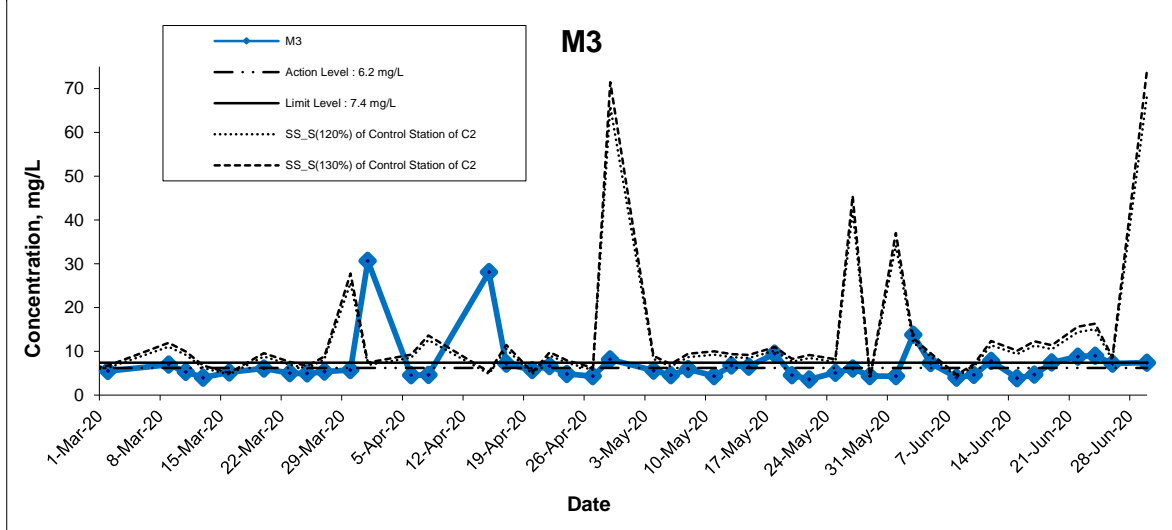
Suspended Solids (Surface) at Mid-Ebb Tide

Title Agreement No. CE 59/2015(EP) Environmental Team for Tseung Kwan O - Lam Tin Tunnel Design and Construction Graphical Presentation of Water Quality Monitoring Results	Scale N.T.S	Project No. MA16034	
	Date Jun 20	Appendix I

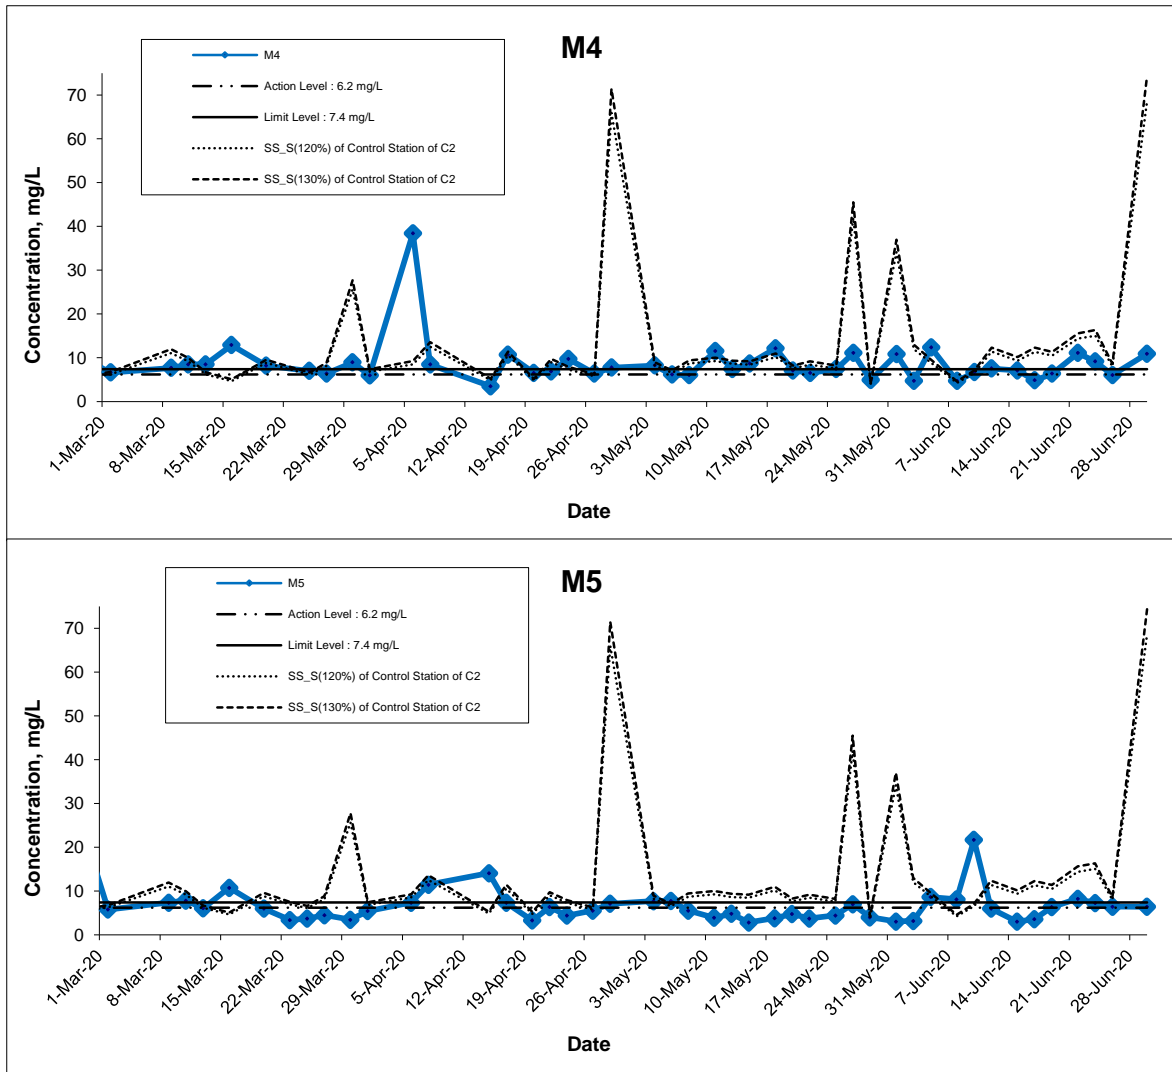
Suspended Solids (Surface) at Mid-Ebb Tide

Title	Agreement No. CE 59/2015(EP) Environmental Team for Tseung Kwan O - Lam Tin Tunnel Design and Construction		Scale	N.T.S	Project No.	MA16034
	Graphical Presentation of Water Quality Monitoring Results		Date	Jun 20	Appendix	I

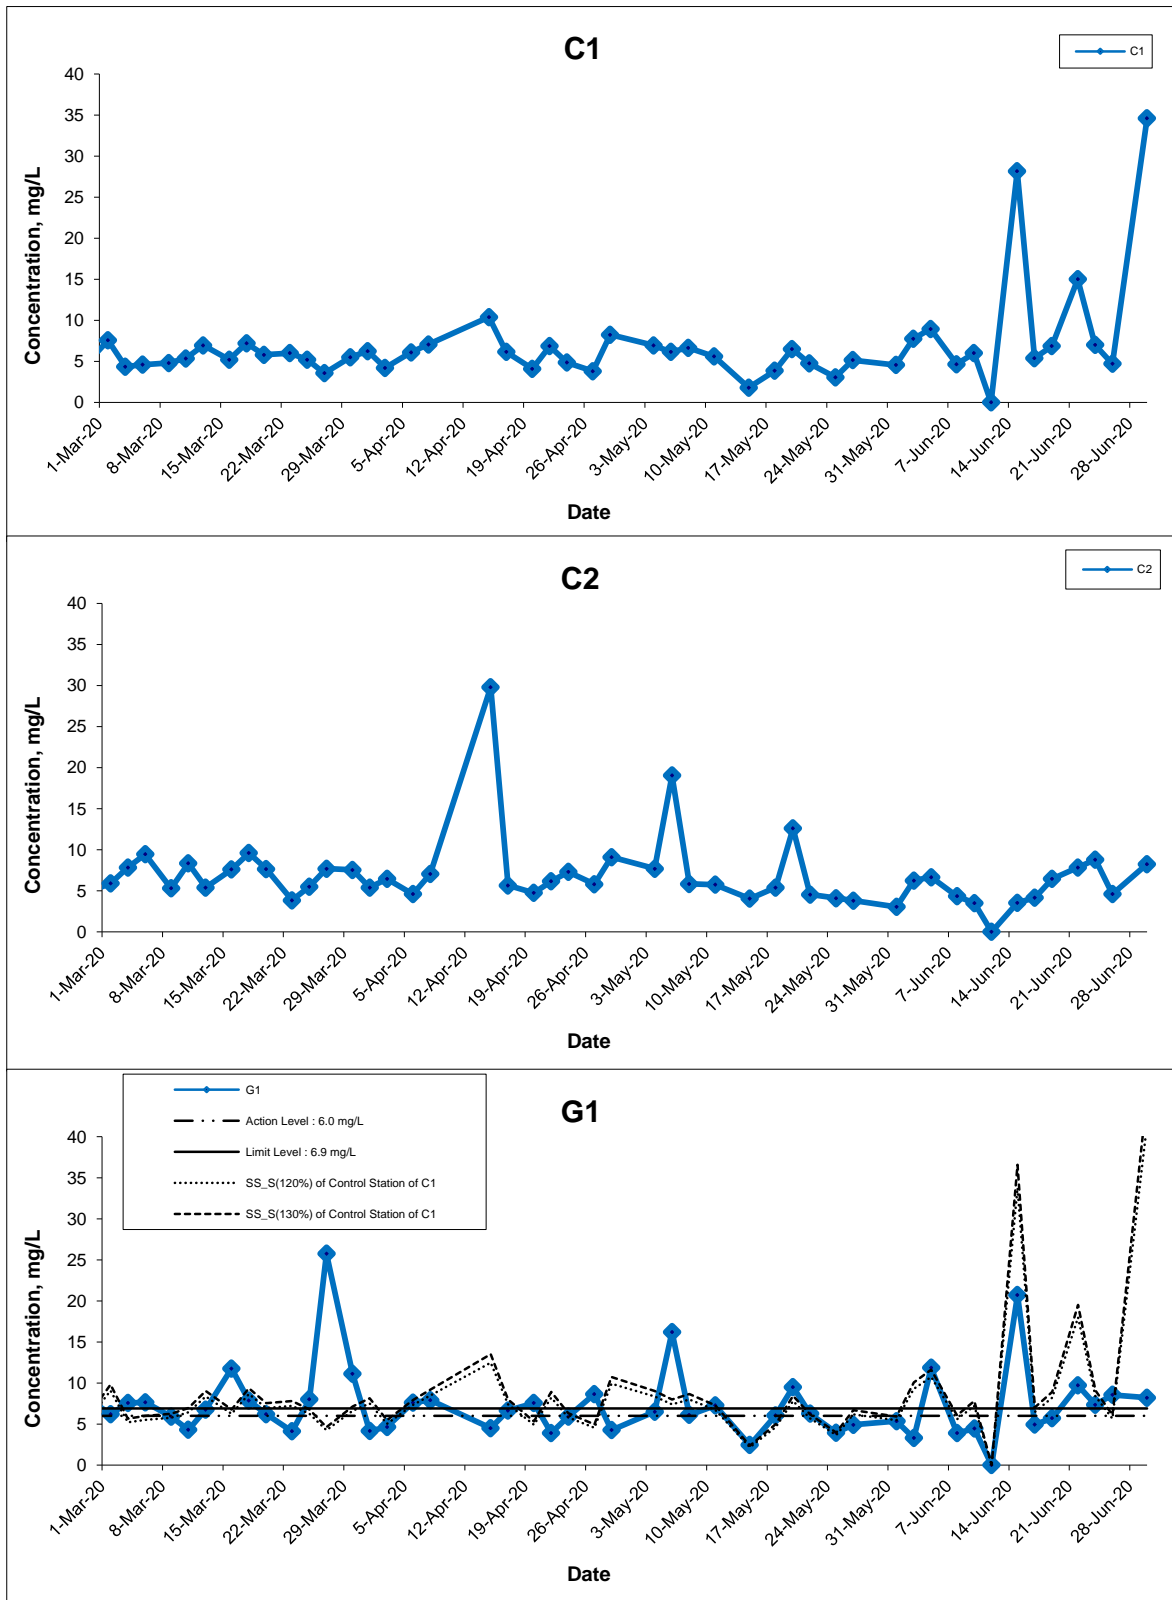
Suspended Solids (Surface) at Mid-Flood Tide

Title Agreement No. CE 59/2015(EP) Environmental Team for Tseung Kwan O - Lam Tin Tunnel Design and Construction Graphical Presentation of Water Quality Monitoring Results	Scale	N.T.S	Project No.	MA16034
	Date	Jun 20	Appendix	I

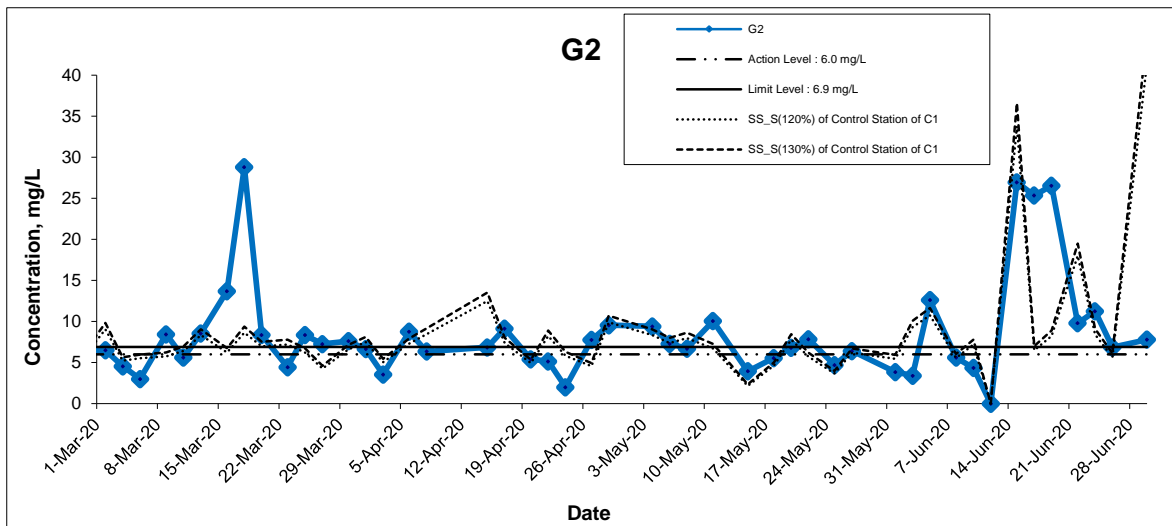
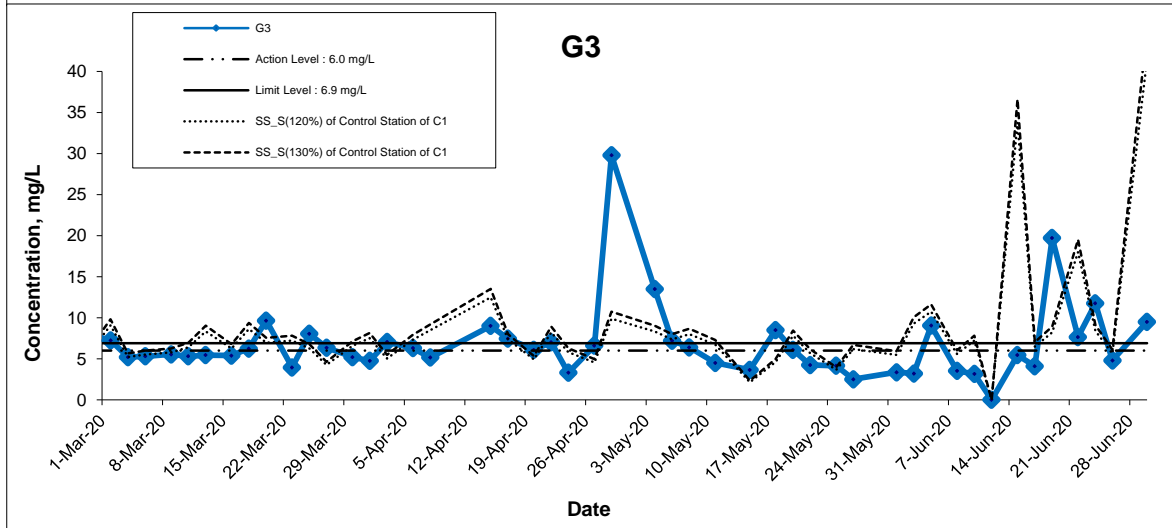
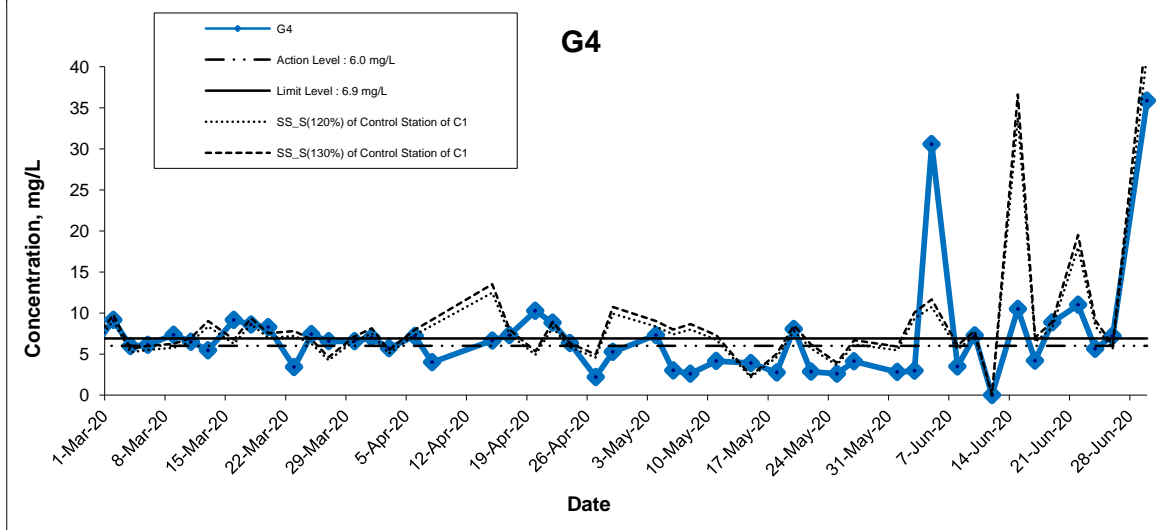
Suspended Solids (Surface) at Mid-Flood Tide

Title Agreement No. CE 59/2015(EP) Environmental Team for Tseung Kwan O - Lam Tin Tunnel Design and Construction Graphical Presentation of Water Quality Monitoring Results	Scale N.T.S	Project No. MA16034	
	Date Jun 20	Appendix I

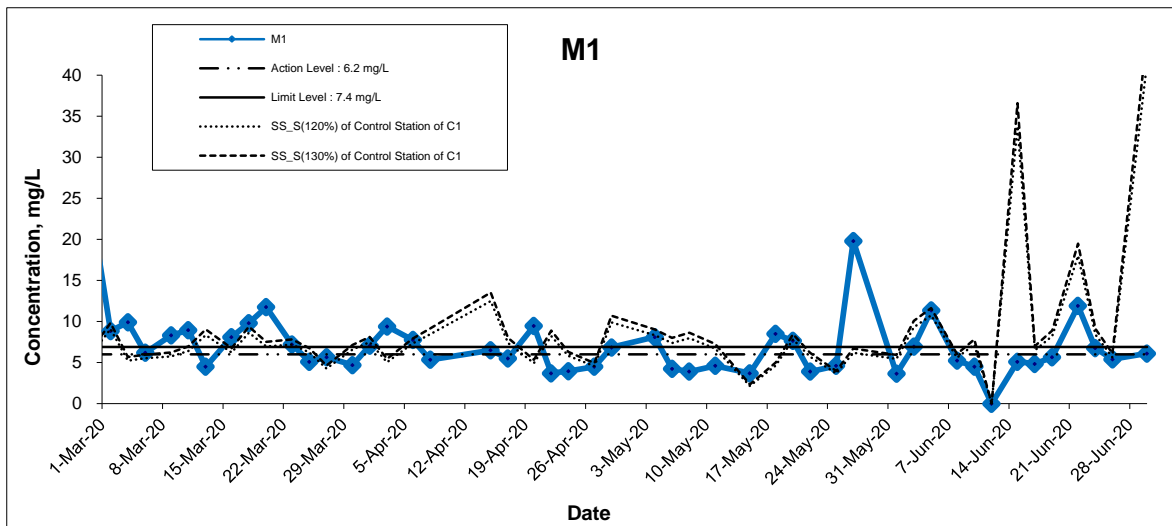
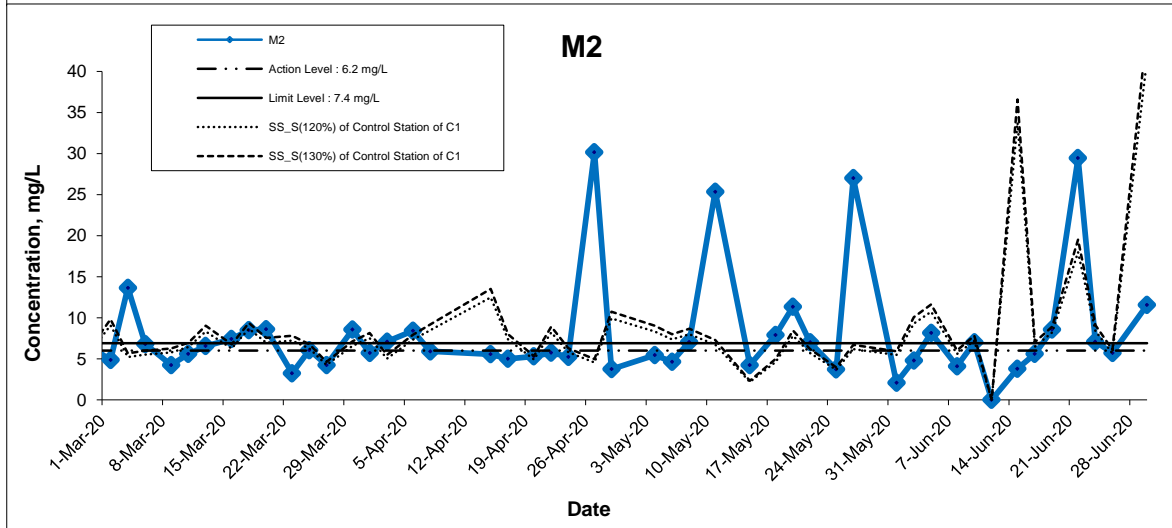
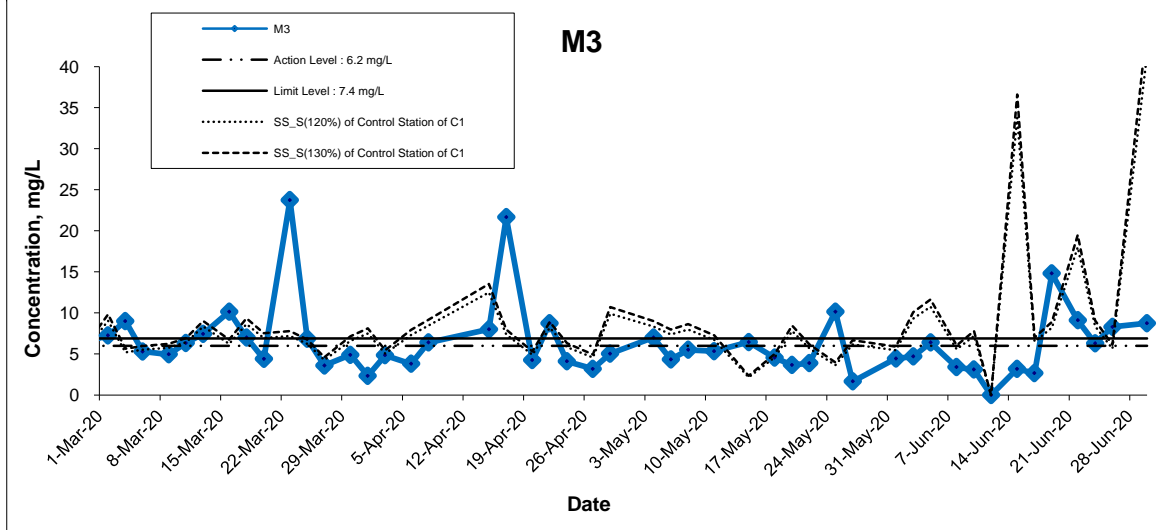
Suspended Solids (Surface) at Mid-Flood Tide

Title Agreement No. CE 59/2015(EP) Environmental Team for Tseung Kwan O - Lam Tin Tunnel Design and Construction Graphical Presentation of Water Quality Monitoring Results	Scale N.T.S	Project No. MA16034	
	Date Jun 20	Appendix I

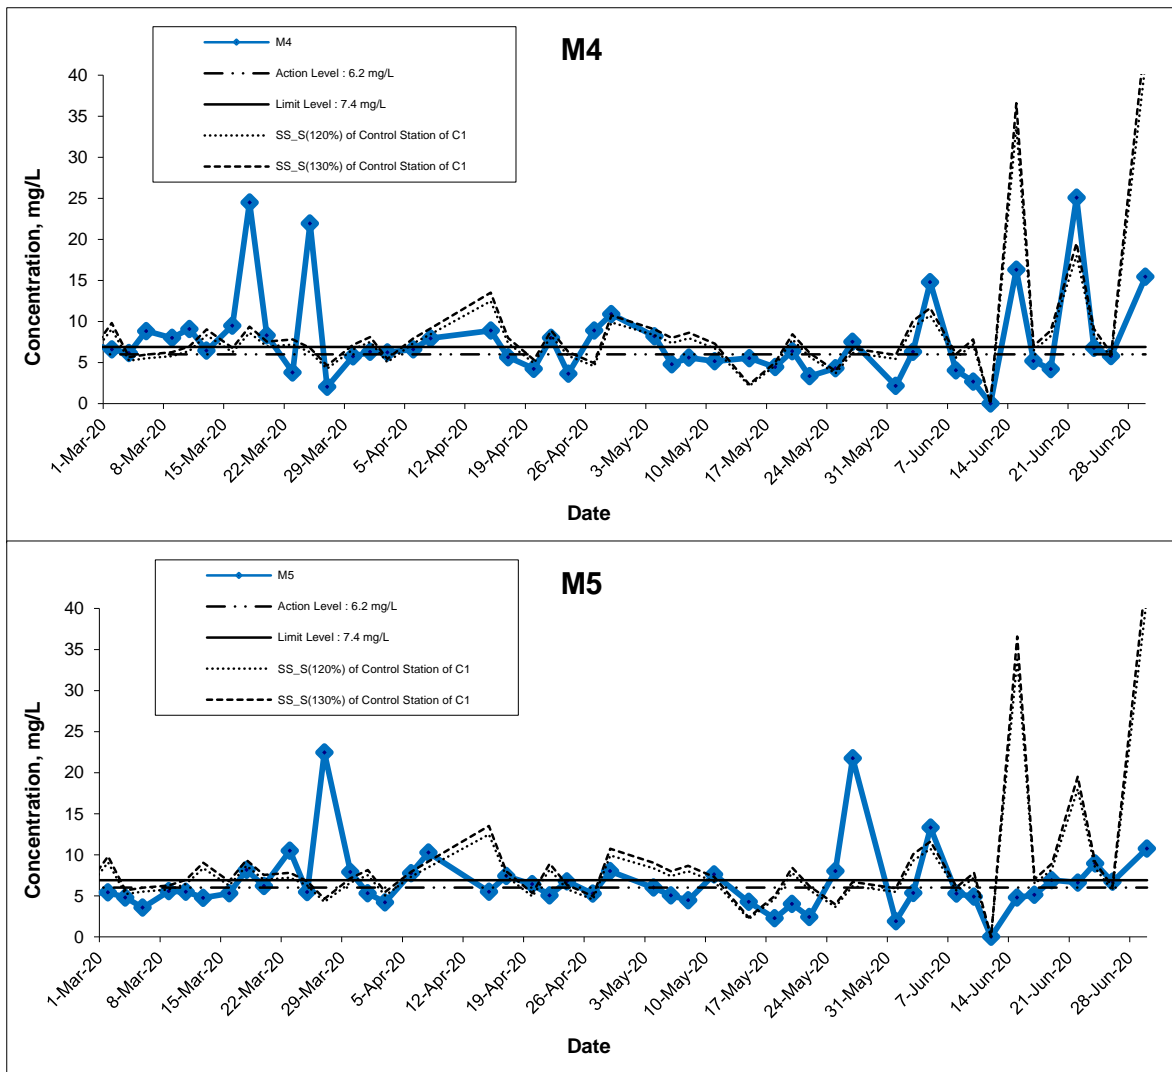
Suspended Solids (Surface) at Mid-Flood Tide

Title	Agreement No. CE 59/2015(EP) Environmental Team for Tseung Kwan O - Lam Tin Tunnel Design and Construction		Scale	N.T.S	Project No.	MA16034
	Graphical Presentation of Water Quality Monitoring Results		Date	Jun 20	Appendix	I

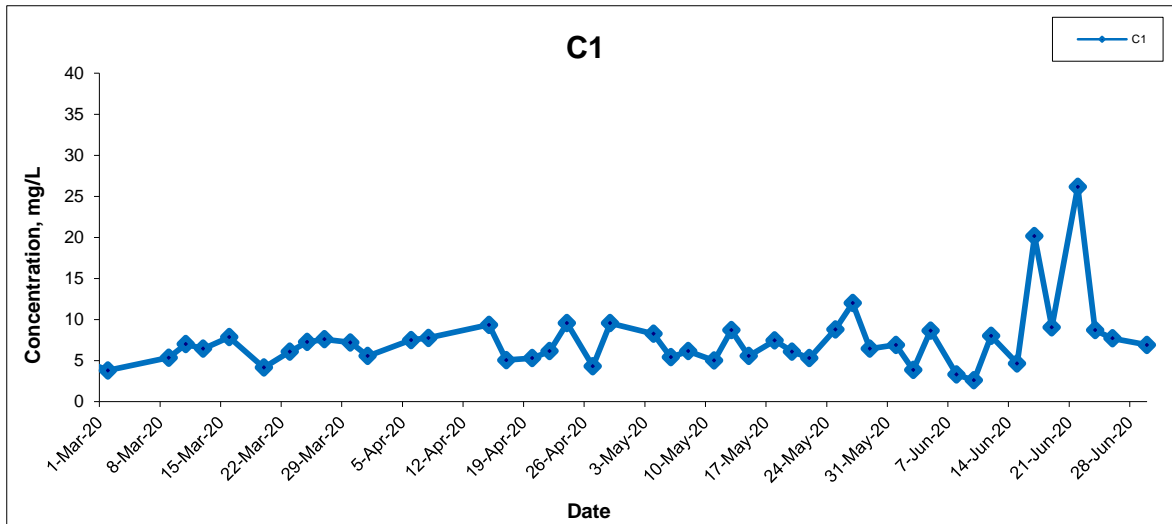
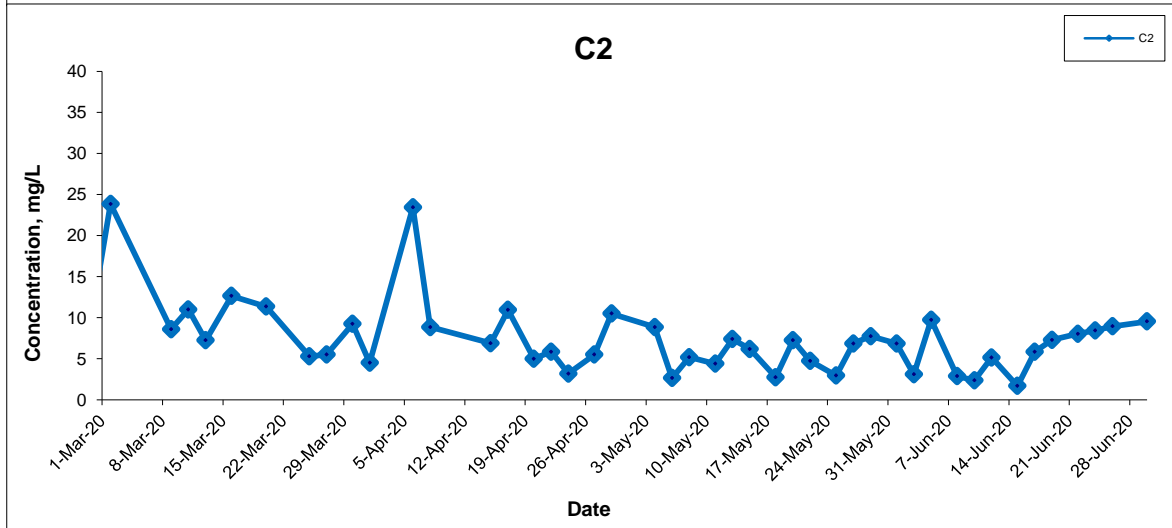
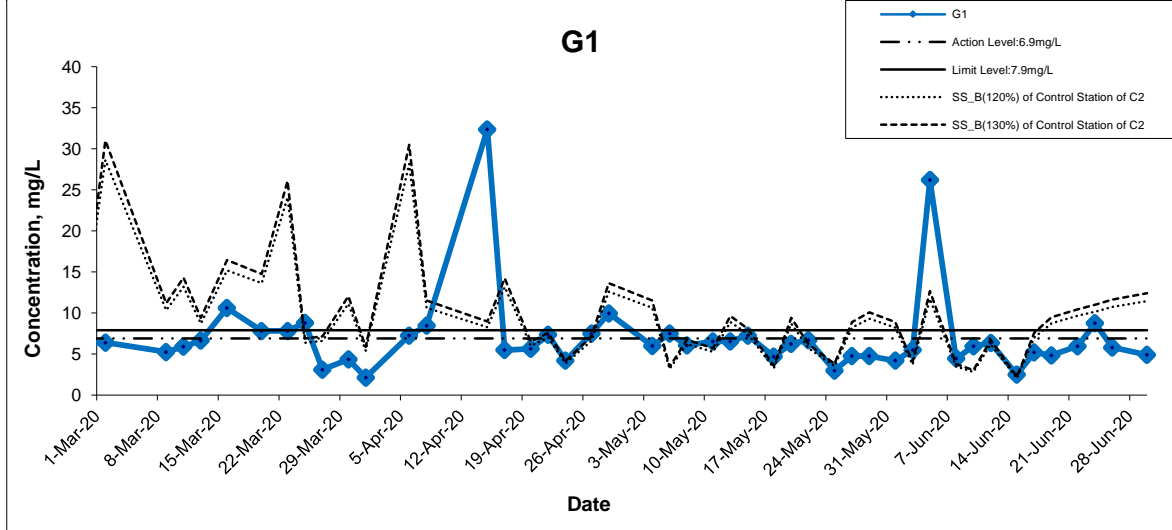
Suspended Solids (Bottom) at Mid-Ebb Tide

Title Agreement No. CE 59/2015(EP) Environmental Team for Tseung Kwan O - Lam Tin Tunnel Design and Construction Graphical Presentation of Water Quality Monitoring Results	Scale	N.T.S	Project No. MA16034	CINOTECH
	Date	Jun 20	Appendix I

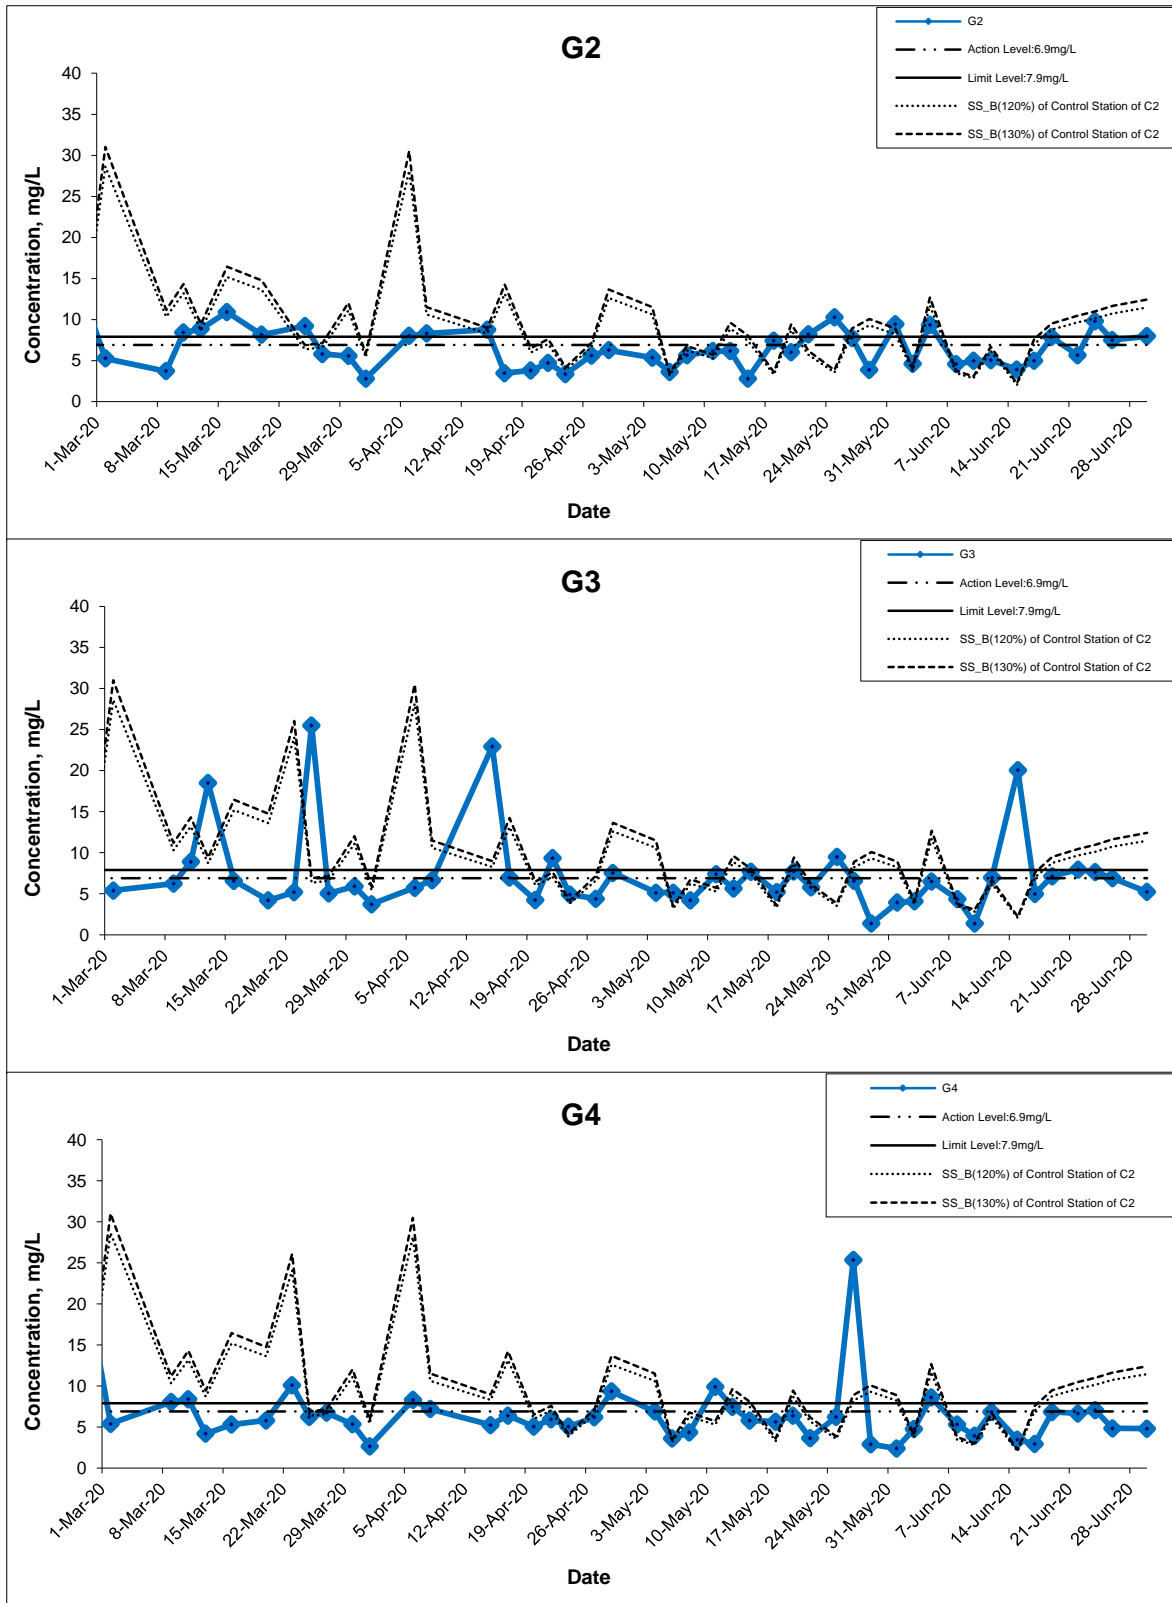
Suspended Solids (Bottom) at Mid-Ebb Tide

Title	Agreement No. CE 59/2015(EP) Environmental Team for Tseung Kwan O - Lam Tin Tunnel Design and Construction	Scale	N.T.S	Project No.	MA16034	CINOTECH
	Graphical Presentation of Water Quality Monitoring Results	Date	Jun 20	Appendix	I

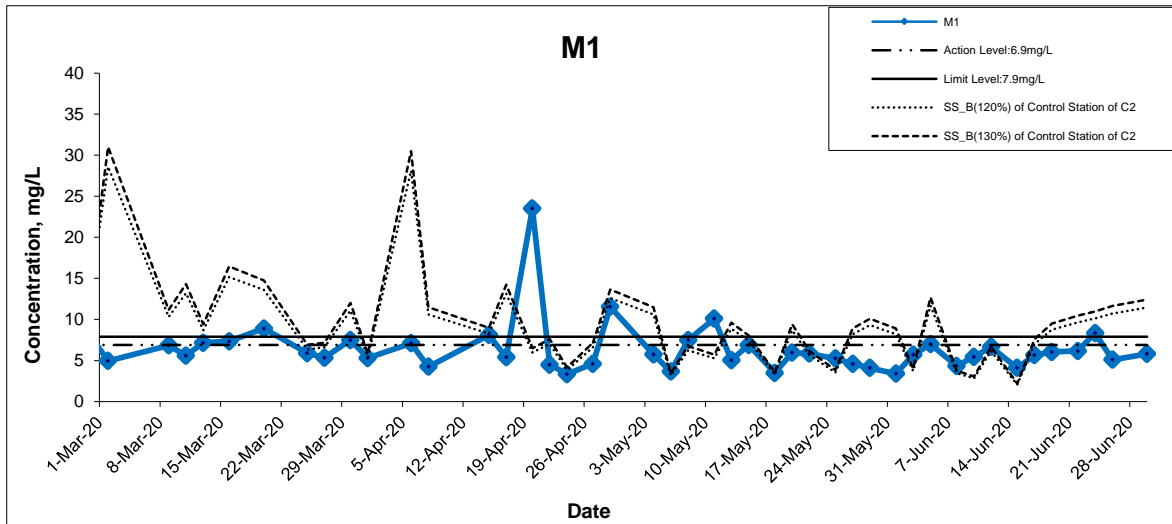
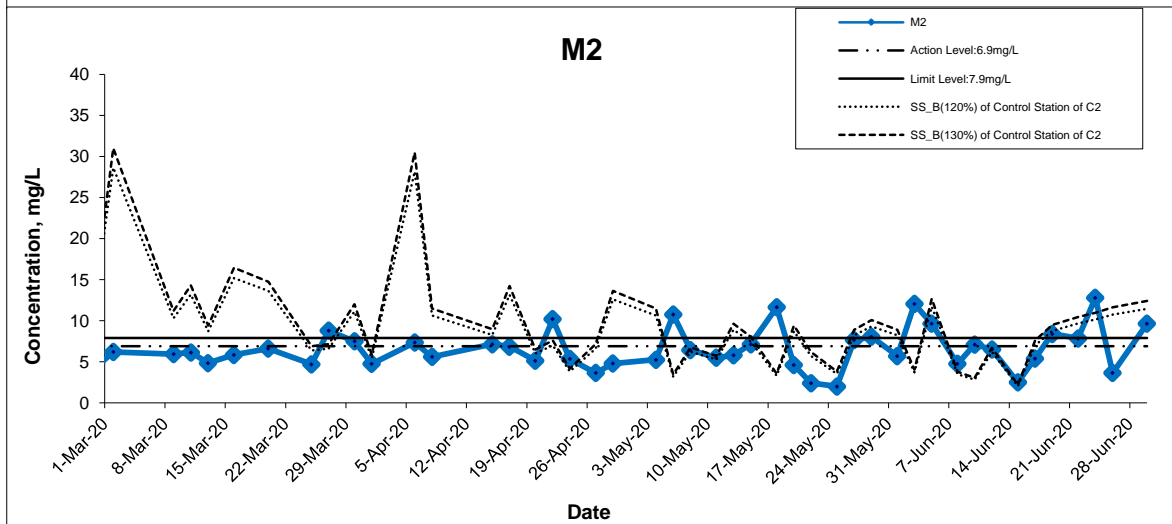
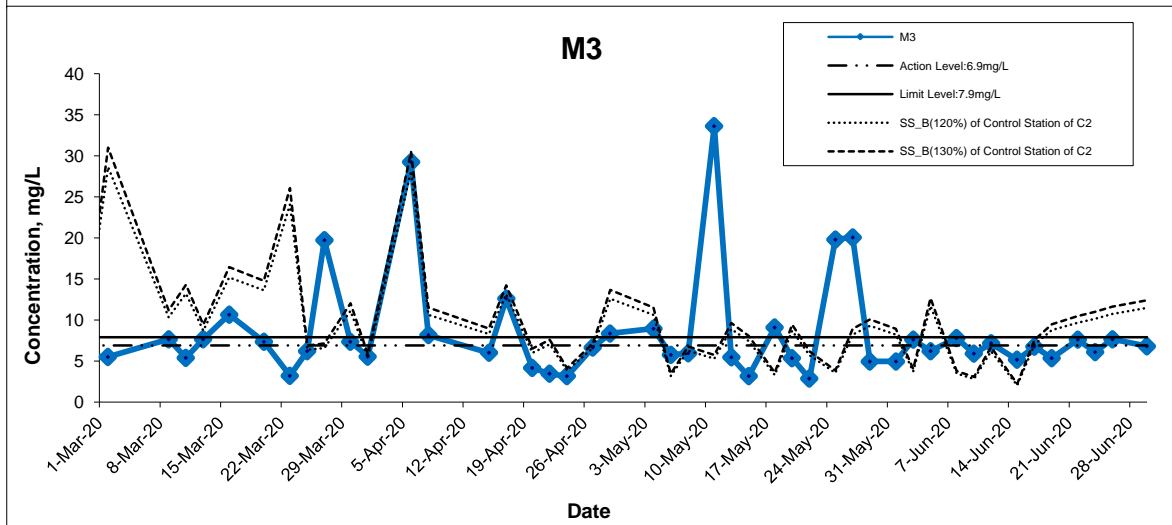
Suspended Solids (Bottom) at Mid-Ebb Tide

Title Agreement No. CE 59/2015(EP) Environmental Team for Tseung Kwan O - Lam Tin Tunnel Design and Construction
Graphical Presentation of Water Quality Monitoring Results

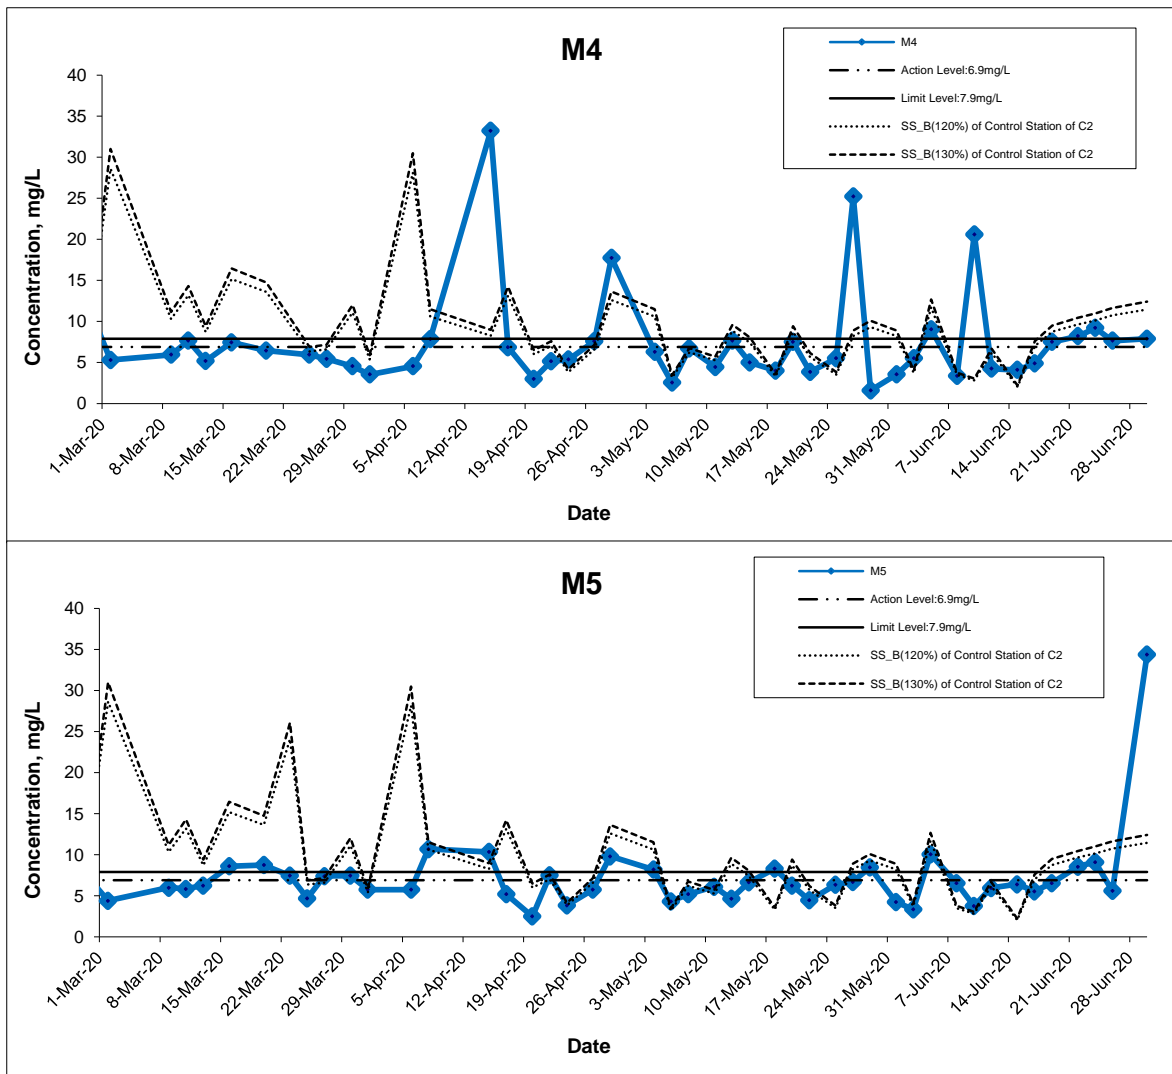
Suspended Solids (Bottom) at Mid-Ebb Tide

Title Agreement No. CE 59/2015(EP) Environmental Team for Tseung Kwan O - Lam Tin Tunnel Design and Construction Graphical Presentation of Water Quality Monitoring Results	Scale N.T.S	Project No. MA16034	
	Date Jun 20	Appendix I

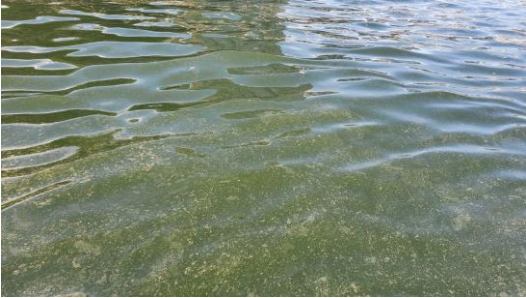
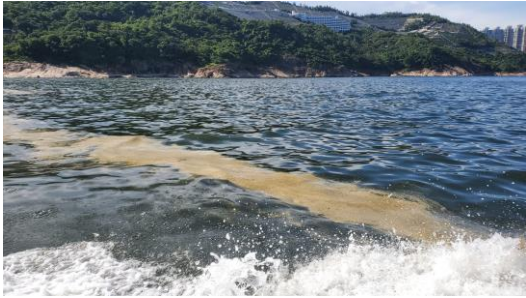
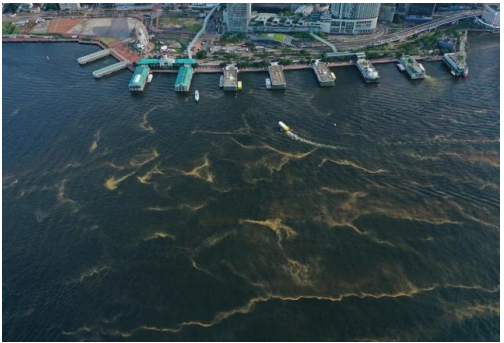
Photo 1 (Recorded on 30 th June 2020)	Photo 2 (Recorded on 30 th June 2020)	Photo 3 (Recorded on 30 th June 2020)

For the June 2020, exceedances for suspended solids and turbidity have been recorded continuously at various monitoring stations. Compare to the last month, more SS exceedance is recorded. It is suspected that the high rainfall in June lead to relatively high SS level by washing down sediments into the sea. In addition, algal bloom had been observed at the open waters around Tseung Kwan O South (Photo 1 - 2) and observed in the whole Victoria Harbour (Photo 3). During water quality monitoring, the water outside the site boundary seemed to be clear and clean (Photo 4 - 6).

- Clear the drainage regularly
- Repair any pipes/ pumps that are malfunctioned
- Make sure the embankment of work areas are complete and capable of preventing surface runoff flow into nearby waterbody directly
- Remove sediments from drainage after heavy rainstorms

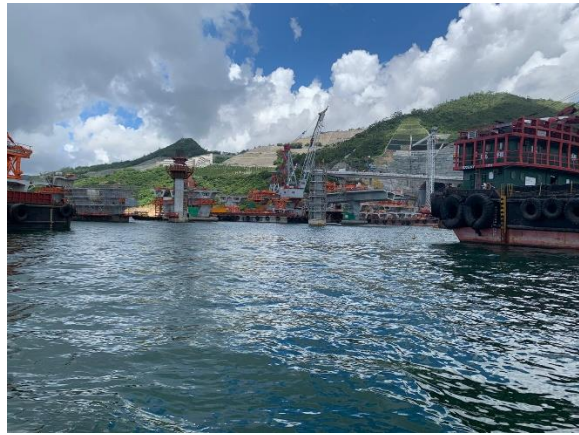
Photo 7 (Recorded on 4th June 2020)

During site inspections, the contractor had clear drainage regularly as a precaution measure (Photo 7 - 8). In addition, silt curtains had been employed around the barge to prevent accidental muddy water spillage (Photo 9). No foam or oil stain was observed during site inspections and marine water monitoring sessions.
