**Agreement No. CE 59/2015 (EP)
Environmental Team for
Tseung Kwan O – Lam Tin Tunnel
Design and Construction**

**Monthly Environmental Monitoring and
Audit Report for
June 2020
(version 1.0)**

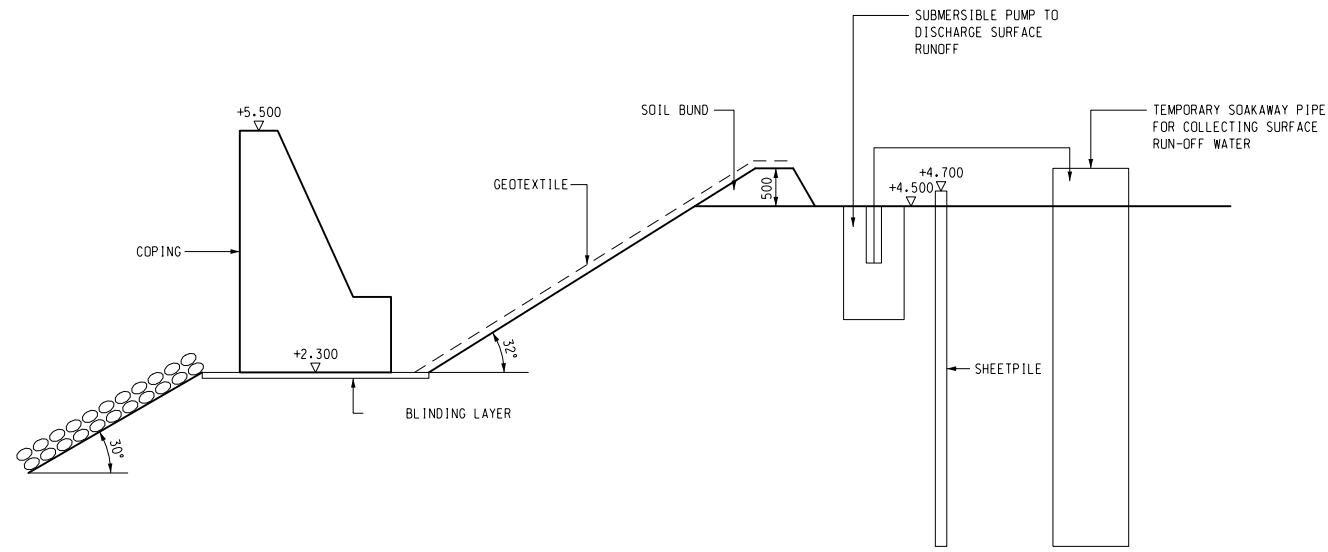
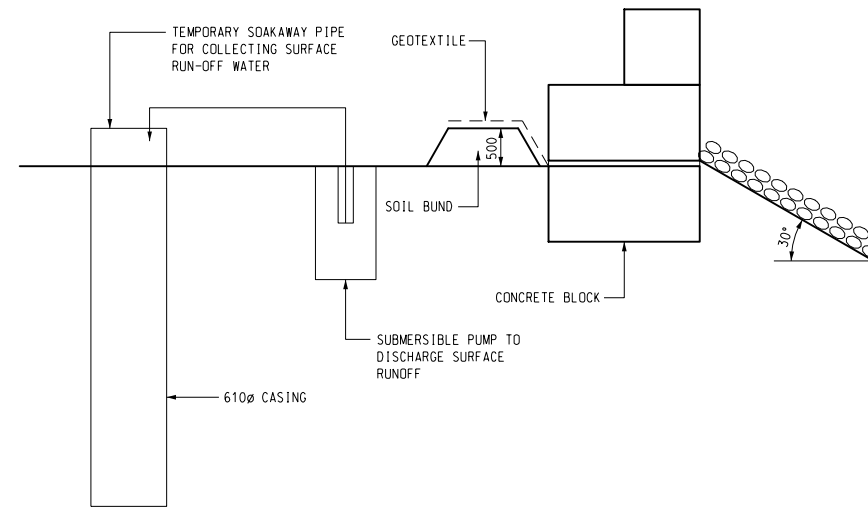
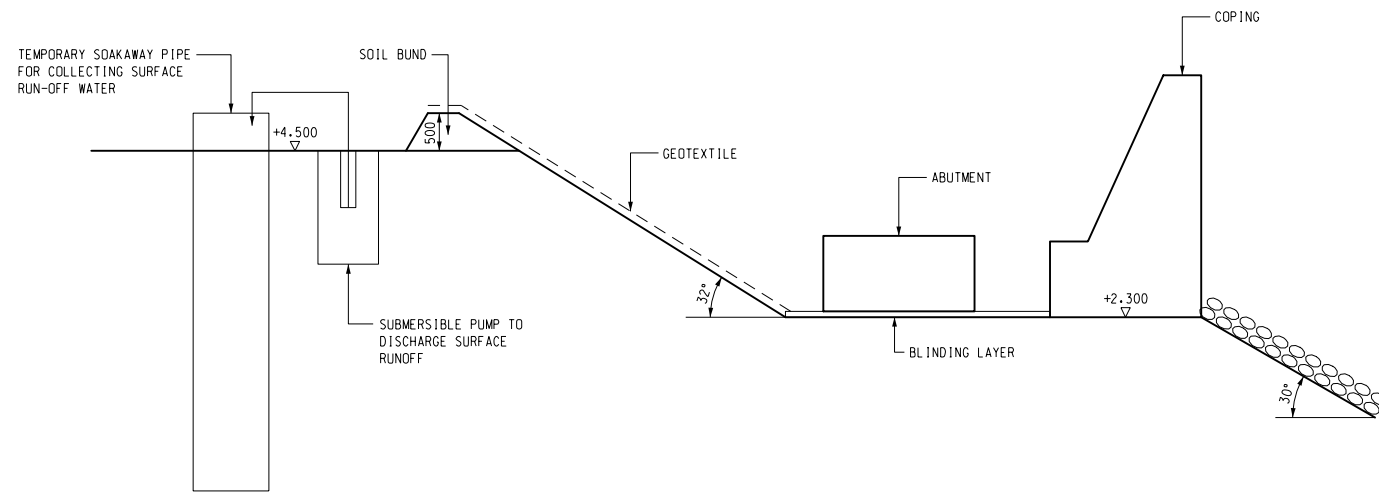
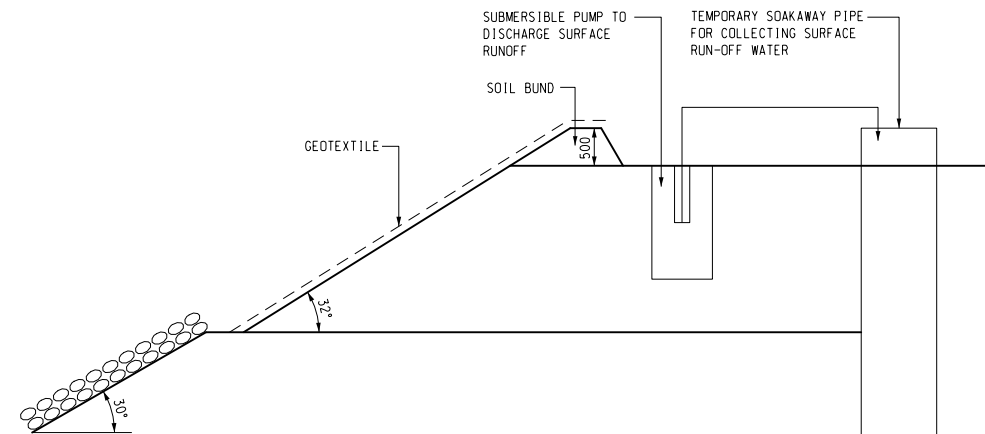
TYPICAL SECTION OF TEMPORARY CONCRETE BLOCK WALL
AFTER REMOVAL OF PRELOADING SURCHARGE

A WEST SIDE

B EAST SIDE

C SOUTH SIDE

D TYPICAL SECTION

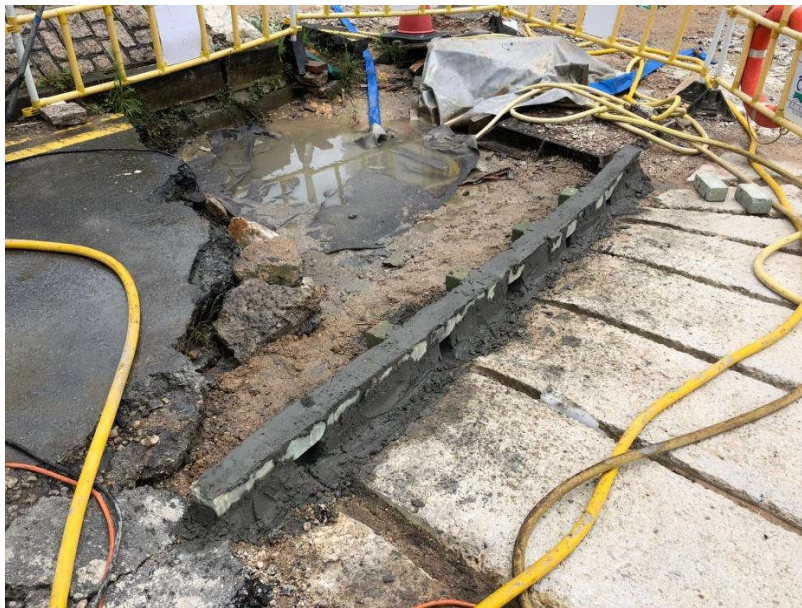
Surface runoff collection

Height difference between the road and site area to form a natural flow. Sump pit was provided for wastewater collection.

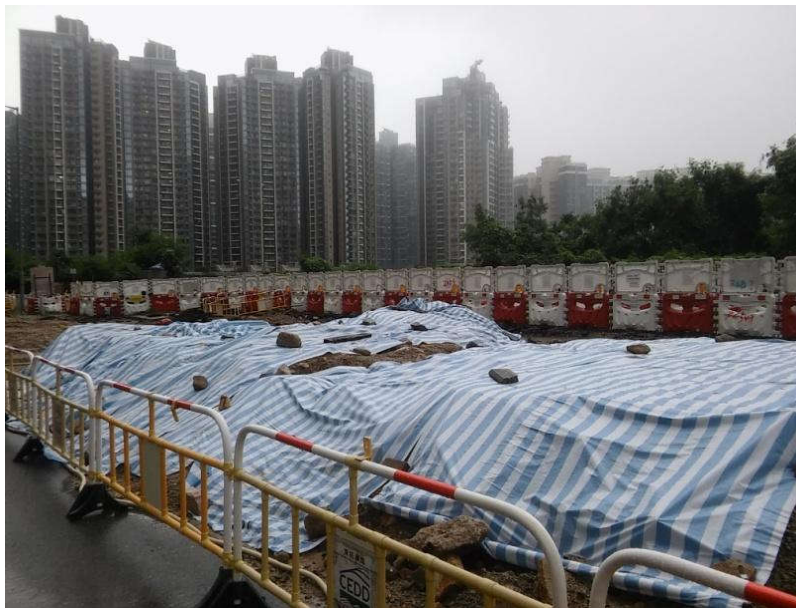
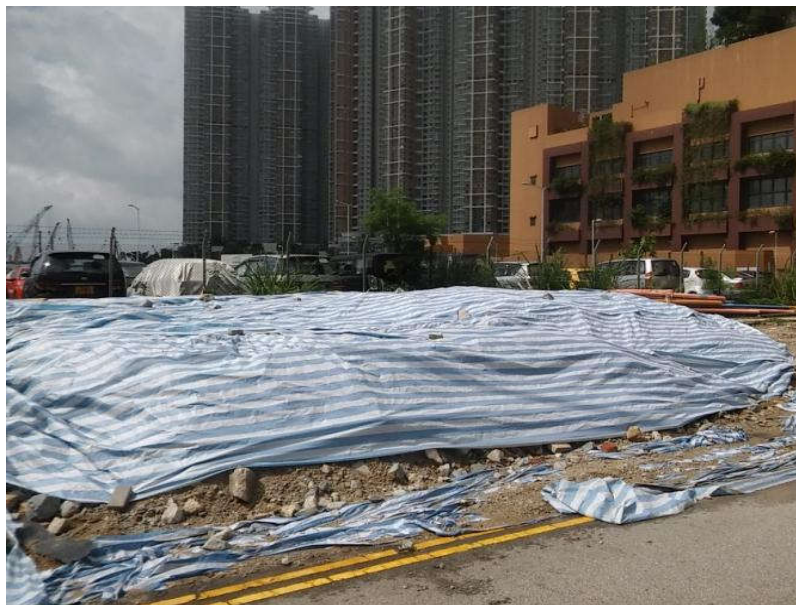
Stockpile Cover

Stockpile Should be proper cover with tarpaulin.
