Civil Engineering and Development Department

**Agreement No. CE 59/2015 (EP)
Environmental Team for
Tseung Kwan O – Lam Tin Tunnel
Design and Construction**

**Monthly Environmental Monitoring and
Audit Report for
September 2020
(version 1.0)**

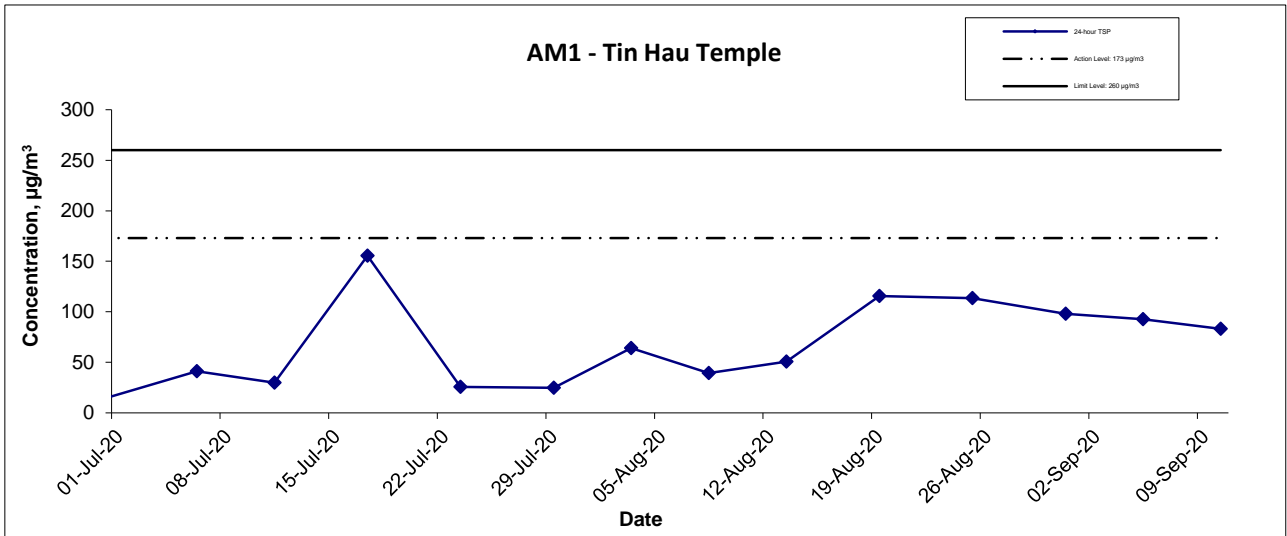
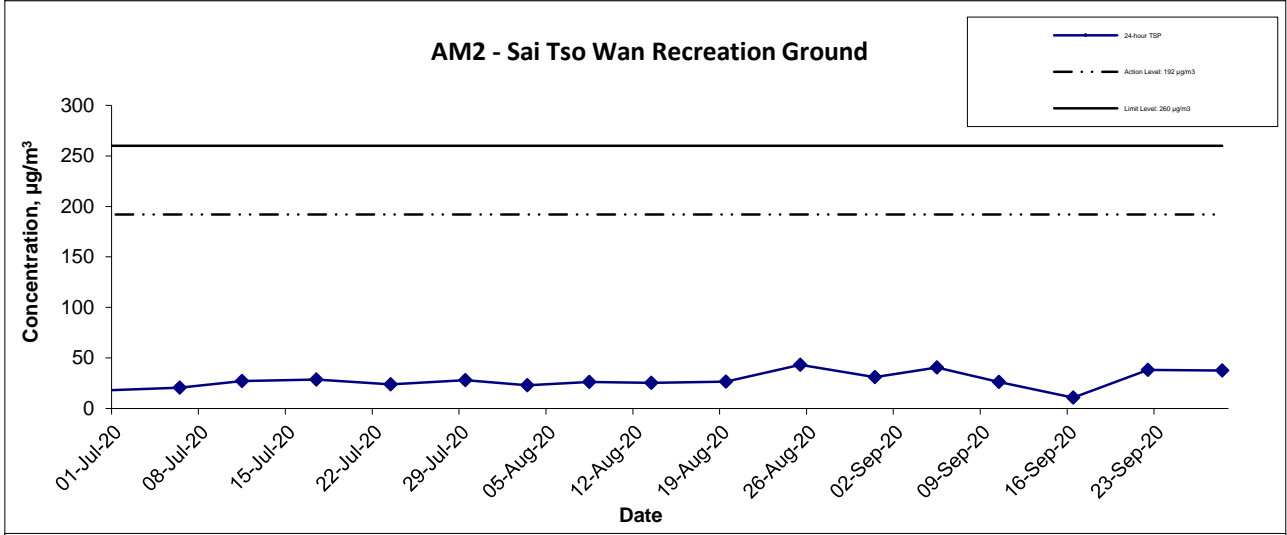
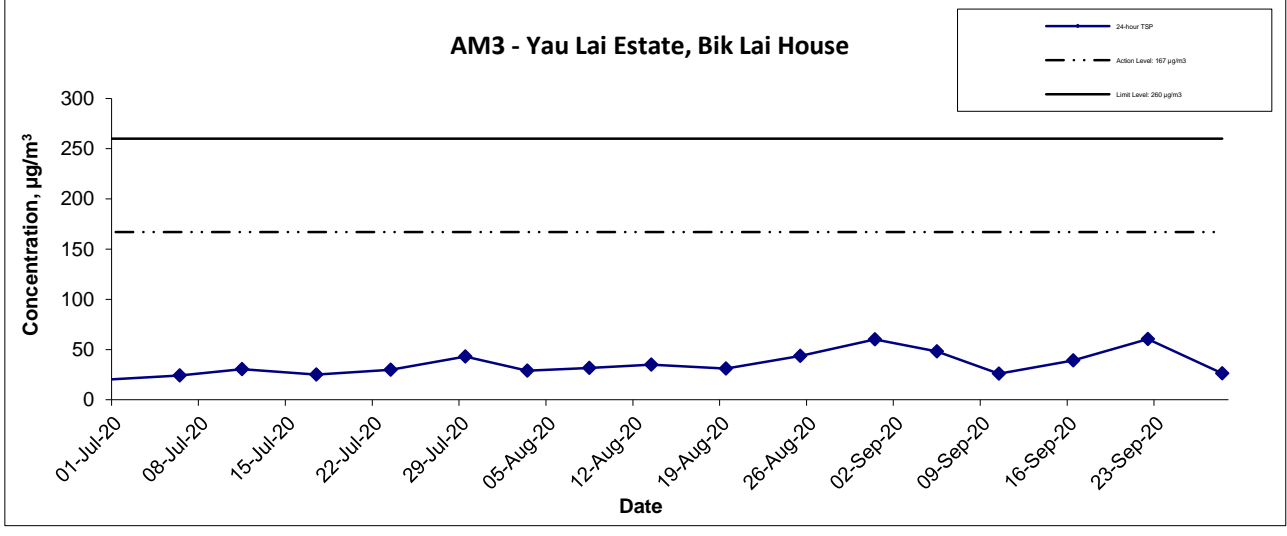
24-hr TSP Concentration Levels

*Measurement cannot be carried out for AM1 since 12 Sep 2020 as no power supply due to technical problems in the system of the Temple.

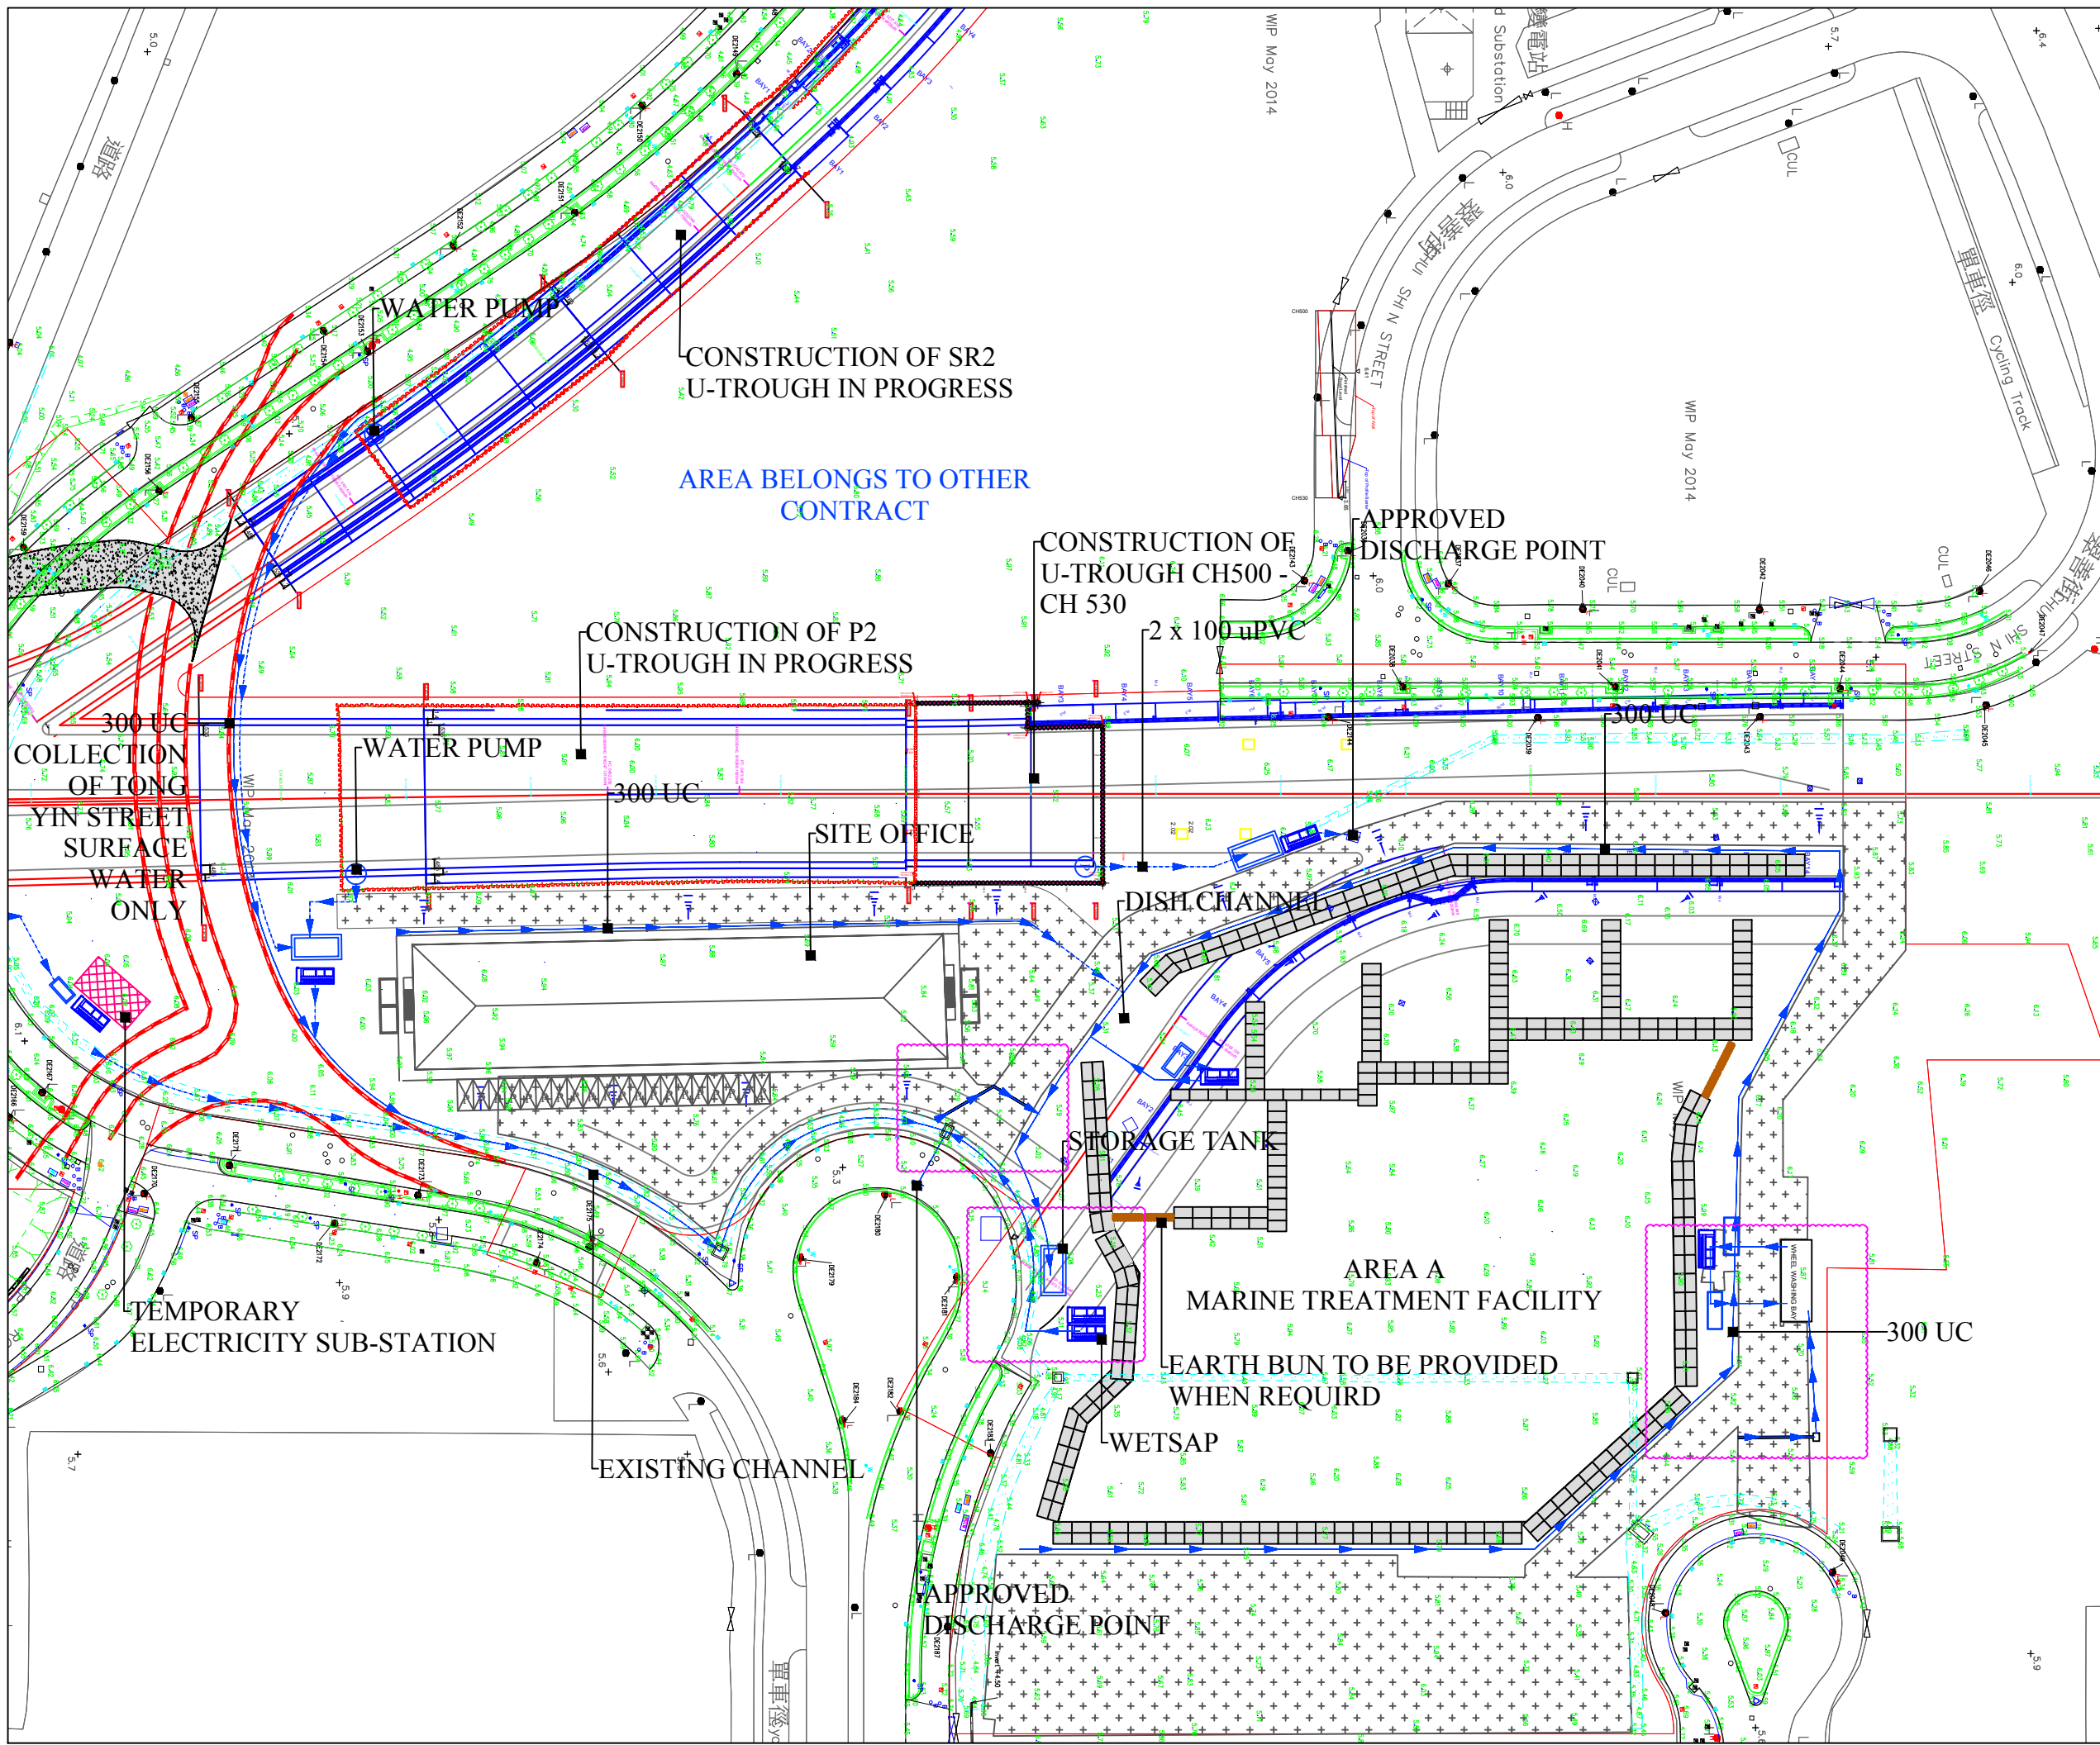
Drawn	Checked	Approved
Scale 1:1000 A3	CAD File No. SK096E	Date 20-07-2018
First issued 20-07-18	Drawing No.	Rev.
© Copyright Reserved 版權所有 不得翻印		
NE201502/CIVIL/096E/GA/001

- NOTES**
1. ALL DIMENSION ARE IN m UNLESS STATED.
- LEGEND:**
- FLOW PATH
 - WETSAP
 - WATER PUMP (TO BE INSTALLED WHEN REQUIRED)
 - EARTH BUN (TO BE PROVIDED WHEN REQUIRED)
 - AREA OF UPDATE

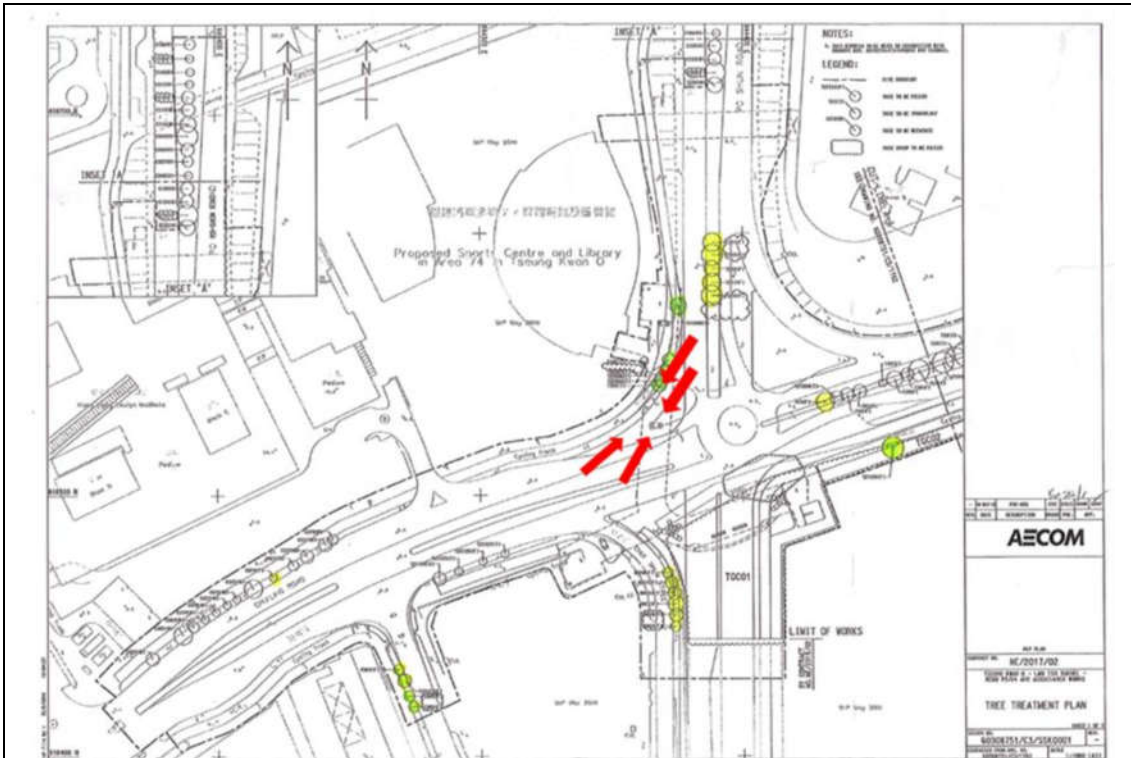
Height difference between the road and site area to form a natural flow. Sump pit was provided for wastewater collection.
