## Agreement No. CE 59/2015 (EP) Environmental Team for Tseung Kwan O – Lam Tin Tunnel Design and Construction

### Monthly Environmental Monitoring and Audit Report for July 2021

(version 1.0)

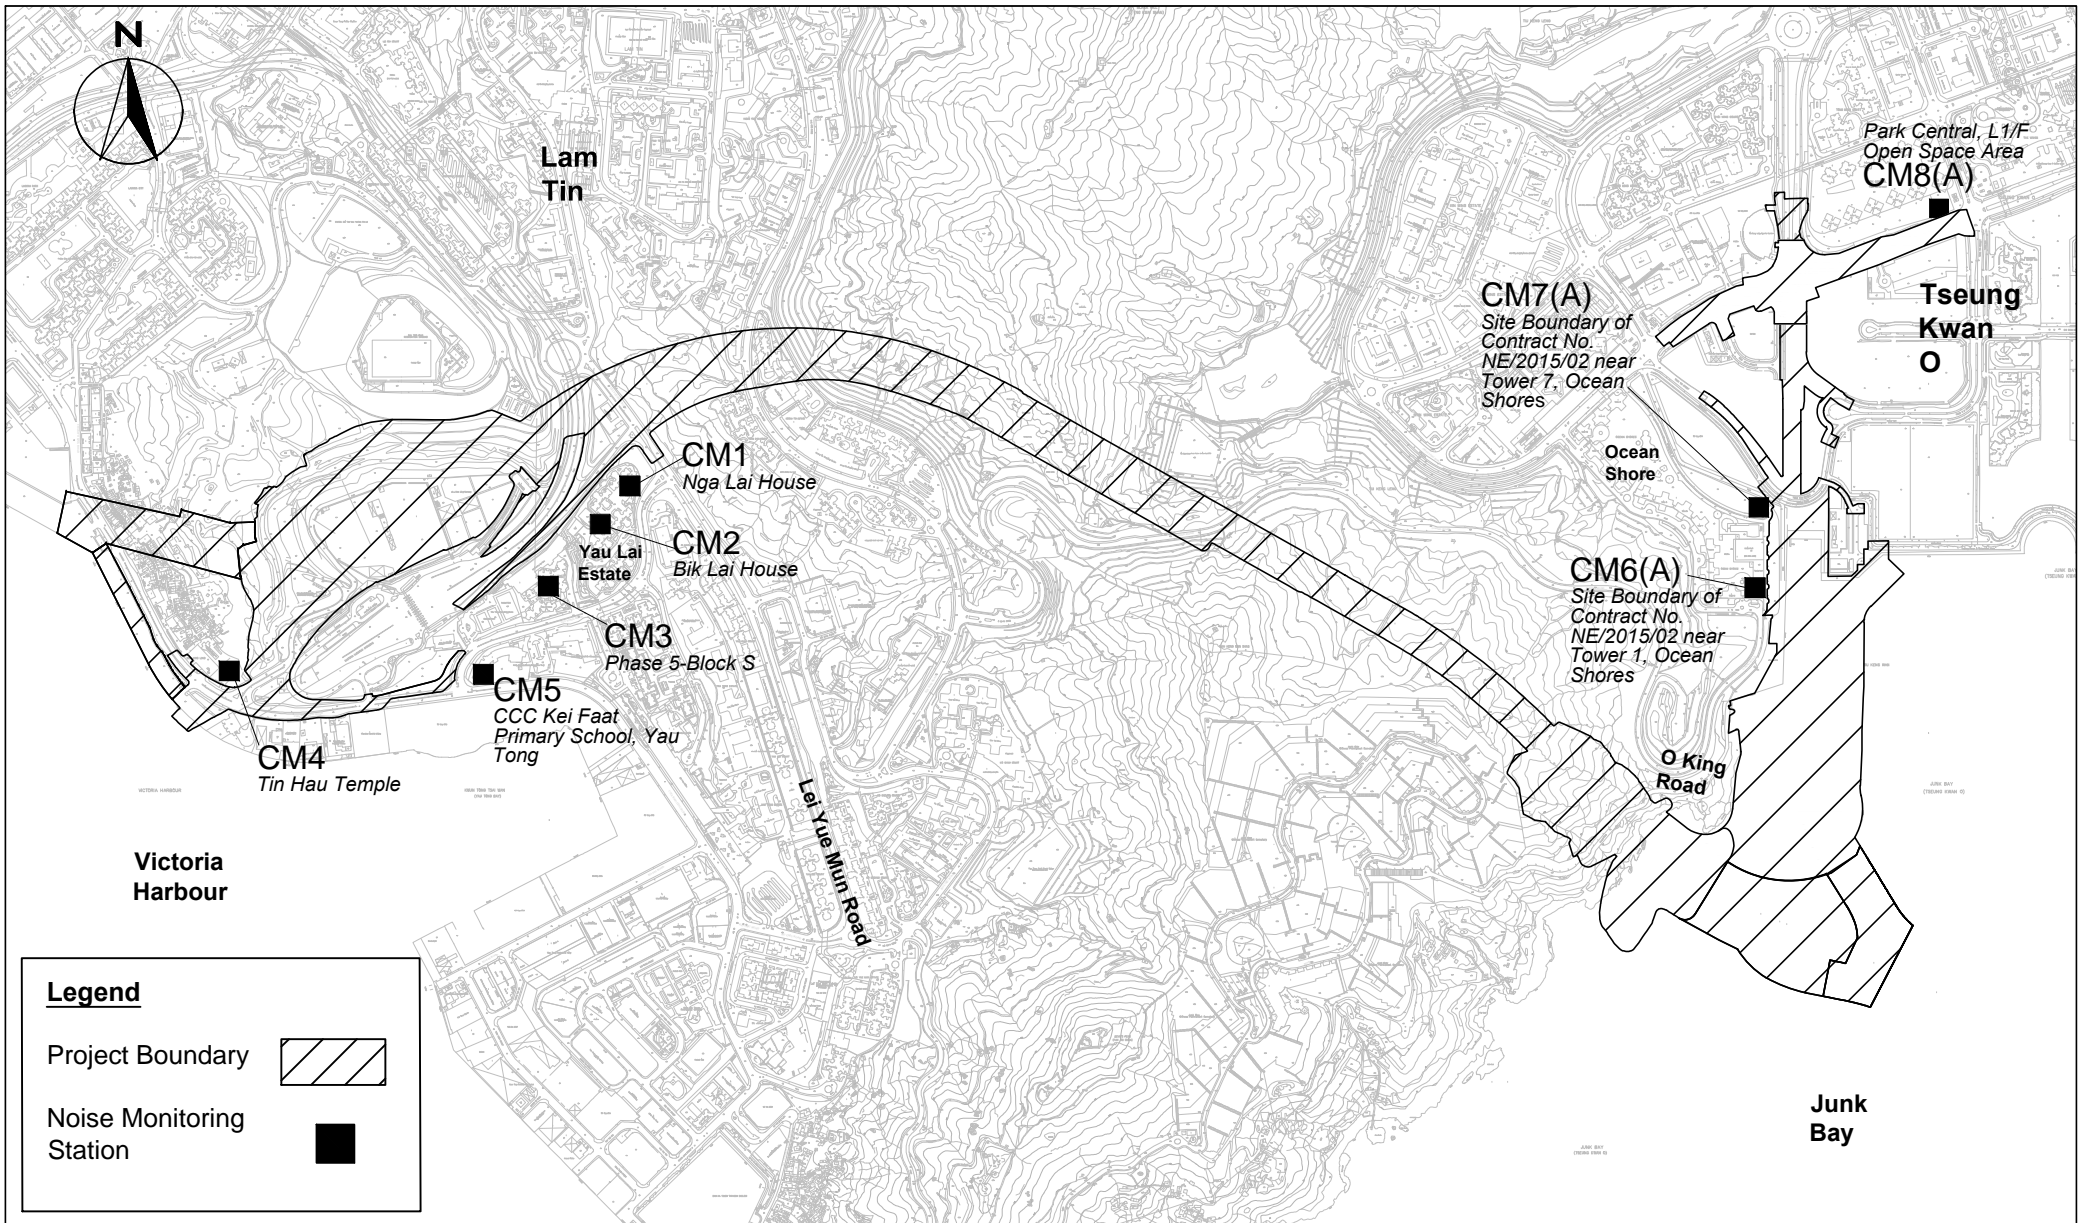
SCALE	1:13000@A4	DATE	11 March 2021	
CHECK	CC	DRAWN	KC	
JOB No.	MA16034	FIGURE NO.	3	REV -

**Noise Monitoring Stations**
