**Agreement No. CE 59/2015 (EP)  
Environmental Team for  
Tseung Kwan O – Lam Tin Tunnel  
Design and Construction**

**Monthly Environmental Monitoring and  
Audit Report for  
October 2021  
(version 1.0)**

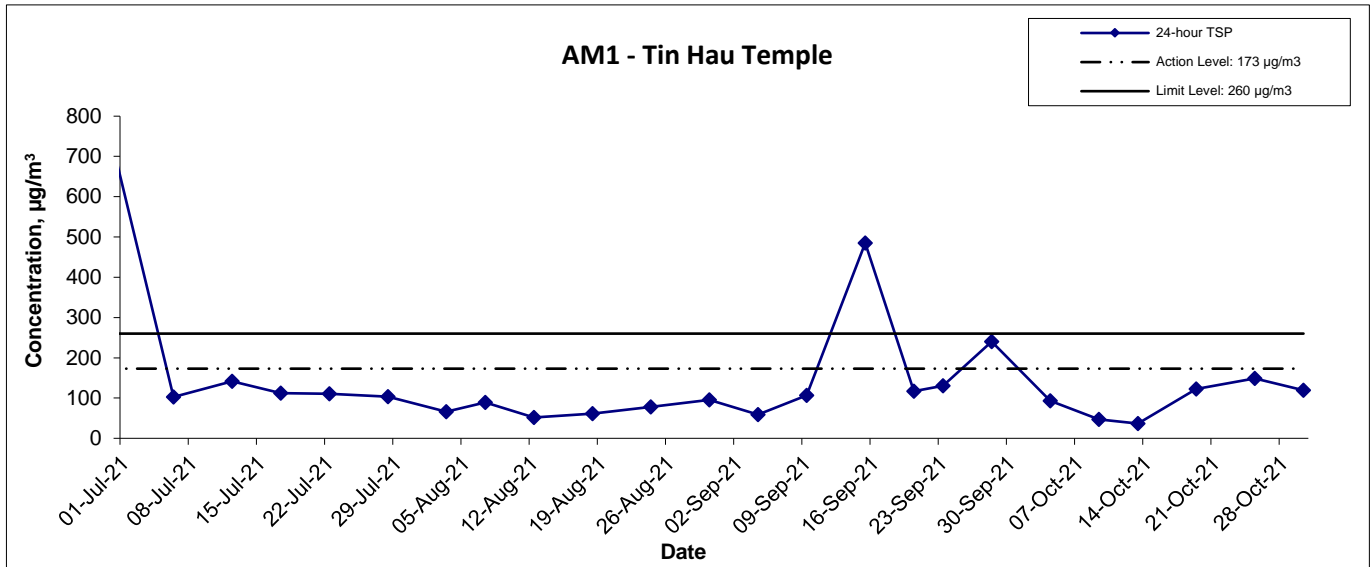
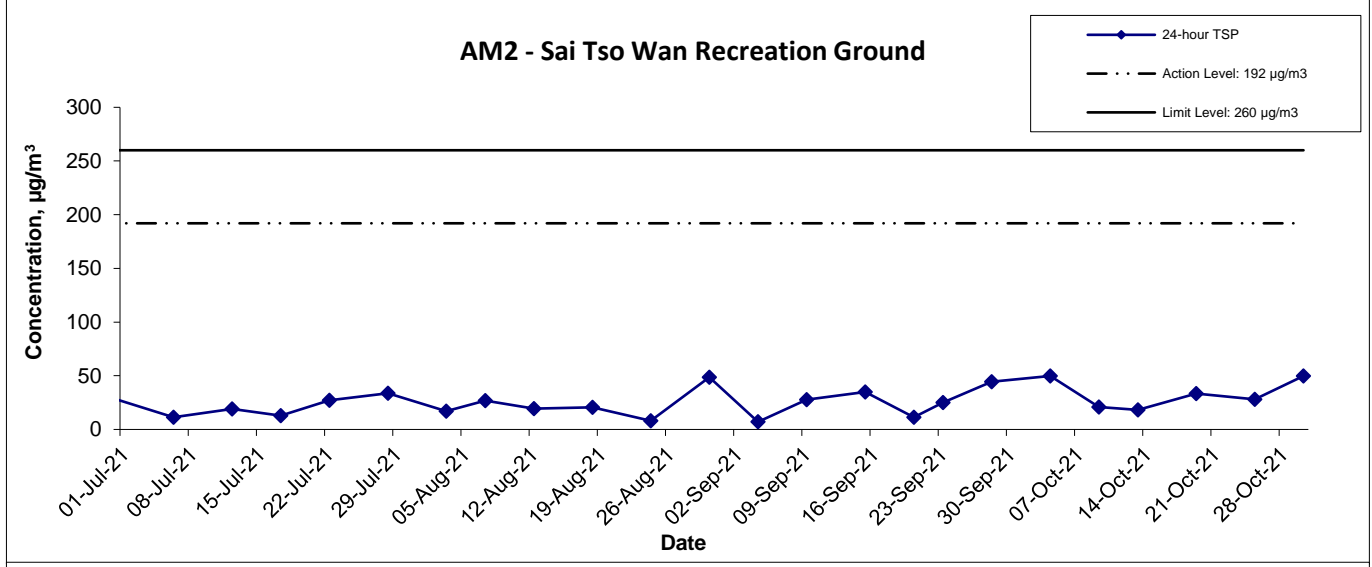
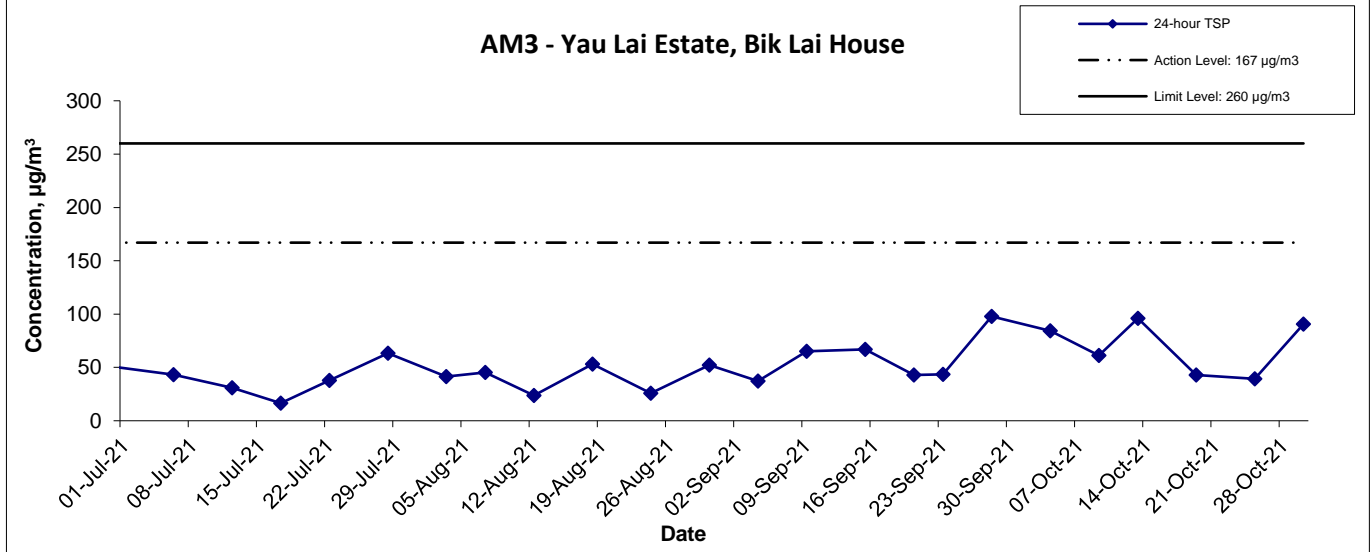
### 24-hr TSP Concentration Levels

Agreement No. CE/59/2015 (EP) Environmental Team for Tseung Kwan O - Lam Tin Tunnel - Design and Construction	Scale N.T.S	Project No. MA16034	CINOTECH
Graphical Presentation of 24-hour TSP Monitoring Results	Date Nov-21	Appendix F

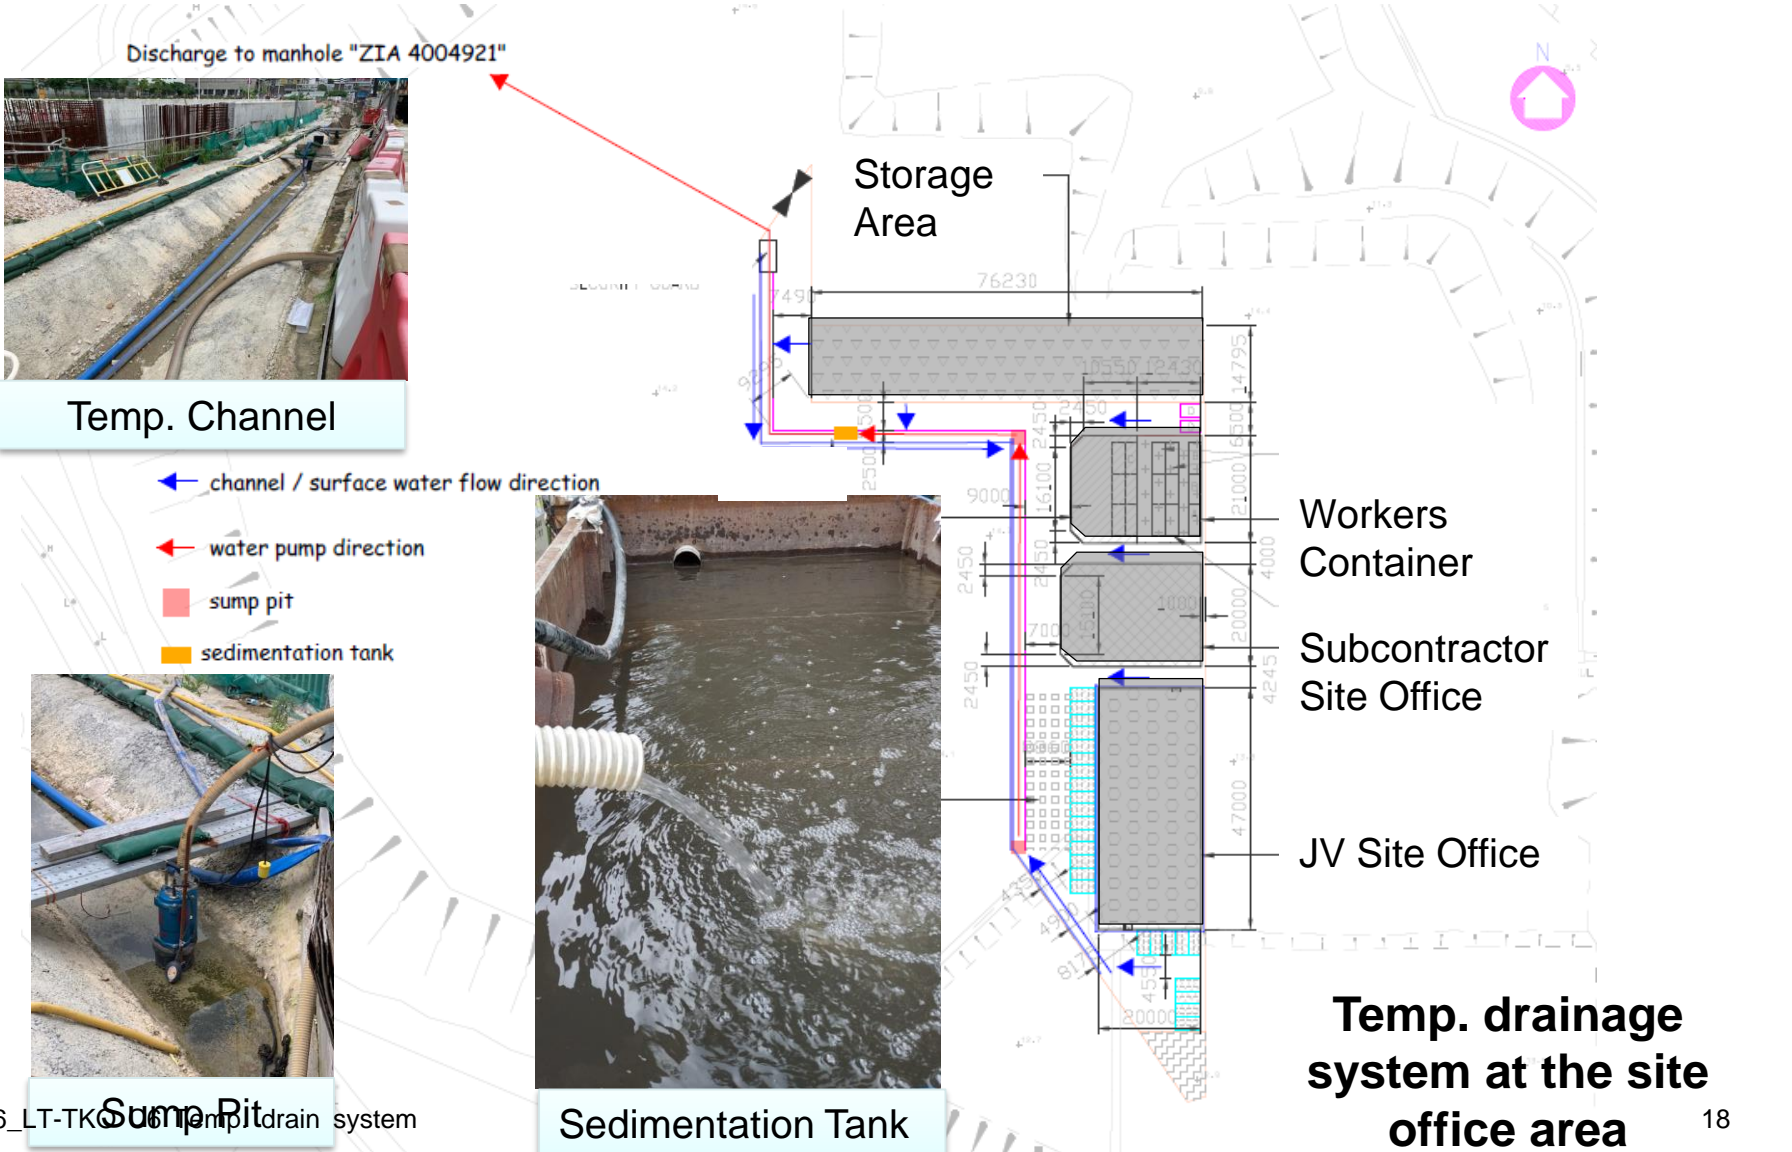
# Site Surface Runoff Measures

Temp. Channel
