# **Civil Engineering and Development Department**

**Agreement No. CE 59/2015 (EP)  
Environmental Team for  
Tseung Kwan O – Lam Tin Tunnel  
Design and Construction**

**Monthly Environmental Monitoring and  
Audit Report for  
January 2022  
(version 1.0)**

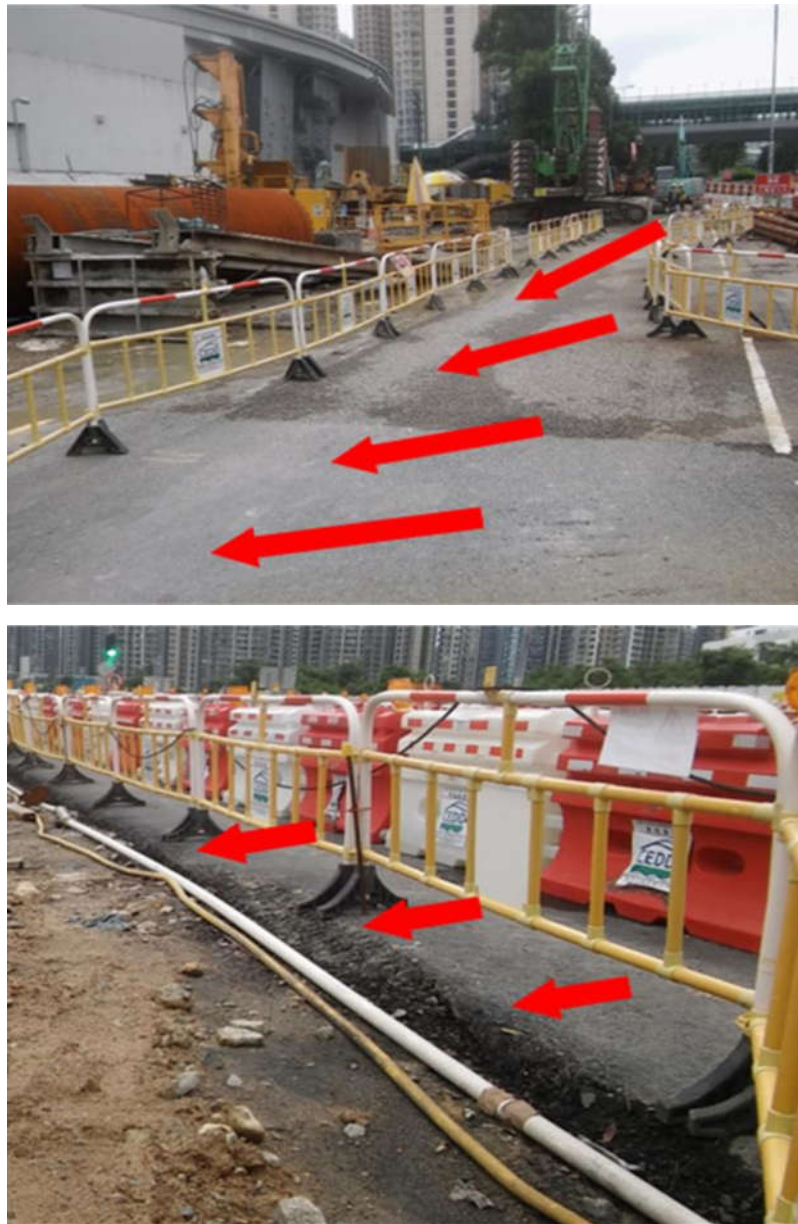
### Surface runoff collection

**Height difference between the road and site area to form a natural flow. Sump pit was provided for wastewater collection.**

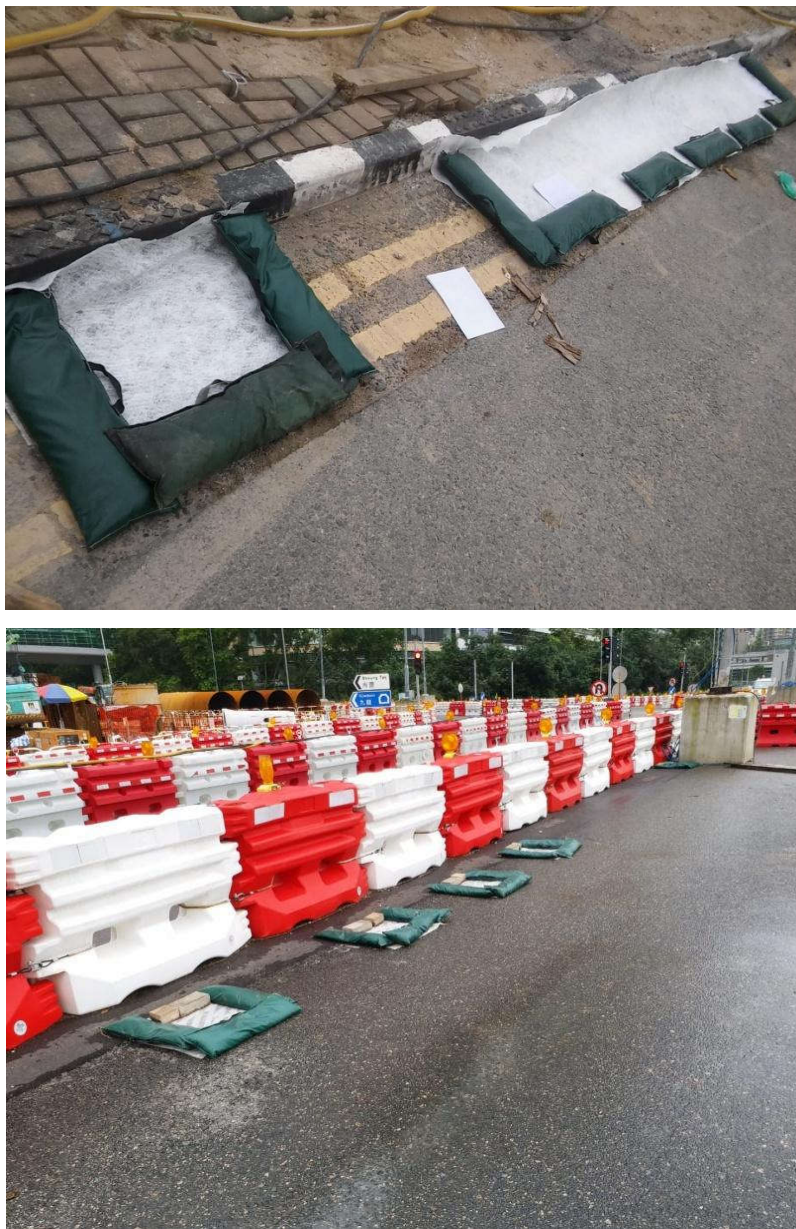
## Gully Protection

**Gully were protected and covered by geotextile.**
