**Agreement No. CE 59/2015 (EP)
Environmental Team for
Tseung Kwan O – Lam Tin Tunnel
Design and Construction**

**Monthly Environmental Monitoring and
Audit Report for
February 2022
(version 1.0)**

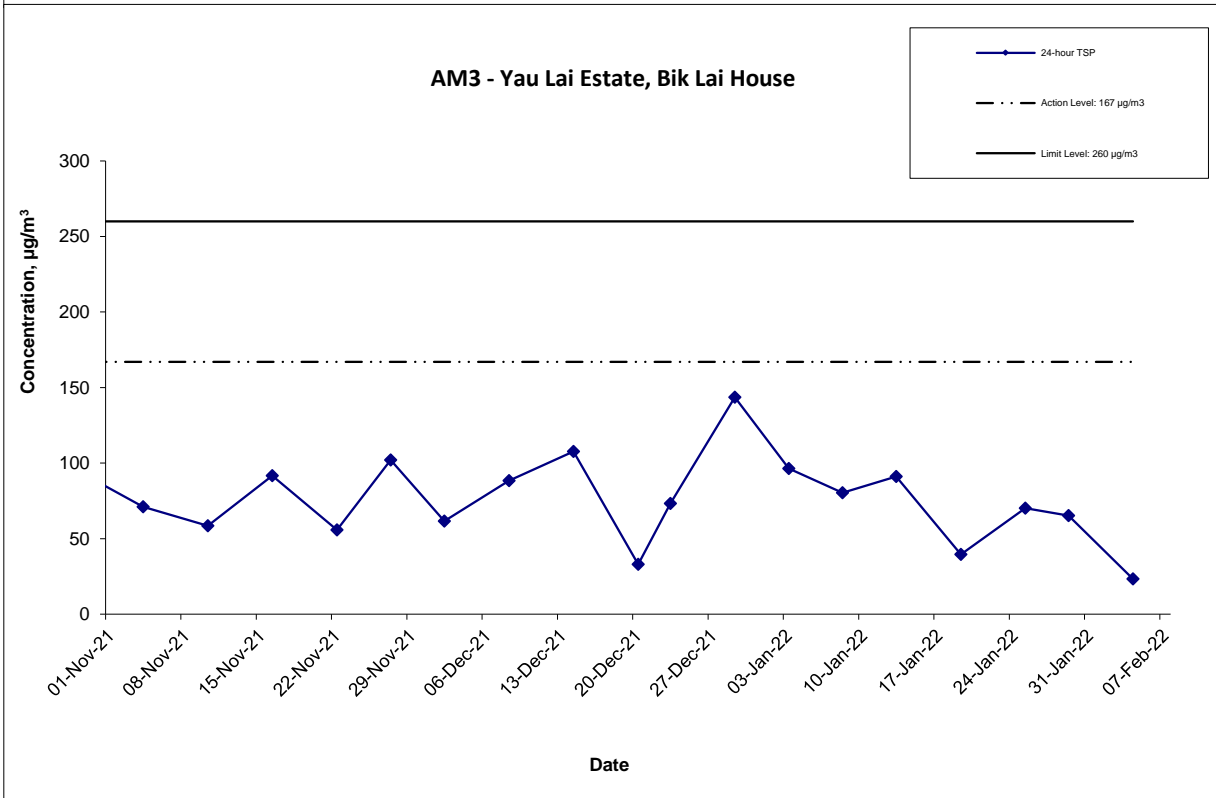
24-hr TSP Concentration Levels

Agreement No. CE/59/2015 (EP) Environmental Team for Tseung Kwan O - Lam Tin Tunnel - Design and Construction Graphical Presentation of 24-hour TSP Monitoring Results	Scale	Project
