Civil Engineering and Development Department

**Agreement No. CE 59/2015 (EP)
Environmental Team for
Tseung Kwan O – Lam Tin Tunnel
Design and Construction**

**Monthly Environmental Monitoring and
Audit Report for
July 2022
(Version 1.0)**

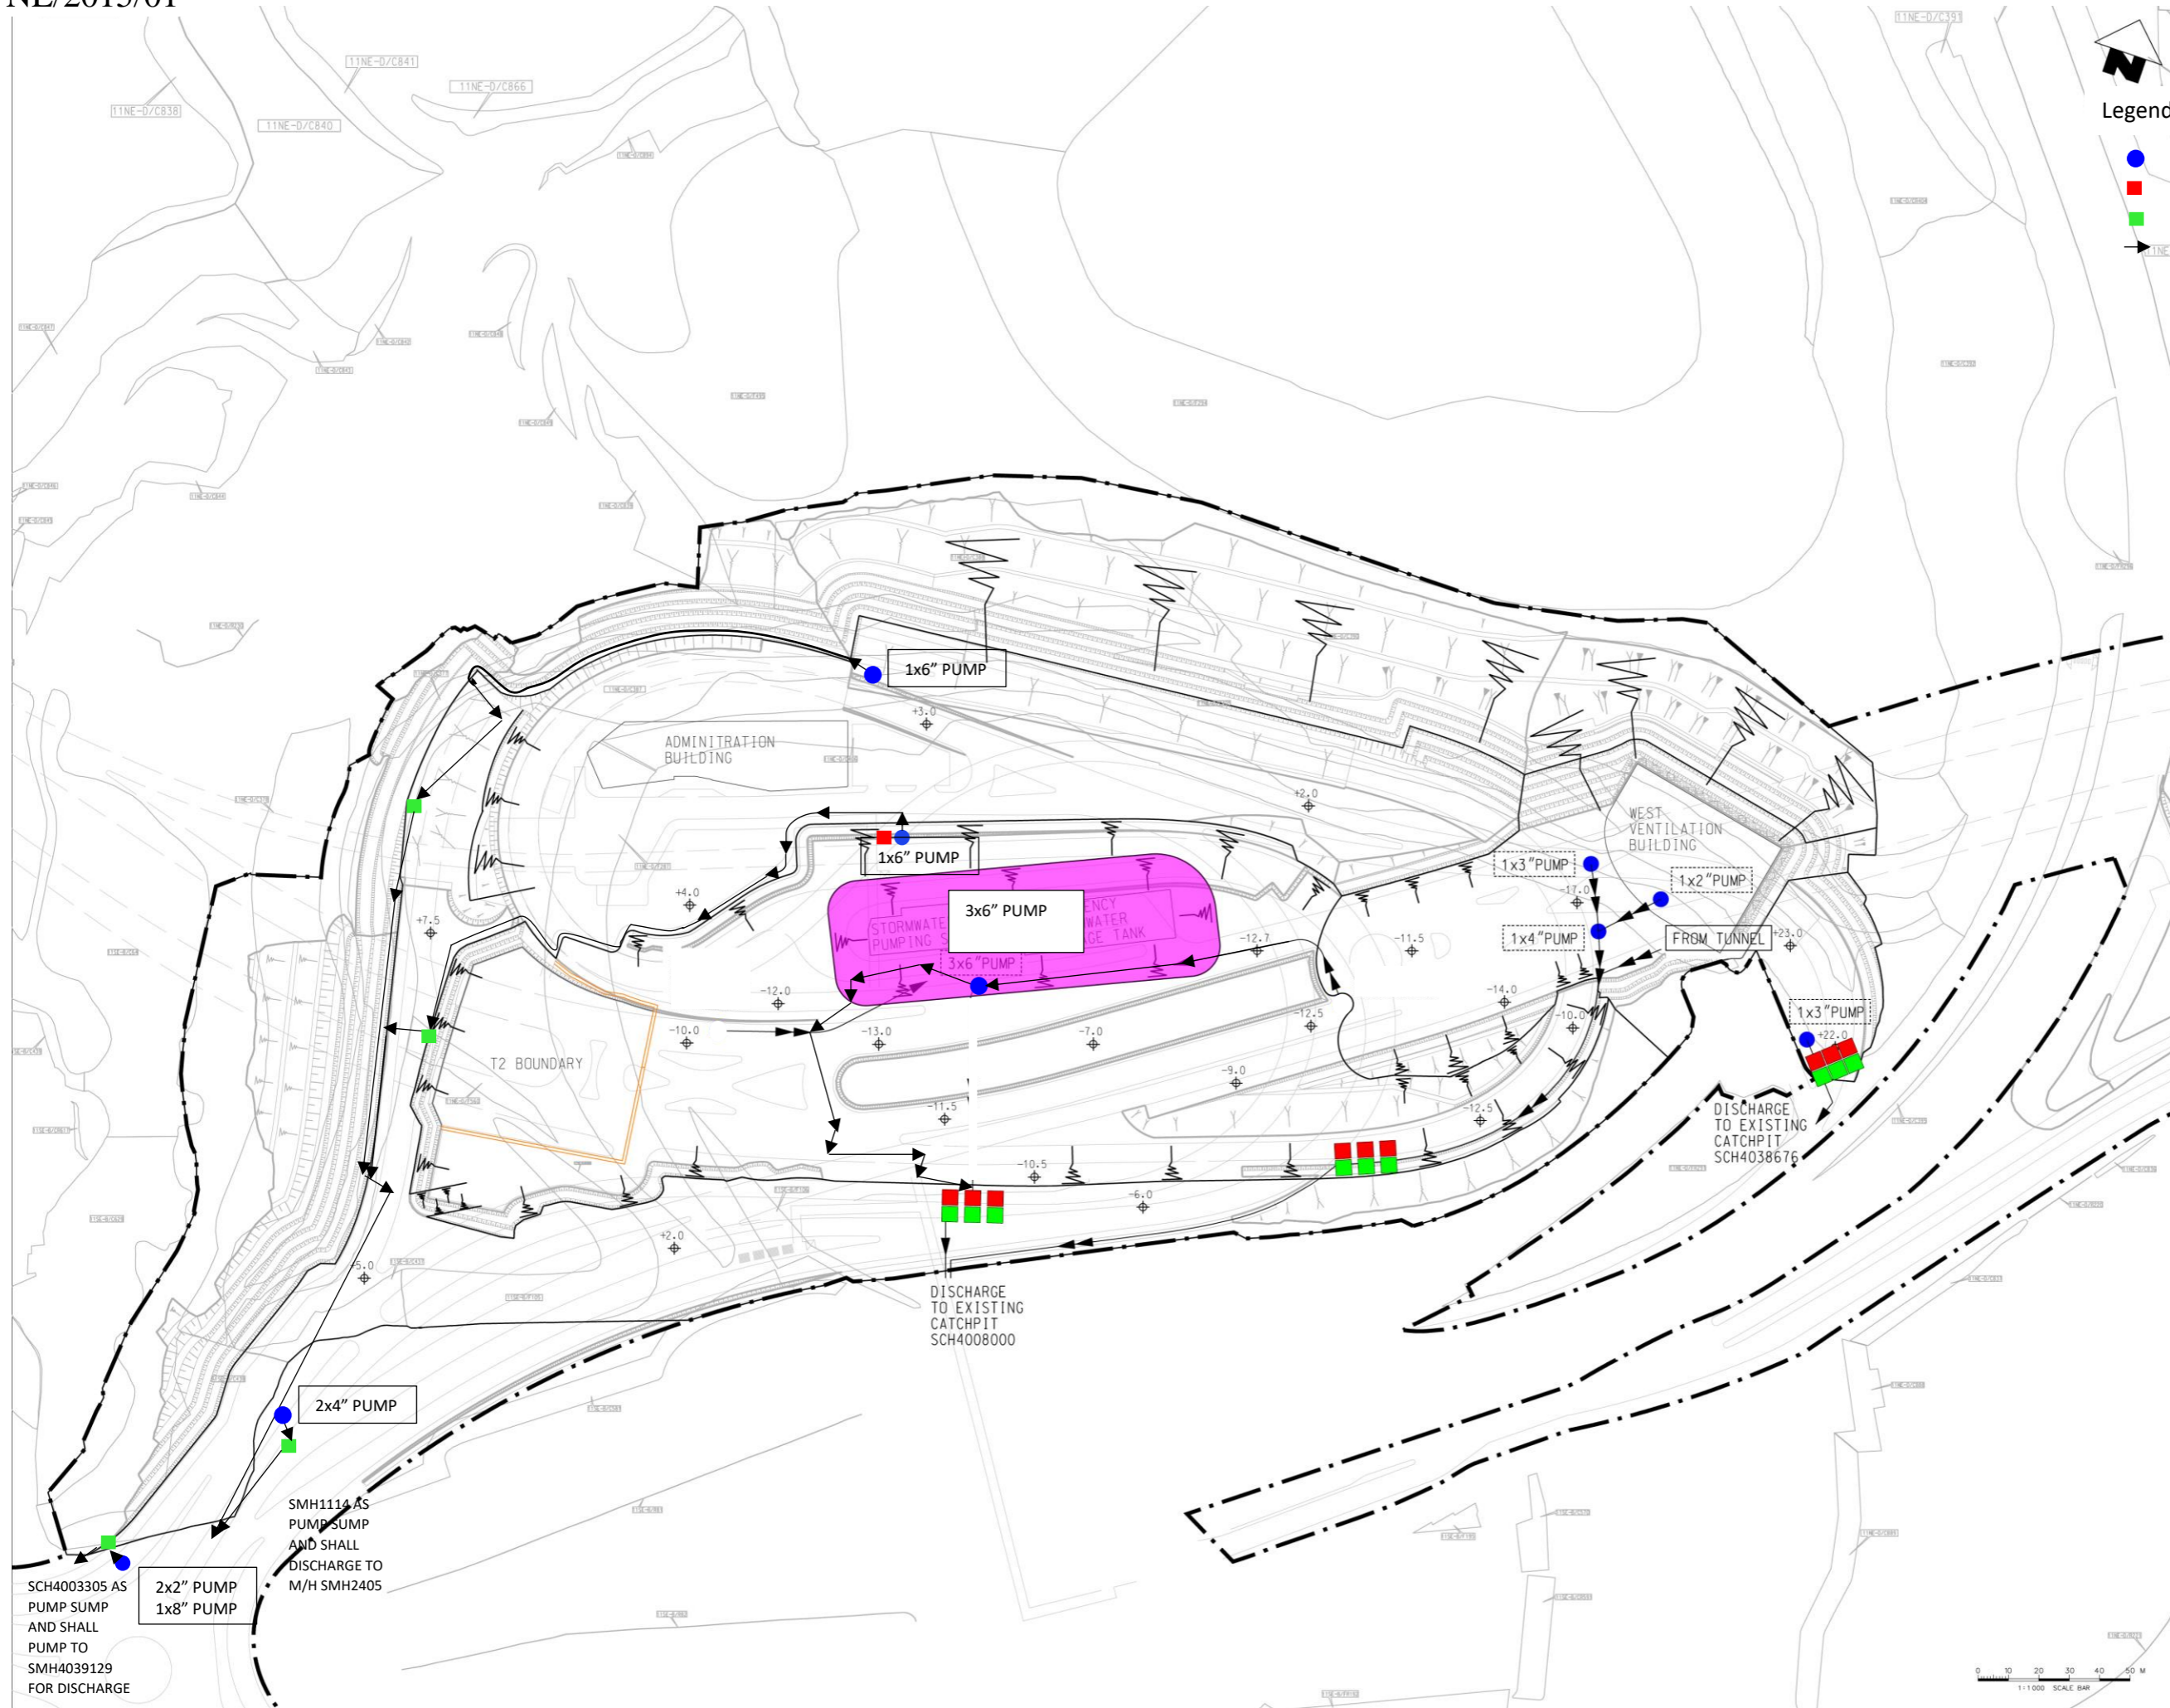
**APPENDIX V
SURFACE RUNOFF MANAGEMENT
PLAN**

- Pump
- Sedimentation Tank
- Wastewater Treatment Plant
- Flow Path
