**Agreement No. CE 59/2015 (EP)  
Environmental Team for  
Tseung Kwan O – Lam Tin Tunnel  
Design and Construction**

**Monthly Environmental Monitoring and  
Audit Report for  
August 2022  
(Version 1.0)**

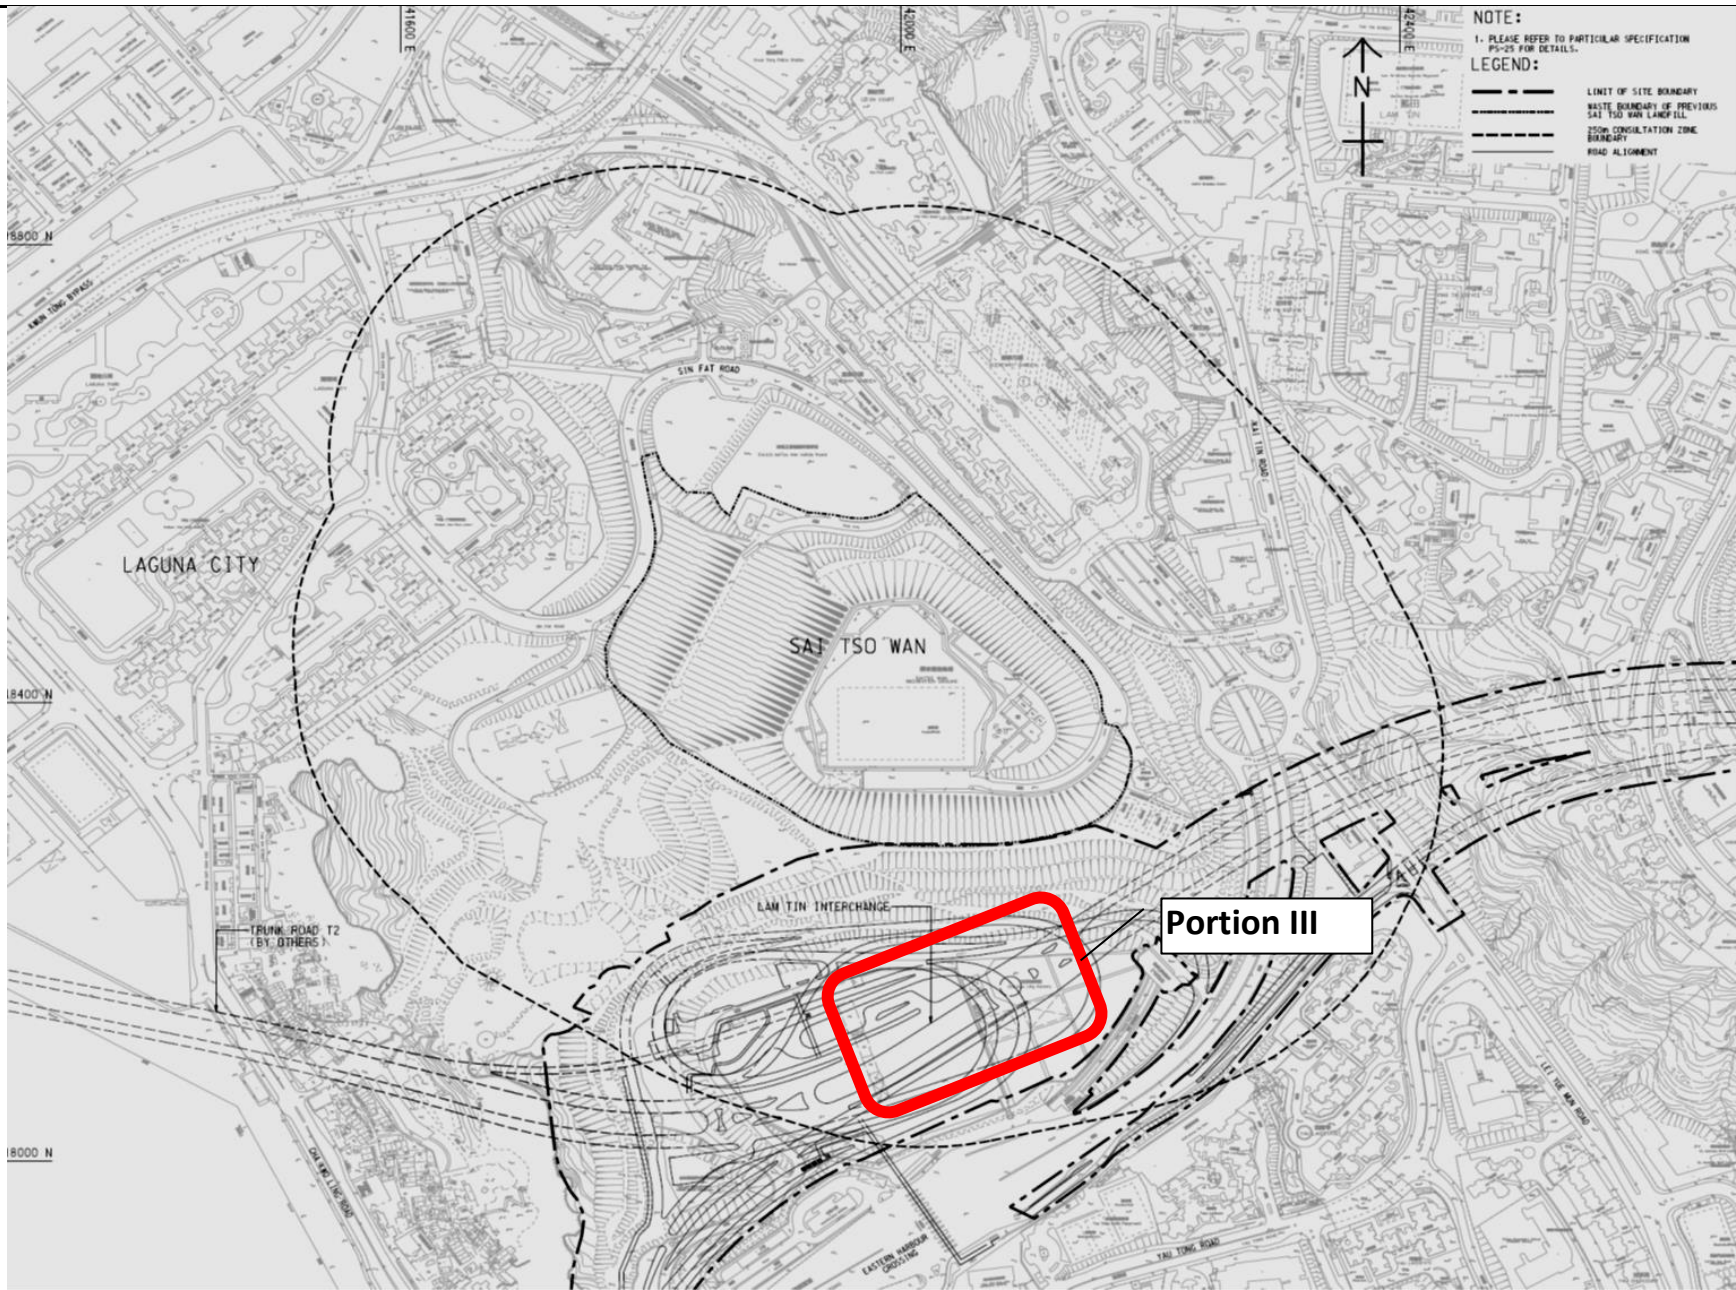
Project No. MA16034  
 Figure 6

Title Agreement No. CE/59/2015 (EP)  
 Environmental Team for Tseung Kwan O - Lam Tin Tunnel - Design and Construction  
 Locations of Landfill Gas Monitoring

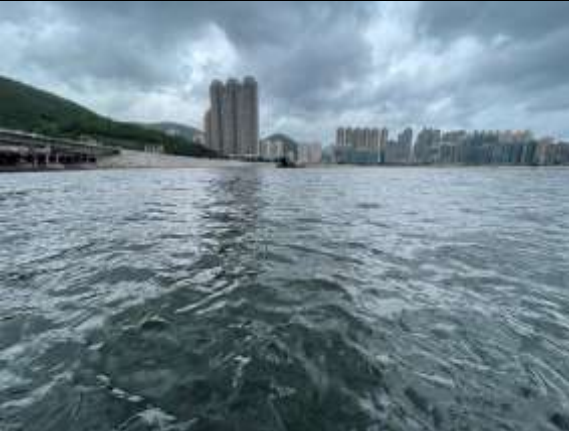
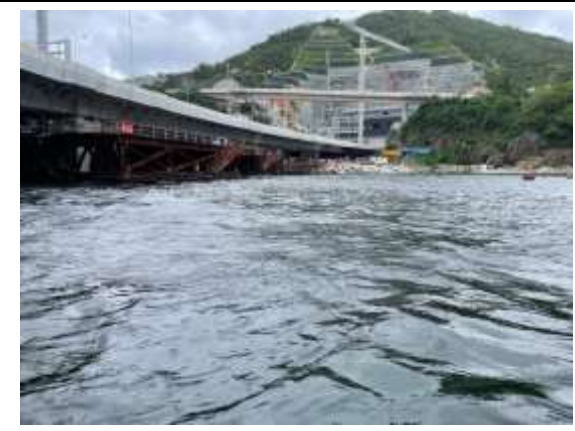
Photo 3 (Recorded on 26 August 2022)

During regular water quality monitoring, the sea appears to be clear in general (Photo 3 & 4). No obvious muddy water was observed during the monitoring.

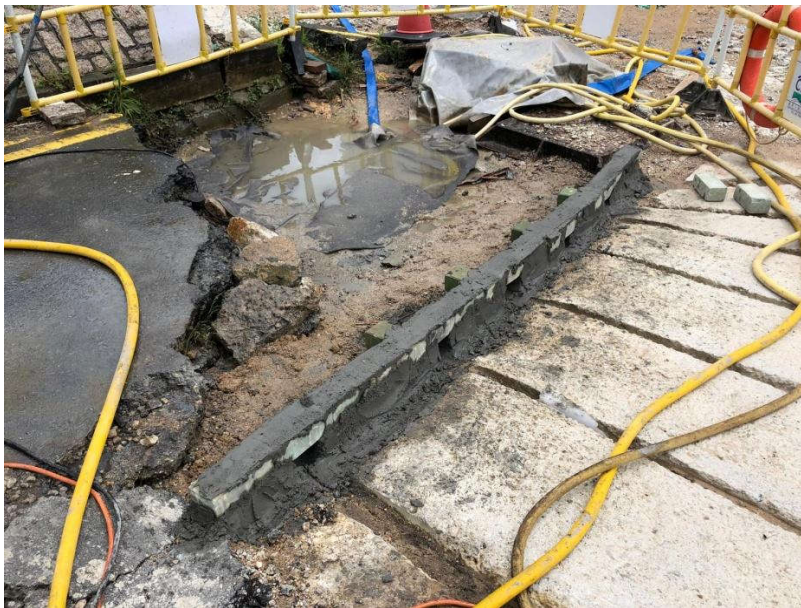
### Surface runoff collection

**Height difference between the road and site area to form a natural flow. Sump pit was provided for wastewater collection.**
