**Agreement No. CE 59/2015 (EP)
Environmental Team for
Tseung Kwan O – Lam Tin Tunnel
Design and Construction**

**Monthly Environmental Monitoring and
Audit Report for
September 2022
(Version 1.0)**

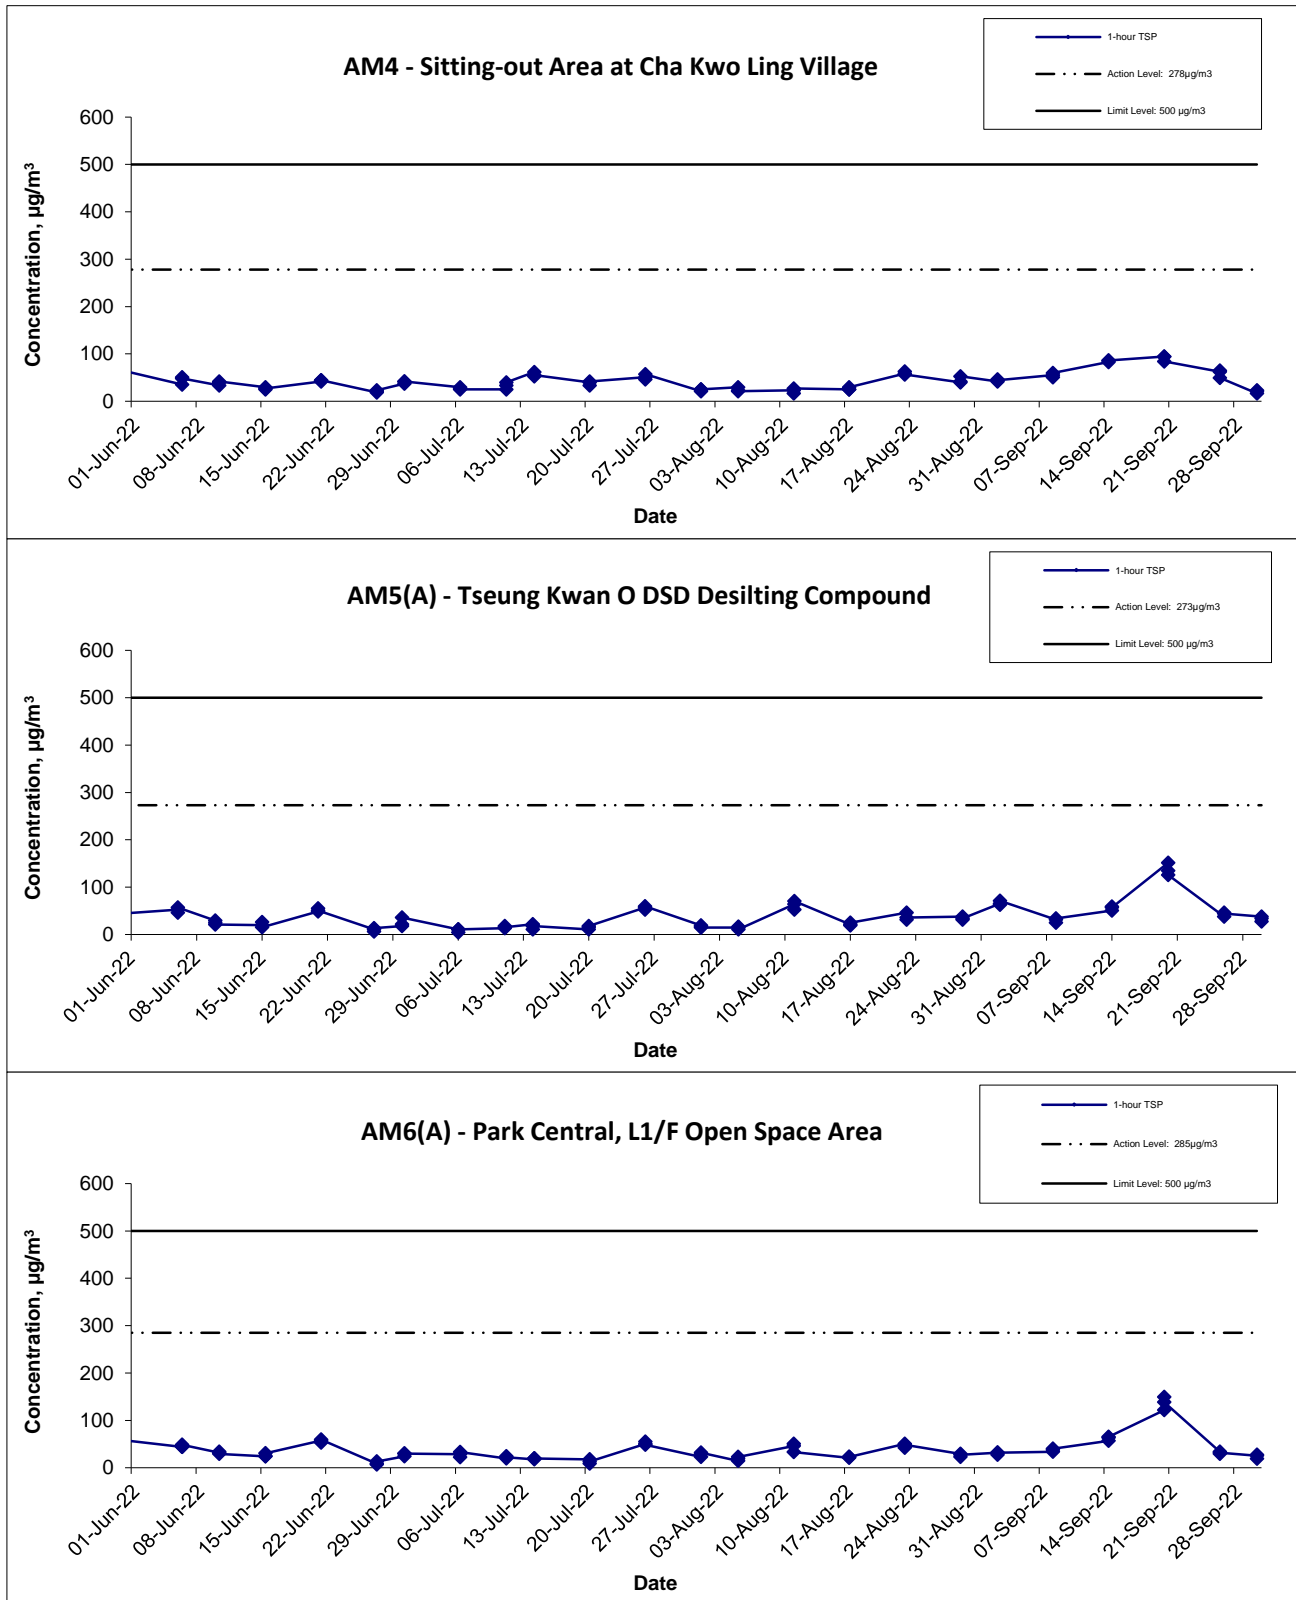
- 3.21 No Action/Limit Level exceedance was recorded for 1-hour TSP monitoring.
- 3.22 One (1) Action and no Limit Level exceedance was recorded for 24-hour TSP monitoring.
- 3.23 The air temperature, precipitation and the relative humidity data was obtained from Hong Kong Observatory where the wind speed and wind direction were recorded by the installed Wind Anemometer at rooftop of Yau Lai Estate Bik Lai House (41/F). The location is shown in **Figure 2**. This weather information for the reporting month is summarized in **Appendix C**.
- 3.24 The monitoring data and graphical presentations of 1-hour and 24-hour TSP monitoring results are shown in **Appendix E** and **Appendix F** respectively.
- 3.25 According to our field observations, the major dust source identified at the designated air quality monitoring stations are as follows:

Agreement No. CE/59/2015 (EP) Environmental Team for Tseung Kwan O - Lam Tin Tunnel - Design and Construction Graphical Presentation of 1-hour TSP Monitoring Results	Scale	Project
