**Agreement No. CE 59/2015 (EP)
Environmental Team for
Tseung Kwan O – Lam Tin Tunnel
Design and Construction**

**Monthly Environmental Monitoring and
Audit Report for
October 2022
(Version 1.0)**

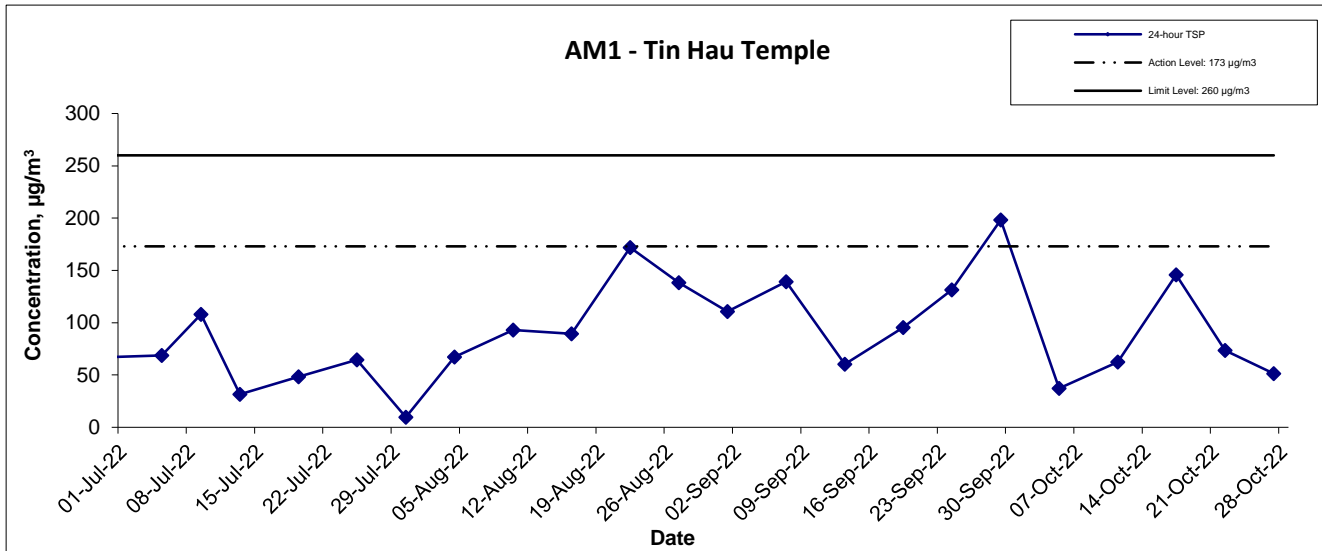
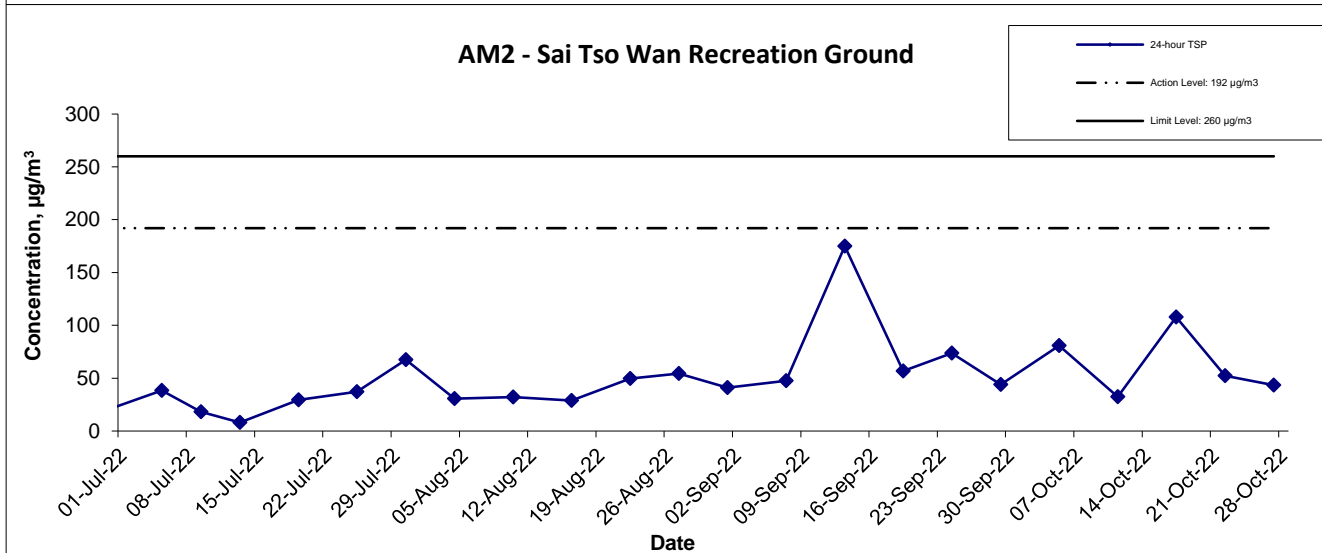
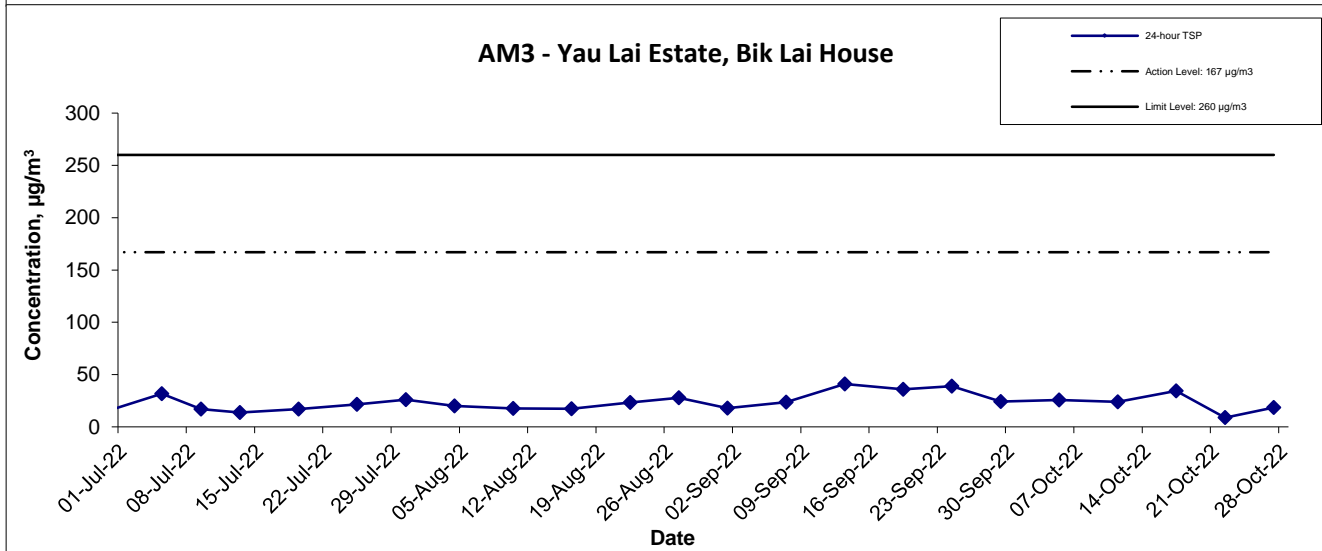
24-hr TSP Concentration Levels

Graphical Presentation of 24-hour TSP Monitoring Results

- 3.21 No Action/Limit Level exceedance was recorded for 1-hour TSP monitoring.
- 3.22 No Action and no Limit Level exceedance was recorded for 24-hour TSP monitoring.
- 3.23 The air temperature, precipitation and the relative humidity data was obtained from Hong Kong Observatory where the wind speed and wind direction were recorded by the installed Wind Anemometer at rooftop of Yau Lai Estate Bik Lai House (41/F). The location is shown in **Figure 2**. This weather information for the reporting month is summarized in **Appendix C**.
- 3.24 The monitoring data and graphical presentations of 1-hour and 24-hour TSP monitoring results are shown in **Appendix E** and **Appendix F** respectively.
- 3.25 According to our field observations, the major dust source identified at the designated air quality monitoring stations are as follows:

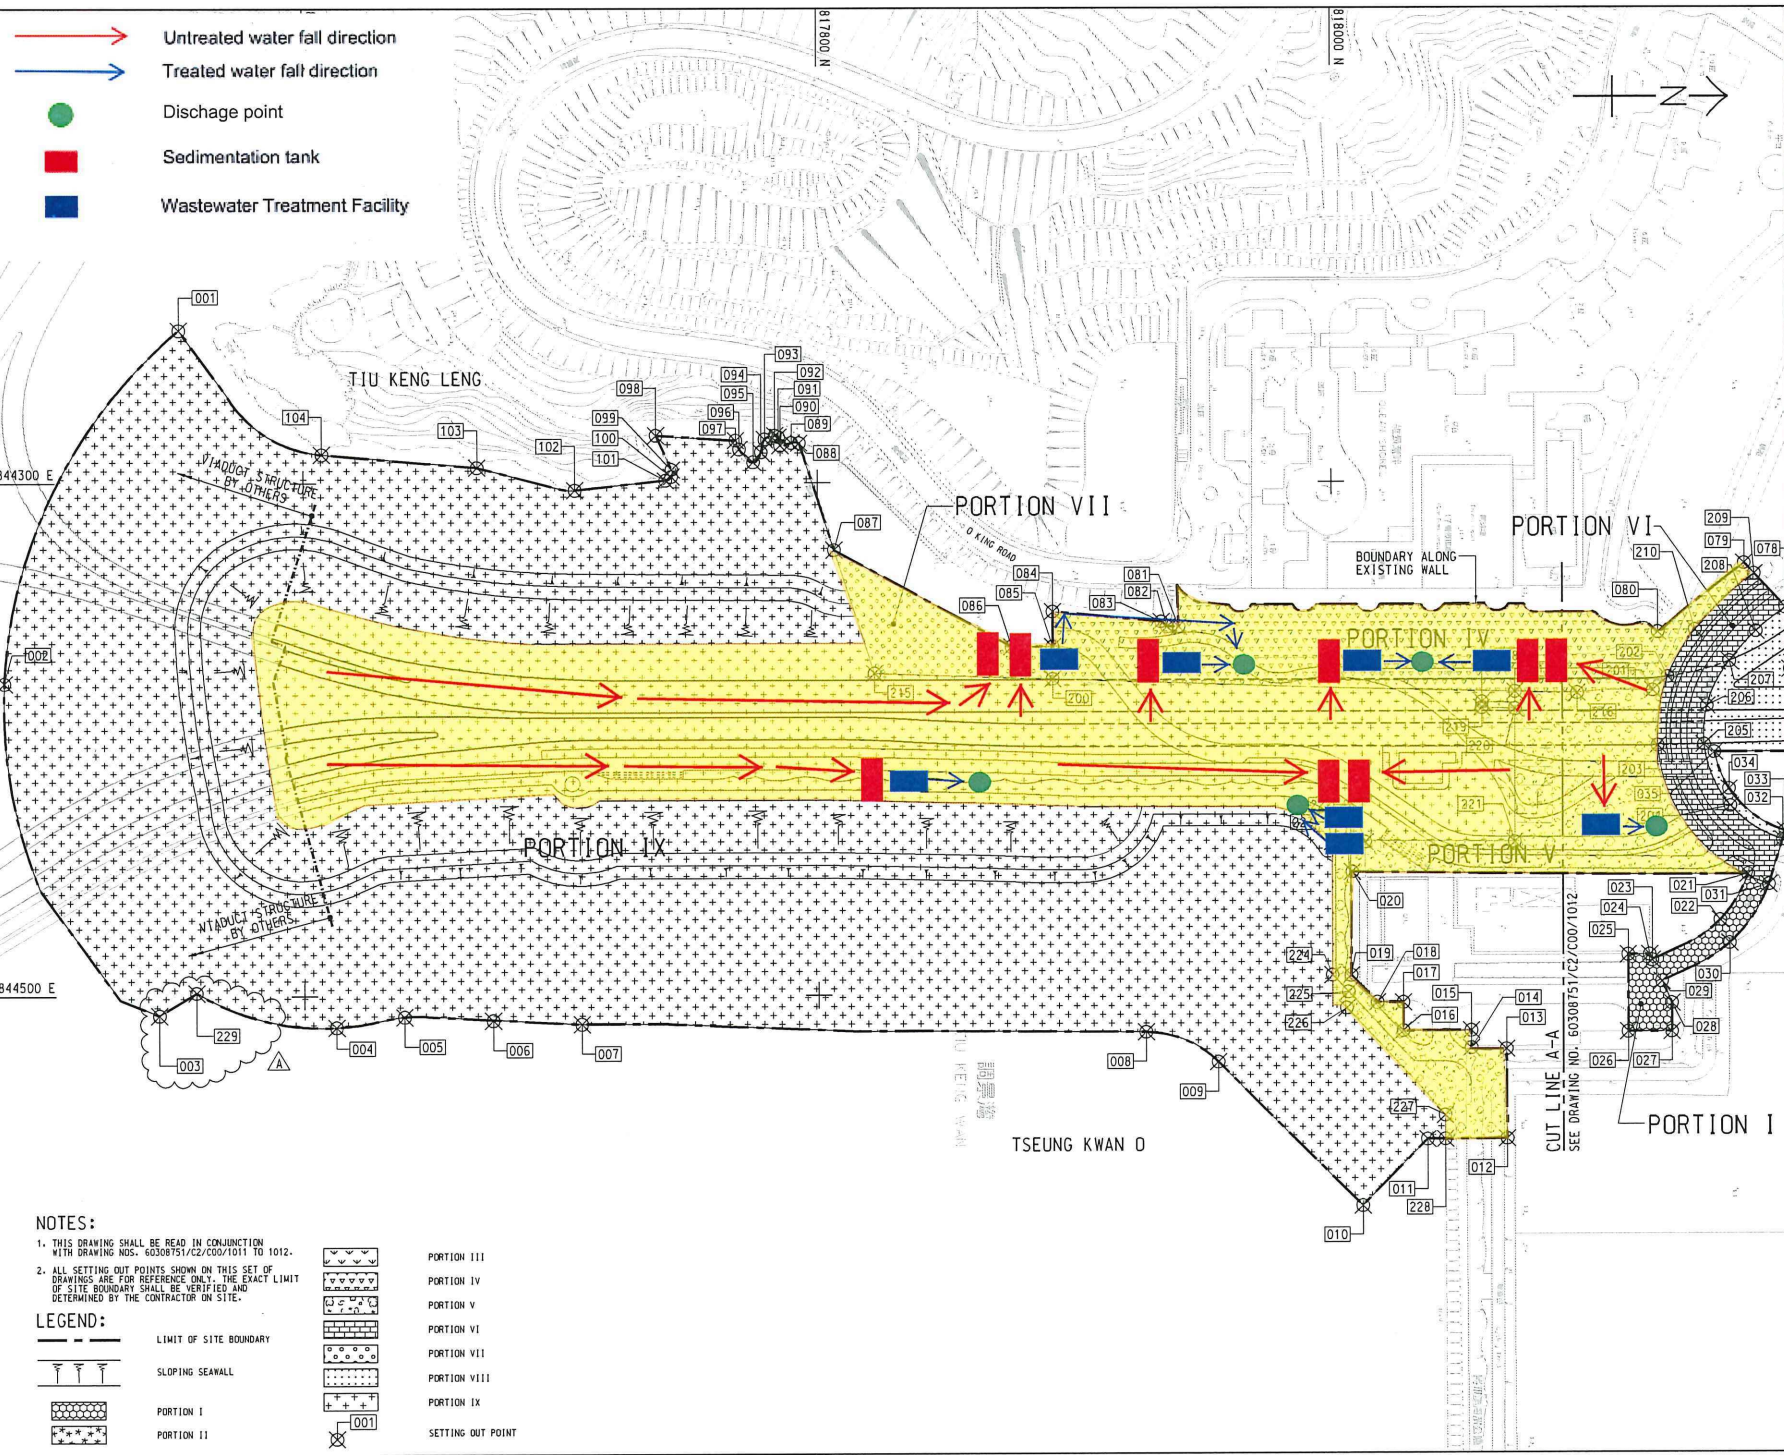
- Untreated water fall direction
- Treated water fall direction
- Discharge point
- Sedimentation tank
- Wastewater Treatment Facility
