Agreement No. CE 59/2015 (EP) Environmental Team for Tseung Kwan O – Lam Tin Tunnel Design and Construction

Monthly Environmental Monitoring and Audit Report for January 2023

(Version 1.0)

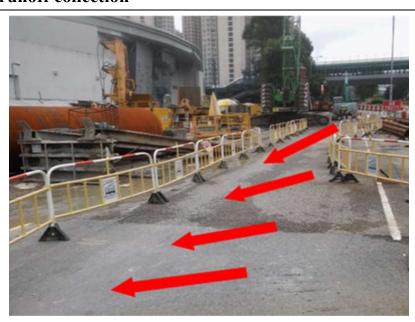
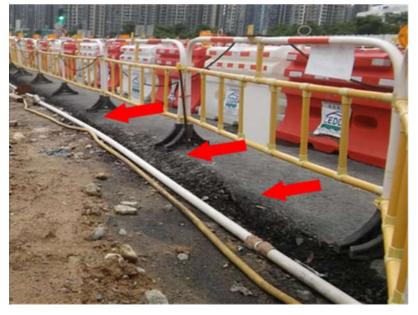
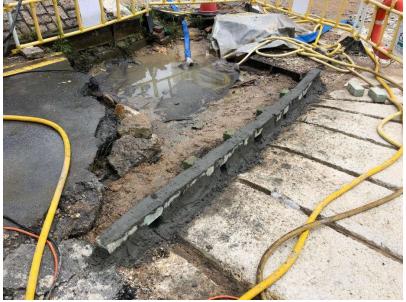
Surface runoff collection

Height difference between the road and site area to form a natural flow. Sump pit was provided for wastewater collection.

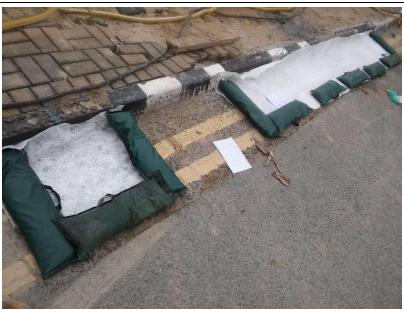
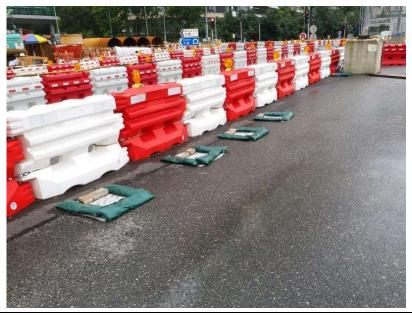
Gully Protection

Gully were protected and covered by geotextile.
