# Civil Engineering and Development Department

**Agreement No. CE 59/2015 (EP)  
Environmental Team for  
Tseung Kwan O – Lam Tin Tunnel  
Design and Construction**

**Monthly Environmental Monitoring and  
Audit Report for  
February 2023  
(Version 1.0)**

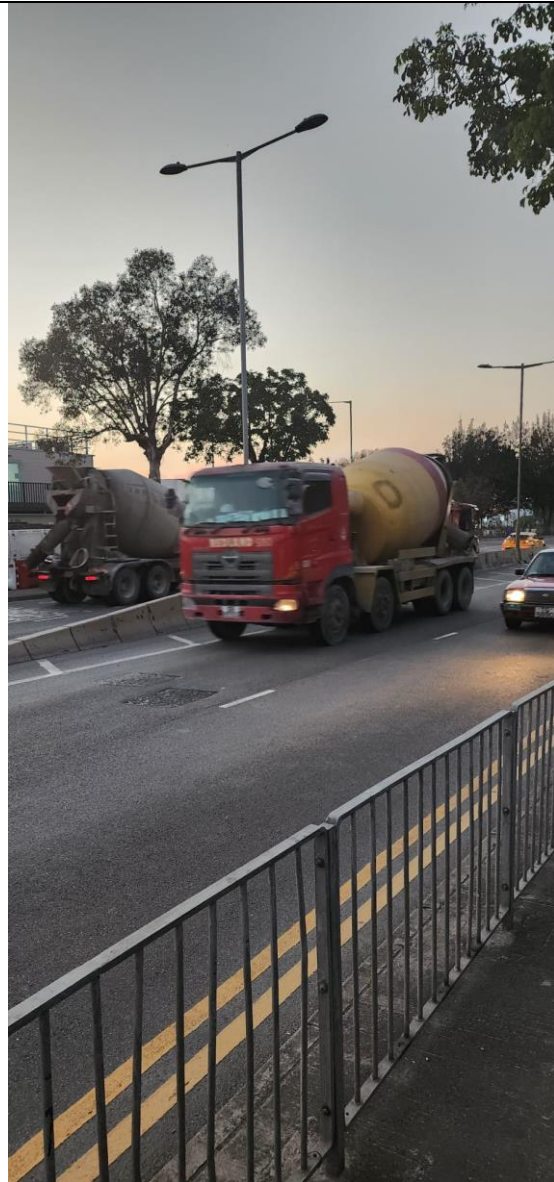
Photo 1 – Road condition along Cha Kwo Ling Road next to station AM4(B) (Taken on 23 Feb 2023)

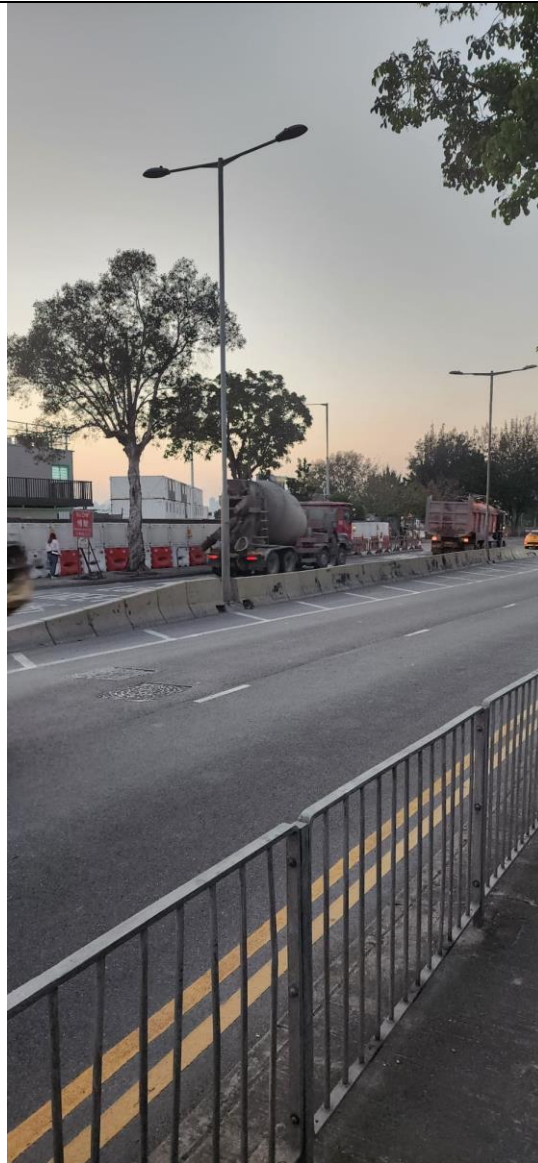
Photo 3 – Road condition along Cha Kwo Ling Road next to station AM4(B) (Taken on 23 Feb 2023)
