**Agreement No. CE 59/2015 (EP)
Environmental Team for
Tseung Kwan O – Lam Tin Tunnel
Design and Construction**

**Quarterly Environmental
Monitoring and Audit Report –
May 2023 – July 2023**

(version 1.0)

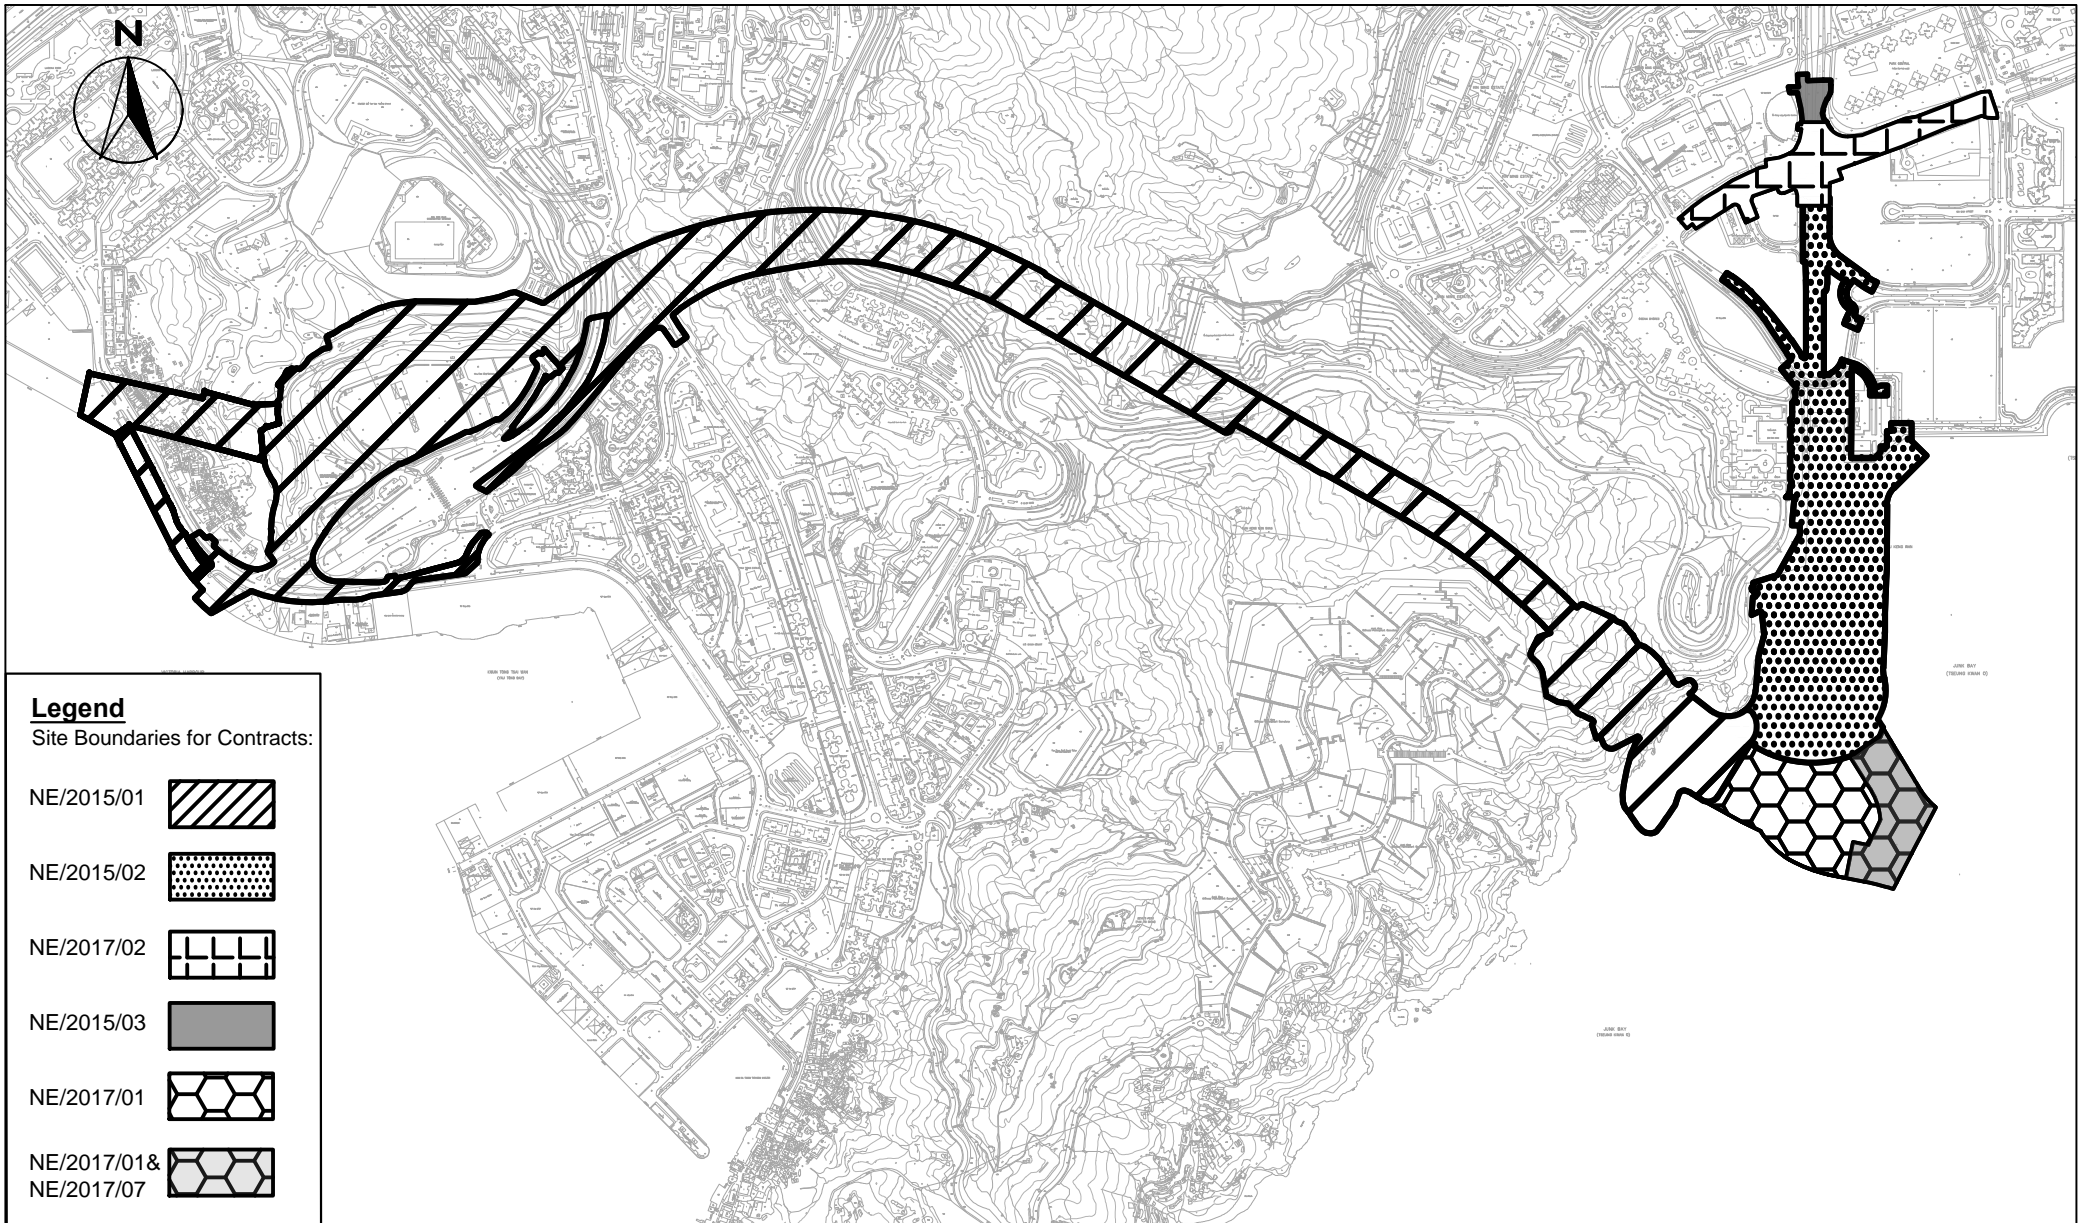
SCALE	1:13000@A4	DATE	15 April 2021	
CHECK	CC	DRAWN	KC	
JOB No.	MA16034	FIGURE NO.	1	REV -

Site Layout Plan

- 1.2 At present, the Tseung Kwan O Tunnel is the main connection between Tseung Kwan O (TKO) and other areas in the territory. To cope with the anticipated transport need, the TKO Study recommended the provision of Tseung Kwan O – Lam Tin Tunnel (TKO-LTT) (hereinafter referred to as “the Project”) and Cross Bay Link (CBL) to meet the long-term traffic demand between TKO and the external areas. The site layout plan for the Project is shown in **Figure 1**.

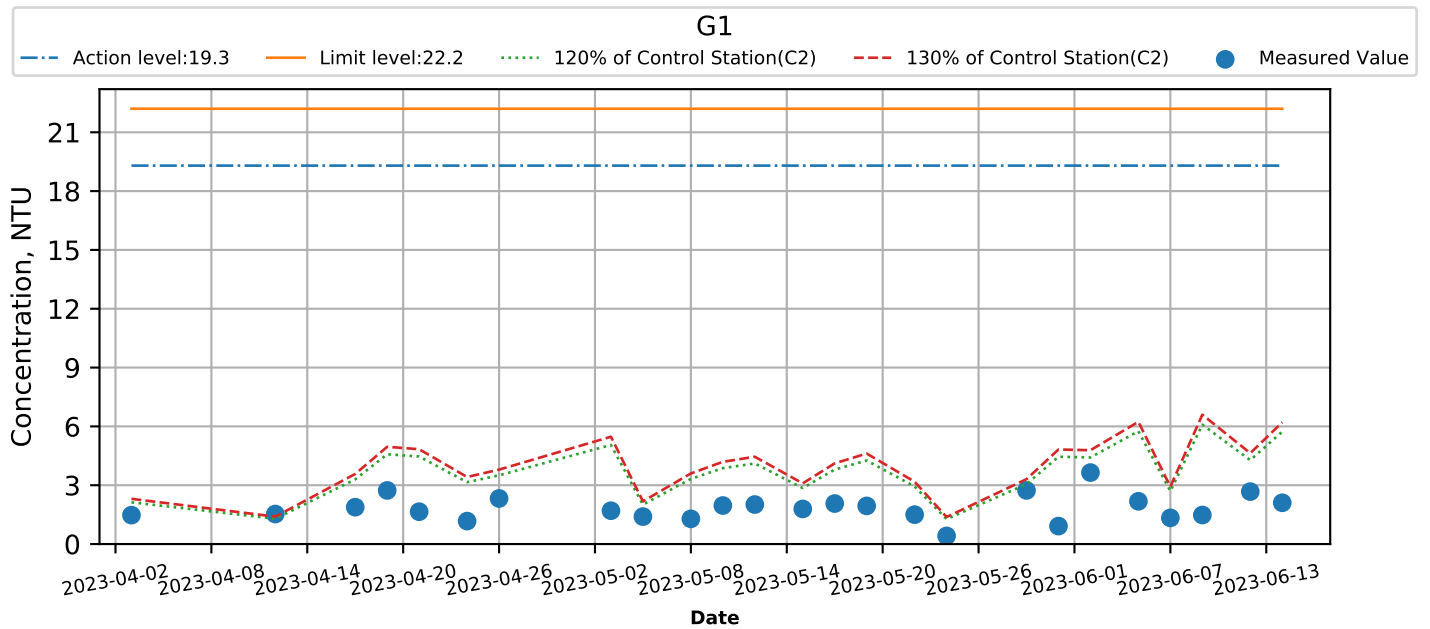
Graphical Presentation of Water Quality Monitoring Results (Apr-2023 to Jun-2023)

Turbidity (Bottom) at Monitoring Stations during Mid-Ebb

- 3.23 Exceedances of turbidity and suspended solids were recorded from various monitoring stations non-specifically among all stations including the control stations. Investigations from May 2023 – June 2023 showed that the range of SS levels recorded in reporting period remained consistent with the records in recent months. Since we officially entered the wet season, all Contractors are reminded to clear the drainage, repair any broken pipes/drainage and ensure there is an embankment surrounding the works area to prevent accidental muddy water spillage or surface runoff due to heavy downpours. Details of the exceedance investigation report can be found in **Appendix K**.

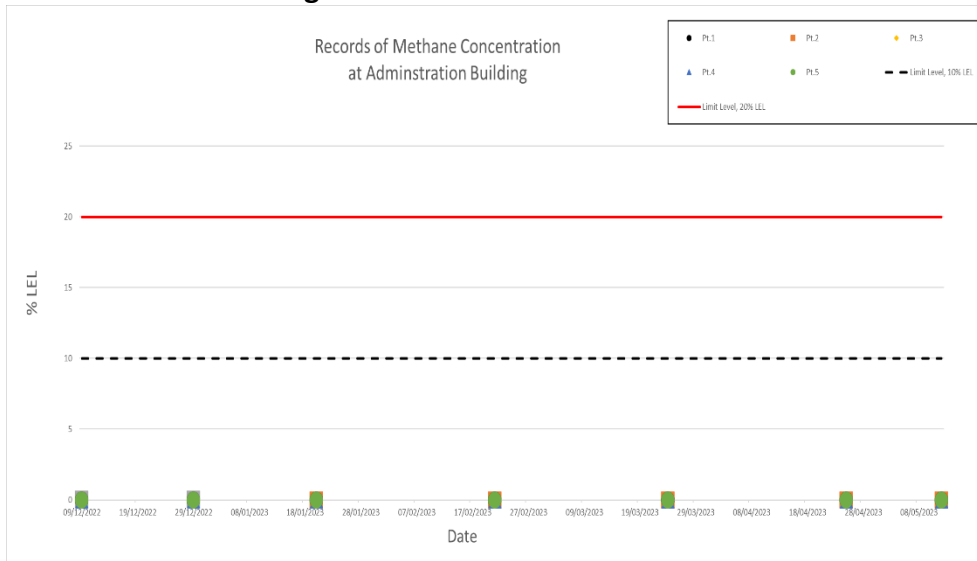
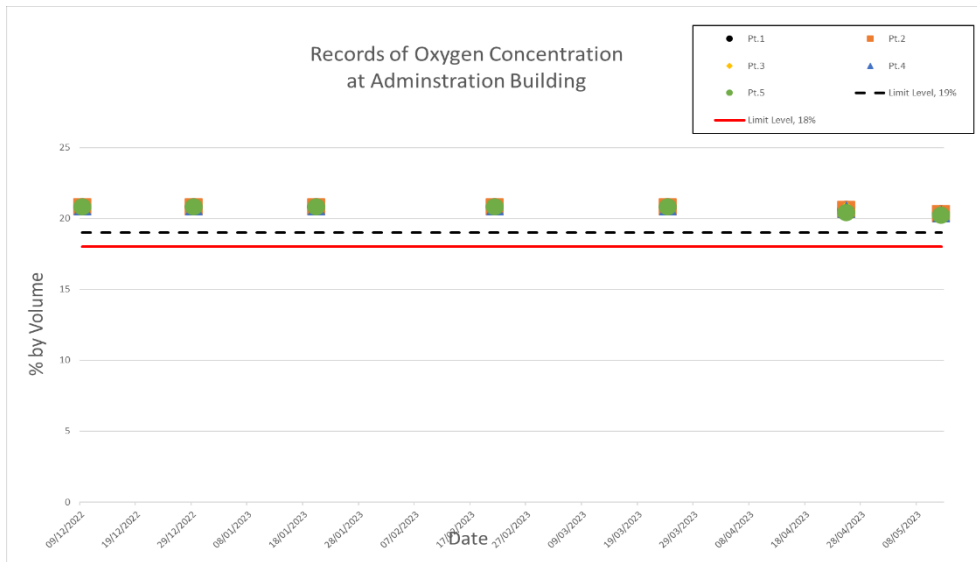
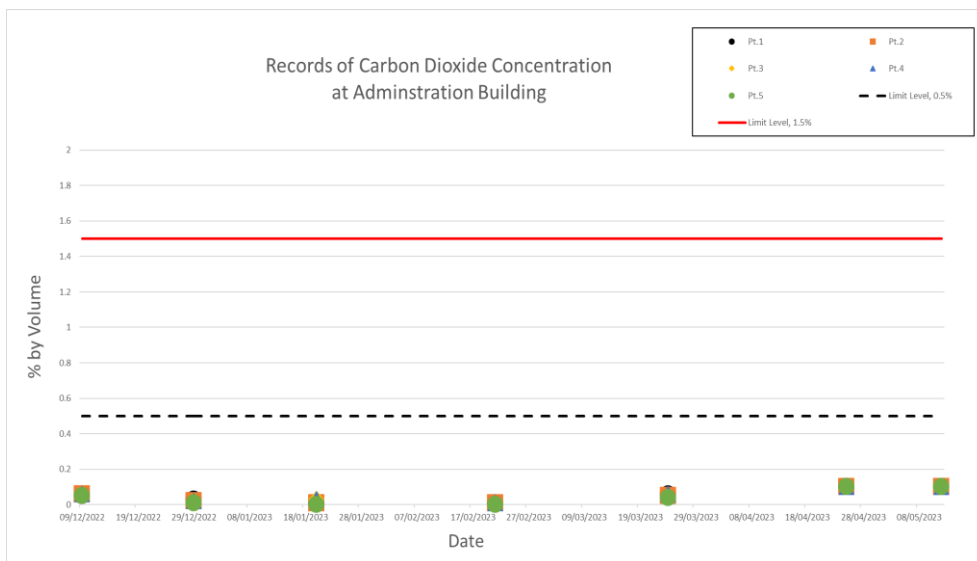
i. Administration Building

The landfill gas measurement was conducted on 12th May 2023. No exceedance of limit level was observed in the Administration Building, Sewage Pumping Station, Stormwater Pumping Station, West Ventilation Building and the tunnel area at Lam Tin. The overall condition was in compliance during the reporting month.

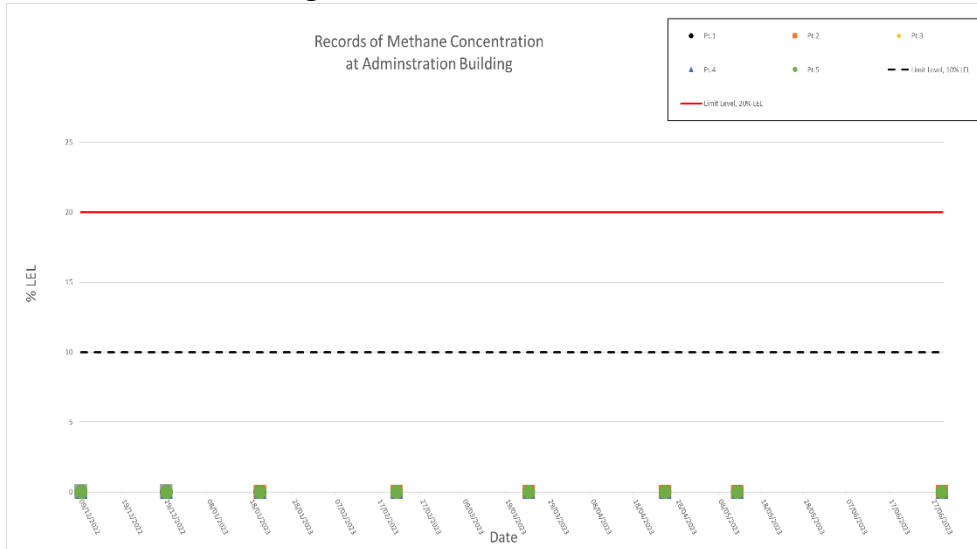
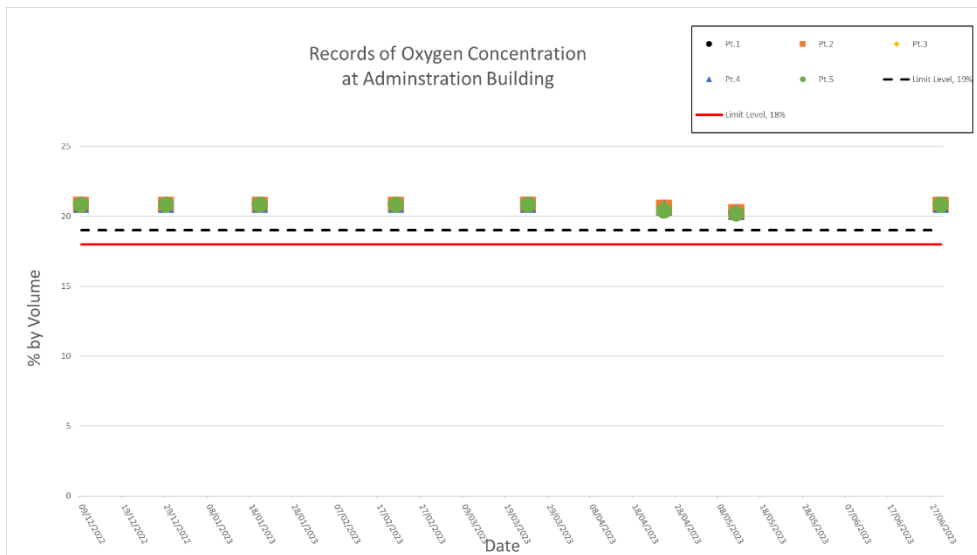
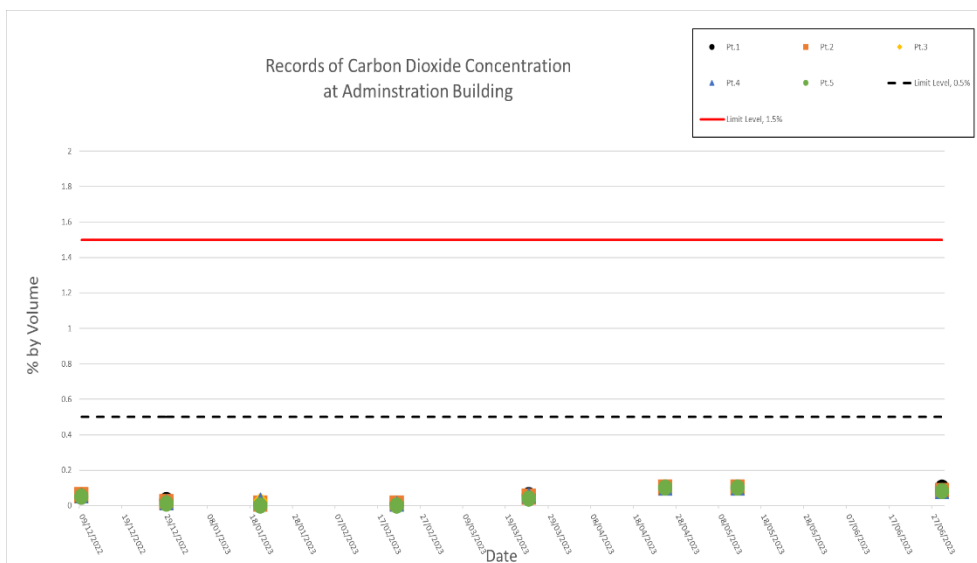
i. Administration Building

The landfill gas measurement was conducted on 29th June 2023. No exceedance of limit level was observed in the Administration Building, Sewage Pumping Station, Stormwater Pumping Station, West Ventilation Building and the tunnel area at Lam Tin. The overall condition was in compliance during the reporting month.

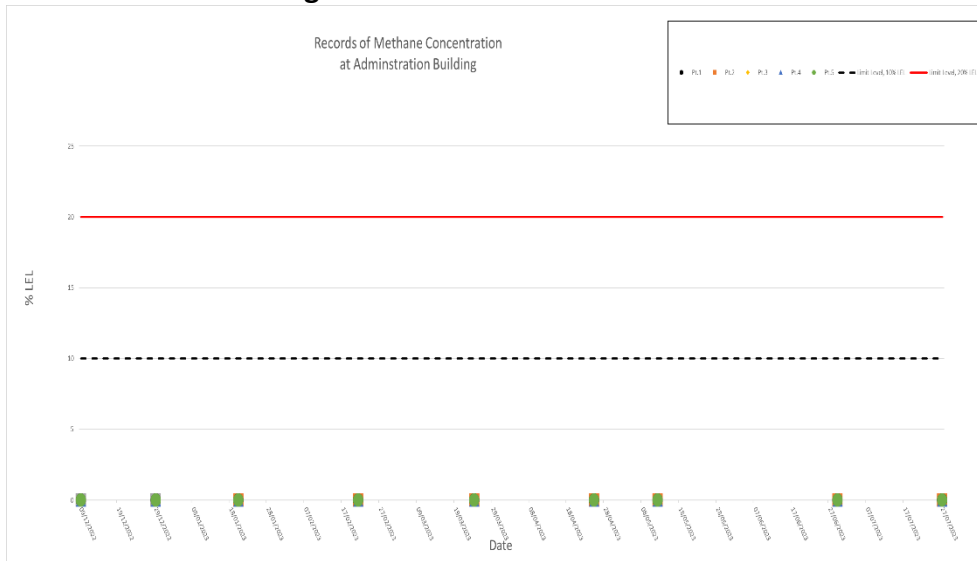
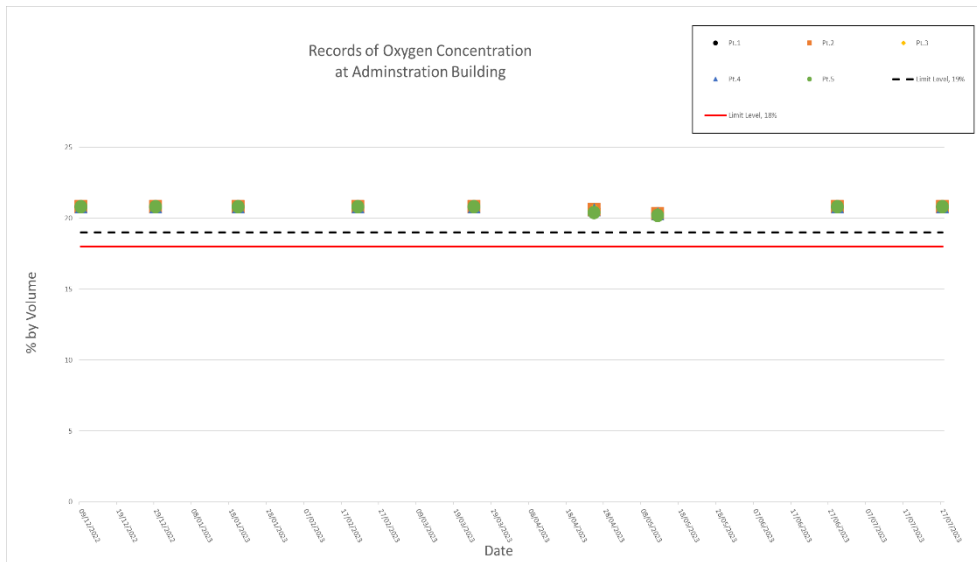
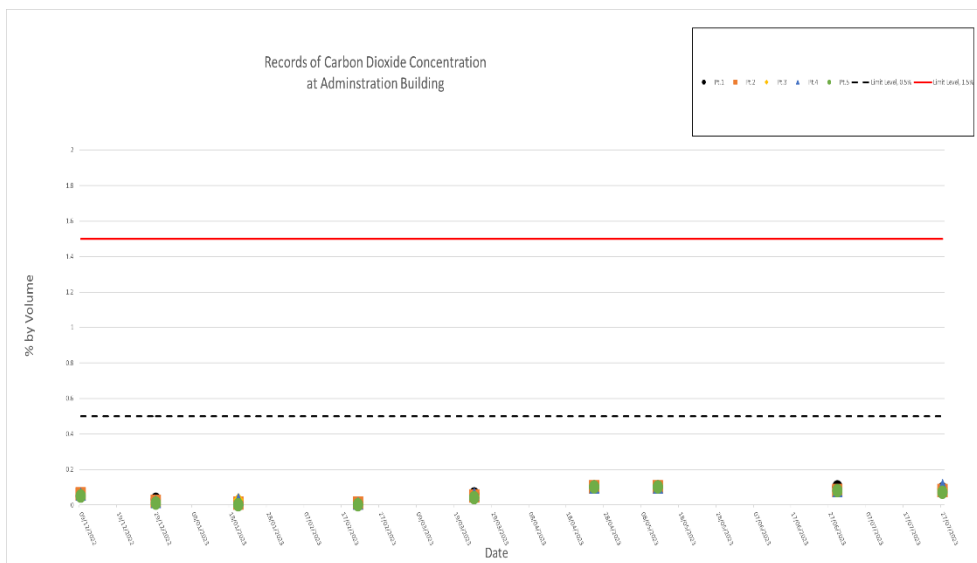
i. Administration Building

The landfill gas measurement was conducted on 27th July 2023. No exceedance of limit level was observed in the Administration Building, Sewage Pumping Station, Stormwater Pumping Station, West Ventilation Building and the tunnel area at Lam Tin. The overall condition was in compliance during the reporting month.

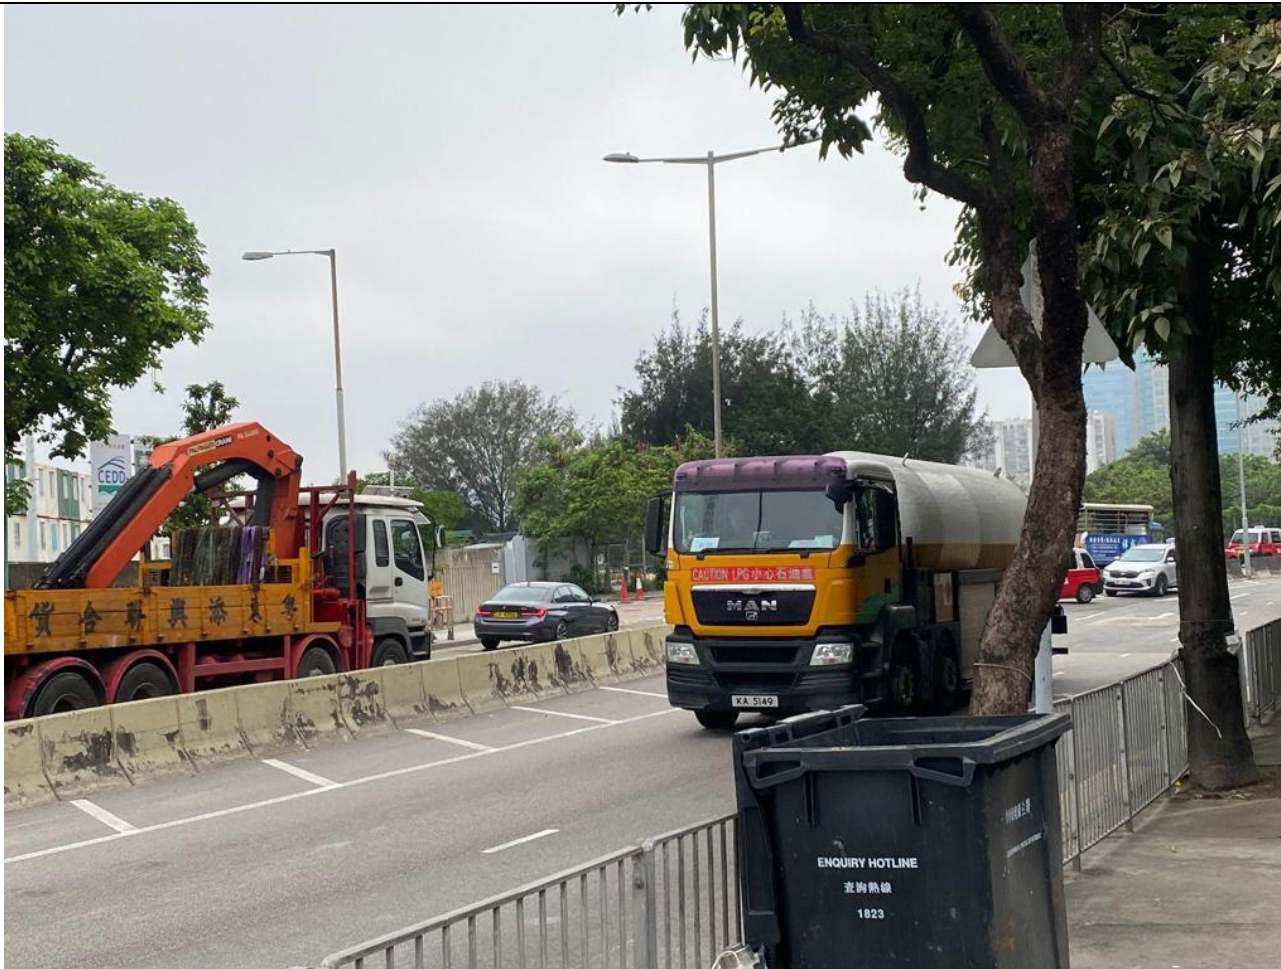
Photo 1 – Road condition along Cha Kwo Ling Road next to station AM4(B) (Taken on 19 May 2023)

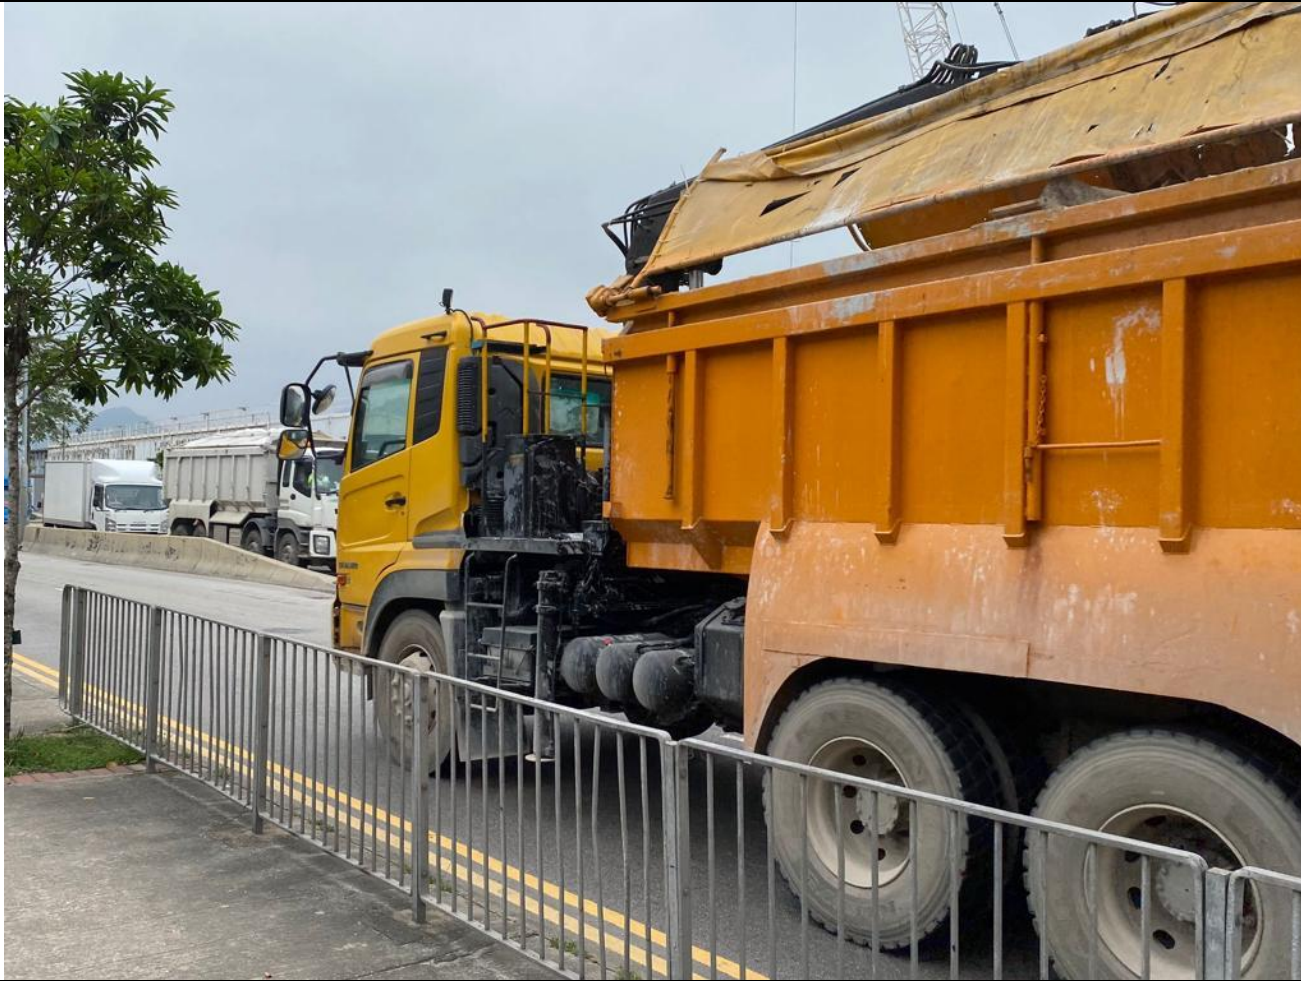
Photo 3 – Road condition along Cha Kwo Ling Road next to station AM4(B) (Taken on 19 May 2023)

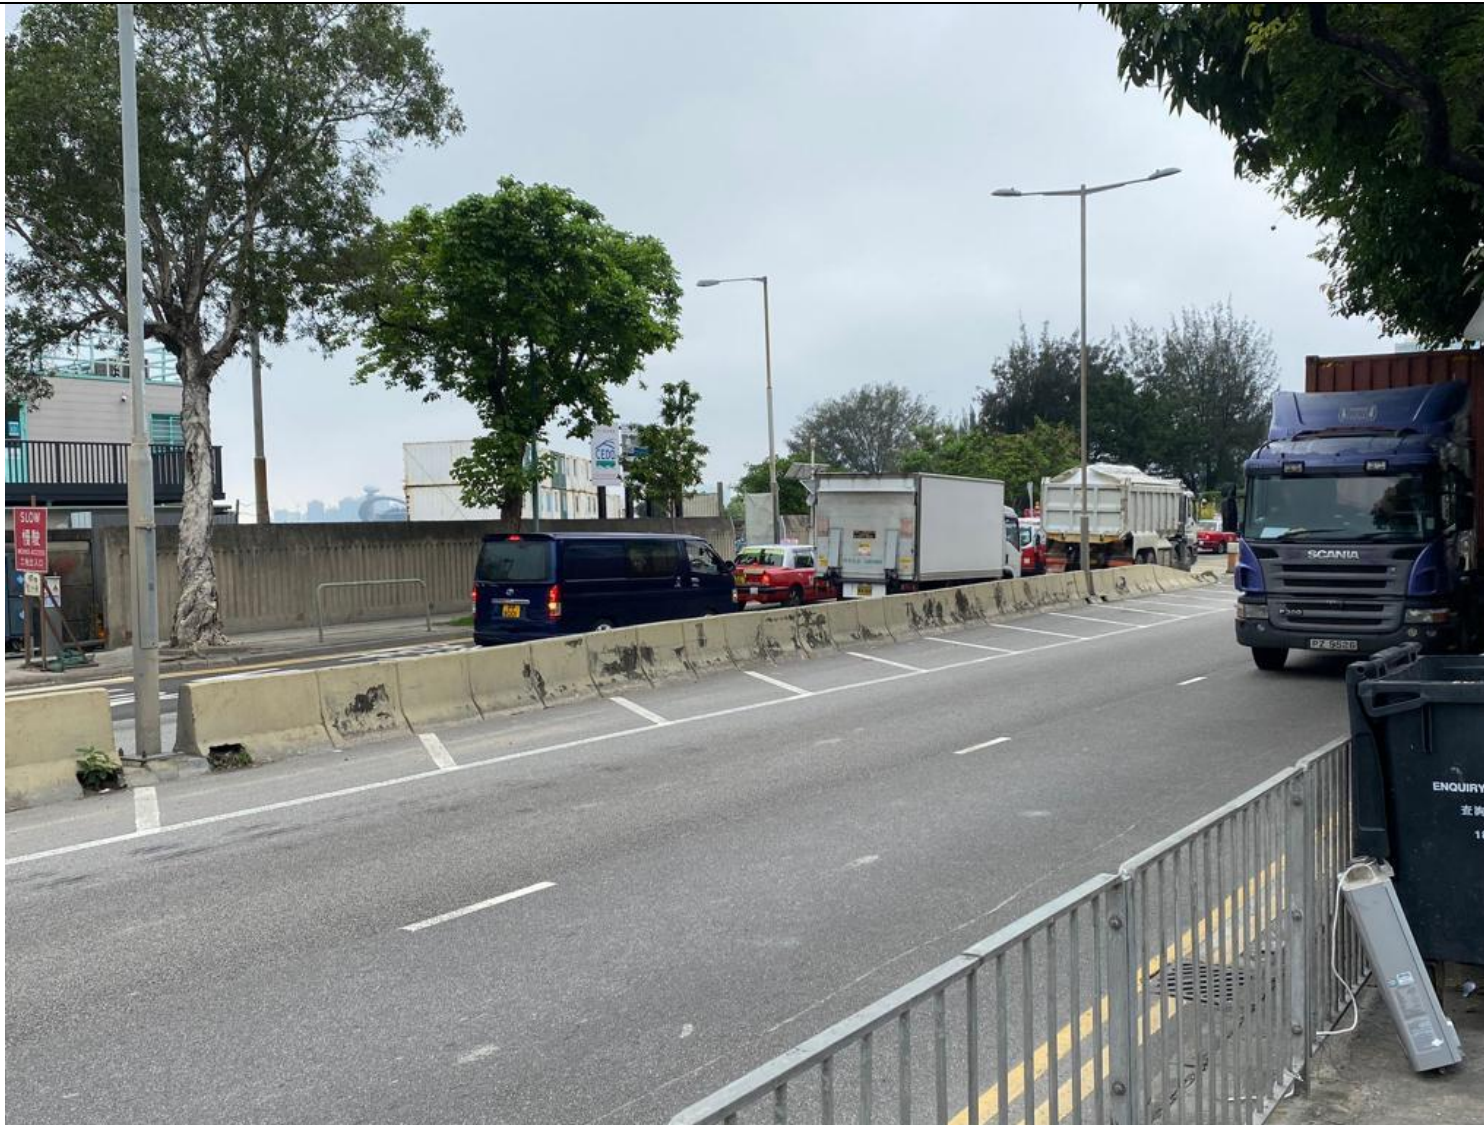
Photo 1 – Road condition along Cha Kwo Ling Road next to station AM4(B) (Taken on 31 May 2023)

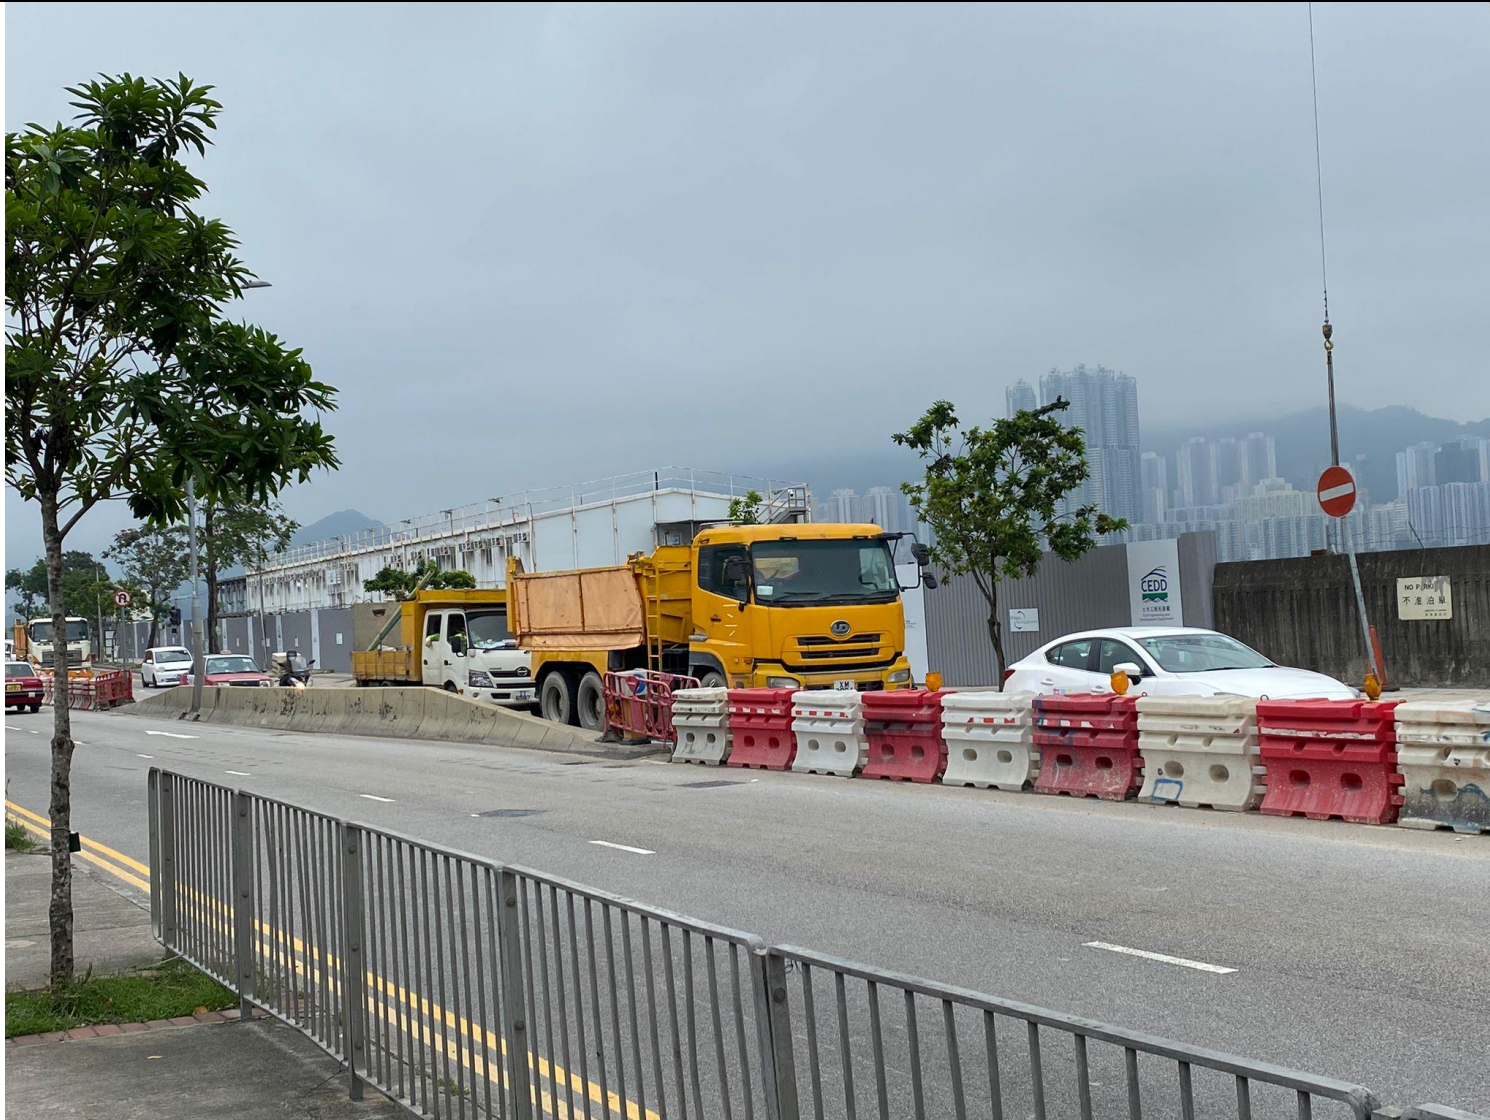
Photo 2 – Road condition along Cha Kwo Ling Road next to station AM4(B) (Taken on 31 May 2023)

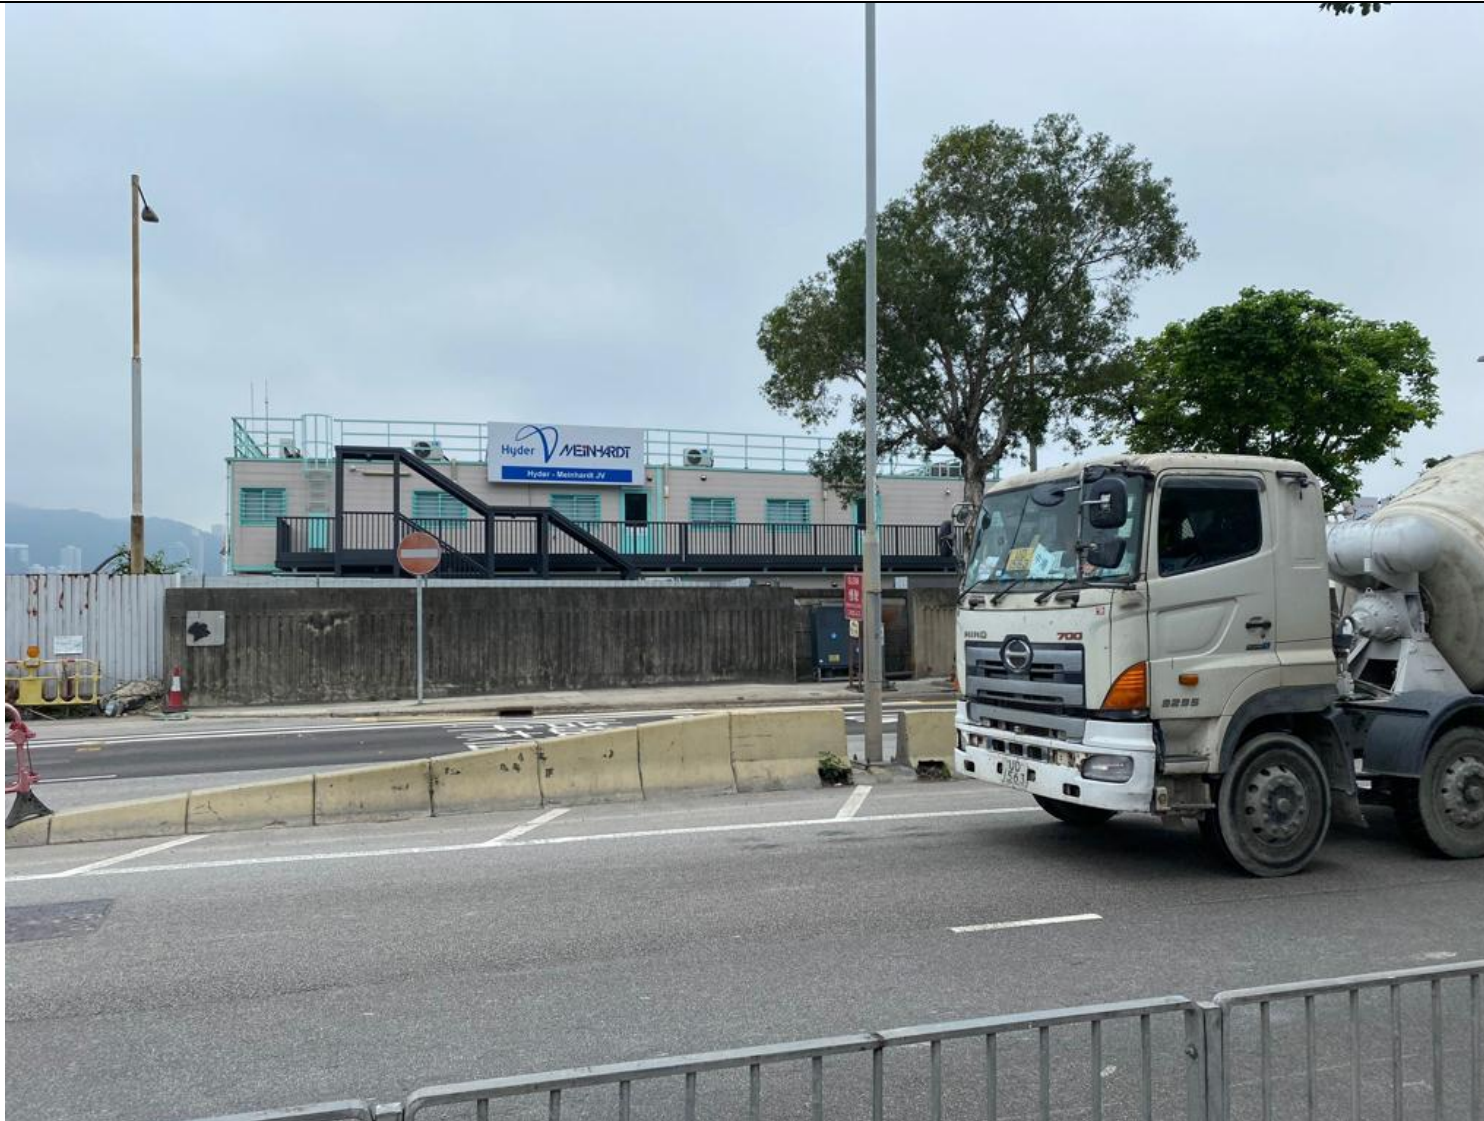
Photo 3 – Road condition along Cha Kwo Ling Road next to station AM4(B) (Taken on 31 May 2023)
