Civil Engineering and Development Department

Agreement No. CE 59/2015 (EP) Environmental Team for Tseung Kwan O – Lam Tin Tunnel Design and Construction

Monthly Environmental Monitoring and Audit Report for July 2023

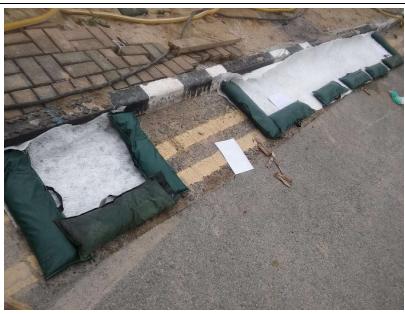
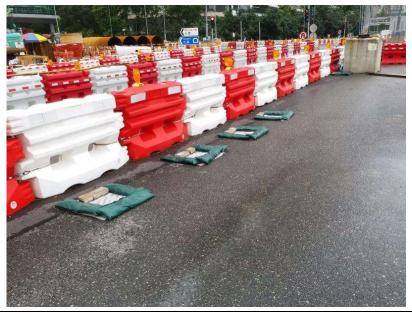
Gully Protection

Gully were protected and covered by geotextile.
