**Agreement No. CE 59/2015 (EP)
Environmental Team for
Tseung Kwan O – Lam Tin Tunnel
Design and Construction**

**Monthly Environmental Monitoring and
Audit Report for
September 2023
(Version 1.0)**

Agreement No.: NTE 06/2016
Independent Environmental Checker for Tseung Kwan O – Lam Tin Tunnel
Monthly Environmental Monitoring and Audit Report for September 2023 (version 1.0)

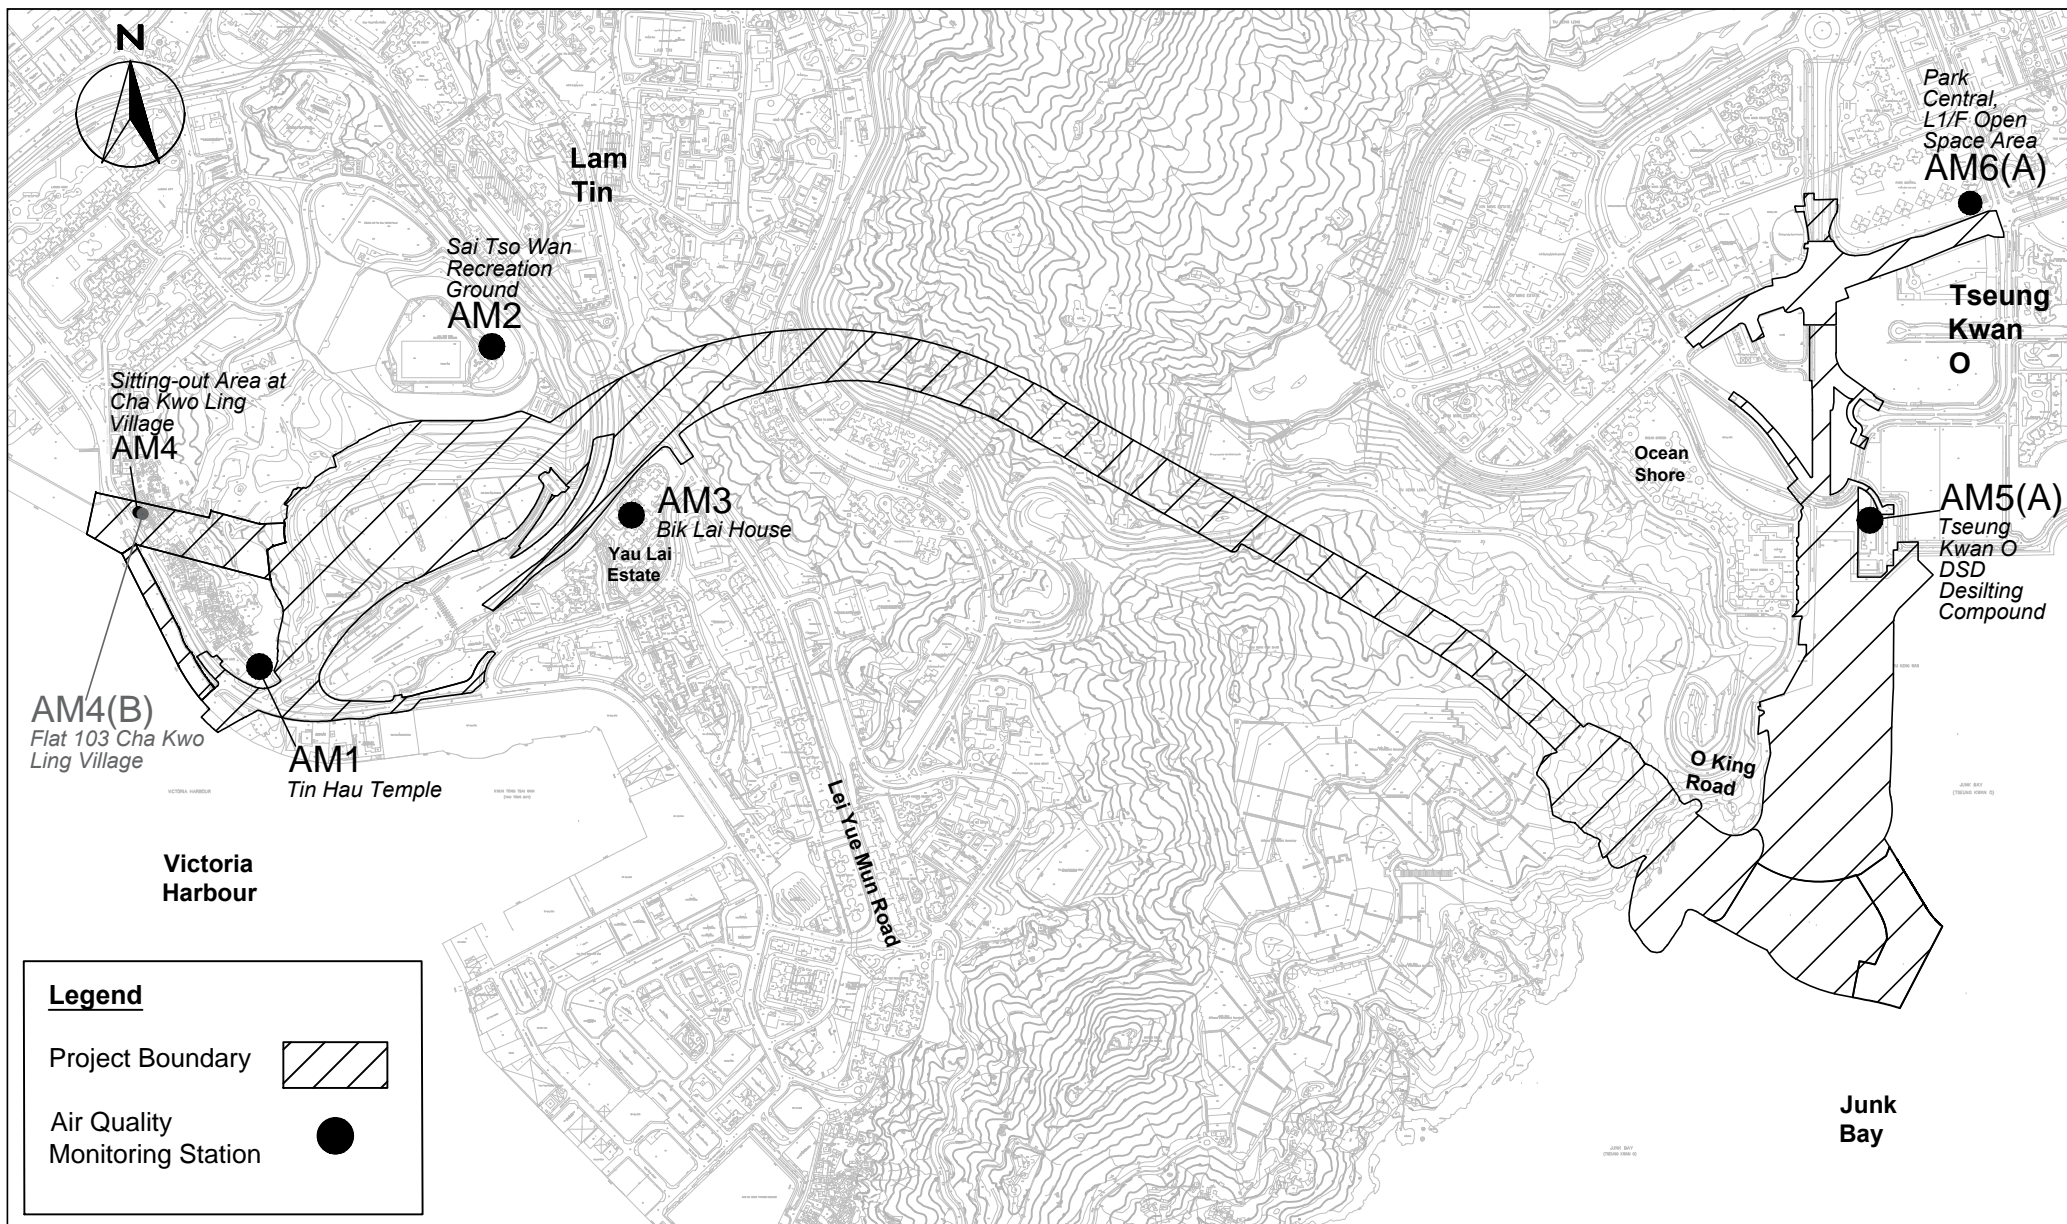
SCALE	1:13000@A4	DATE	2 October 2022
CHECK	CC	DRAWN	KC
JOB No.	MA16034	FIGURE NO.	2
		REV	-

Air Quality Monitoring Station

- 3.3 High Volume Samplers (HVS) were used to carry out 24-hour TSP monitoring. Direct reading dust meter were also used to measure 1-hour average TSP levels. The 1-hour sampling was determined periodically by HVS to check the validity and accuracy of the results measured by direct reading method.
- 3.4 Wind data monitoring equipment was set at rooftop (about 41/F) of Yau Lai Estate Bik Lai House for logging wind speed and wind direction such that the wind sensors are clear of obstructions or turbulence caused by building. The wind data monitoring equipment is re-calibrated at least once every six months and the wind directions are divided into 16 sectors of 22.5 degrees each. The location is shown in **Figure 2**.

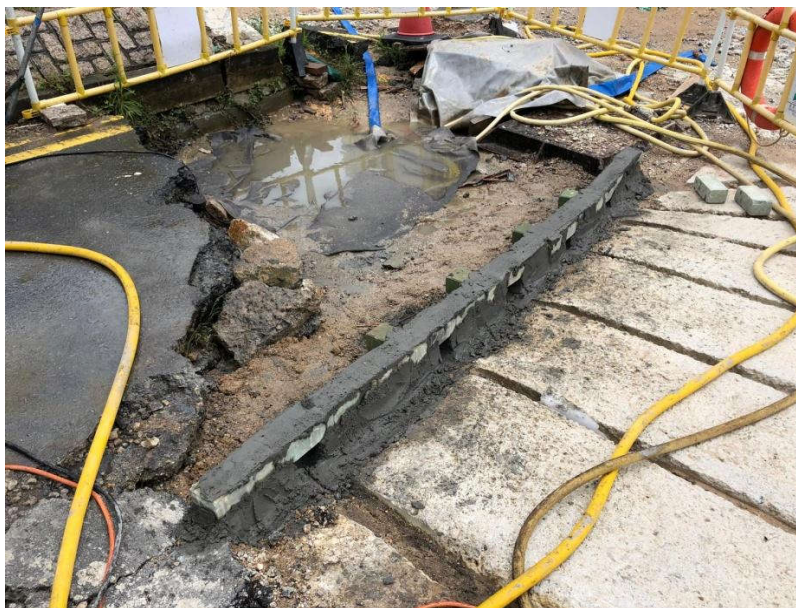
Surface runoff collection

Height difference between the road and site area to form a natural flow. Sump pit was provided for wastewater collection.

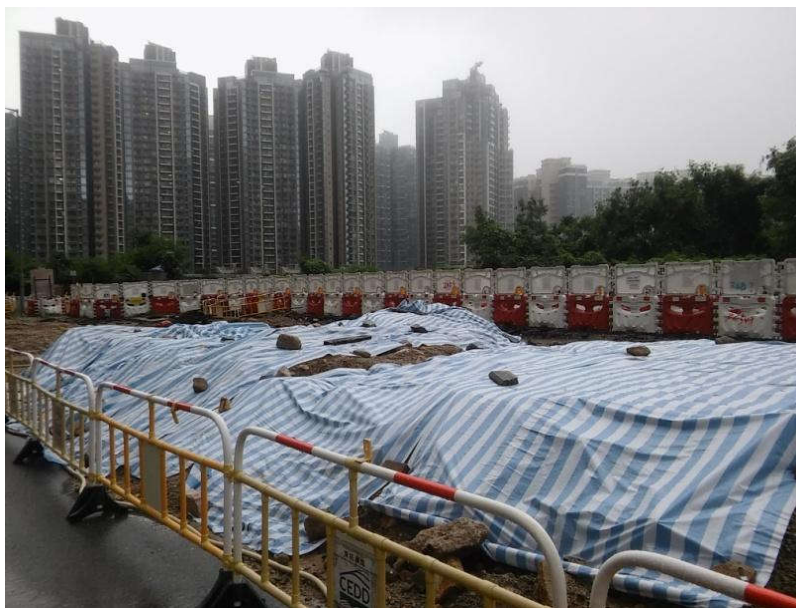
Stockpile Cover

Stockpile Should be proper cover with tarpaulin.

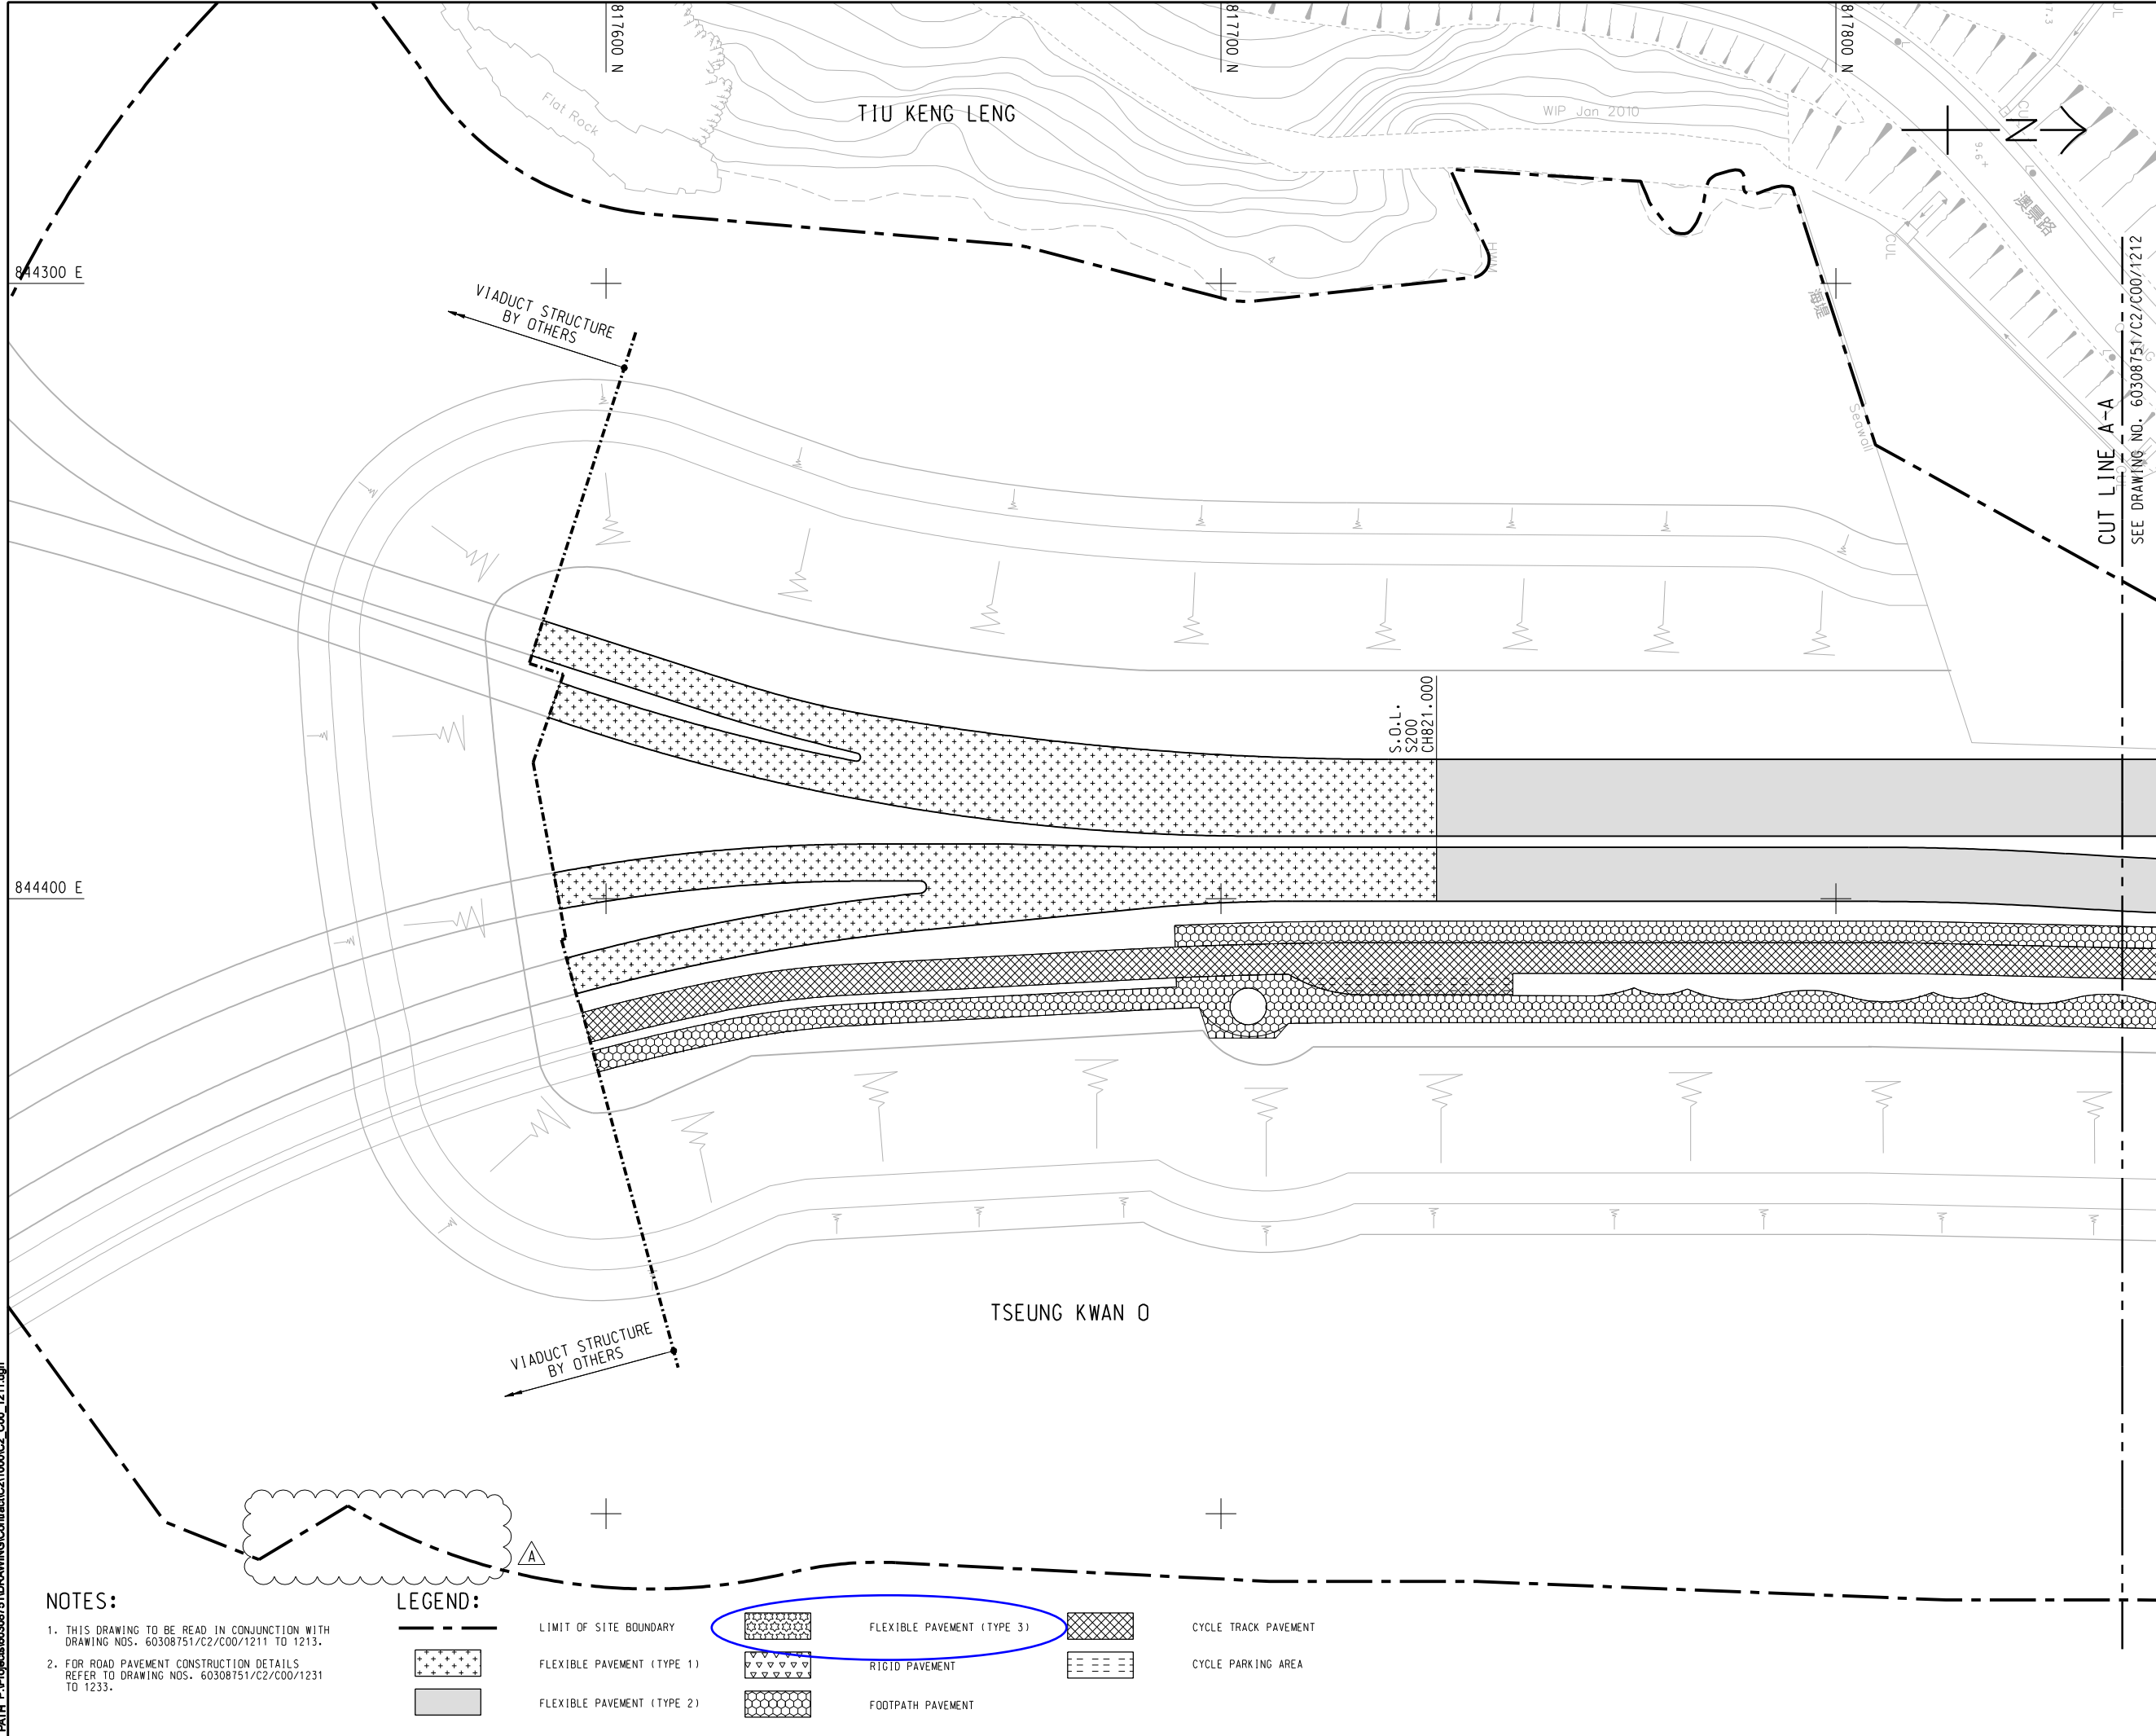
SHEET NUMBER
60308751/C2/C00/1211B

- NOTES:
- THIS DRAWING TO BE READ IN CONJUNCTION WITH DRAWING NOS. 60308751/C2/C00/1211 TO 1213.
 - FOR ROAD PAVEMENT CONSTRUCTION DETAILS REFER TO DRAWING NOS. 60308751/C2/C00/1231 TO 1233.

SHEET TITLE
ROAD PAVEMENT LAYOUT

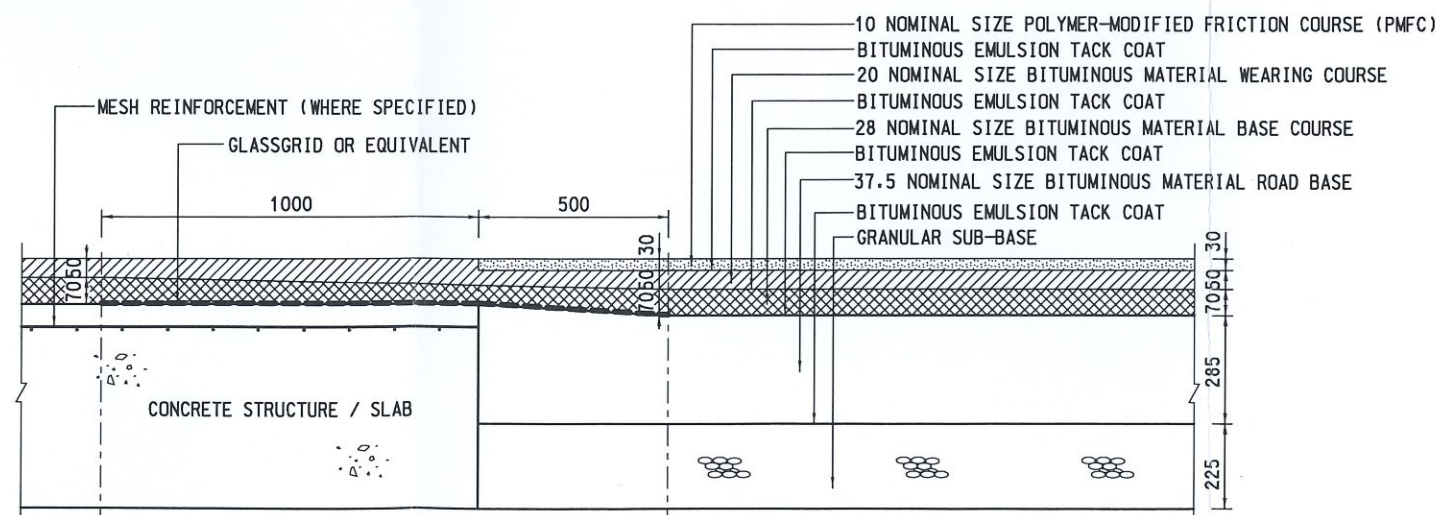
TRANSITION DETAILS BETWEEN FLEXIBLE PAVEMENT ON STRUCTURE AND FLEXIBLE PAVEMENT AT-GRADE
N.T.S.

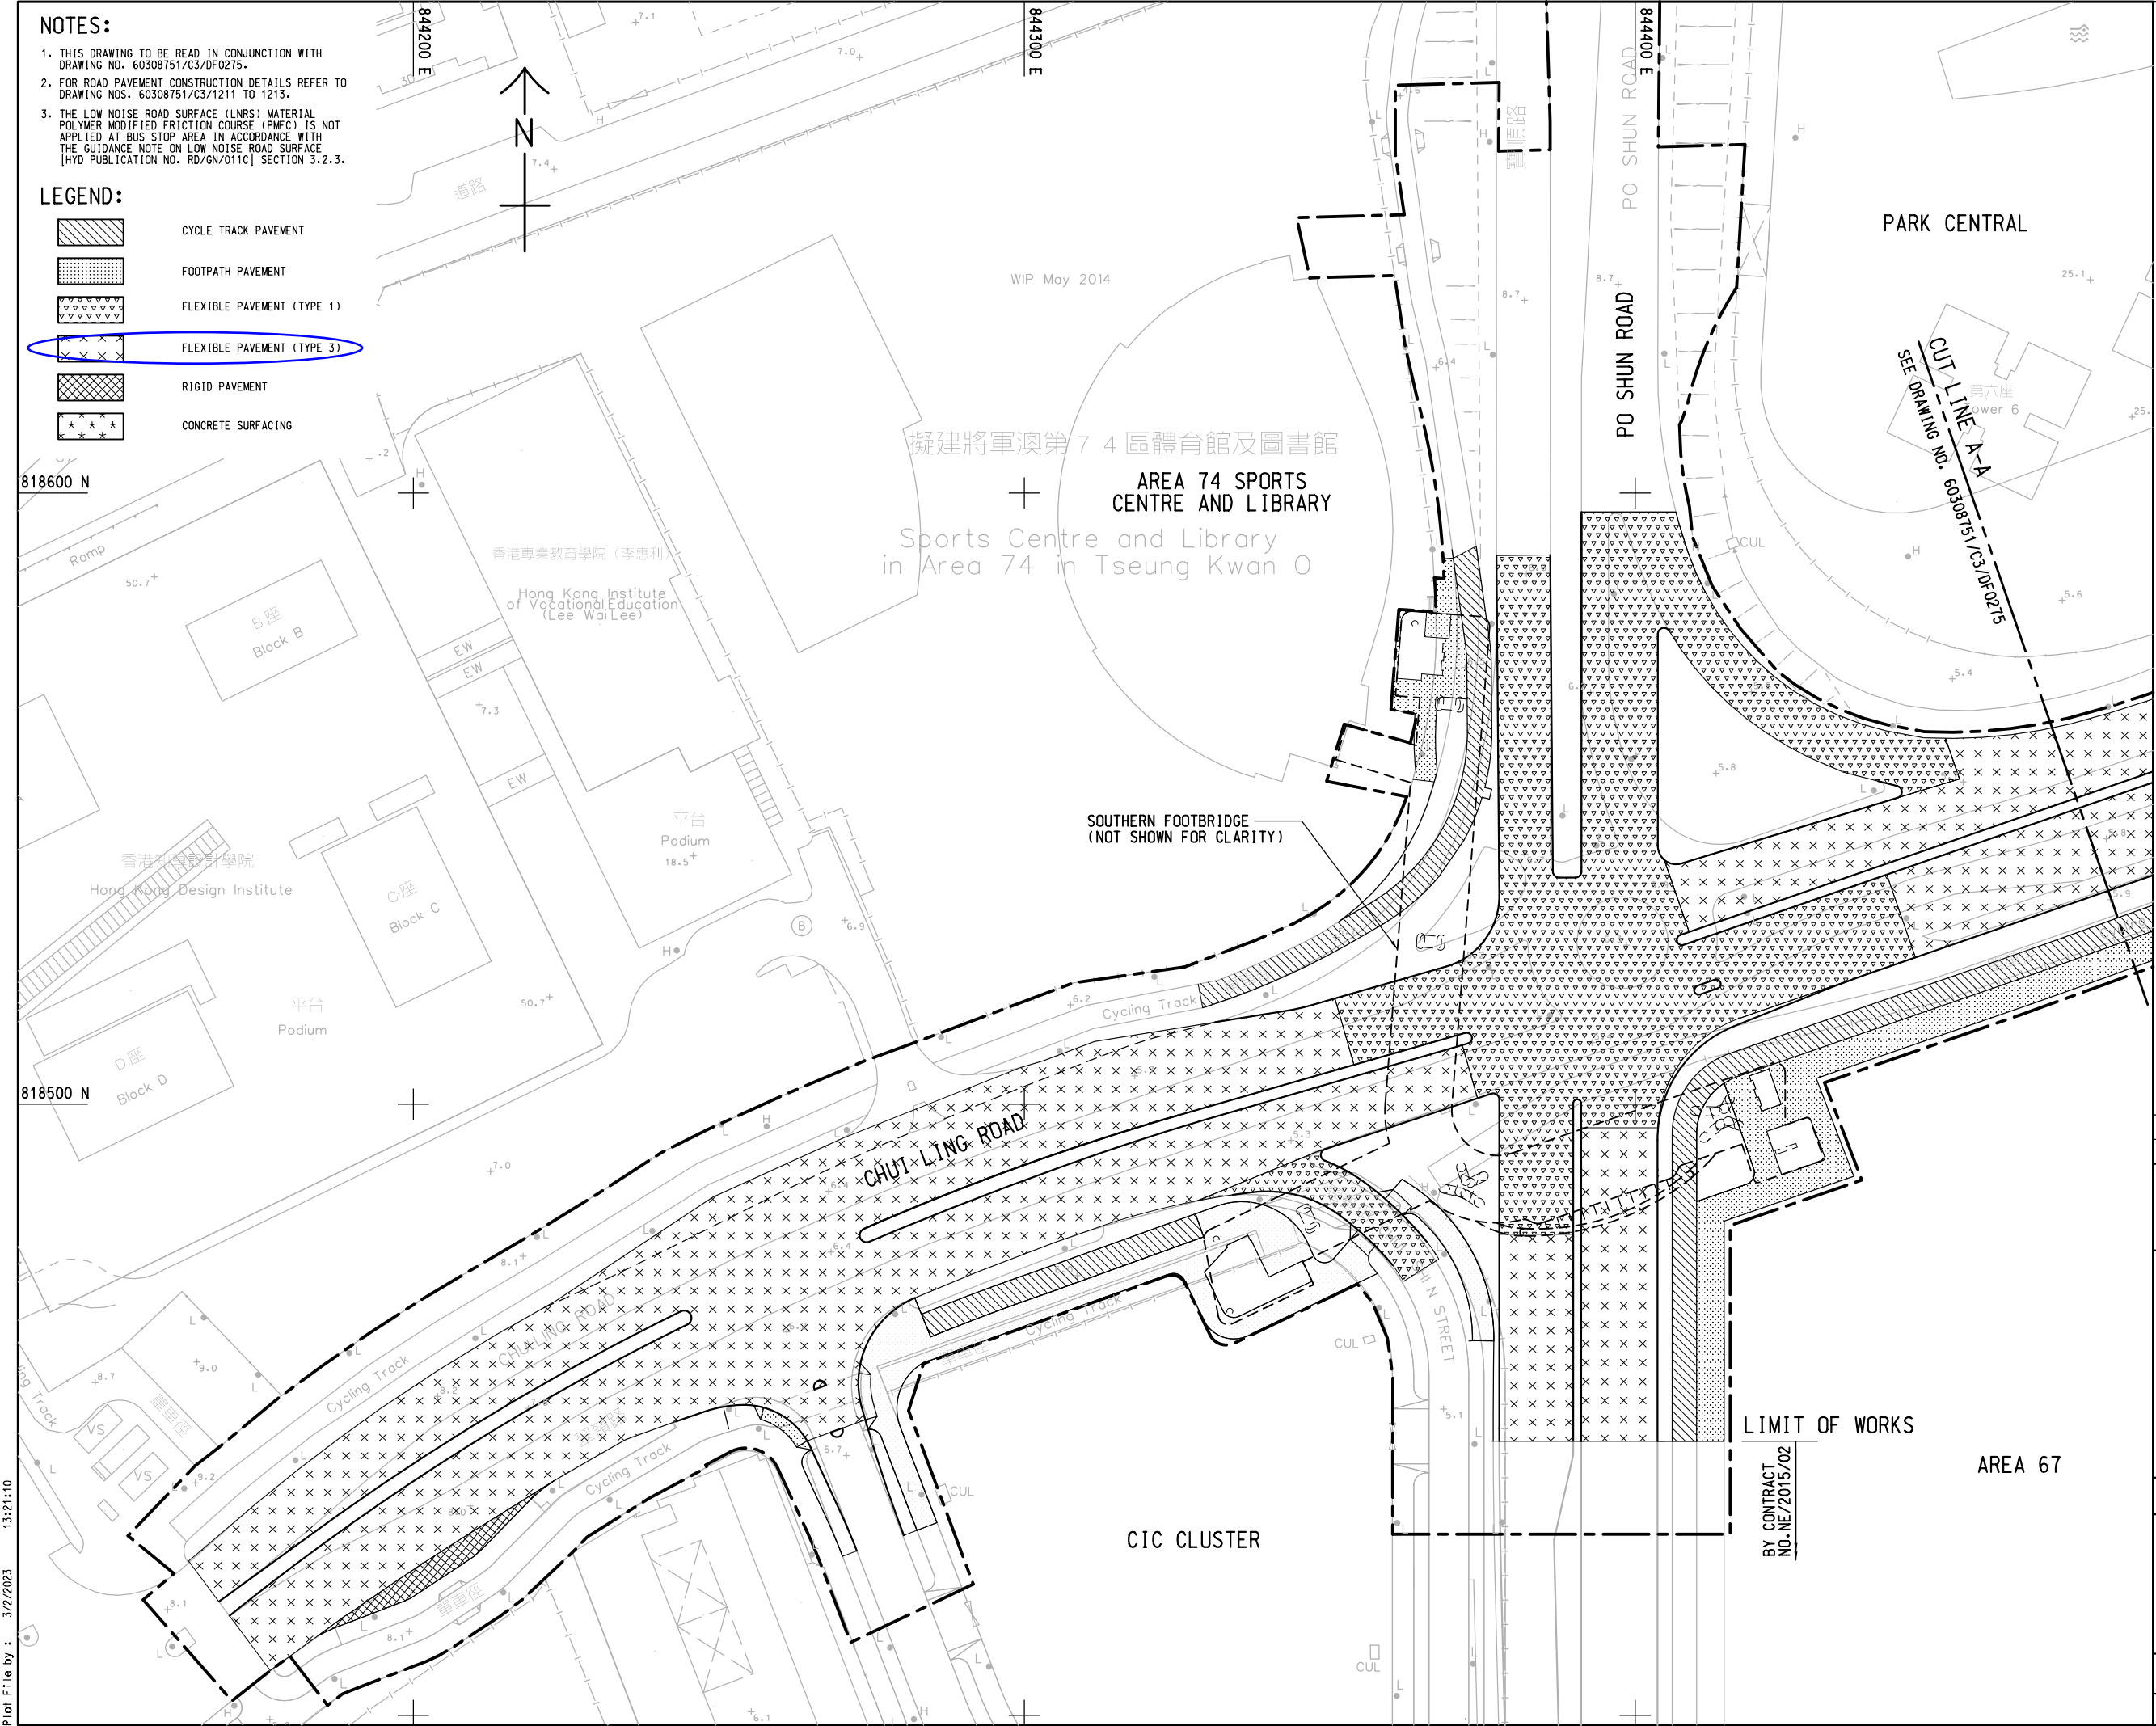
- NOTES:
1. THIS DRAWING TO BE READ IN CONJUNCTION WITH DRAWING NO. 60308751/C3/DF0275.
 2. FOR ROAD PAVEMENT CONSTRUCTION DETAILS REFER TO DRAWING NOS. 60308751/C3/1211 TO 1213.
 3. THE LOW NOISE ROAD SURFACE (LNRS) MATERIAL POLYMER MODIFIED FRICTION COURSE (PMFC) IS NOT APPLIED AT BUS STOP AREA IN ACCORDANCE WITH THE GUIDANCE NOTE ON LOW NOISE ROAD SURFACE [HYD PUBLICATION NO. RD/GN/011C] SECTION 3.2.3.

KEY PLAN	
CONTRACT NO. NE/2017/02	
TSEUNG KWAN O - LAM TIN TUNNEL - ROAD P2/D4 AND ASSOCIATED WORKS	
ROAD PAVEMENT LAYOUT	
SHEET 1 OF 2	
SKETCH NO. 60308751/C3/DF0274	REV. -
EXTRACTED FROM DRG. NO. 60308751/C3/1201	SCALE 1:1000(A3)

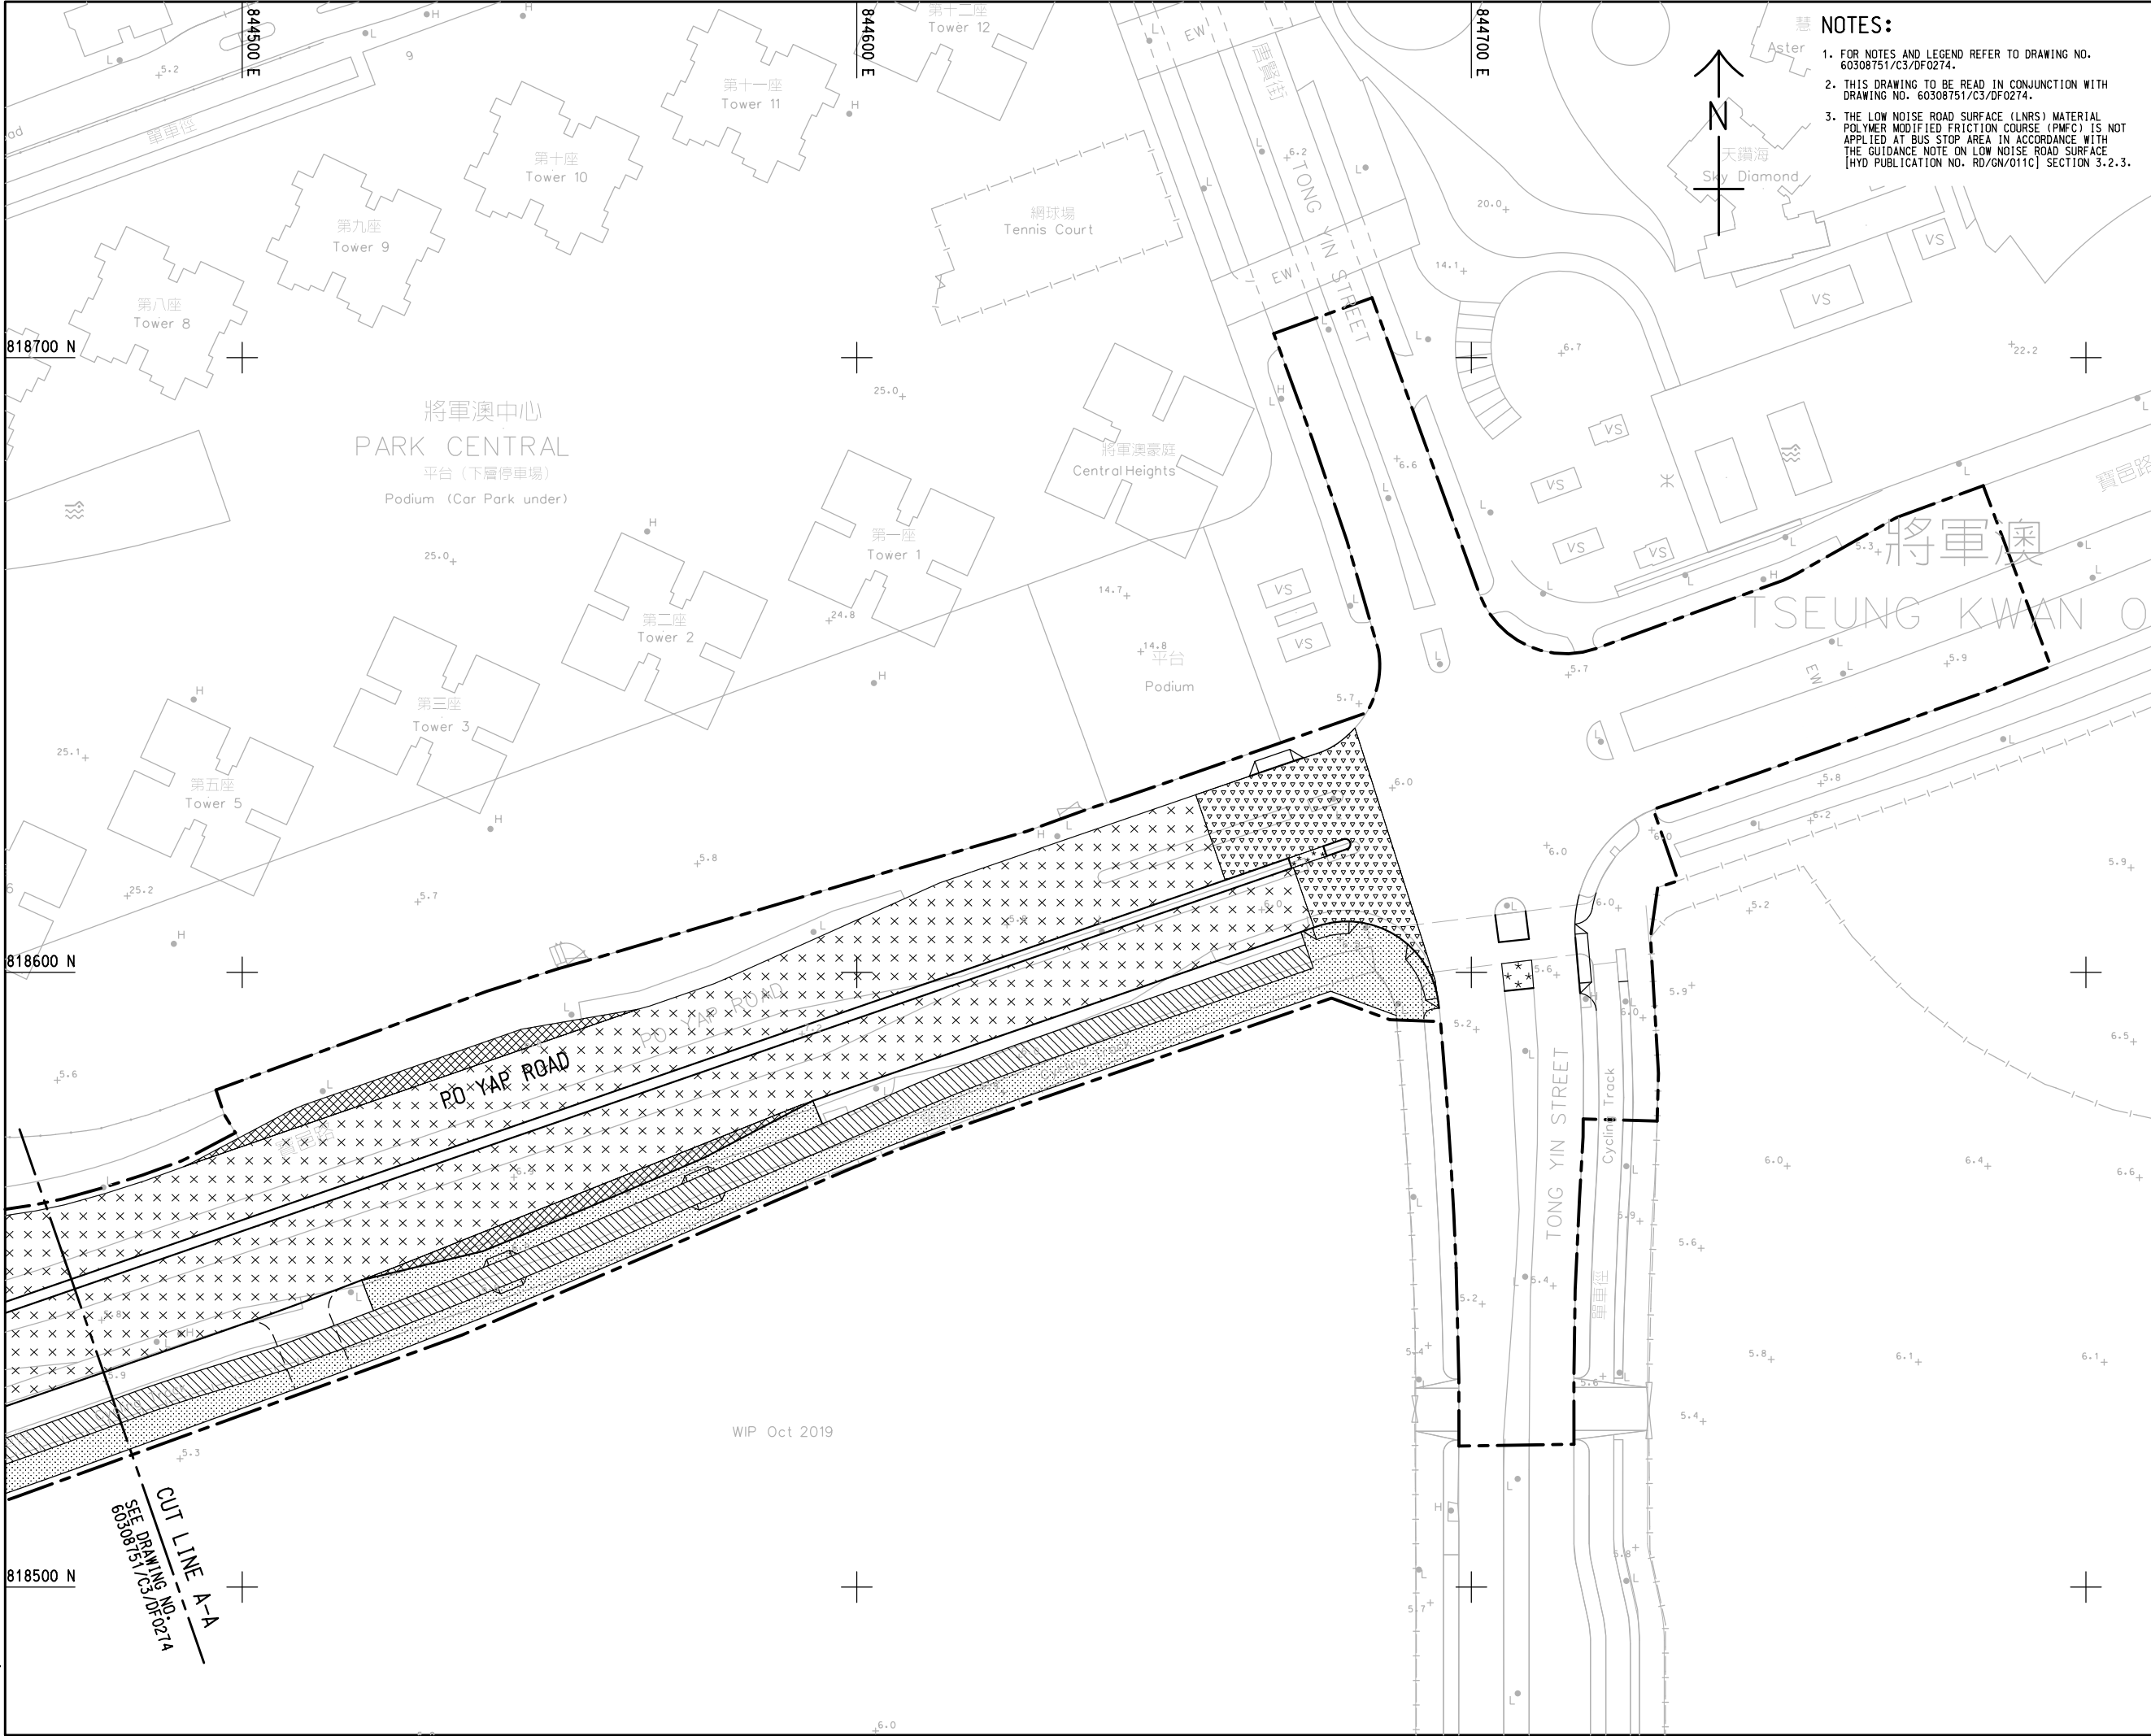
- NOTES:
1. FOR NOTES AND LEGEND REFER TO DRAWING NO. 60308751/C3/DF0274.
 2. THIS DRAWING TO BE READ IN CONJUNCTION WITH DRAWING NO. 60308751/C3/DF0274.
 3. THE LOW NOISE ROAD SURFACE (LNRS) MATERIAL POLYMER MODIFIED FRICTION COURSE (PMFC) IS NOT APPLIED AT BUS STOP AREA IN ACCORDANCE WITH THE GUIDANCE NOTE ON LOW NOISE ROAD SURFACE [HYD PUBLICATION NO. RD/GN/011C] SECTION 3.2.3.
