# Civil Engineering and Development Department

**Agreement No. CE 59/2015 (EP)  
Environmental Team for  
Tseung Kwan O – Lam Tin Tunnel  
Design and Construction**

**Monthly Environmental Monitoring and  
Audit Report for  
November 2023  
(Version 1.0)**

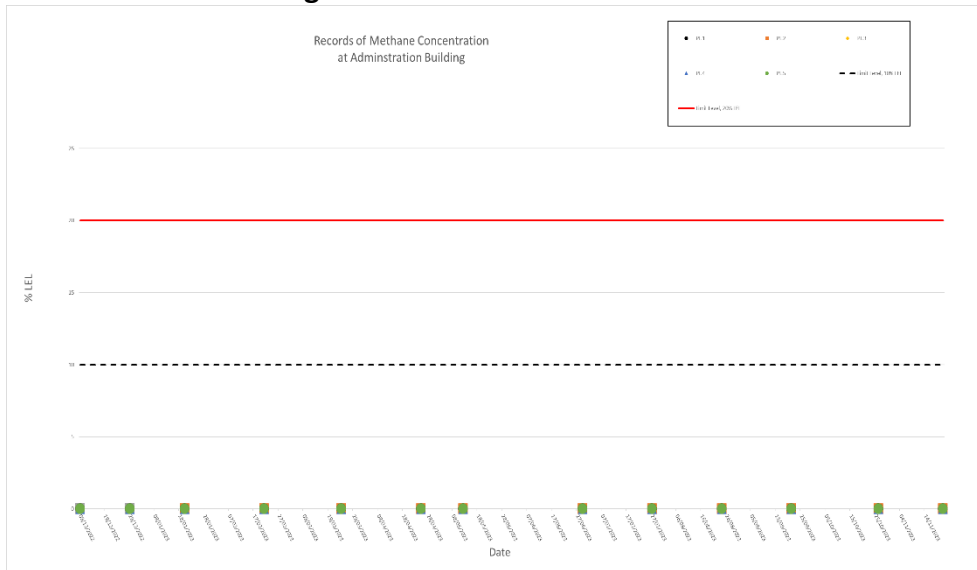
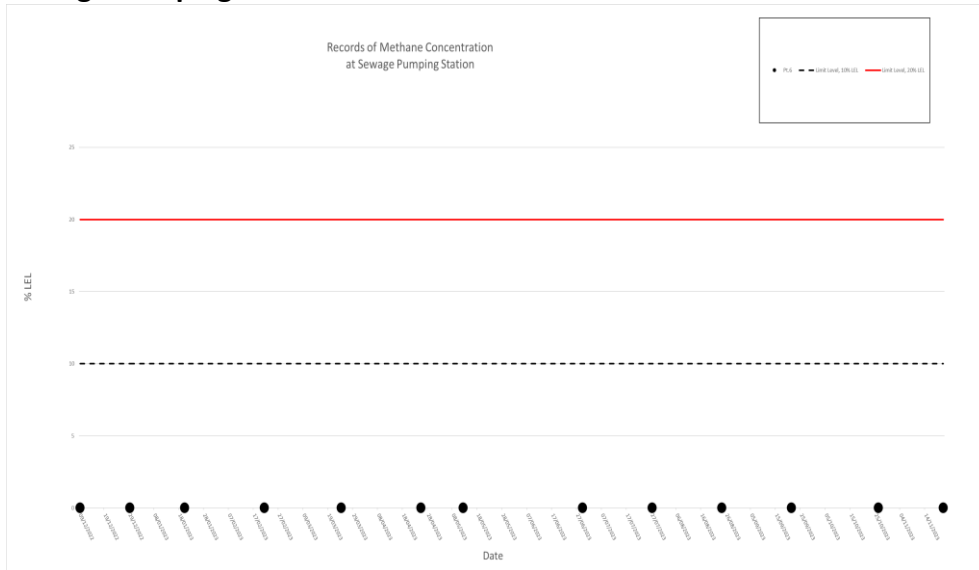
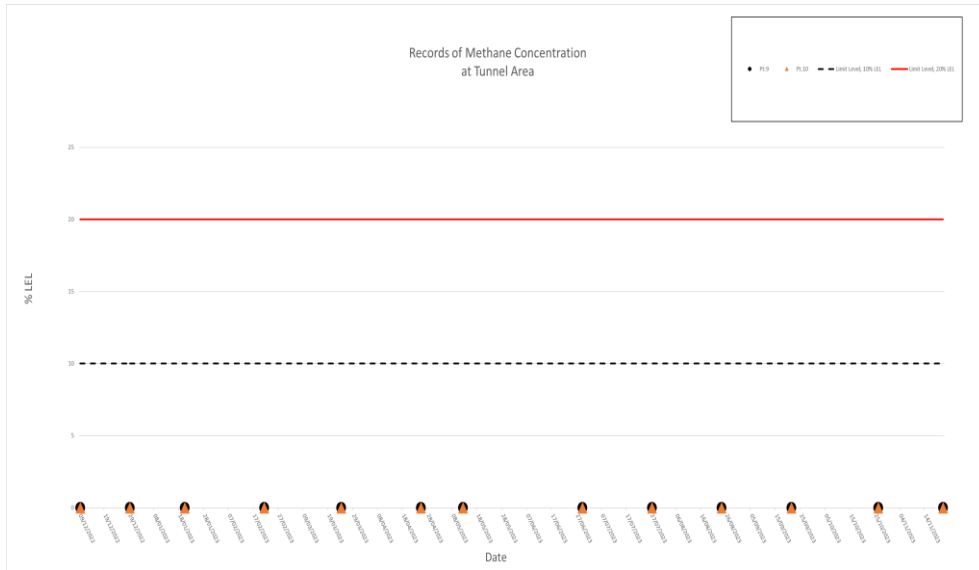
The landfill gas measurement was conducted on 21<sup>st</sup> November 2023. No exceedance of limit level was observed in the Administration Building, Sewage Pumping Station, Stormwater Pumping Station, West Ventilation Building and the tunnel area at Lam Tin. The overall condition was in compliance during the reporting month.
