**Agreement No. CE 59/2015 (EP)  
Environmental Team for  
Tseung Kwan O – Lam Tin Tunnel  
Design and Construction**

**Quarterly Environmental  
Monitoring and Audit Report –  
May 2021 – July 2021**

**(version 2.0)**

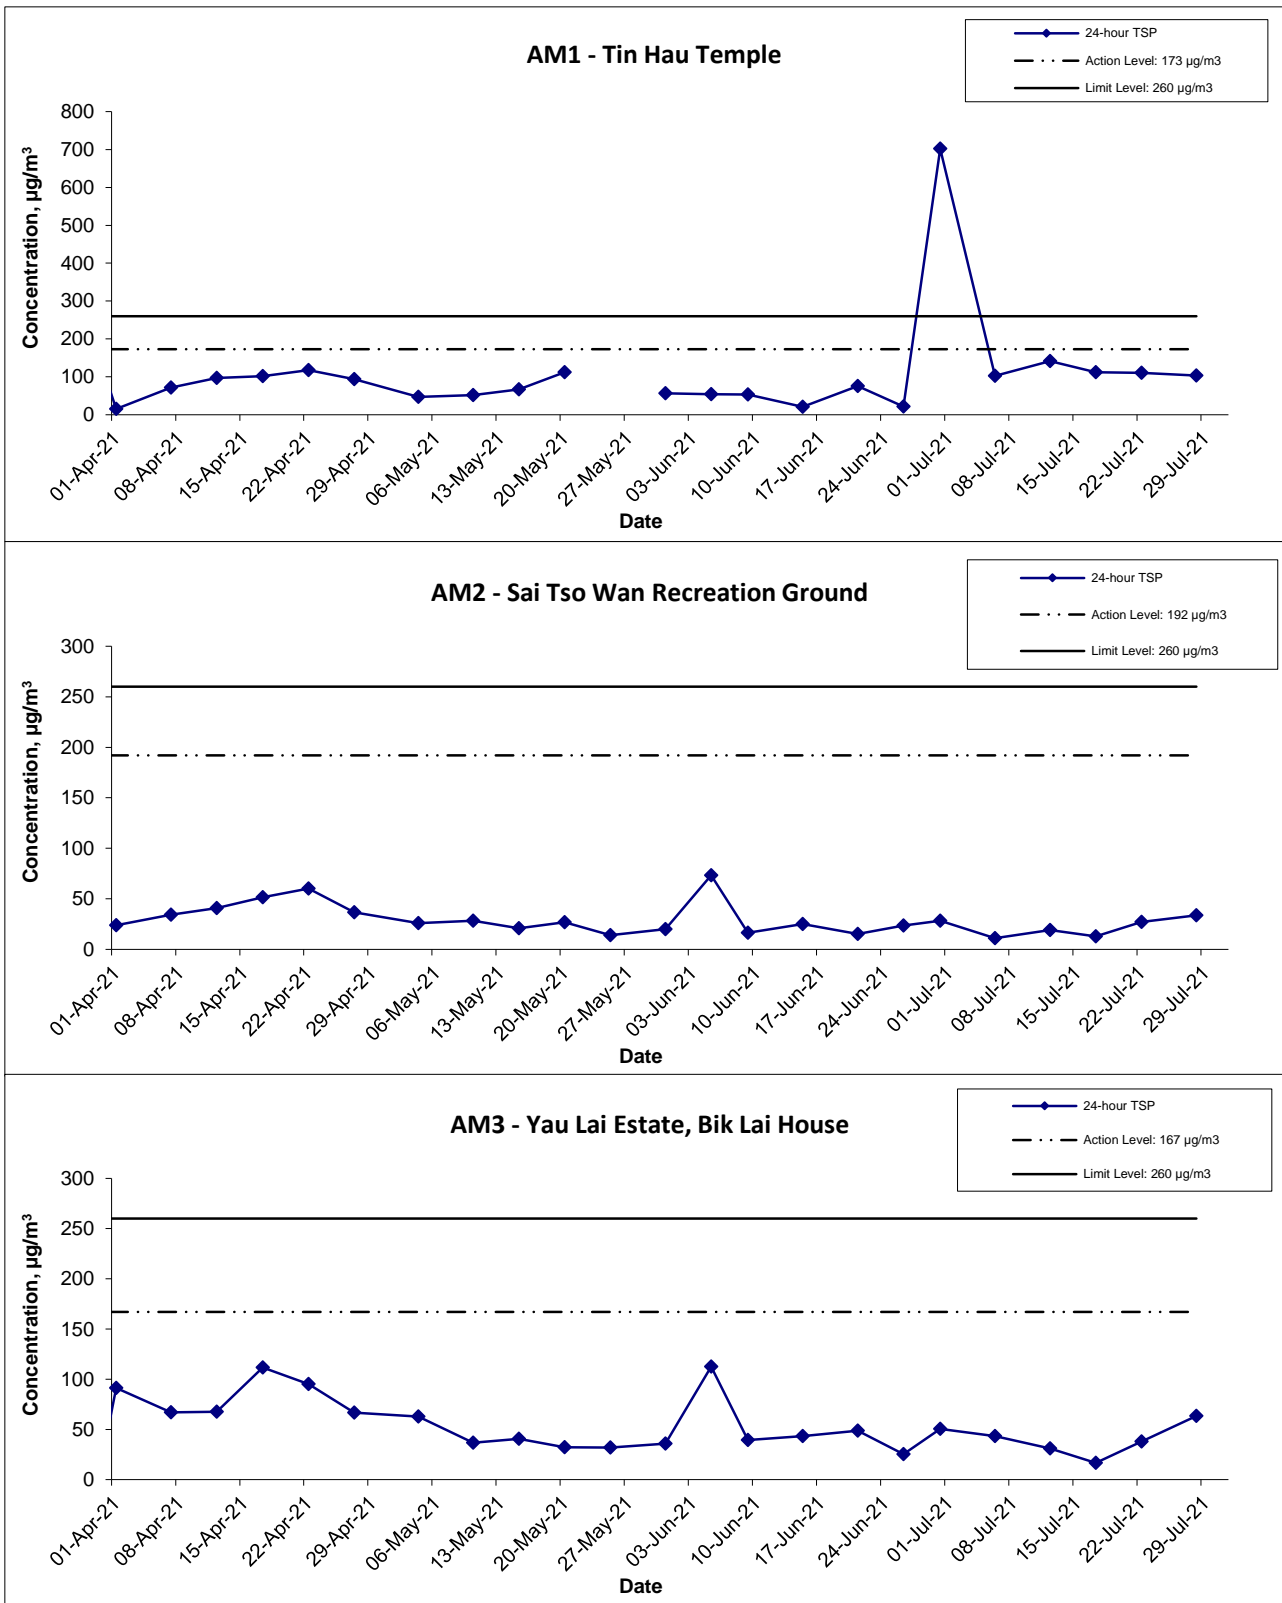
### 24-hr TSP Concentration Levels

\*No electricity supply due the Tin Hau Temple's renovation works on 25 May 2021.

Agreement No. CE/59/2015 (EP) Environmental Team for Tseung Kwan O - Lam Tin Tunnel - Design and Construction  Graphical Presentation of 24-hour TSP Monitoring Results	Scale	N.T.S	Project No.	MA16034	
	Date	Aug-21	Appendix	F

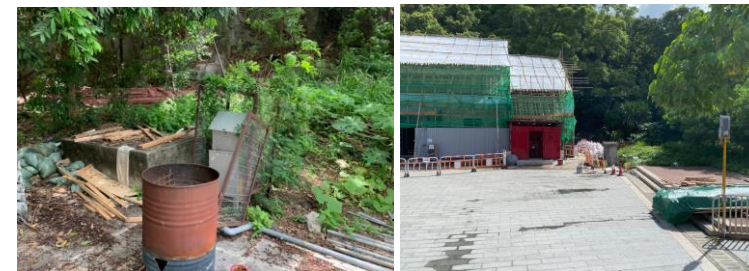
The exceedance was considered as non-project related:

- According to our field observation, renovation works of Tin Hau Temple was operating during the monitoring period (As shown in photo).

**Part B – Conclusion:** The exceedance of the air quality limit level for 24-hour TSP monitoring was not related to the Project.

**Part C – Recommendation:** N/A.

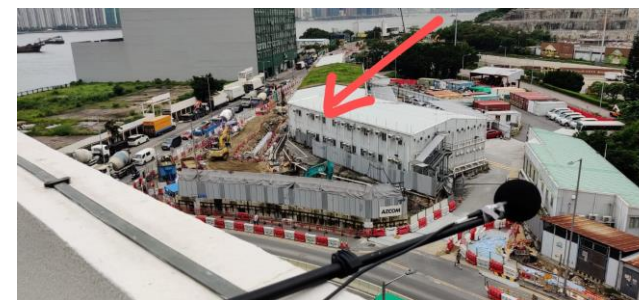
The exceedance was considered related to the Project works:

- According to our field observation, breaking noise was identified as the dominant noise source (as shown in photo).
- Apart from the breaker, road traffic and excavator were observed during the monitoring.

**Part B – Conclusion:** The exceedance of daytime noise limit levels was related to the Project.

**Part C – Recommendation:** Daytime noise exceedance was recorded despite noise barrier had been erected near the breaker. The contractor is reminded to strictly follow approved CNMP and show enhancement at Portion WA2a.
