**Agreement No. CE 59/2015 (EP)
Environmental Team for
Tseung Kwan O – Lam Tin Tunnel
Design and Construction**

**Quarterly Environmental
Monitoring and Audit Report –
November 2021 – January 2022**

Quarterly Environmental Monitoring and Audit Report for November 2021 to January 2022

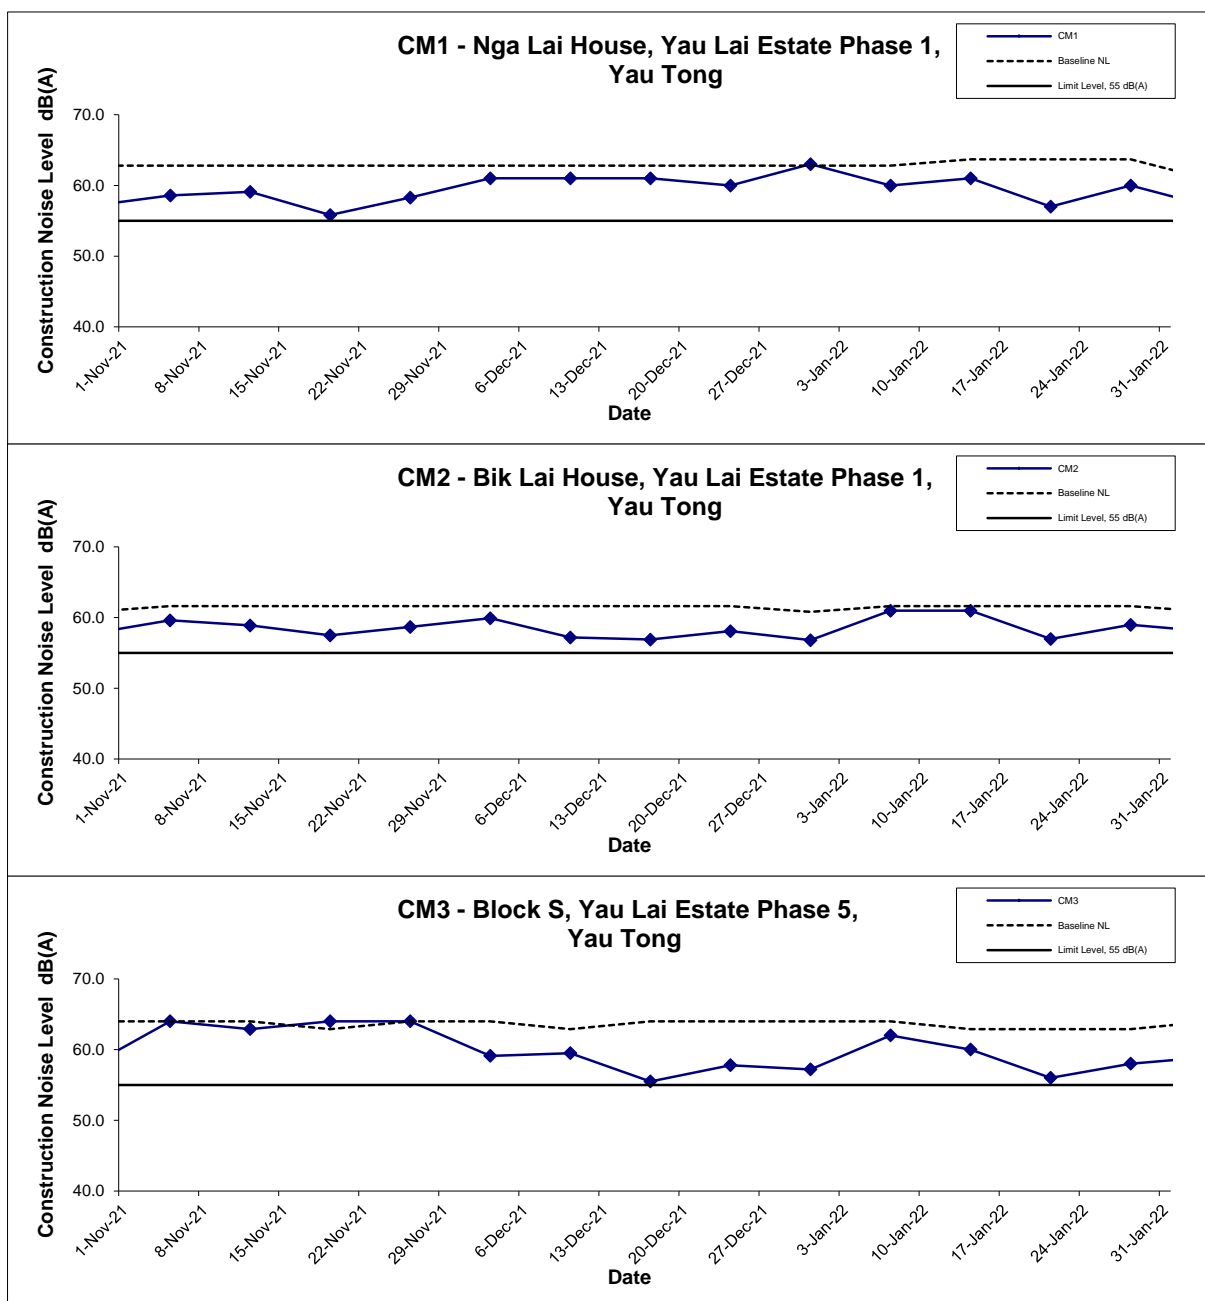
Noise Levels (Restricted Hours - 2300-0700 on normal weekdays)

Title Agreement No. CE/59/2015 (EP)
 Environmental Team for Tseung Kwan O - Lam Tin Tunnel -
 Design and Construction
 Graphical Presentation of Restricted Noise Monitoring Results
