# Civil Engineering and Development Department

**Agreement No. CE 59/2015 (EP)  
Environmental Team for  
Tseung Kwan O – Lam Tin Tunnel  
Design and Construction**

**Quarterly Environmental  
Monitoring and Audit Report –  
November 2022 – January 2023**

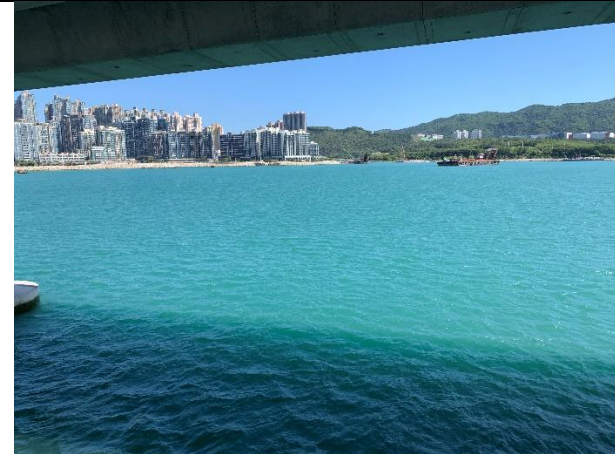
Photo 4 (Recorded on 21 November 2022)

During regular water quality monitoring, the sea appears to be clear in general (Photo 4). No obvious muddy water was observed during the monitoring.

Dive inspection shall be conducted regularly to ensure the condition of the silt curtain. Good site practices such as the provision of perimeter cut-off drain to direct off-site water, regular removal of silt and sediment from sediment tanks, and covering open stockpiles shall be conducted as far as possible. Chemicals shall be placed away from the seafront area to prevent accidental leakage.

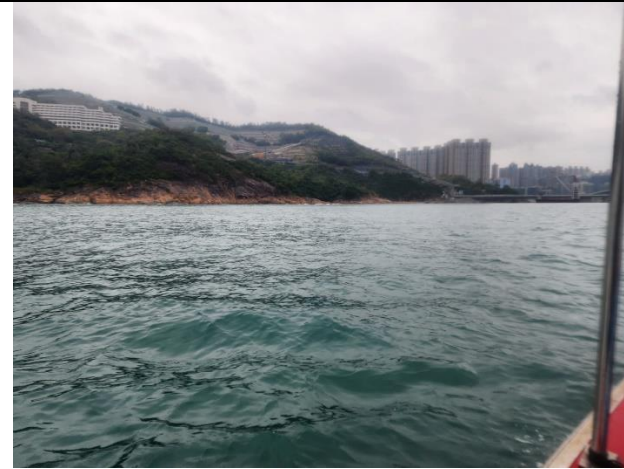
Photo 2 (Recorded on 21 December 2022)

During regular water quality monitoring, the sea appears to be clear in general (Photo 2 & 3). No obvious muddy water was observed during the monitoring.

Dive inspection shall be conducted regularly to ensure the condition of the silt curtain. Good site practices such as the provision of perimeter cut-off drain to direct off-site water, regular removal of silt and sediment from sediment tanks, and covering open stockpiles shall be conducted as far as possible. Chemicals shall be placed away from the seafront area to prevent accidental leakage.

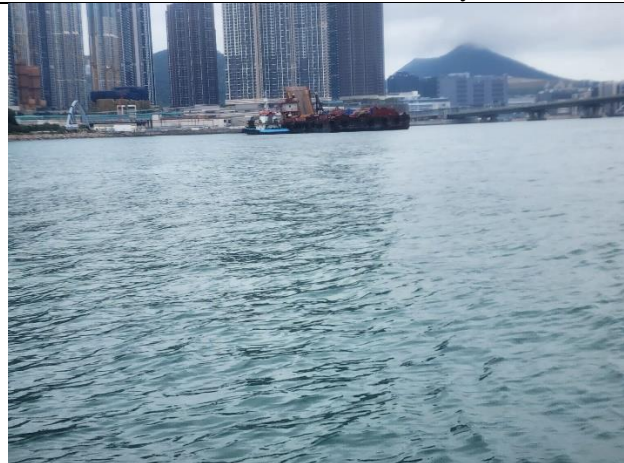
Photo 3 (Recorded on 10 January 2023)

During regular water quality monitoring, the sea appears to be clear in general (Photo 3). No obvious muddy water was observed during the monitoring.

Dive inspection shall be conducted regularly to ensure the condition of the silt curtain. Good site practices such as the provision of perimeter cut-off drain to direct off-site water, regular removal of silt and sediment from sediment tanks, and covering open stockpiles shall be conducted as far as possible. Chemicals shall be placed away from the seafront area to prevent accidental leakage.
