**Shatin to Central Link –  
Tai Wai to Hung Hom Section and  
Mong Kok East to Hung Hom Section**

Monthly EM&A Report No. 74

[Period from 1 to 31 October 2018]

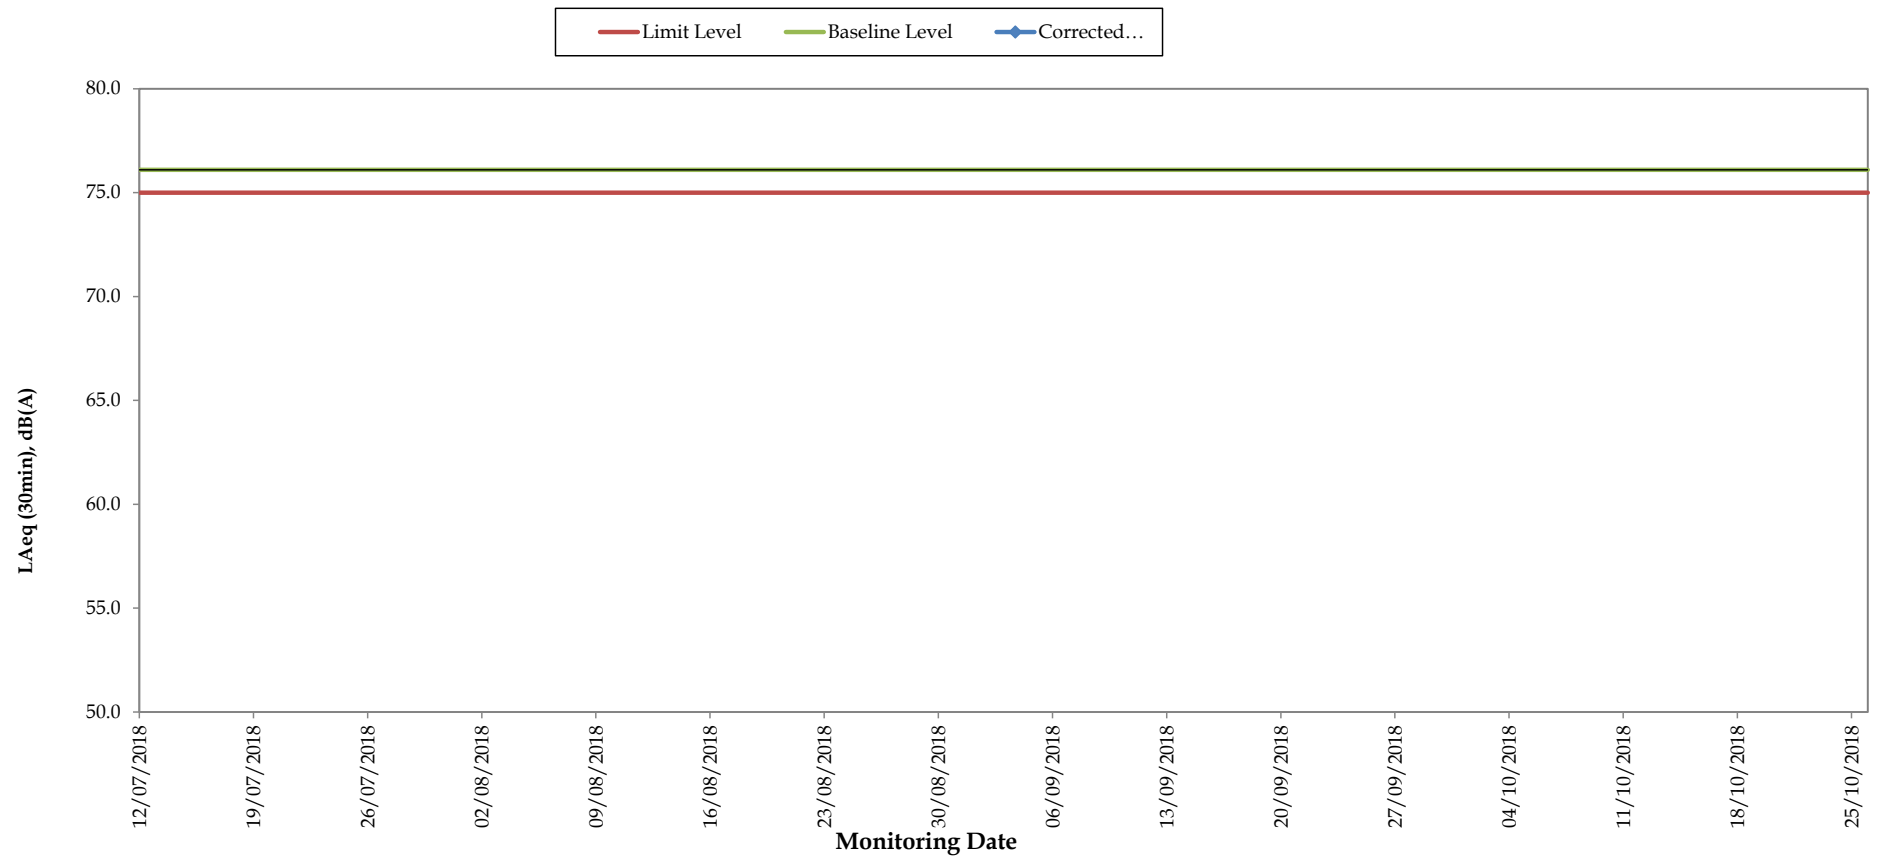
# Regular Noise Monitoring Results at NMS-CA-6 (No. 16-23 Nam Kok Road) (LAeq, 30min) for the Past 4 Months

- For those corrected noise levels that are not shown in this graph, the measured noise levels are equal to or below baseline level.

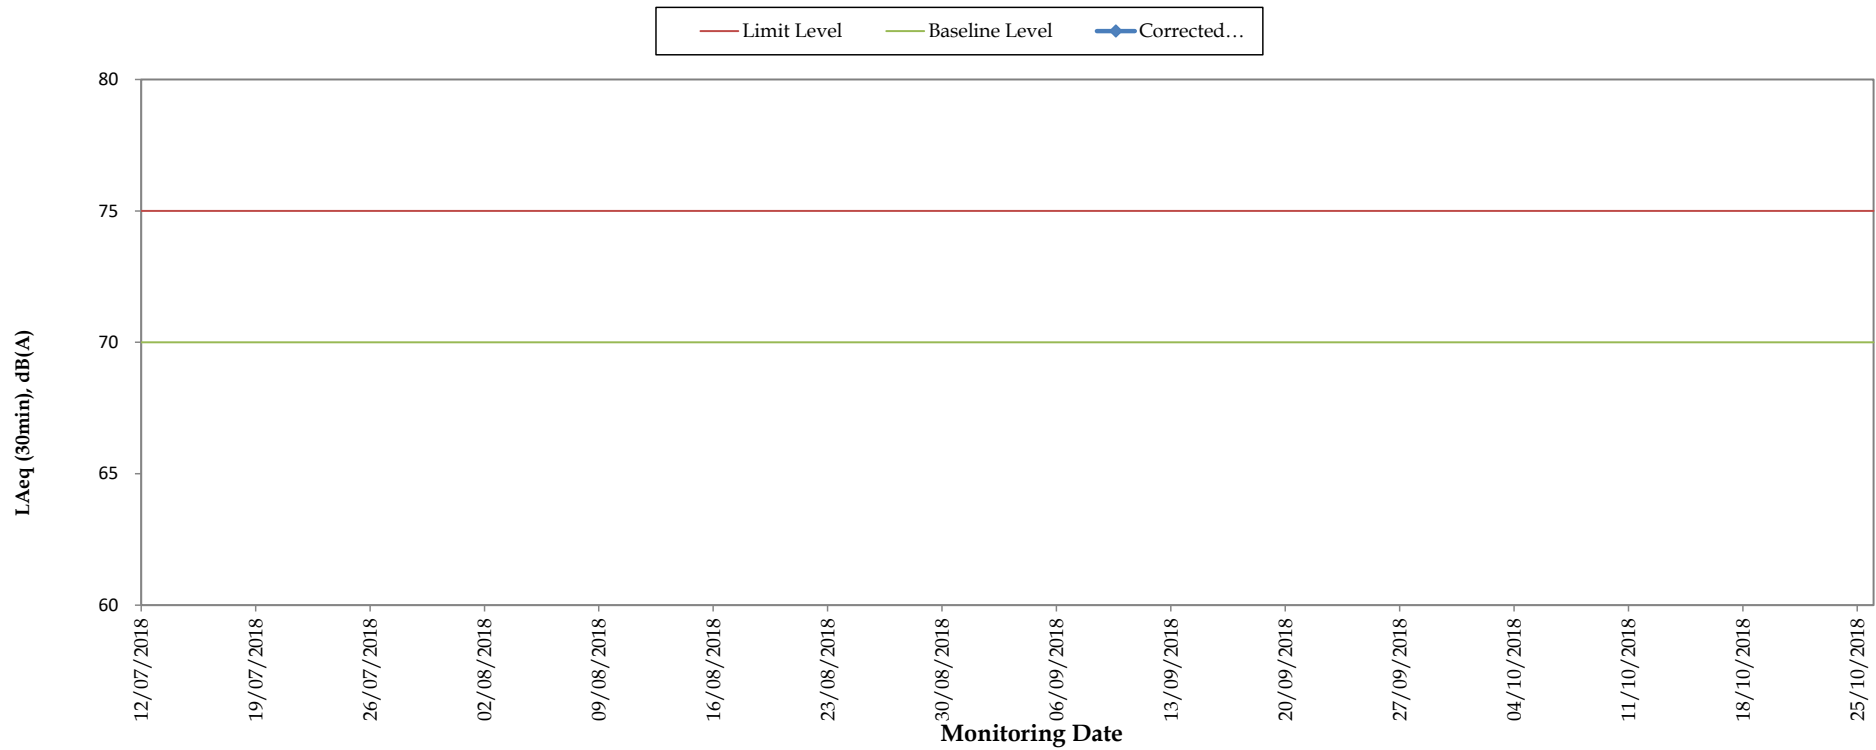
# Regular Noise Monitoring Results at NMS-CA-7 (Skytower Tower 2) (LAeq, 30min) for the Past 4 Months

- For those corrected noise levels that are not shown in this graph, the measured noise level s are equal to or below baseline level.

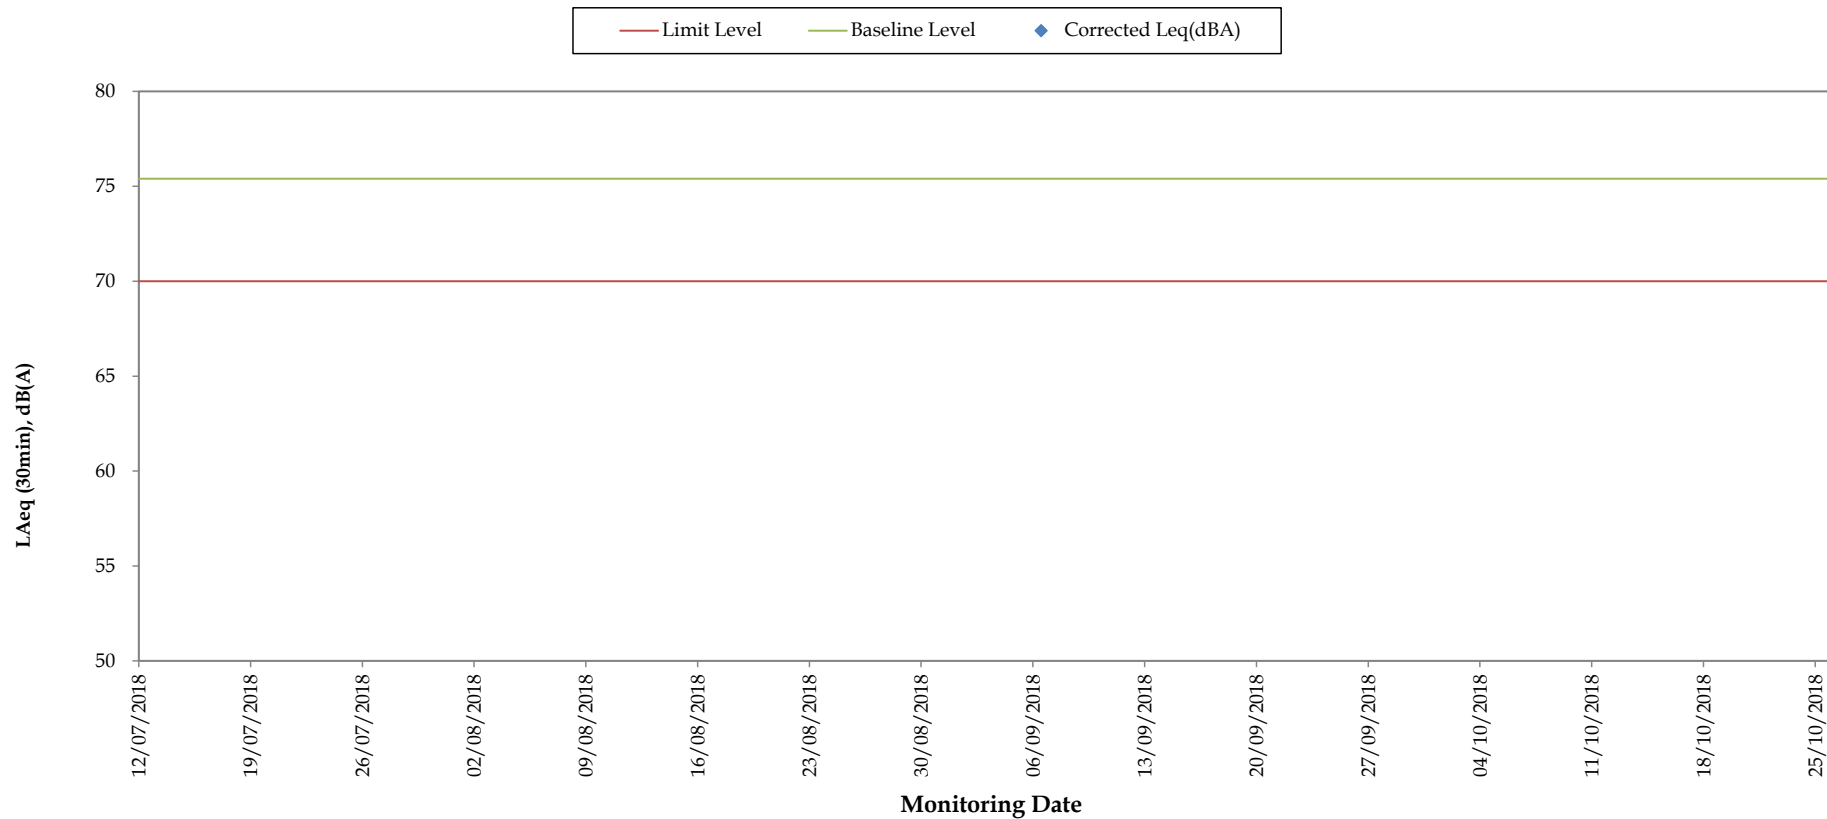
## Regular Noise Monitoring Results at NMS-CA- 8 (SKH Good Shepherd Primary School) (LAeq, 30min) for the Past 4 Months

- For those corrected noise levels that are not shown in this graph, the measured noise levels are equal to or below baseline level.
- The limit level was updated from 78dB(A) to 79 dB(A) on 22 Aug 2013 as per the latest CNMP and CNMMP.
- The limit level was updated from 79dB(A) to 70dB(A)/65dB(A) (during normal/examination period) from April 2016, as the continuous noise monitoring was completed in March 2016 according to the latest CNMP

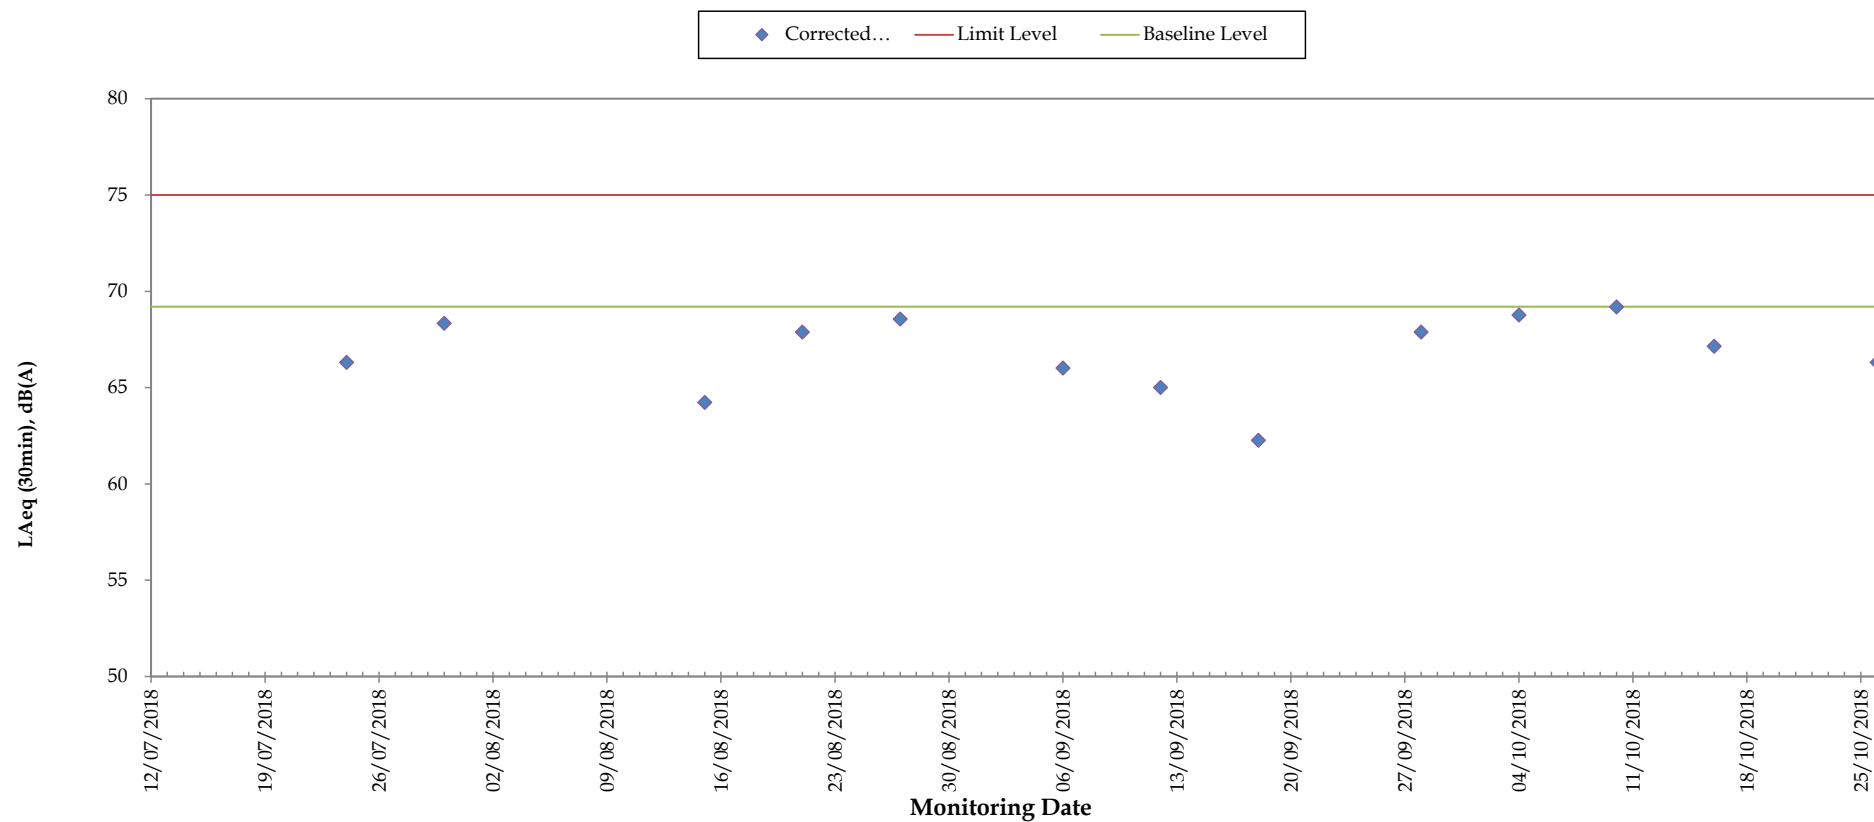
# Regular Noise Monitoring Results at NMS-CA-9 (Kong Yiu Mansion) (LAeq, 30min) ) for the Past 4 Months

- For those corrected noise levels that are not shown in this graph, the measured noise levels are equal to or below baseline level.

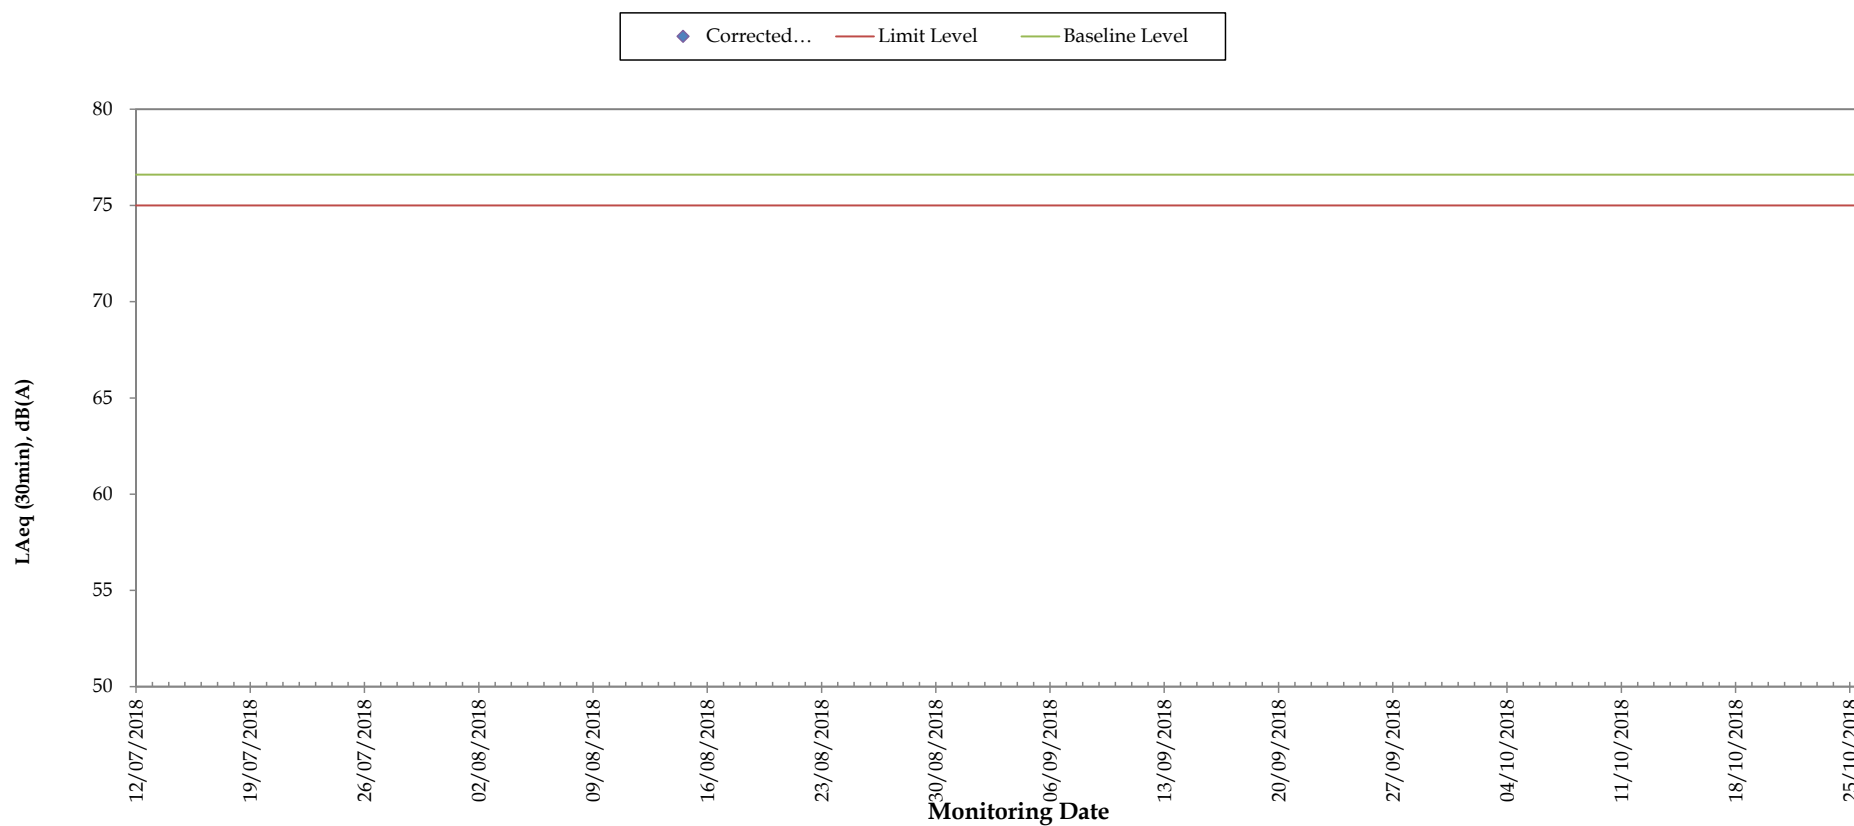
# Regular Noise Monitoring Results at NMS-CA-10 (Chat Ma Mansion) (LAeq, 30min) for the Past 4 Months

- For those corrected noise levels that are not shown in this graph, the measured noise levels are equal to or below baseline level.
