**Shatin to Central Link –
Tai Wai to Hung Hom Section and
Mong Kok East to Hung Hom Section**

Monthly EM&A Report No. 75

[Period from 1 to 30 November 2018]

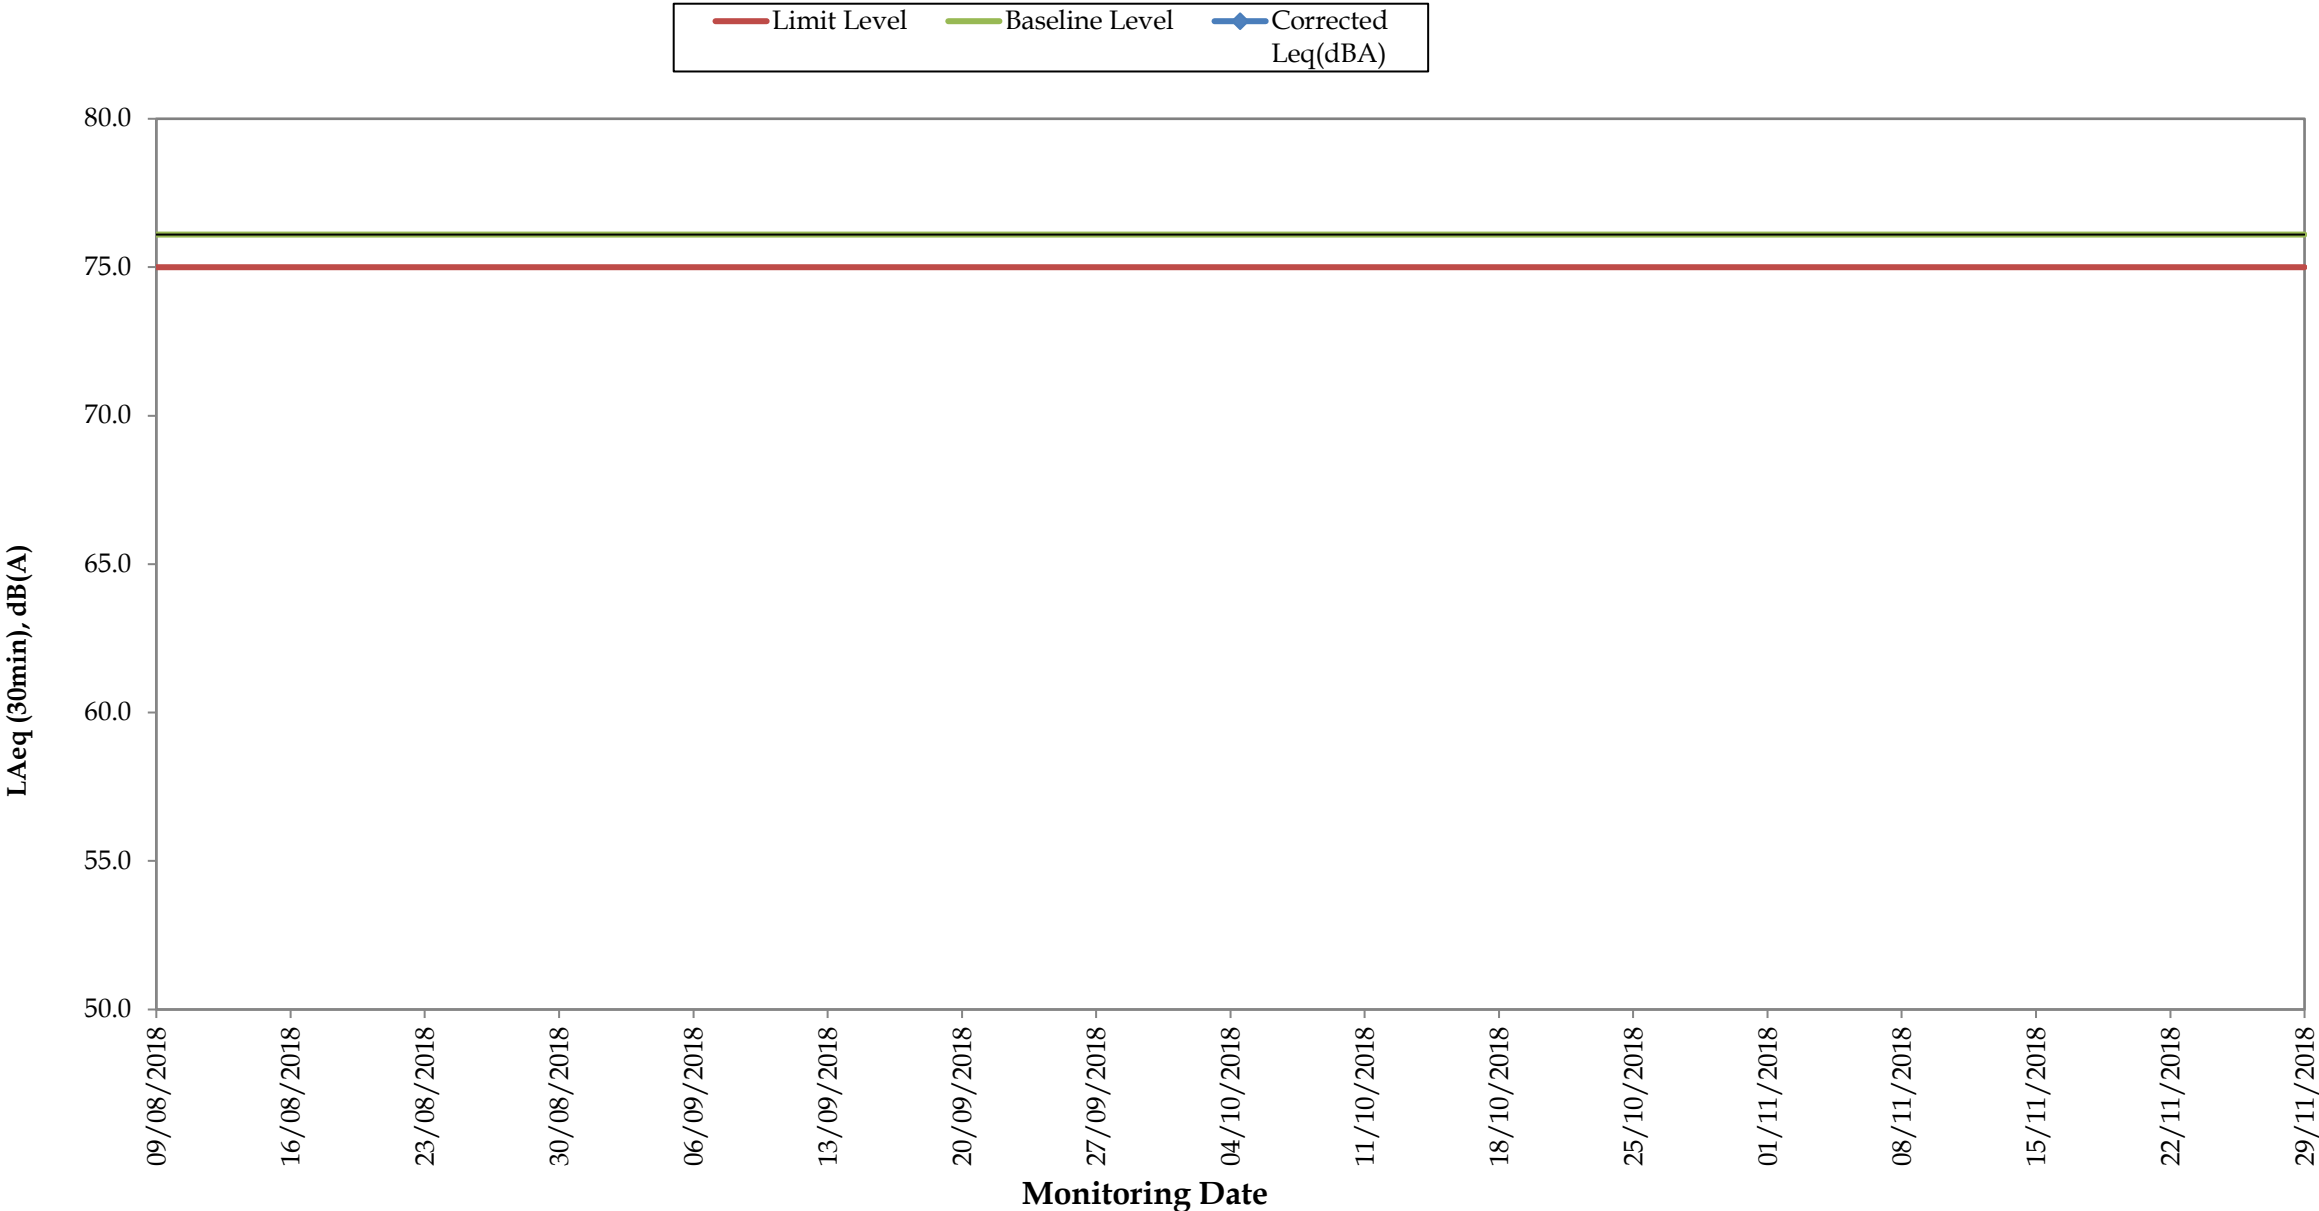
**Regular Noise Monitoring Results at NMS-CA-6 (No. 16-23 Nam Kok Road) (LAeq, 30min)
for the Past 4 Months**

- For those corrected noise levels that are not shown in this graph, the measured noise level s are equal to or below baseline level.

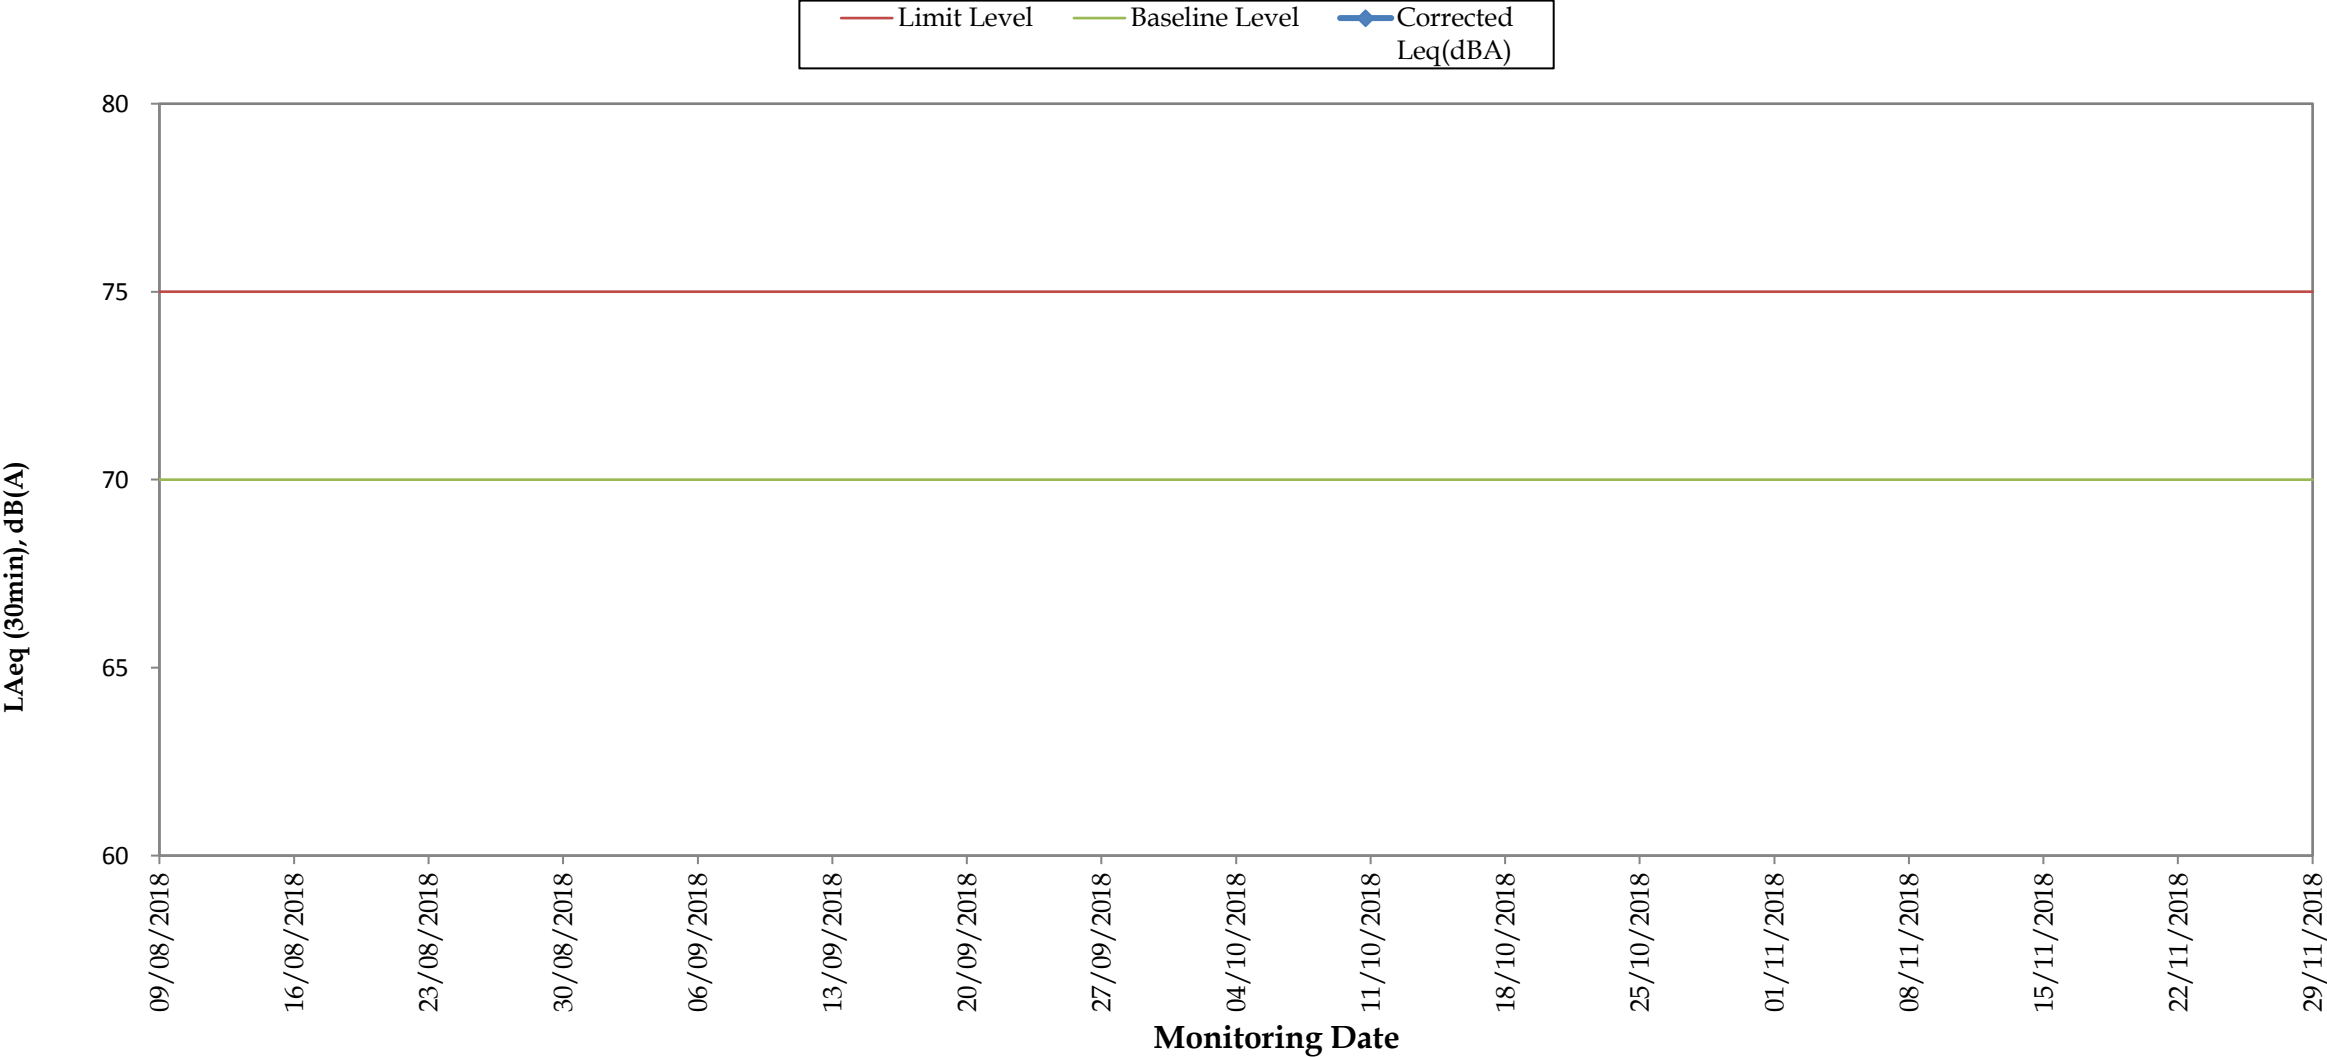
Regular Noise Monitoring Results at NMS-CA-7 (Skytower Tower 2) (LAeq, 30min)
for the Past 4 Months

- For those corrected noise levels that are not shown in this graph, the measured noise level s are equal to or below baseline level.

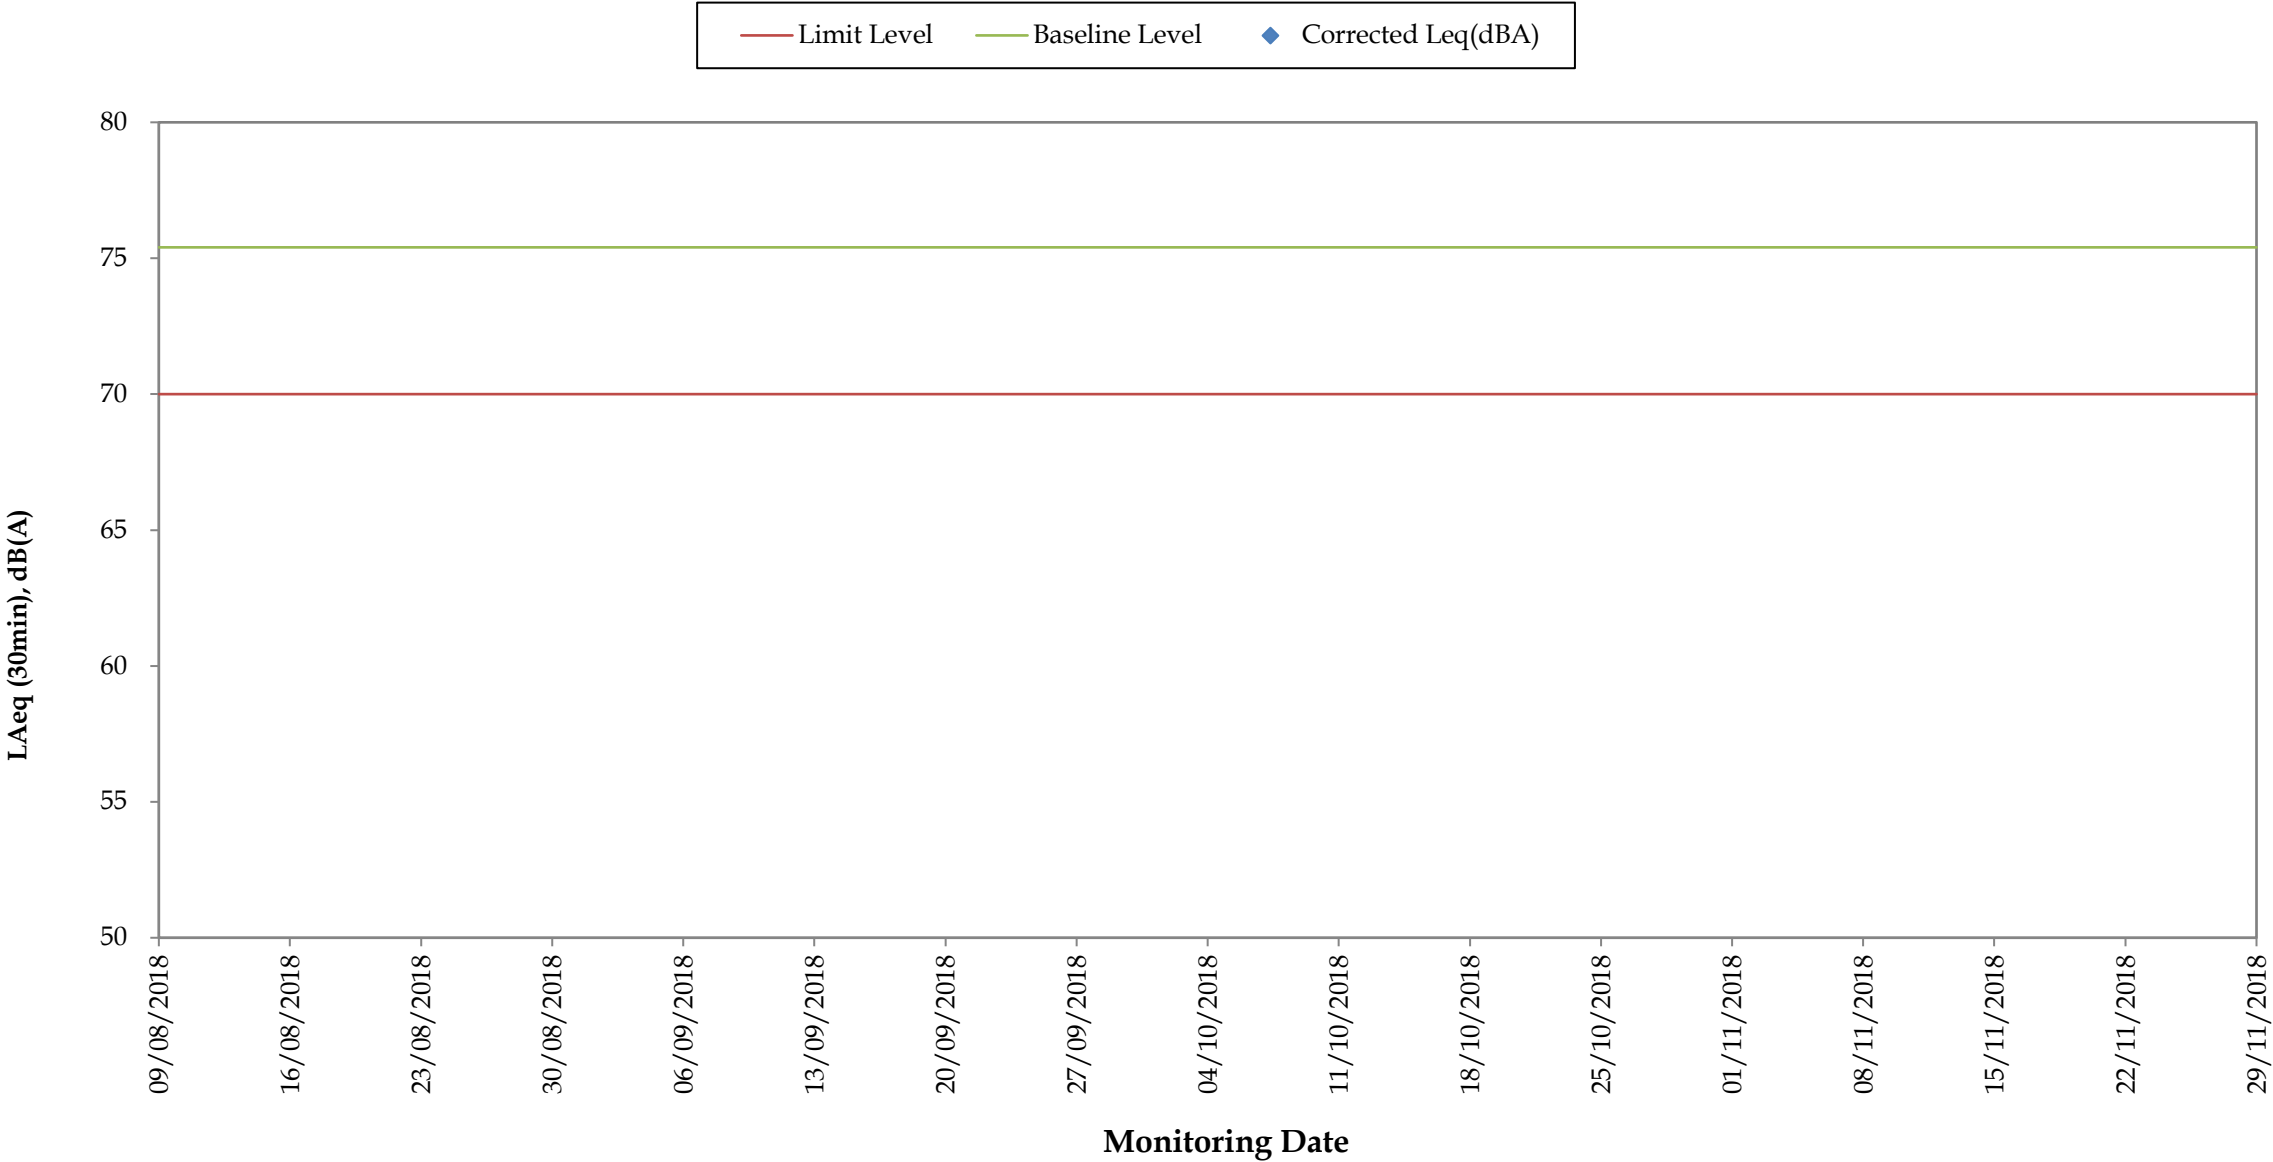
**Regular Noise Monitoring Results at NMS-CA- 8 (SKH Good Shepherd Primary School)
(LAeq, 30min) for the Past 4 Months**

- Remarks:
- For those corrected noise levels that are not shown in this graph, the measured noise levels are equal to or below baseline level.
 - The limit level was updated from 78dB(A) to 79 dB(A) on 22 Aug 2013 as per the latest CNMP and CNMMP.
 - The limit level was updated from 79dB(A) to 70dB(A)/65dB(A) (during normal/ examination period) from April 2016, as the continuous noise monitoring was completed in March 2016 according to the latest CNMP

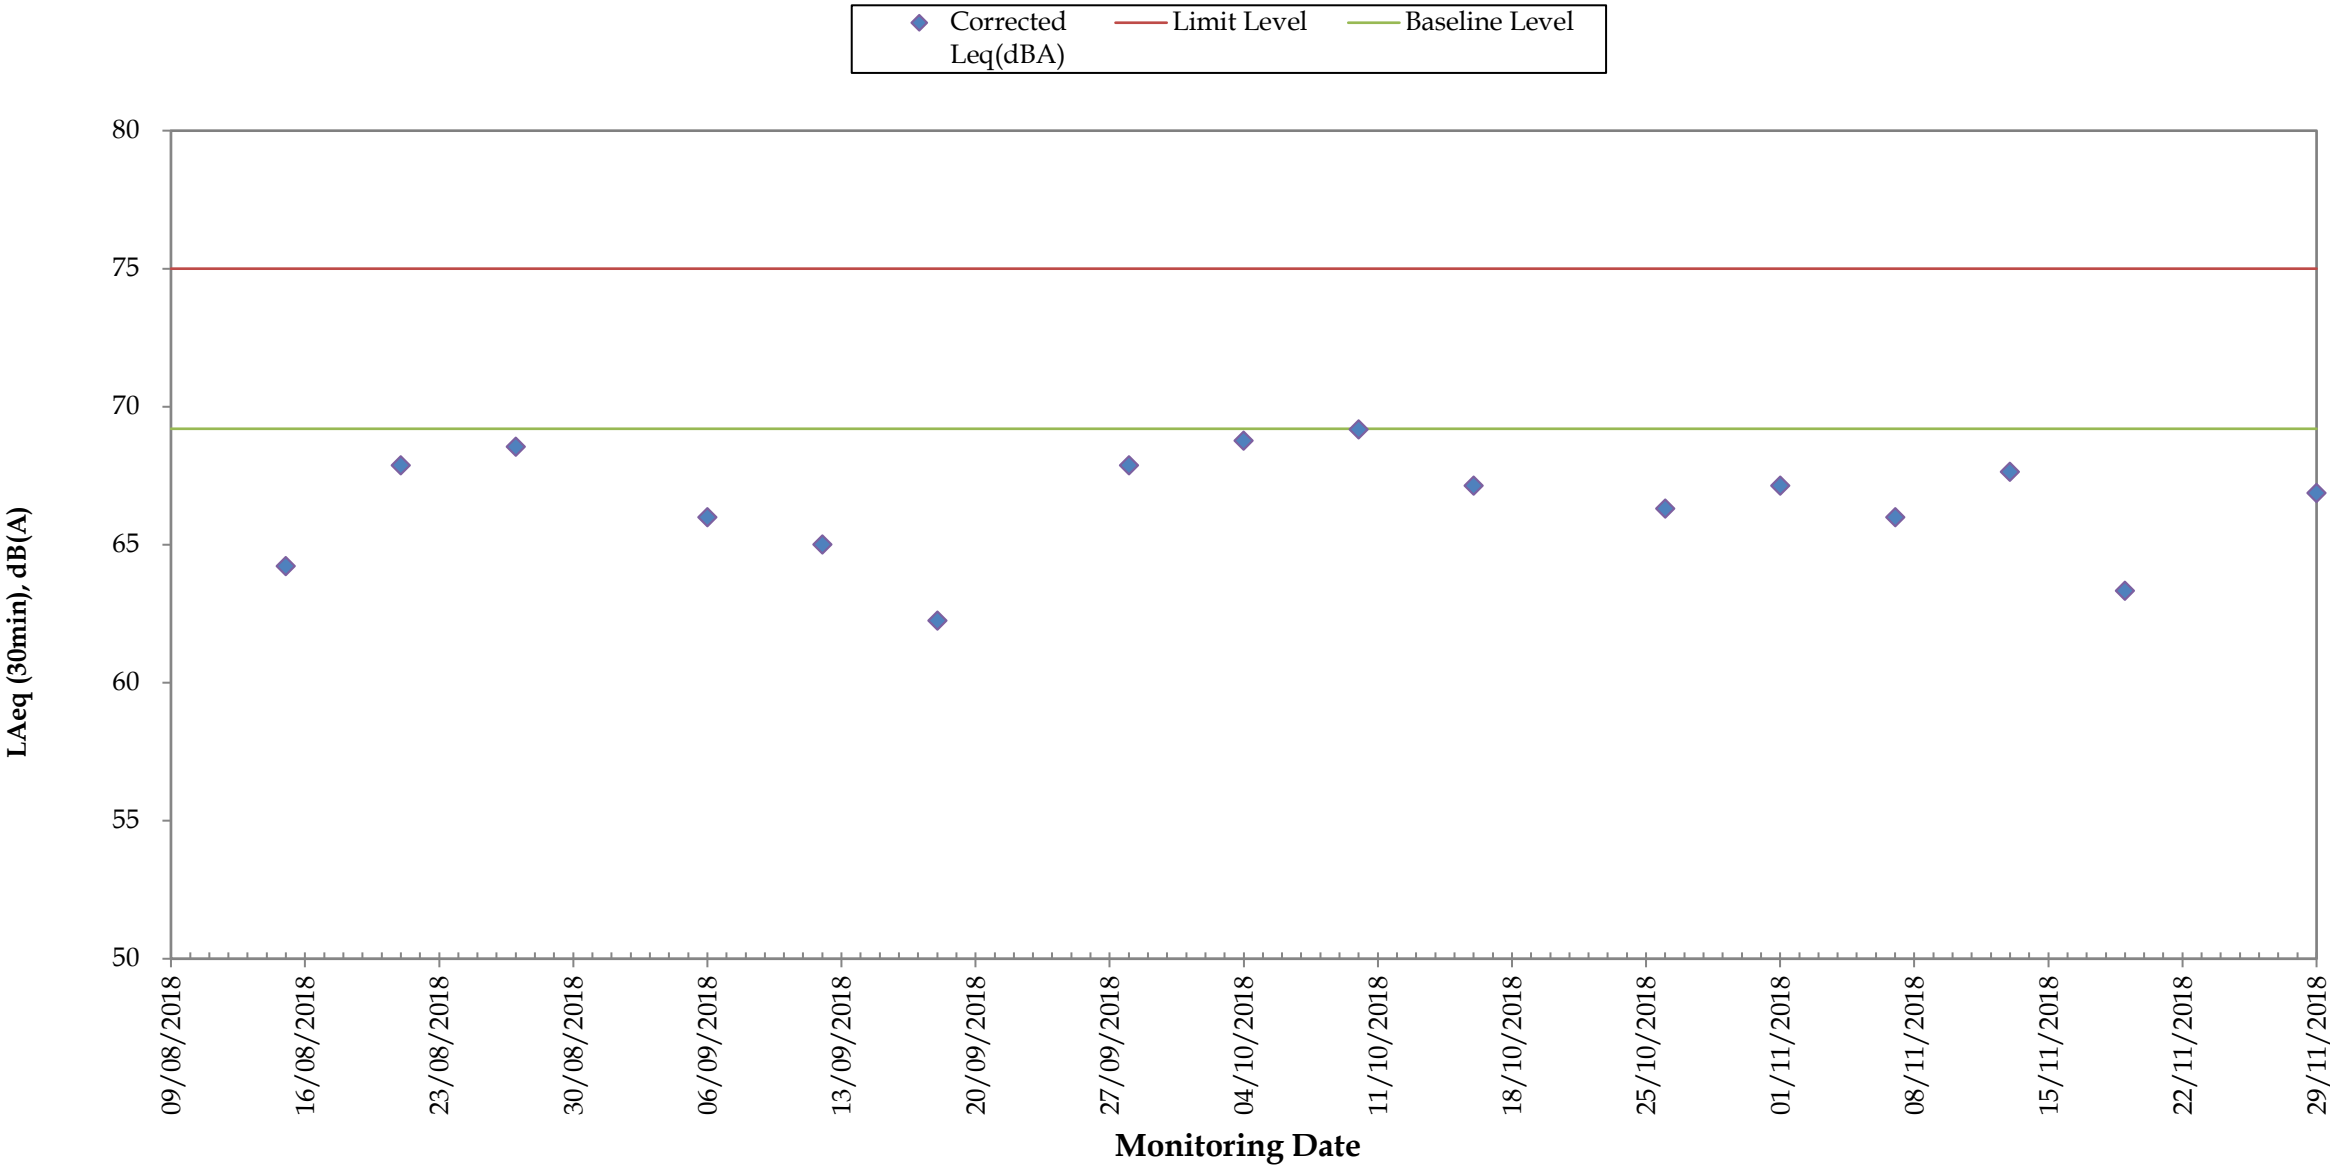
Regular Noise Monitoring Results at NMS-CA-9 (Kong Yiu Mansion)
(LAeq, 30min)) for the Past 4 Months

- For those corrected noise levels that are not shown in this graph, the measured noise level s are equal to or below baseline level.

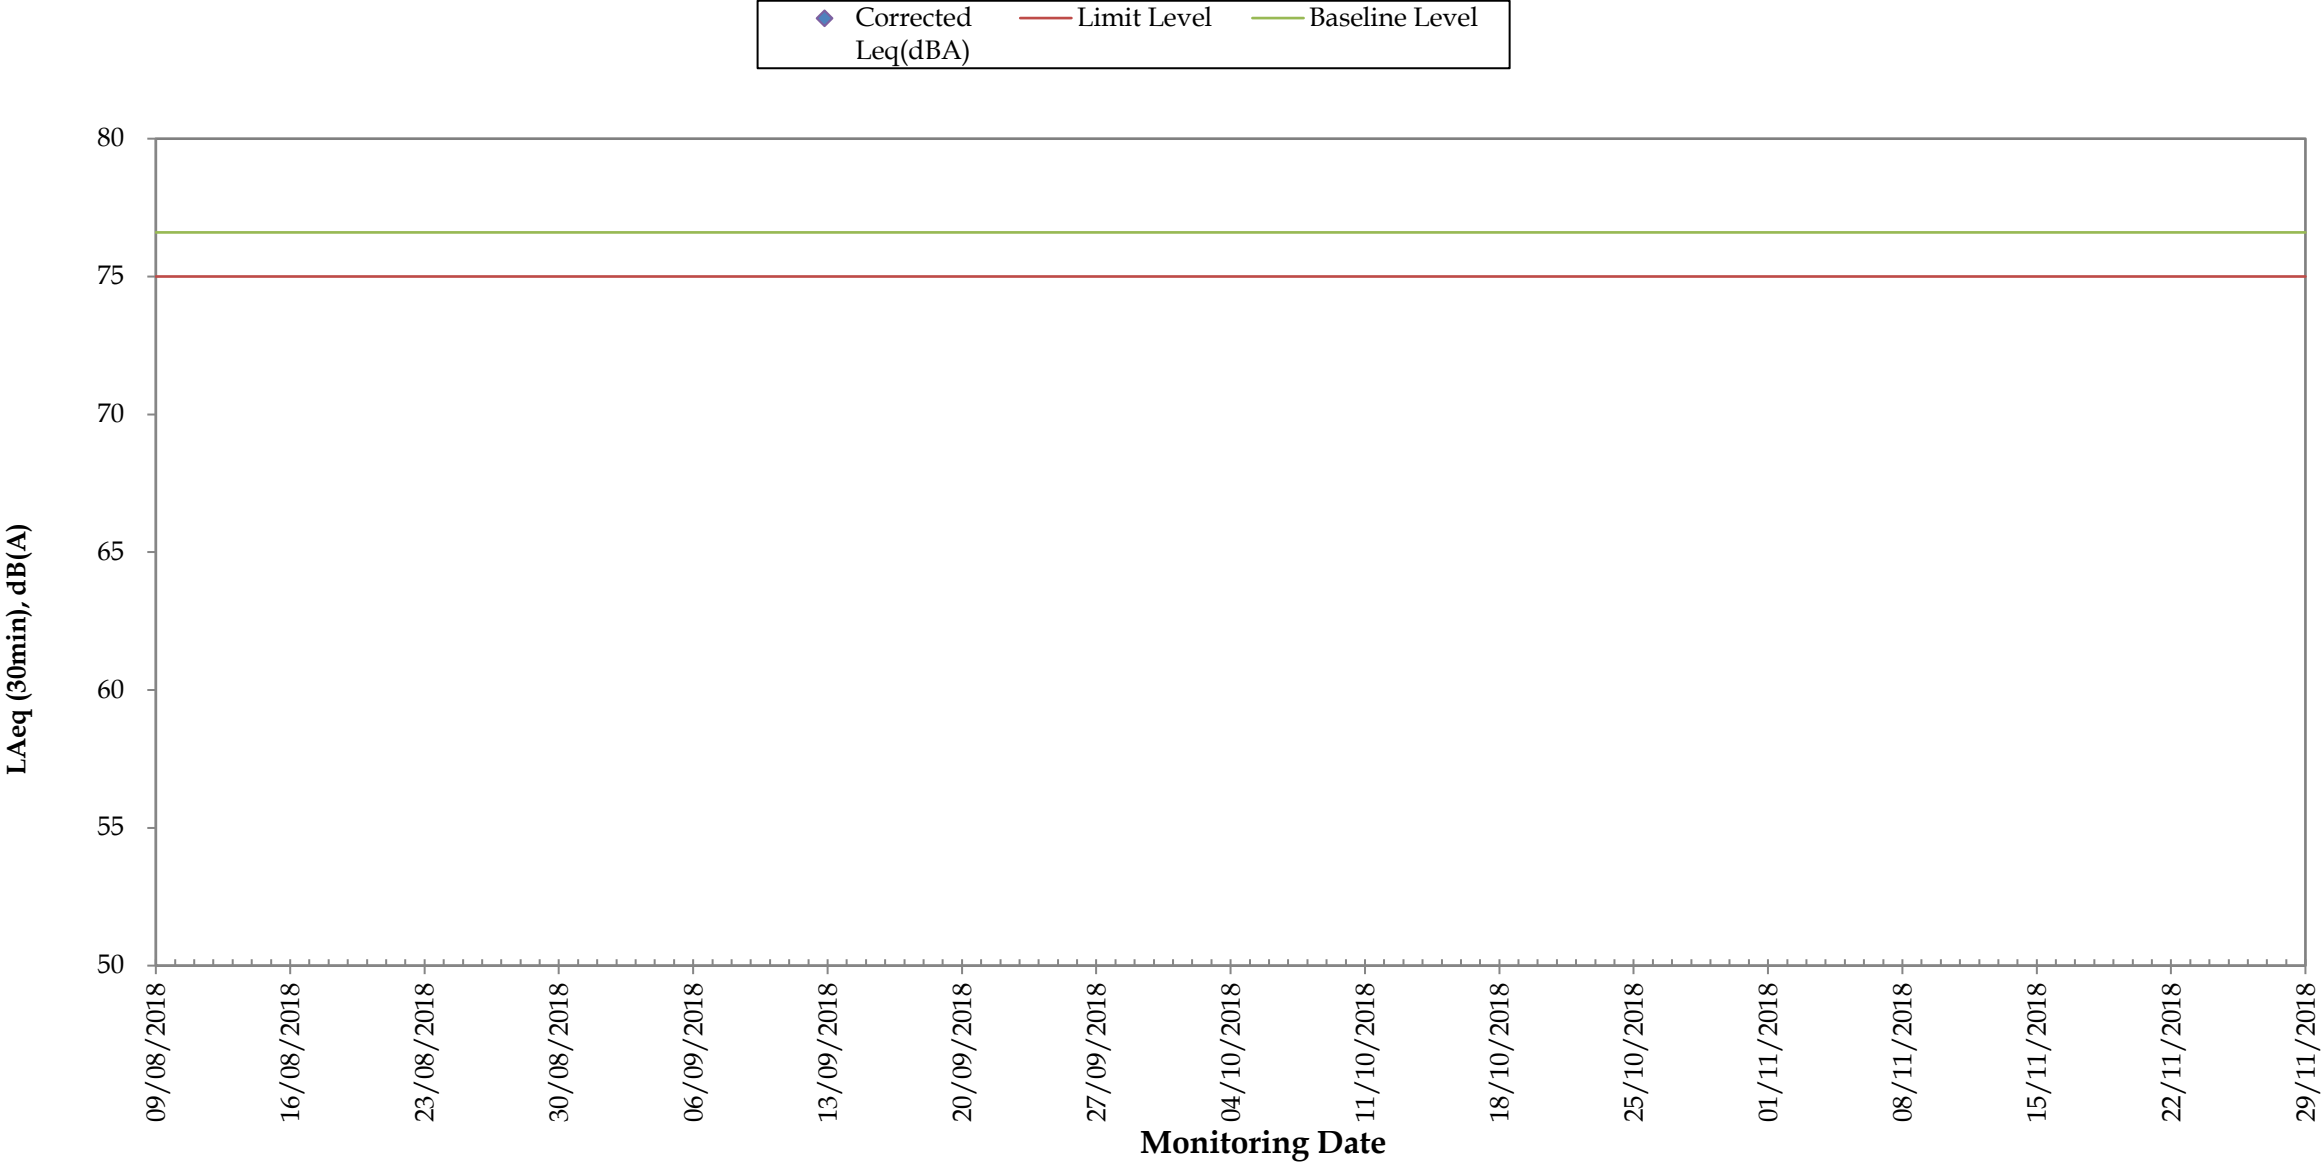
**Regular Noise Monitoring Results at NMS-CA-10 (Chat Ma Mansion) (LAeq, 30min)
for the Past 4 Months**

- For those corrected noise levels that are not shown in this graph, the measured noise levels are equal to or below baseline level.

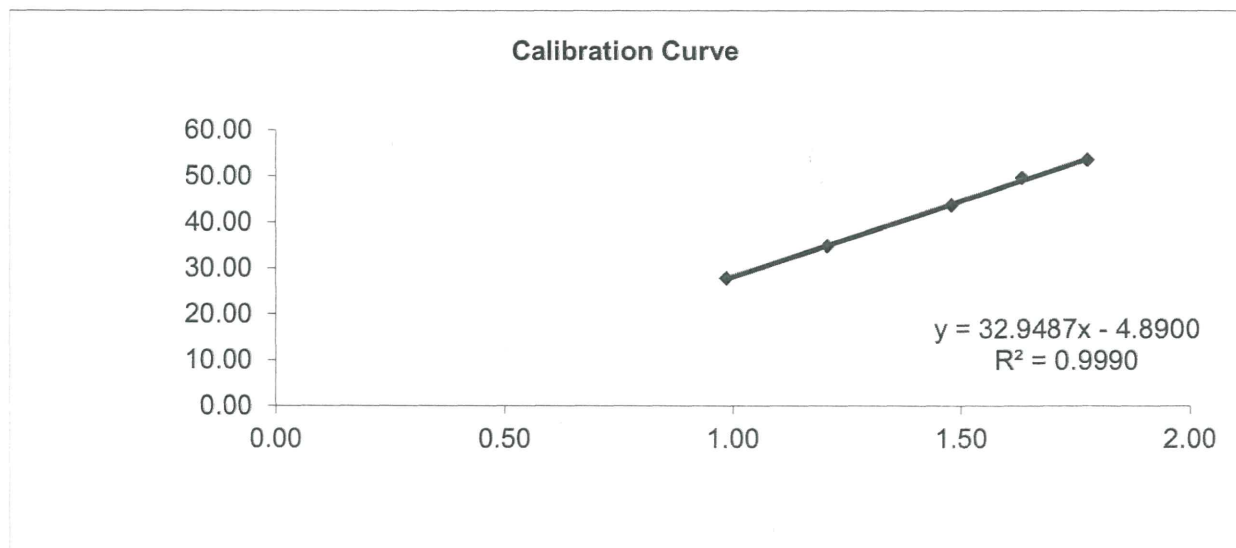
Linear Regression

Sampler slope (m) : **32.9487**
 Sampler intercept (b) : **-4.8900**
 Correlation coefficient (R²) : **0.9990**
