Ocean Park Tai Shue Wan Water World Project

Monthly EM&A Report December 2020

This is the 43rd monthly EM&A report for the construction phase of Waterpark Main Building Works submitted under Condition 3.4 of the Environmental Permit (No. EP-487/2014/A). This report summarises the findings on EM&A during the period from 1 to 31 December 2020.

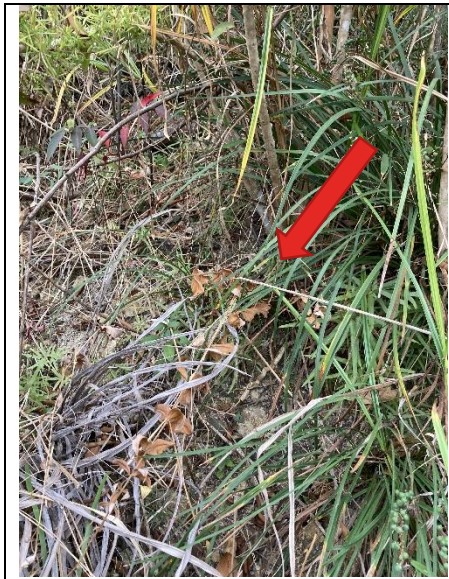
Photo 1 – Group 2 of *Platycodon Grandiforus*

It was observed that chlorosis and leaf drop occurred on Group 2 of *Platycodon grandiflorus* (see Photo 1 of **Appendix L** of this report). On the other hand, Group 1 of *Platycodon grandiflorus* could not be found within the fenced area due to natural life cycle of this perennial herbaceous species, and new shoots would be expected to emerge from the underground part in the next growing season.

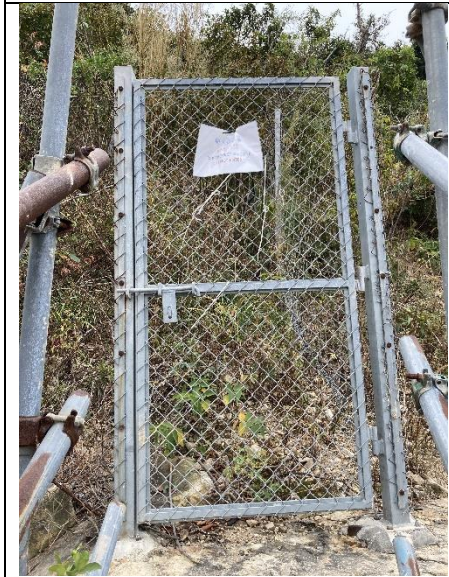
Photo 2 – Current situation of fencing and warning sign

The preventive mitigation measures, i.e., erecting of temporary protective fencing and sign post, were found to be effectively implemented for human disturbance (see Photo 2 of **Appendix L** of this report), and there is no signs or evidence (e.g. dust coating of plant) to suggest that the on-going construction activities with the Project Area has affected the health condition of the *Platycodon grandiflorus*.
