Ocean Park Tai Shue Wan Water World Project

Monthly EM&A Report February 2021

March 2021

This is the 45th monthly EM&A report for the construction phase of Waterpark Main Building Works submitted under Condition 3.4 of the Environmental Permit (No. EP-487/2014/A). This report summarises the findings on EM&A during the period from 1 to 28 February 2021.

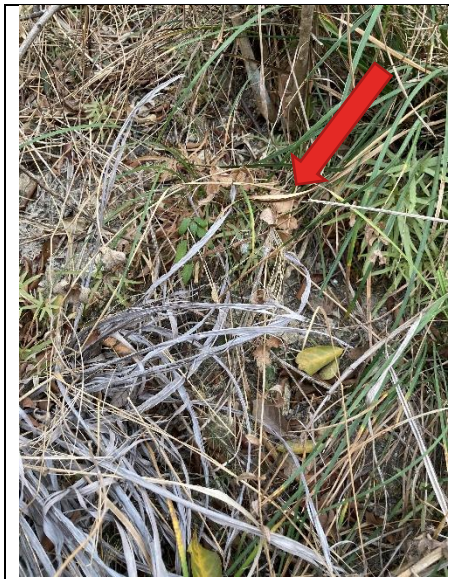
Photo 1 – Group 2 of *Platycodon Grandiflorus*

It was observed that chlorosis and leaf drop occurred on Group 2 of *Platycodon grandiflorus* (see Photo 1 of **Appendix L** of this report). On the other hand, Group 1 of *Platycodon grandiflorus* could not be found within the fenced area due to natural life cycle of this perennial herbaceous species, and new shoots would be expected to emerge from the underground part in the next growing season.

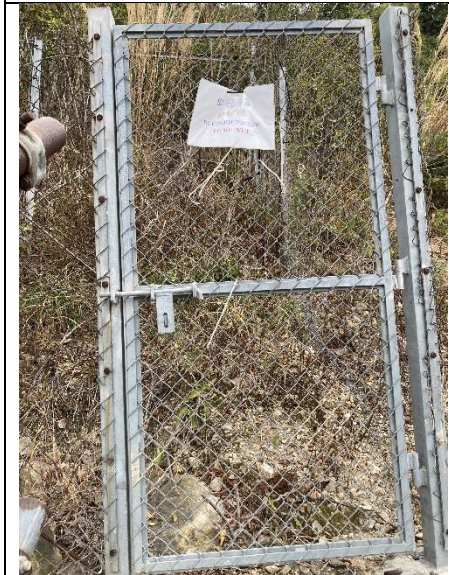
Photo 2 – Current situation of fencing and warning sign

The preventive mitigation measures, i.e., erecting of temporary protective fencing and sign post, were found to be effectively implemented for human disturbance (see Photo 2 of **Appendix L** of this report), and there is no signs or evidence (e.g. dust coating of plant) to suggest that the on-going construction activities with the Project Area has affected the health condition of the *Platycodon grandiflorus*.
