Contract No. 13/WSD/16

Mainlaying in Tseung Kwan O

Monthly EM&A Report No.4 (Period from 1 to 30 November 2018)

December 2018 (Rev. 0)

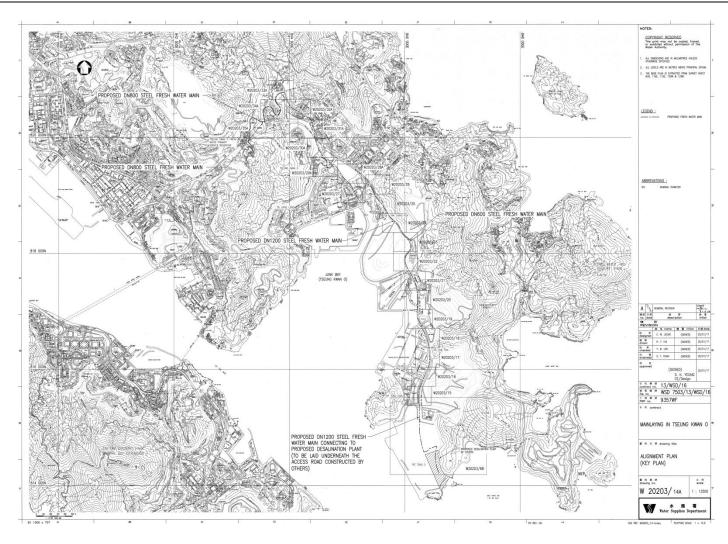
Figure 1.1 Overview of Mainlaying in TKO

- 1.1.3 The scope of the Contract may be considered in brief, to consist of the laying of about 10km long 1200mm diameter fresh water mains and the associated works along the alignment of the Project as shown with the overall view in **Figure 1.1**.

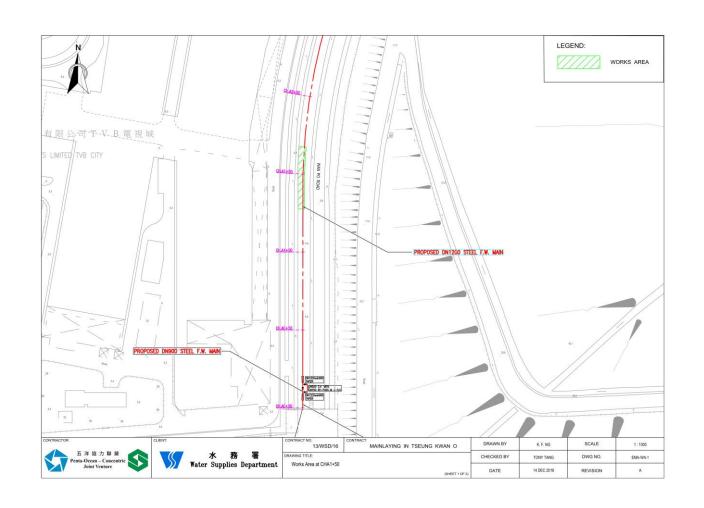
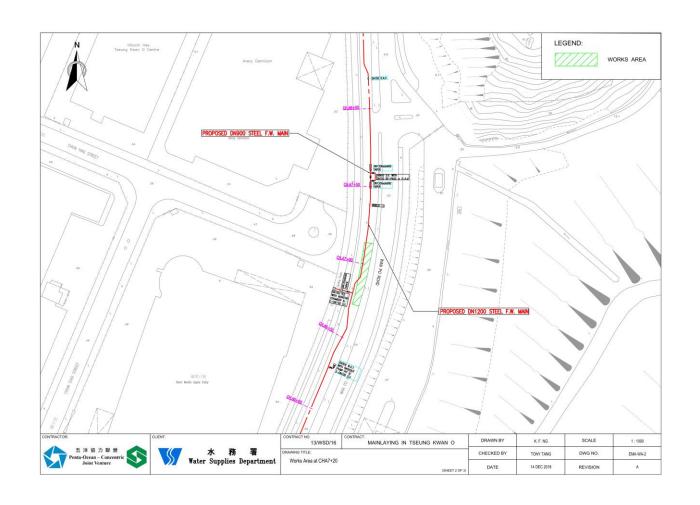
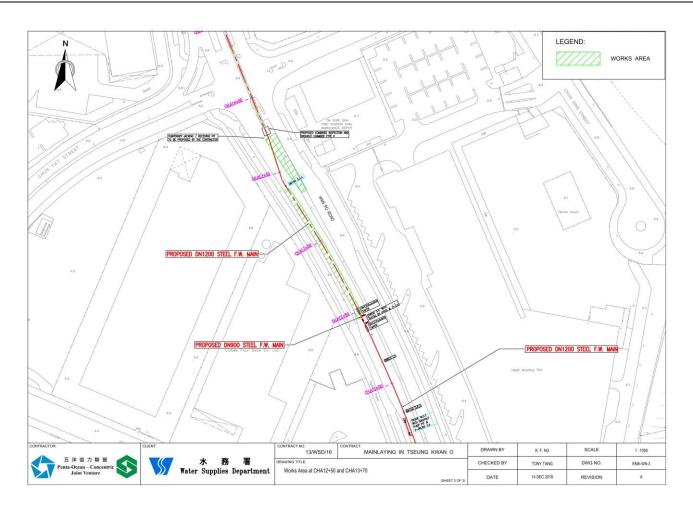
Figure 1.3 Location of Major Construction Works Undertaken during the Reporting Month

Location of works	Construction works undertaken	Remarks on progress	
Portion J of the Project Site	Continue utilities checking and detection before road works.	In Progress	
(Figure 1.3)	• Ground Investigation works at 20 no. of trial pits done at Wan Po Road (CH. A3+50, 5+30, 13+70, 15+40, 16+30, 18+50, 19+00, 22+70, 27+50 and 41+10), Po Hong Road (CH. A44+80, 51+80, 59+70, 63+60 and 66+90), Ling Hong Road (CH. A55+50 and 56+00), Po Shun Road (CH. A37+25 and footpath near Hong Kong Velodrome for alternative alignment)	• Completed	
	3 nos. of work fronts implemented as scheduled for the open-trench between CH. A0+00 to 13+70	In Progress	
	Trench excavation at CHA1+50, CH7+20, CH13+50	In Progress

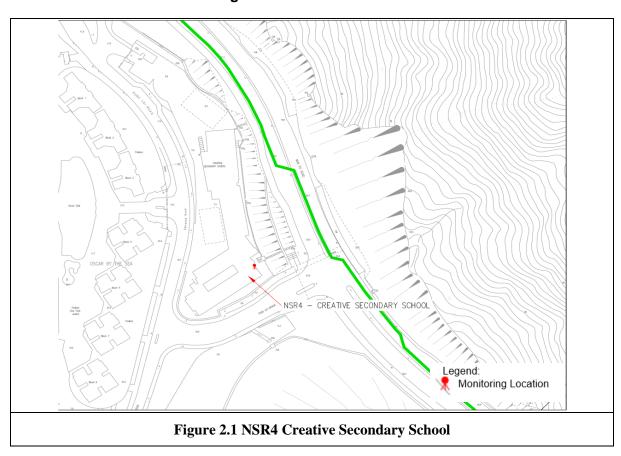
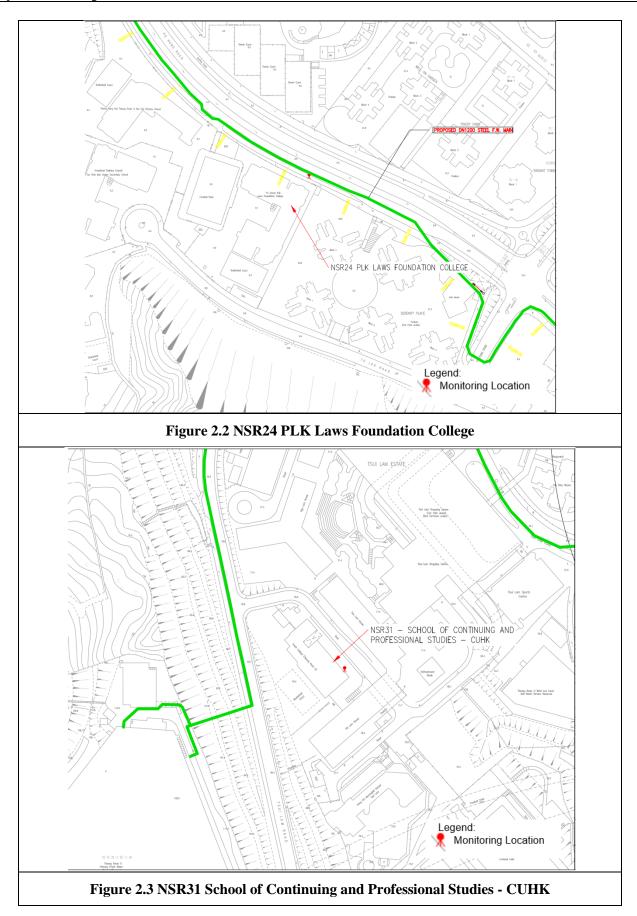
2.3.3 Three noise monitoring locations for impact monitoring at the nearby sensitive receivers are shown in **Figure 2.1-2.3.**

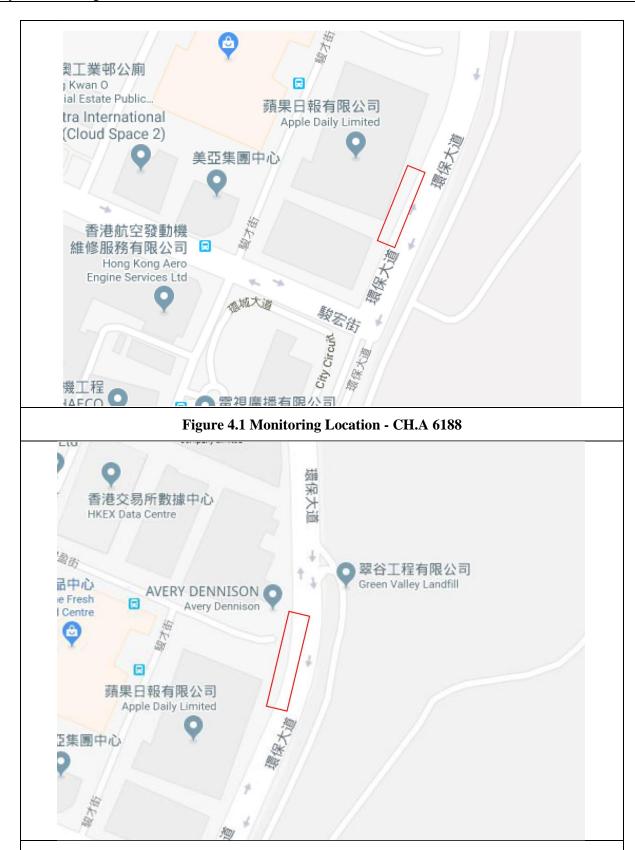
Figure 4.2 Monitoring Location -CH.A 001528

- Directly after the excavation has been completed; and
- Periodically whilst the excavation remains open.
- 4.2.3 The area required to be monitored for landfill gas in the reporting period are shown in **Figure 4.1** to **Figure 4.3**.
