Contract No. 13/WSD/16

Mainlaying in Tseung Kwan O

**Monthly EM&A Report No.15
(Period from 1 to 31 October 2019)**

November 2019

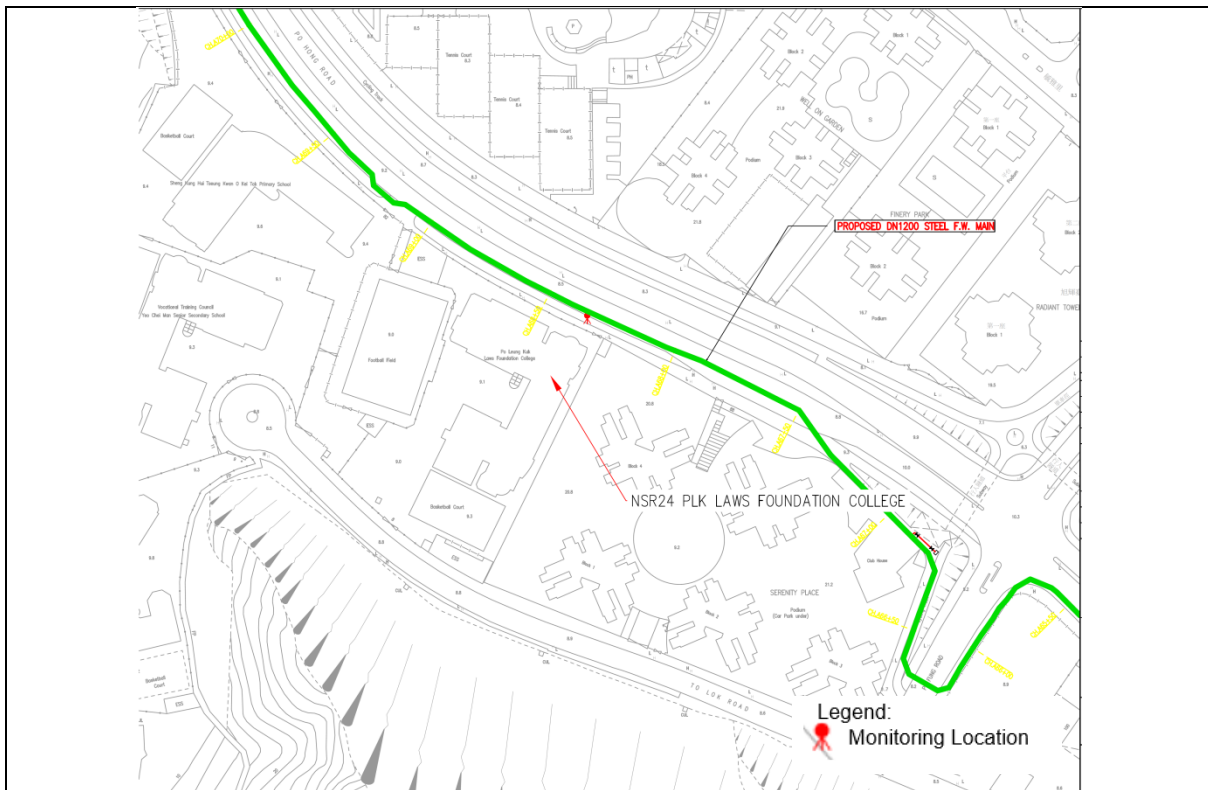
Figure 2.2 NSR24 PLK Laws Foundation College

2.3.3 Three noise monitoring locations for impact monitoring at the nearby sensitive receivers are shown in **Figure 2.1-2.3**.

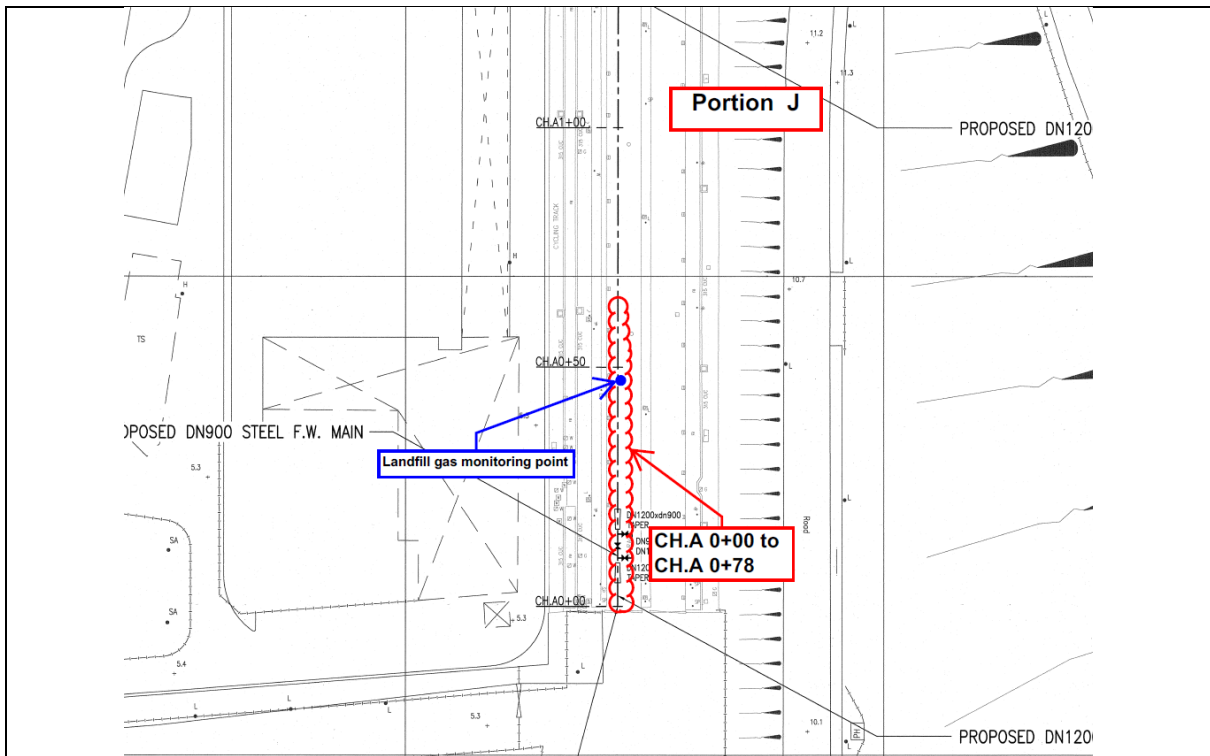
Figure 4.1 Monitoring Location - CH.A 0+78 (CH.A 0+22)

4.2.3 The area required to be monitored for landfill gas in the reporting period are shown in **Figure 4.1** to **Figure 4.6**.
