Contract No. 13/WSD/16

Mainlaying in Tseung Kwan O

**5th Quarterly EM&A Report
For August 2019 to October 2019**

November 2019
(Rev. 0)

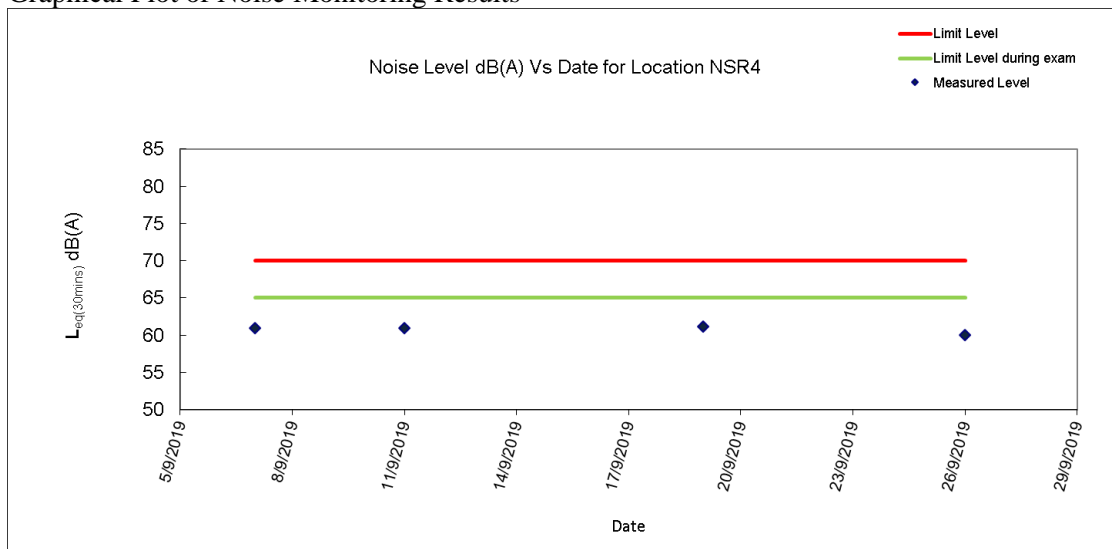
Date	Time	Weather	$L_{eq-30min}$ dB(A)	$L_{10-30min}$ dB(A)	$L_{90-30min}$ dB(A)
7/9/2019	11:50 - 12:20	Sunny	60.9	63.9	51.5
11/9/2019	10:20 - 10:50	Sunny	61.0	64.0	57.1
19/9/2019	10:15 - 10:45	Sunny	61.2	64.6	57.8
26/9/2019	10:40 - 11:10	Sunny	60.0	63.3	51.0

Graphical Plot of Noise Monitoring Results
