China Harbour – Zhen Hua Joint Venture

**Contract No.: CV/2015/07
Handling of Surplus Public Fill
(2016-2018)**

**TUEN MUN AREA 38 FILL BANK
MONTHLY EM&A REPORT NO.19
(NOVEMBER 2018)**

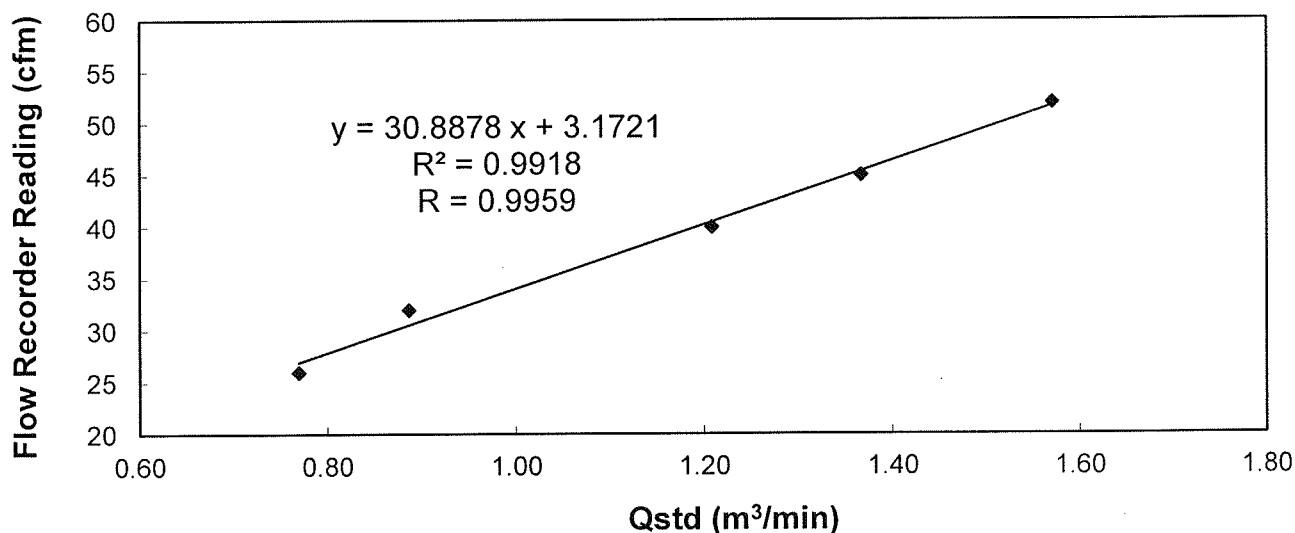
Sampler 2484 Calibration Curve
Site: Tuen Mun 38 (TM-A1)

Acceptance Criteria : Correlation coefficient (r) of the calibration curve greater than 0.990 after a 5-point calibration

The high volume sampler complies* / ~~does not comply*~~ with the specified requirements and is deemed acceptable* / unacceptable* for use.

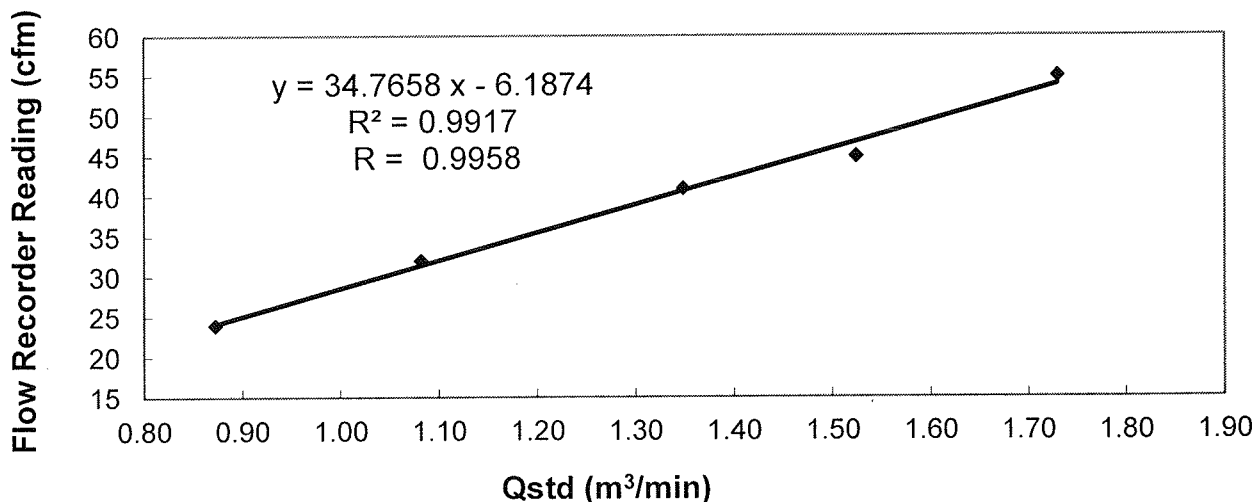
Sampler 1180 Calibration Curve
Site: Tuen Mun (TM-RA2)

Acceptance Criteria : Correlation coefficient (r) of the calibration curve greater than 0.990 after a 5-point calibration

The high volume sampler complies* / does not comply* with the specified requirements and is deemed acceptable* / unacceptable * for use.

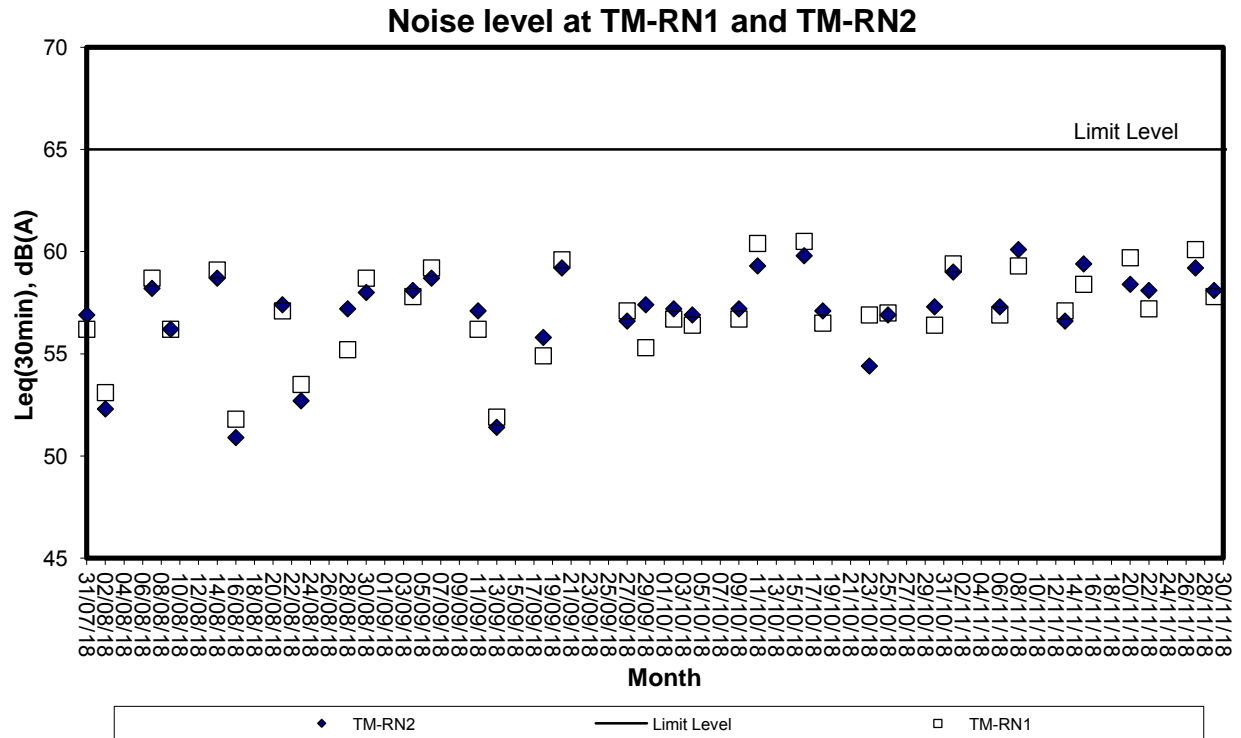
Noise Monitoring (Day-time)

The major sources of noise pollution observed in this reporting month were noise from the traveling dump trucks and from the operation of site machines.
