**Contract No.: CV/2015/07  
Handling of Surplus Public Fill  
(2016-2018)**

**TUEN MUN AREA 38 FILL BANK  
MONTHLY EM&A REPORT NO.20  
(DECEMBER 2018)**

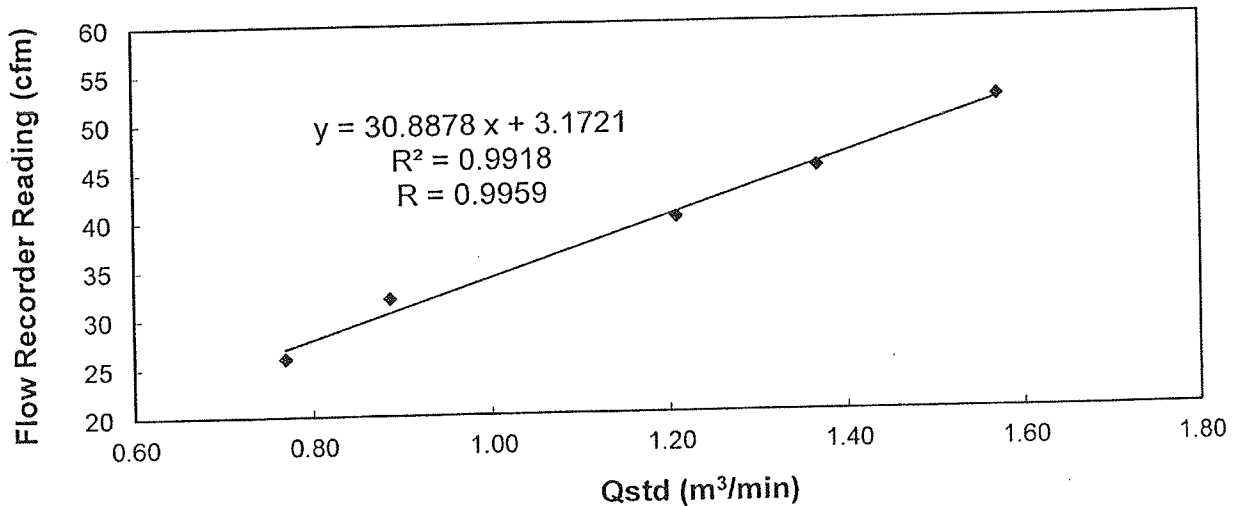
**Sampler 2484 Calibration Curve**  
Site: Tuen Mun 38 (TM-A1)

Results :	Flow recorder reading (cfm)	52	45	40	32	26
	Qstd (Actual flow rate, m <sup>3</sup> /min)	1.57	1.37	1.21	0.89	0.77
	Pressure : 760.56 mm Hg	Temp. : 302 K

Acceptance Criteria : Correlation coefficient (r) of the calibration curve greater than 0.990 after a 5-point calibration

The high volume sampler complies\* / does not comply\* with the specified requirements and is deemed acceptable\* / unacceptable\* for use.

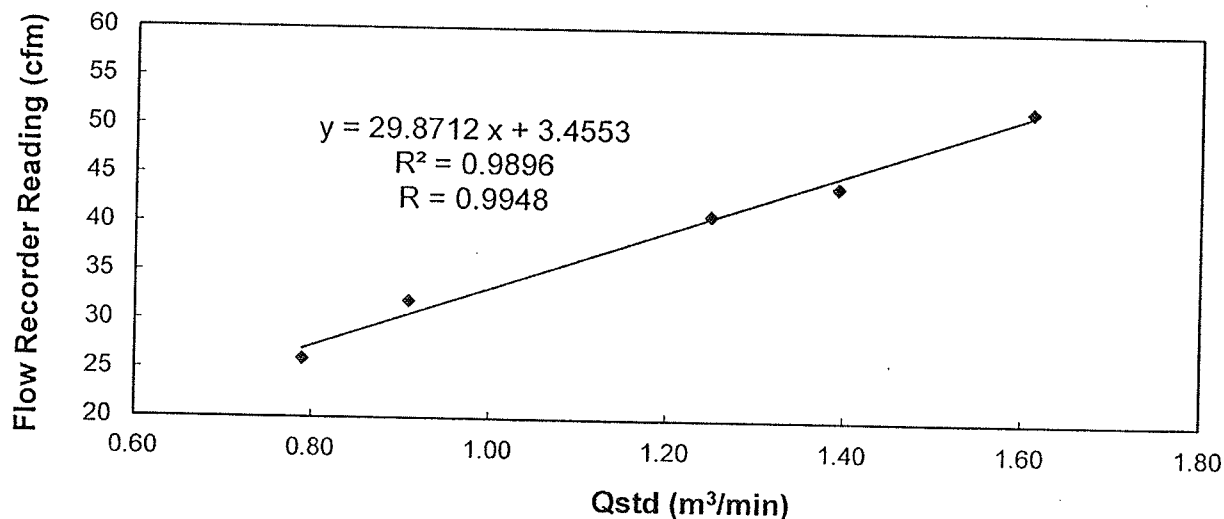
Sampler 2484 Calibration Curve  
Site: Tuen Mun 38 (TM-A1)

Results	Flow recorder reading (cfm)	52	44	41	32	26
	Qstd (Actual flow rate, m <sup>3</sup> /min)	1.61	1.39	1.25	0.91	0.79
	Pressure : 768.81 mm Hg	Temp. : 290 K

Acceptance Criteria : Correlation coefficient (r) of the calibration curve greater than 0.990 after a 5-point calibration

The high volume sampler complies\* / ~~does not comply\*~~ with the specified requirements and is deemed acceptable\* / unacceptable\* for use.

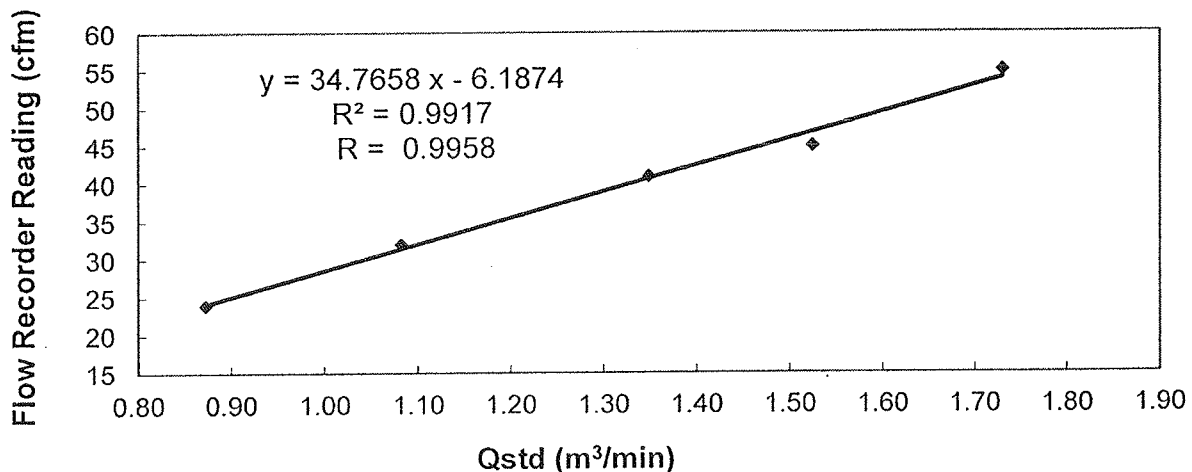
**Sampler 1180 Calibration Curve**  
**Site: Tuen Mun (TM-RA2)**

<b>Results</b> :	Flow recorder reading (cfm)	55	45	41	32	24
	Qstd (Actual flow rate, m <sup>3</sup> /min)	1.73	1.52	1.35	1.08	0.87
	Pressure :                      760.56 mm Hg	Temp. :                      302 K

Acceptance Criteria : Correlation coefficient (r) of the calibration curve greater than 0.990 after a 5-point calibration

The high volume sampler complies\* / ~~does not comply\*~~ with the specified requirements and is deemed acceptable\* / unacceptable\* for use.

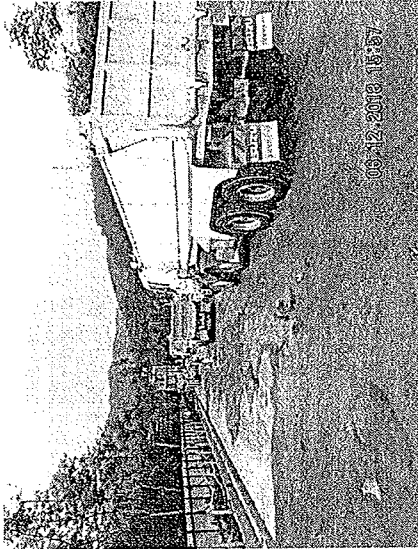
<p>Photo 181206_001(Near Wheel washing facilities)</p>		
--	--	--

Date	Key Findings	Action(s) Taken recommended by ET	Action(s) Taken by the Contractor during the site audit	Rectification Status by ET
06 December 2018	Mud was found accumulated on the haul road near wheel washing facilities (New item)	To clean the accumulated mud properly.	---	Follow-up
13 December 2018	Mud was found accumulated on the haul road near wheel washing facilities (Previous item)	To clean the accumulated mud properly.	The accumulated mud were cleaned.	Closed
17 December 2018	No defective work or observation was recorded during the weekly ET site inspection.			
27 December 2018	No defective work or observation was recorded during the weekly ET site inspection.
