**Monthly EM&A Report
(February 2021)**

Contract Name : Environmental Team for Drainage
Improvement Works at Ngong Ping
(Contract No. DC/2019/06)

Report No. : 0118/20/ED/0306A

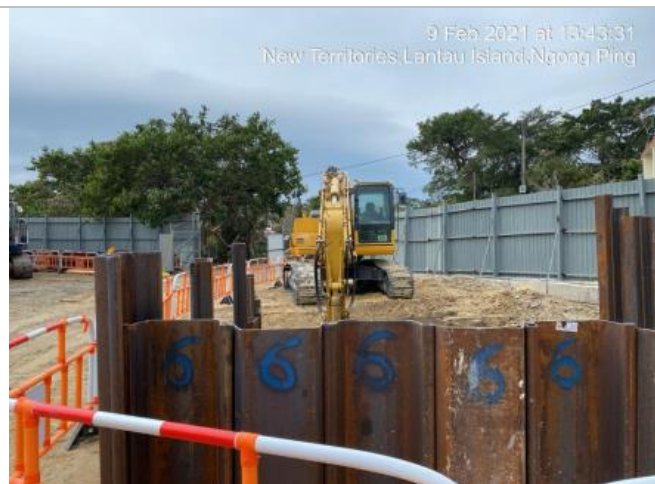
Excavation

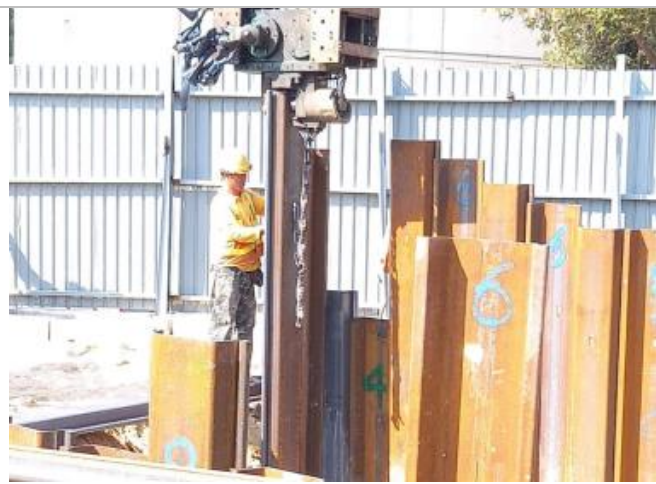
Sheet Piling

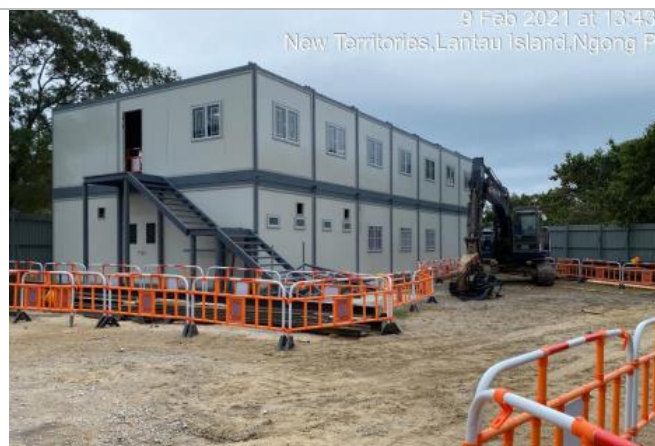
Set up site office
