**Monthly EM&A Report  
(February 2021)**

**Contract Name** : Environmental Team for Drainage  
Improvement Works at Ngong Ping  
(Contract No. DC/2019/06)

**Report No.** : 0118/20/ED/0306B

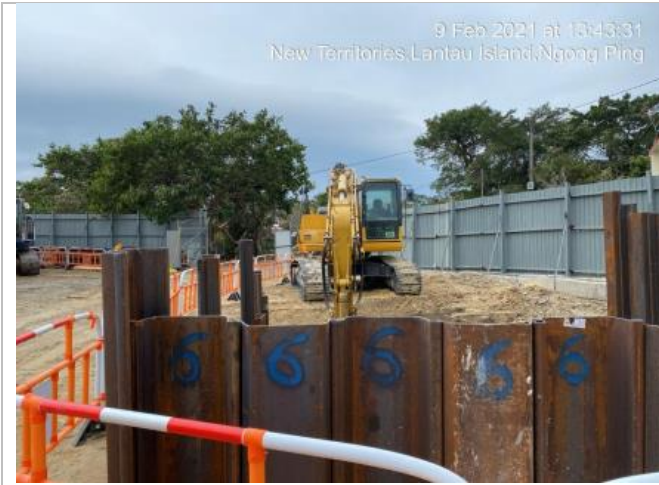
**Excavation**

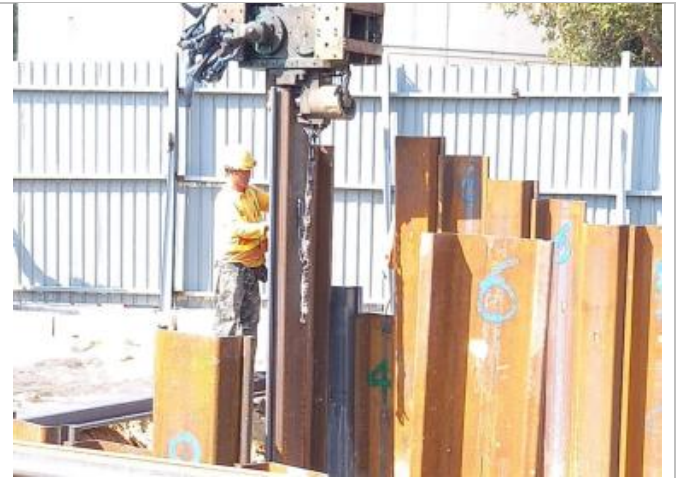
**Sheet Piling**

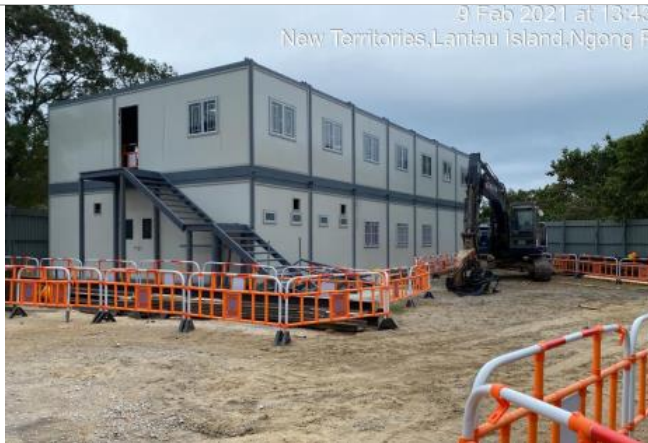
**Set up site office**
