Environmetnal Team Services for Contract No. SS H504 Design and Construction of Chai Wan Government Complex and Vehicle Depot

2nd Monthly EM&A Report (December 2021)

Contract No. SS H504
Design and
Construction of Chai
Wan Government
Complex and Vehicle
Depot

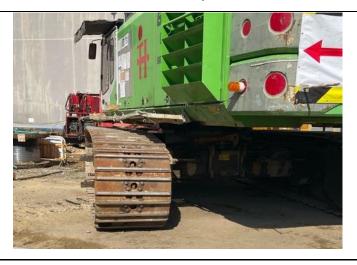
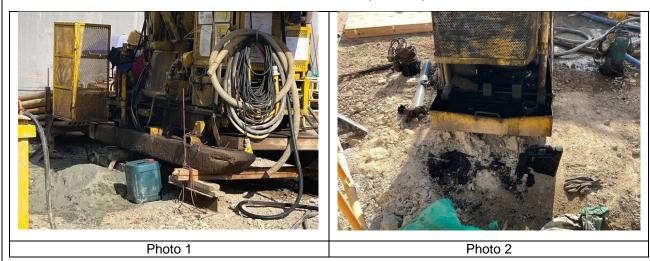
- 1. Several chemical storage drums without labels and drip pans have been found. (Photo 1)
- 2. Oil stain was observed near the GI works area. (Photo 2)

- 1. Contractor was reminded to provide labels and drip pans for chemical drums properly
- 2. The contractor was reminded to clean the oil stain and dispose of as chemical waste.
