Environmetnal Team Services for Contract No. SS H504 Design and Construction of Chai Wan Government Complex and Vehicle Depot

3rd Monthly EM&A Report (January 2022)

Contract No. SS H504 Design and Construction of Chai Wan Government Complex and Vehicle Depot

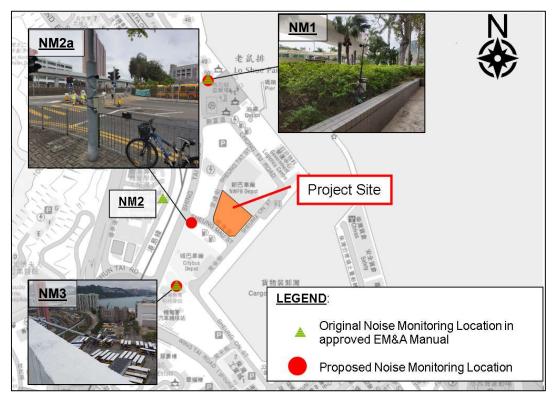
Figure 3-1 Location of Noise Monitoring Stations (NM1, NM2a and NM3)

Lamp Post no. 47447 at Sheung Mau Street (NM2a), which is located between project site and original noise monitoring location, Hong Kong Institute of Vocational Education (Chai Wan) - Academic Block (NM2), is found suitable and available to be an alternative noise monitoring location for NM2. Also, NM2a, which has a direct line of sight towards project site (where construction works will be carried out and likely to have noise impacts), is located closer to project site than NM2 and thus considered as a representative noise monitoring location. Monitoring position at NM2a is proposed at 2m above ground due to security concerns and minimize the road traffic noise contribution. Noise measurement at NM2a will be considered as free-field and a correction of +3dB(A) would be made to the noise monitoring results. The alternative location of NM2a, were therefore proposed and agreed by the Independent Environmental Checker (IEC).

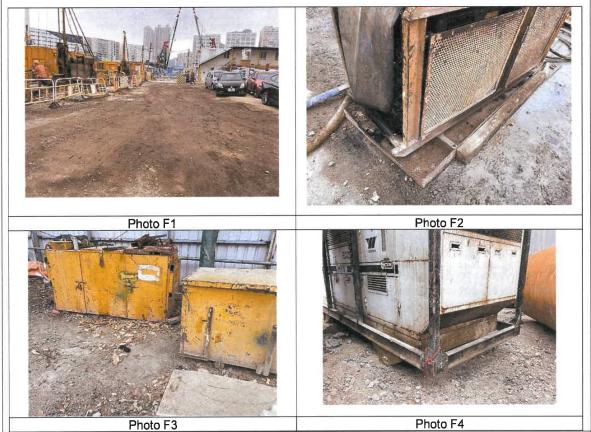
- 1. Water spraying was applied at the haul road. (Photo F1)
- 2. The drip tray was cleared. (Photo F2)
- 3. The chemical containers have been removed off site. (Photo F3)
- 4. The oil stain under the air compressor was cleared and disposed of as chemical waste. (Photo F4)

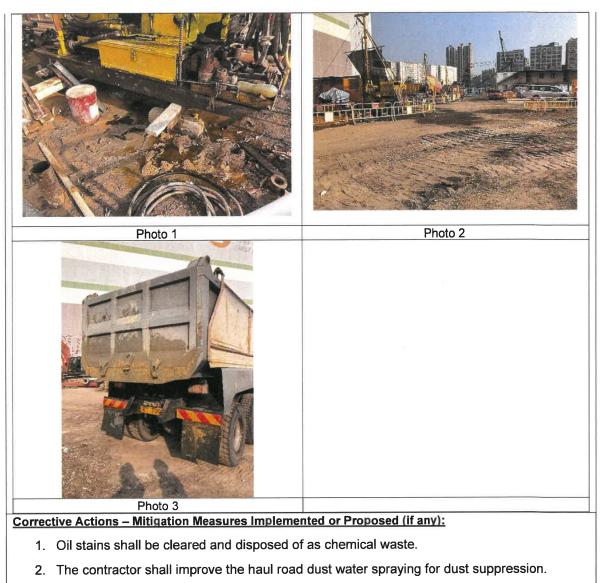
1. Oil stains are observed under the pre-drilling rig. (Photo 1)

- 1. Dusty haul road is observed. (Photo 2)
- 2. The excavated slurry is observed dripping at the back of the truck. (Photo 3)

- Oil stain was observed under the pre-drilling rig. The contractor was remained to clear Oil stains and dispose of as chemical waste.
- Dusty haul road was observed. The contractor shall improve the haul road dust water spraying for dust suppression.
- The excavated slurry was observed dripping at the back of the truck. The contractor was remained to provide appropriate measures to the trucks in order to prevent adverse environmental impacts to the public road.

3. The contractor is reminded to provide appropriate measures to the trucks in order to prevent adverse environmental impacts to the public road.

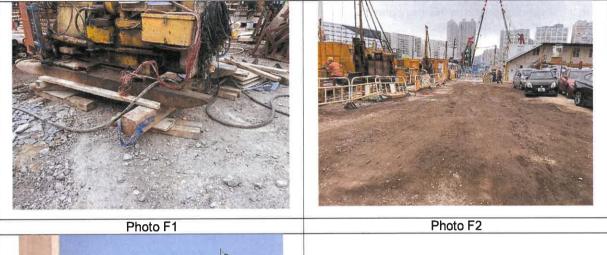
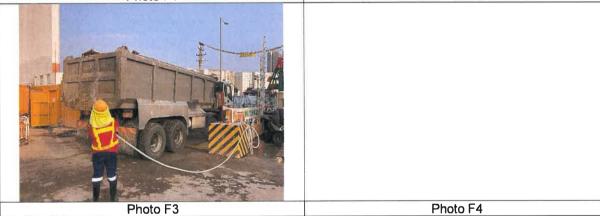
- 1. The leakage was fixed and the oil stains were cleared. (Photo F1)
- 2. The haul road is watered regularly. (Photo F2)
- 3. Vehicle washing was strengthened to prevent mud and slurry deposited on public road. (Photo F3)

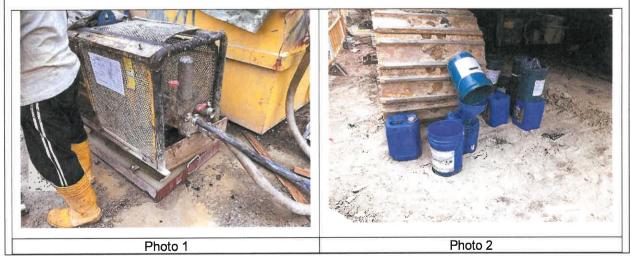
- 1. The drip tray is full. (Photo 1)
- 2. Oil drums are observed without drip trays. (Photo 2)

- The drip tray was full. The drip tray shall be cleared regularly to maintain its proper function.
- Oil drums were observed without drip trays. Oil drums shall be placed on drip trays.

- 1. The drip tray shall be cleared regularly to maintain its proper function.
- 2. Oil drums shall be placed on drip trays.

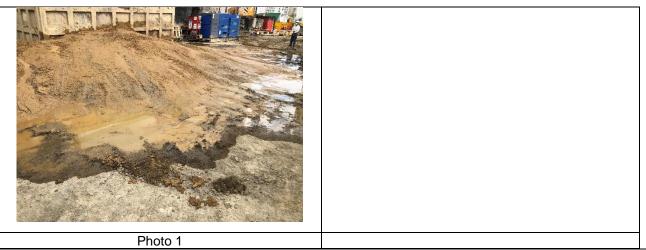
1. Sandbag barriers are not provided for temporary stockpiling area. (Photo 1)

1. Sand bags and channels shall be provided to divert the washout of temporary stockpile to silt removal facilities.

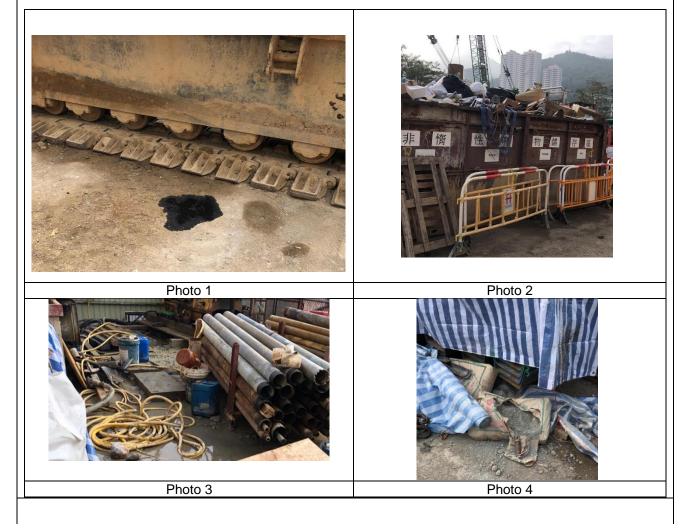
- 1. Oil stain is observed. (Photo 1)
- 2. General wastes are found in non-inert waste storage tank. (Photo 2)
- 3. Chemical container is observed without drip tray. (Photo 3)
- 4. Cement is not covered entirely by impervious sheeting. (Photo 4)

- Oil stain was observed. The oil stain shall be cleared and disposed of as chemical waste.
- General wastes were found in non-inert waste storage tank. General waste shall be stored properly to enhance reuse or recycling of material and disposal of it.
- Chemical container was observed without drip tray. It shall be placed on a drip tray.
- Cement bags were not covered entirely by impervious sheeting. They shall be covered entirely by impervious sheeting.

- 1. Oil stain shall be cleared and disposed of as chemical waste.
- 2. General waste shall be sorted properly to enhance reuse or recycling of material and disposal of it.
- 3. Chemical container shall be placed on drip tray.
- 4. Cement shall be covered entirely by impervious sheeting.
