# Environmethal Team Services for Contract No. SS H504 Design and Construction of Chai Wan Government Complex and Vehicle Depot

6<sup>th</sup> Monthly EM&A Report (April 2022)

Contract No. SS H504
Design and
Construction of Chai
Wan Government
Complex and Vehicle
Depot

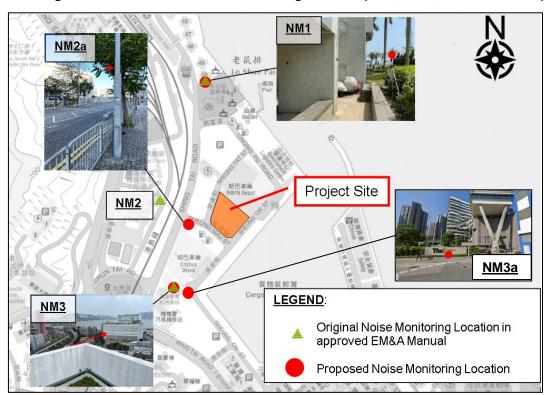
Figure 3-1 Location of Noise Monitoring Stations (NM1, NM2a, NM3 and NM3a)

Lamp Post no. 47447 at Sheung Mau Street (NM2a), which is located between project site and original noise monitoring location, Hong Kong Institute of Vocational Education (Chai Wan) - Academic Block (NM2), is found suitable and available to be an alternative noise monitoring location for NM2. Also, NM2a, which has a direct line of sight towards project site (where construction works will be carried out and likely to have noise impacts), is located closer to project site than NM2 and thus considered as a representative noise monitoring location. Monitoring position at NM2a is proposed at 2m above ground due to security concerns and minimize the road traffic noise contribution. Noise measurement at NM2a will be considered as free-field and a correction of +3dB(A) would be made to the noise monitoring results. The alternative location of NM2a, were therefore proposed and agreed by the Independent Environmental Checker (IEC).

According to the email notification received from Chai Wan THEi Campus on 12 February 2022, due to current COVID-19 development, the monitoring location at NM3 (Rooftop of Chai Wan THEi Campus) is temporary inaccessible. The noise monitoring at NM3 has been temporary relocated to the adjusted location named NM3a from 12 February 2022 until further notice from THEi. The location of NM3a is shown in **Figure 3-1**. Due to the adjustment of the location of NM3a to NM3, the measured noise level at AM3a would represent the noise levels at NM3.

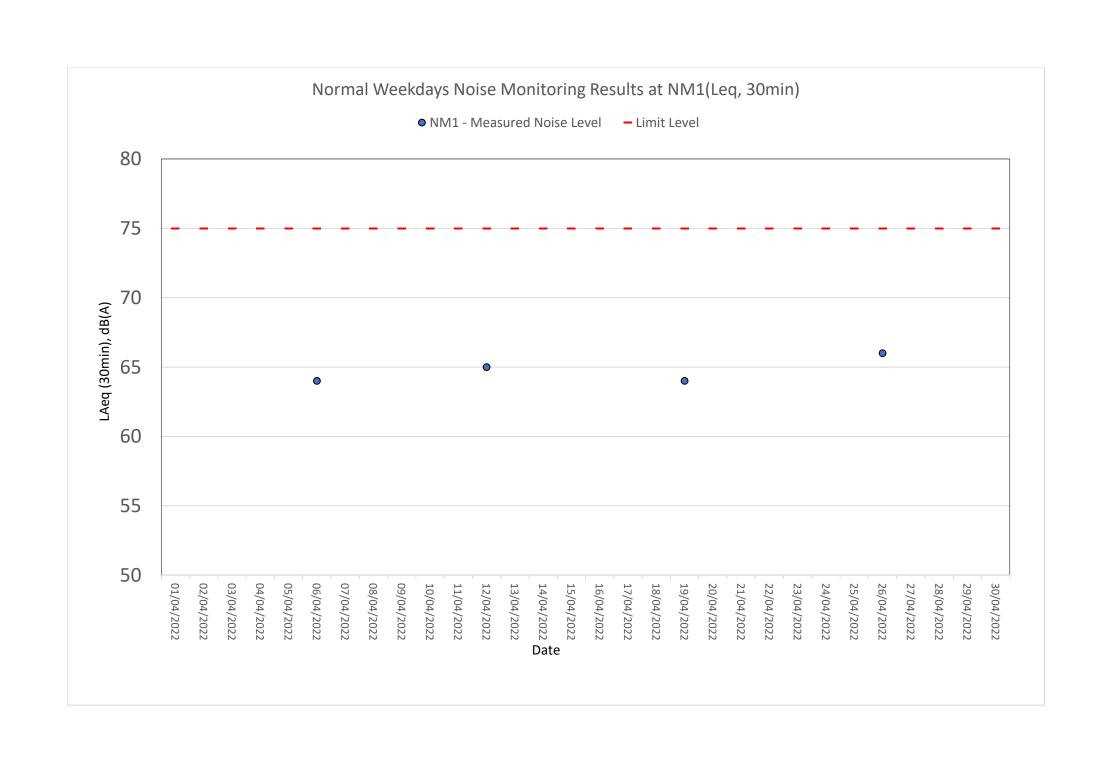
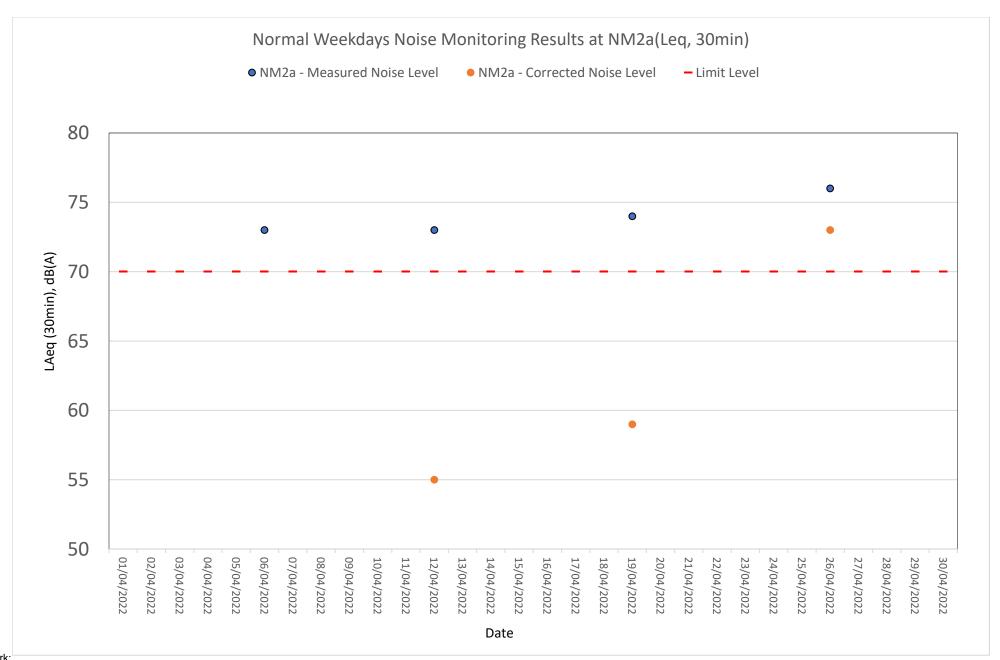
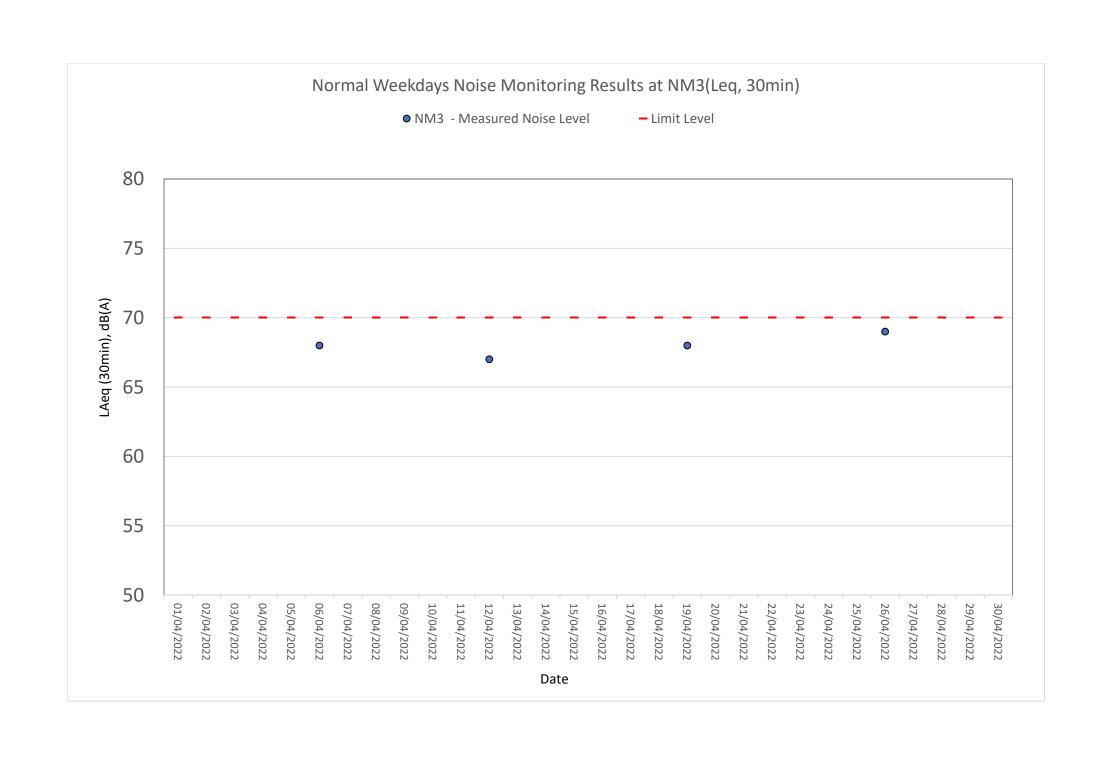
<sup>^</sup>On 6 April 2022, the measured noise level of NM2a exceeded the limit level of 70dB(A). However, it was lower than the baseline level of 73.4dB(A). Therefore, it is not considered as an limit level exceedance.

<sup>^</sup>On 26 April 2022, the measured noise level of NM2a exceeded the limit level of 70dB(A). it was concluded that the noise exceedance on 26 April 2022 was likely to be attributed to road traffic noise and unlikely to be attributed to the Project works.

# The measured noise level exceeded the noise level of 70dB(A) and it was higher than the baseline level of 73.4 dB(A). Therefore, baseline correction was carried out and the corrected noise level which solely represent the noise level of Construction works are lower than the noise criteria. As such the EAP was not triggered.

On 6 April 2022, the measured nose level of NM2a exceeded the action level of 70dB(A). However, it was lower than the baseline level of 73.4dB(A). Therefore, it is not considered as an Action Level exceedance. On 26 April 2022, the measured nose level of NM2a exceeded the action level of 70dB(A). it was concluded that the noise exceedance on 26 April 2022 was likely to be attributed to road traffic noise and unlikely to be attributed to the Project works.

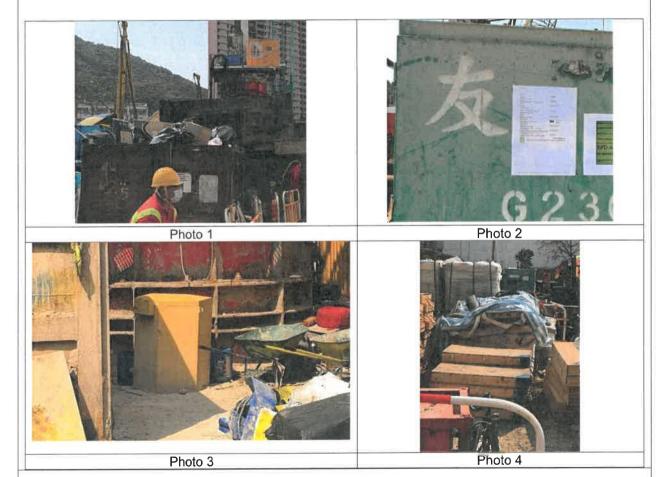
- 1. General wastes are found in non-inert waste storage tank. (Photo 1)
- 2. Noise label is expired. (Photo 2)

- 1. Chemical containers are observed without drip tray. (Photo 3)
- 2. Cement is not covered entirely by impervious sheeting. (Photo 4)

- 1. General waste shall be sorted properly to enhance reuse or recycling of material and disposal of it.
- 2. Contractor was reminded to update the noise label.
- 3. Contractor was reminded to provide drip tray for the chemical container.
- 4. Cement shall be covered entirely by impervious sheeting.

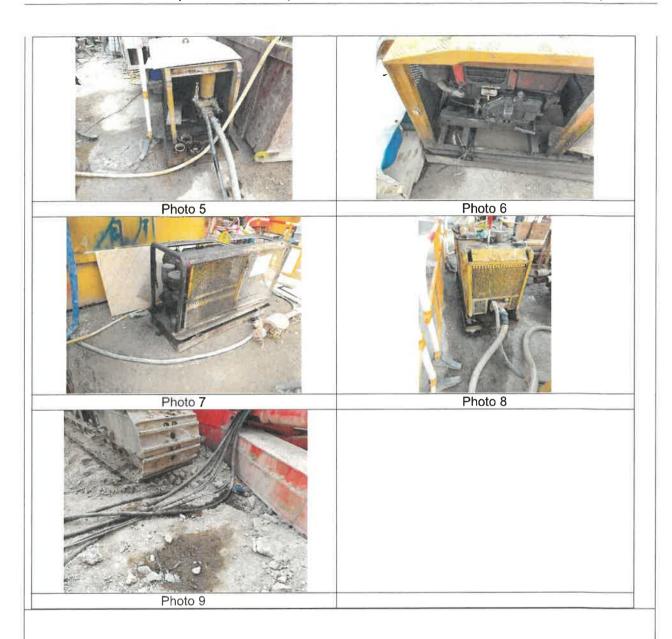
Photo 4

- Dry haul road is observed. The Contractor was reminded to schedule watering haul roads and work areas.
- The color of NRMM labels are inaccurate. The Contractor was reminded to replace the NRMM labels.
- The drip trays are full. The drip tray shall be cleared.
- Oil stains are observed. Oil stains shall be cleared and disposed of as chemical waste.

- 1. The Contractor was reminded to schedule watering haul roads and work areas.
- 2. The Contractor was reminded to replace the NRMM labels.
- 3. The drip tray shall be cleared.
- 4. Oil stains shall be cleared and disposed of as chemical waste.
