# Environmetnal Team Services for Contract No. SS H504 Design and Construction of Chai Wan Government Complex and Vehicle Depot

8<sup>th</sup> Monthly EM&A Report (June 2022)

Contract No. SS H504
Design and
Construction of Chai
Wan Government
Complex and Vehicle
Depot

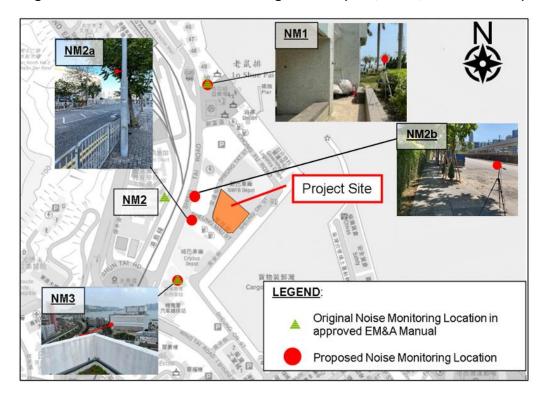
Figure 3-1 Location of Noise Monitoring Stations (NM1, NM2a, NM2b and NM3)

To respond to the comment raised by EPD on monitoring location of NM2a by email dated 23 May 2022 and site meeting on 6 June 2022, the monitoring location of NM2a was adjusted to the pedestrian road at Shing Tai Road (NM2b) which is located between project site and original noise monitoring location, Hong Kong Institute of Vocational Education (Chai Wan) - Academic Block (NM2). Compared with NM2a, NM2b is far away from the traffic light and therefore should be able to minimise the traffic noise issue. This arrangement was started from 28 June 2022 and has been agreed by the Independent Environmental Checker (IEC). Noise measurement at NM2b will be considered as free-field and a correction of +3dB(A) would be made to the noise monitoring results.

Due to the adjustment of the location of NM2a to NM2b, the measured noise level at NM2b would represent the noise levels at NM2.

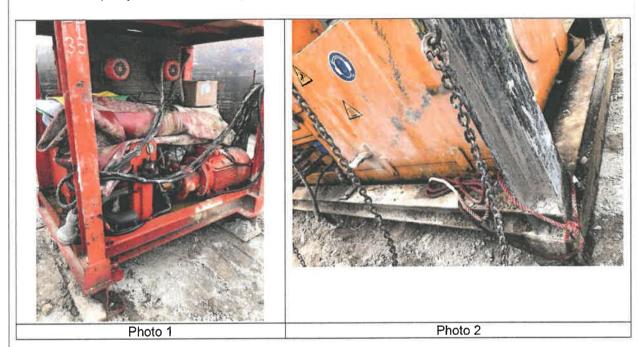
1. The drip trays are full of water. (Photo 1 & Photo 2)

The Contractor was reminded to clear the drip trays regularly.
