# Environmetnal Team Services for Contract No. SS H504 Design and Construction of Chai Wan Government Complex and Vehicle Depot

10<sup>th</sup> Monthly EM&A Report (August 2022)

Contract No. SS H504 Design and Construction of Chai Wan Government Complex and Vehicle Depot

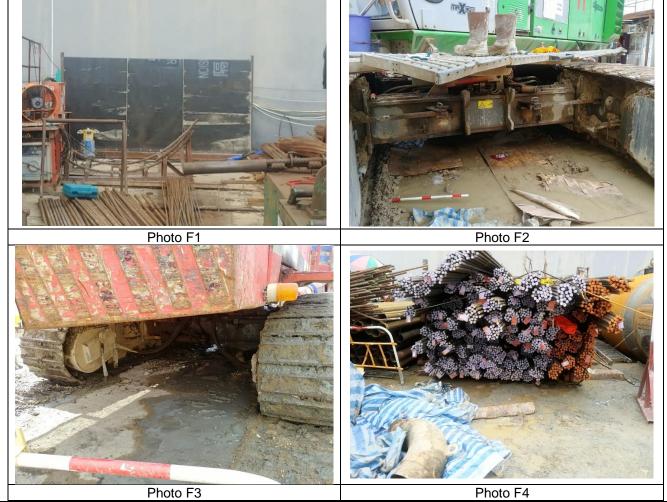
- 1. Noise barrier was provided to generator. (Photo F1)
- 2. Oil stains were cleared and disposed of as chemical waste. (Photo F2 and F3)
- 3. Fuel containers were removed. (Photo F4)

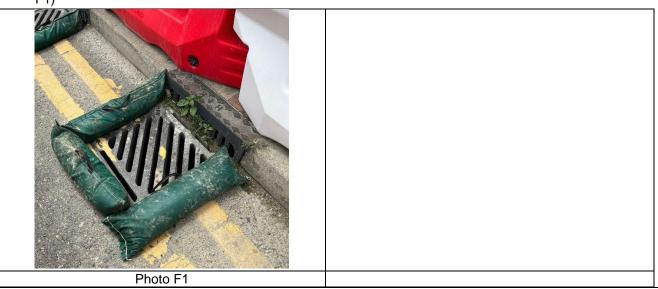
1. Sandbags were provided to prevent any washout from construction site to the drainage system. (Photo F1)

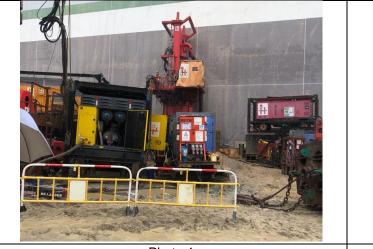
Photo 1

1. An air compressor is operated with doors open. (Photo 1)
