# Environmetnal Team Services for Contract No. SS H504 Design and Construction of Chai Wan Government Complex and Vehicle Depot

11th Monthly EM&A Report (September 2022)

Contract No. SS H504
Design and
Construction of Chai
Wan Government
Complex and Vehicle
Depot

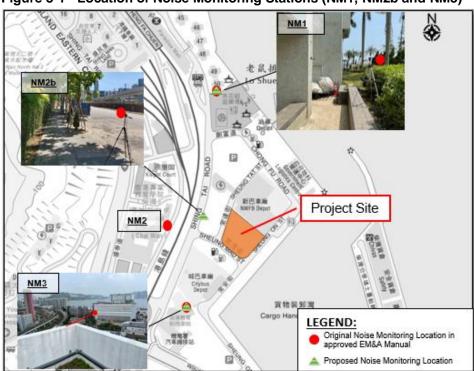
Figure 3-1 Location of Noise Monitoring Stations (NM1, NM2b and NM3)

Due to the adjustment of the location of NM2a to NM2b, the measured noise level at NM2b would represent the noise levels at NM2.

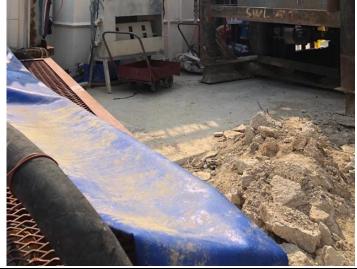
Photo 1

1. The stockpile of excavated material is observed dry and dusty. (Photo 1)

The stockpile of excavated material was observed dry and dusty. The Contractor was reminded to cover the stockpile with impervious sheet to minimize dust dispersion.
