Environmethal Team Services for Contract No. SS H504 Design and Construction of Chai Wan Government Complex and Vehicle Depot

12th Monthly EM&A Report (October 2022)

Contract No. SS H504
Design and
Construction of Chai
Wan Government
Complex and Vehicle
Depot

12th Monthly EM&A Report

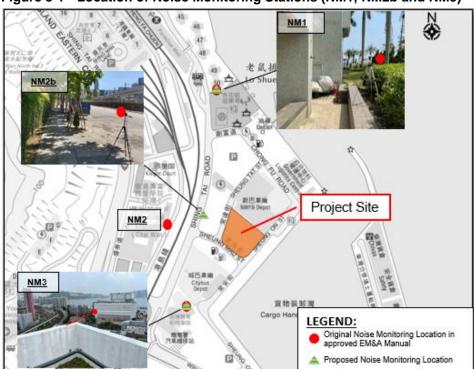
Figure 3-1 Location of Noise Monitoring Stations (NM1, NM2b and NM3)

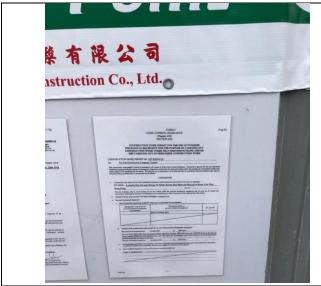
Photo 1

1. The valid CNP is not observed at the site entrance. (Photo 1)

The valid CNP was not observed at the site entrance. The Contractor was reminded to display the valid CNP at the site entrance.
