Environmethal Team Services for Contract No. SS H504 Design and Construction of Chai Wan Government Complex and Vehicle Depot

13th Monthly EM&A Report (November 2022)

13th Monthly EM&A Report

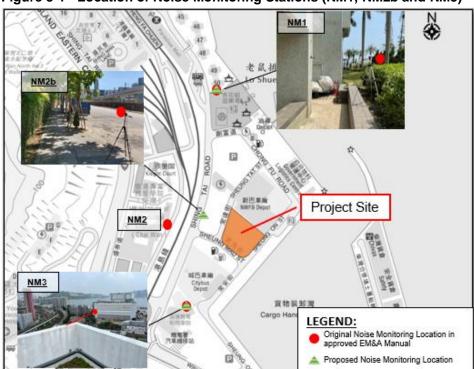
Figure 3-1 Location of Noise Monitoring Stations (NM1, NM2b and NM3)

Due to the adjustment of the location of NM2a to NM2b, the measured noise level at NM2b would represent the noise levels at NM2.

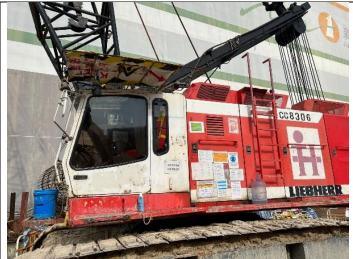
Photo F1

1. Valid NRMM label was placed on the mobile crane. (Photo F1)
