Environmetnal Team Services for Contract No. SS H504 Design and Construction of Chai Wan Government Complex and Vehicle Depot

14th Monthly EM&A Report (December 2022)

Contract No. SS H504 Design and Construction of Chai Wan Government Complex and Vehicle Depot

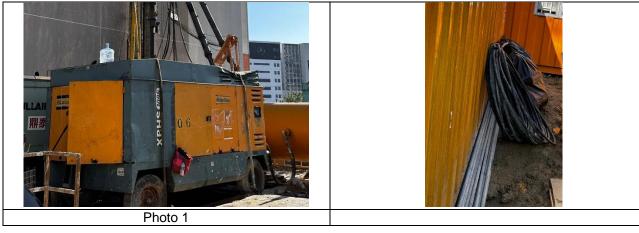
v up action for previous Site Inspection: NRMM label was replaced. (Photo F1)	
	Photo F1	
	vation(s):	
1.	An air compressor is operated with door opened. (Photo 1)	
2.	Bags of waste are not stored properly. (Photo 2)

- 1. The Contractor has been reminded to close the doors when air compressors are operating.
- 2. General waste shall be stored within enclosed waste bin or compaction units separately from the construction and chemical wastes.

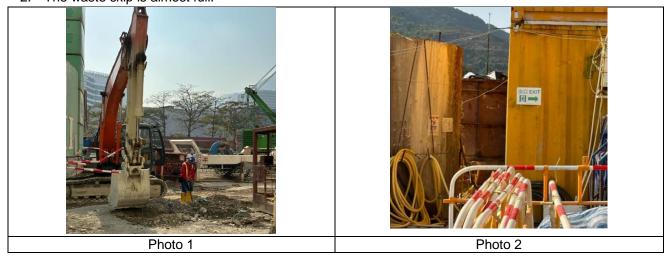
Photo F1

- Potential dust emission was generated from loading and unloading activity. The Contractor has been reminded to spray with water during loading and unloading to prevent dust dispersion.
- The waste skip was almost full. The Contractor has been recommended to increase the frequency of waste disposal to prevent accumulation of waste.

- 1. Potential dust emission is generated from loading and unloading activity.
- 2. The waste skip is almost full.

- 1. The Contractor has been reminded to spray with water during loading and unloading to prevent dust dispersion.
- 2. The Contractor has been recommended to increase the frequency of waste disposal to prevent accumulation of waste.
