Environmetnal Team Services for Contract No. SS H504 Design and Construction of Chai Wan Government Complex and Vehicle Depot

21st Monthly EM&A Report (July 2023)

Contract No. SS H504 Design and Construction of Chai Wan Government Complex and Vehicle Depot

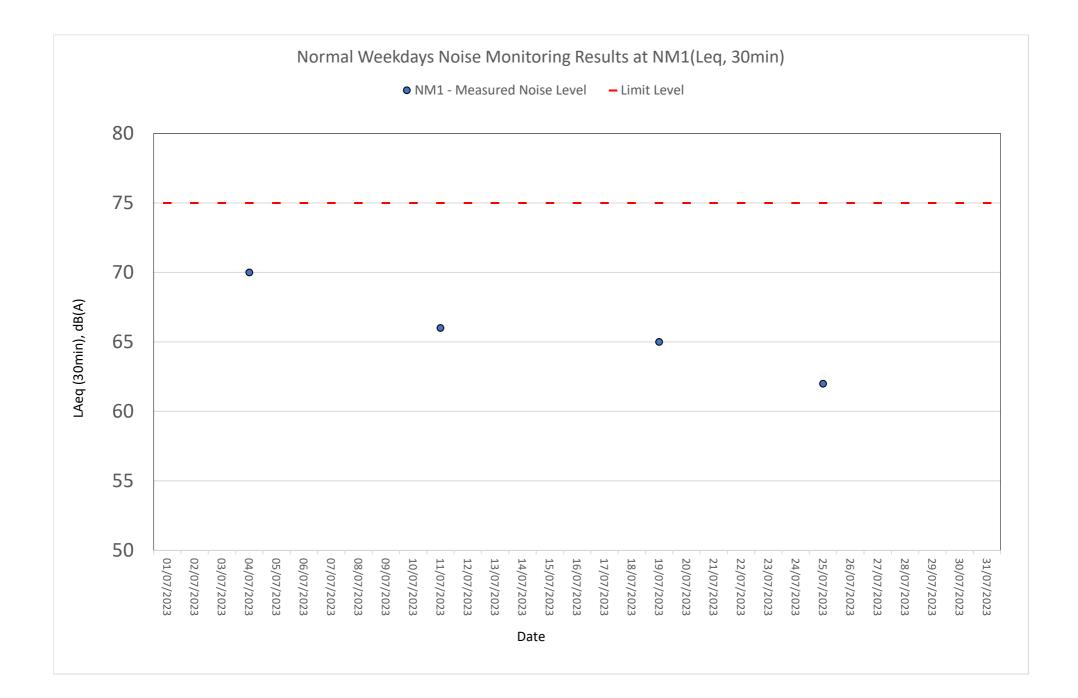
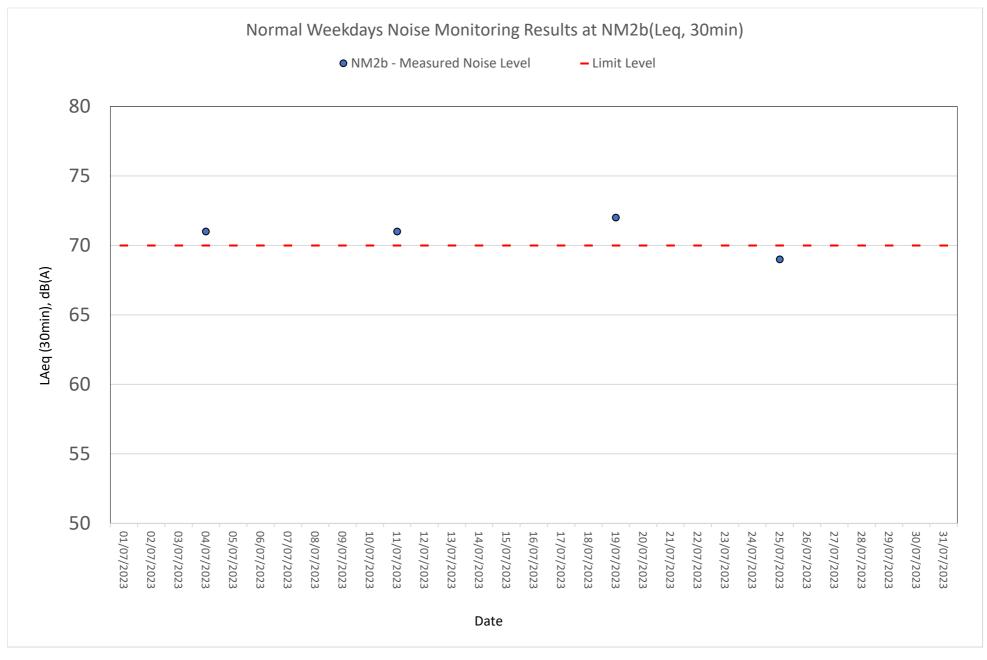
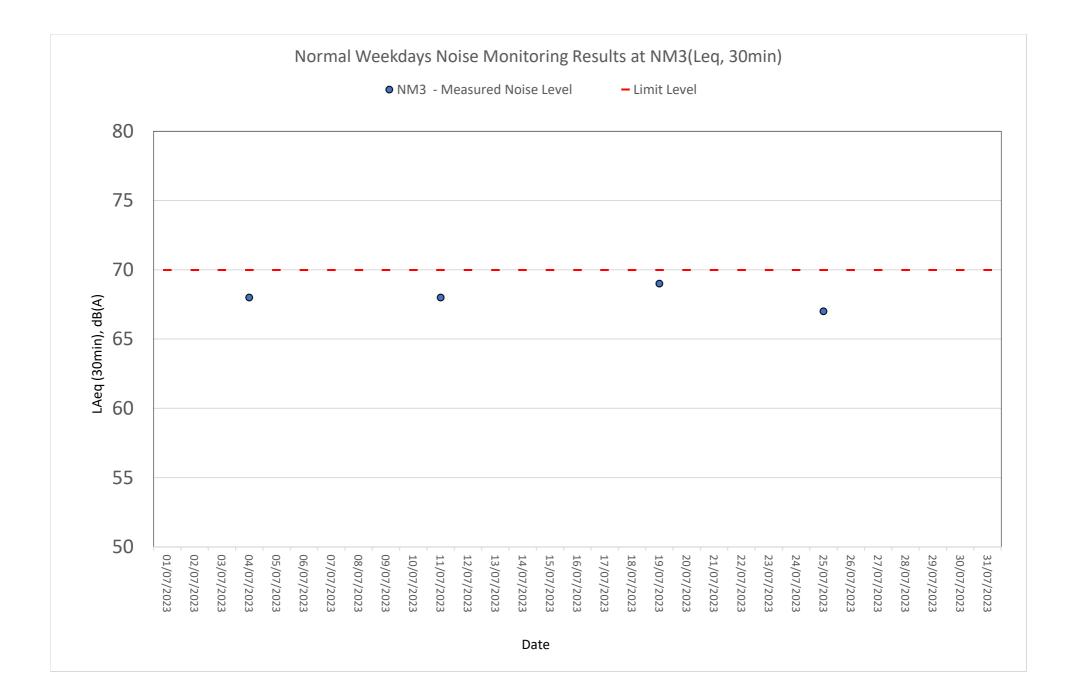
* A facade correction of +3 dB(A) was applied to the measured noise level.

^On 04, 11 and 19 July 2023, the measured noise levels of NM2b exceeded the limit level of 70dB(A). However, they were lower than the baseline level of 73.4 dB(A). Therefore, they are not considered as an limit level exceedance.

On 04, 11 and 19 July 2023, the measured noise levels of NM2b exceeded the limit level of 70dB(A). However, they were lower than the baseline level of 73.4 dB(A). Therefore, they are not considered as an limit level exceedance.

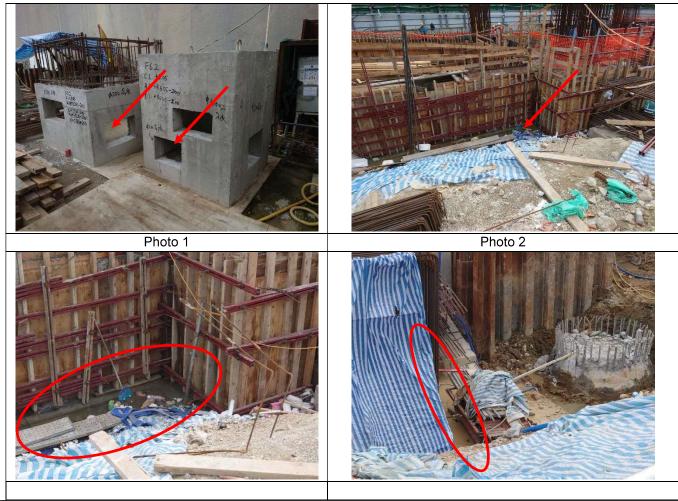
- 1. The accumulated water is found at the low elevation & potential areas of the construction site. (Photo 1 to 4)
- 2. The general wastes are existed in the open area. (Photo 3)

- 1. The contractor has recommended to review whether the accumulated water at the lower elevation & potential areas was collected to the sedimentation tanks or cleared to avoid mosquito breeding.
- 2. The contractor has recommended that the general wastes generated on-site were stored in enclosed bins & were collected to the waste separation facilities for paper, aluminum cans and plastic bottles etc.

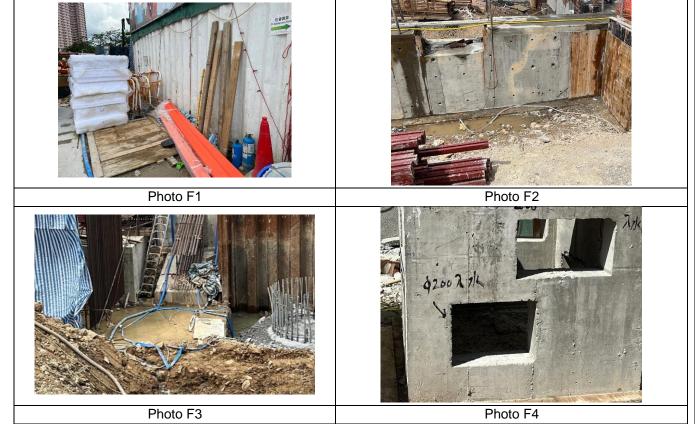
- 1. General wastes were removed in the open area. (Photo F1 and F2)
- 2. The Contractor has placed water pump to remove the stagnant water in lower elevation. (Photo F2 and F3)
- 3. The stagnant water inside the cement blocks was removed. (Photo F4)

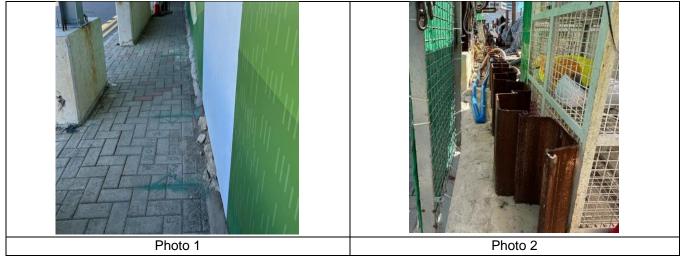
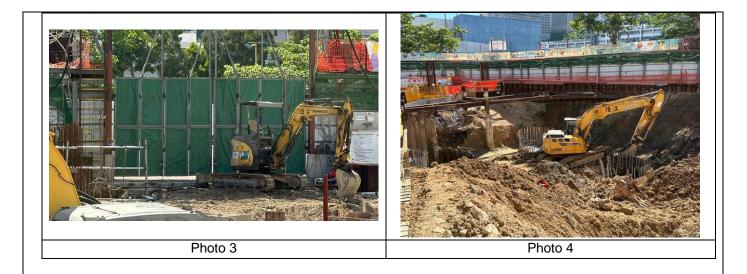
1. The footing of hoarding is not sealed properly. (Photo 1)

- 1. The Contractor has been reminded to implement measures at the entrances before the arrival of tropical cyclone and rainfall. (Photo 2 and Photo 3)
- 2. The Contractor has been reminded to implement surface protection measures on the exposed surface and stockpiles before the arrival of tropical cyclone and rainfall. (Photo 4)

- 1. The footing of hoarding shall be properly sealed to avoid seepage of surface run-off out of construction site.
- 2. Earth bunds or sand bag barriers should be provided to properly direct stormwater to silt removal facilities.
- 3. The exposed slope surfaces and stockpiles should be covered by tarpaulin or alternative to prevent soil erosion during the rainfall.

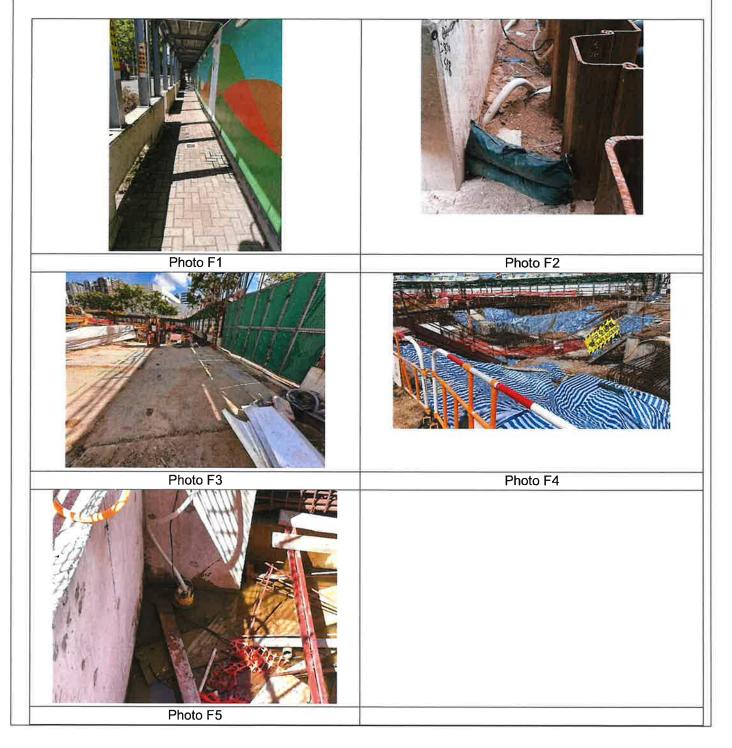
- 1. The Contractor was ensured the footing of the hoarding are properly sealed. (Photo F1)
- 2. Sandbag barriers were placed to intercept the leakage of the surface runoff. (Photo F2)
- 3. The construction area closed to another vehicular entrance has been paved and intercepting channel has been provided to prevent leakage of surface runoff. (Photo F3)
- 4. The exposed slope was covered with impervious sheets before the rainfall. (Photo F4)
- 5. Water pump was placed in the lower elevation to direct surface runoff to silt removal facility. (Photo F5)

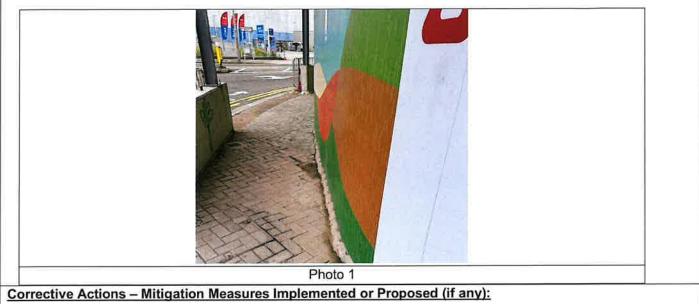
1. The Contractor shall review the existing footing of the hoarding to ensure no leakage out of the site boundary. (Photo 1)

1. Footing of hoarding shall be sealed to avoid seepage of surface run-off out of construction site.
