Environmetnal Team Services for Contract No. SS H504 Design and Construction of Chai Wan Government Complex and Vehicle Depot

22nd Monthly EM&A Report (August 2023)

Contract No. SS H504 Design and Construction of Chai Wan Government Complex and Vehicle Depot

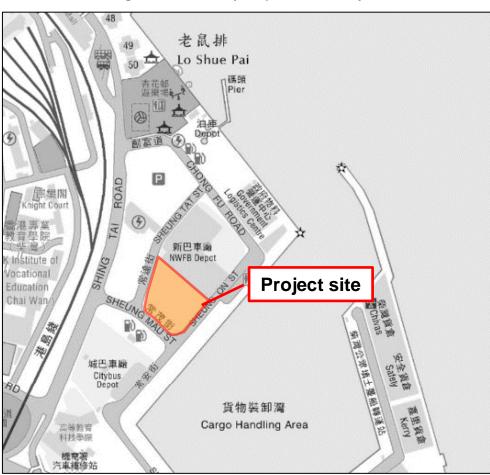
Figure 1-1 A layout plan of the Project

2.2.1 The scope of works of the Project, which is a Designated Project under the EIA Ordinance (EIAO), will construct joint user building comprising the government office, store, laboratory, transport pool and vehicle depot facilities in Chai Wan District. The Site is bounded by NWFB Depot to the north, Sheung On Street to the east, Sheung Mau Street to the south and Sheung Tat Street to the west. A layout plan of the Project is provided in **Figure 1-1**.

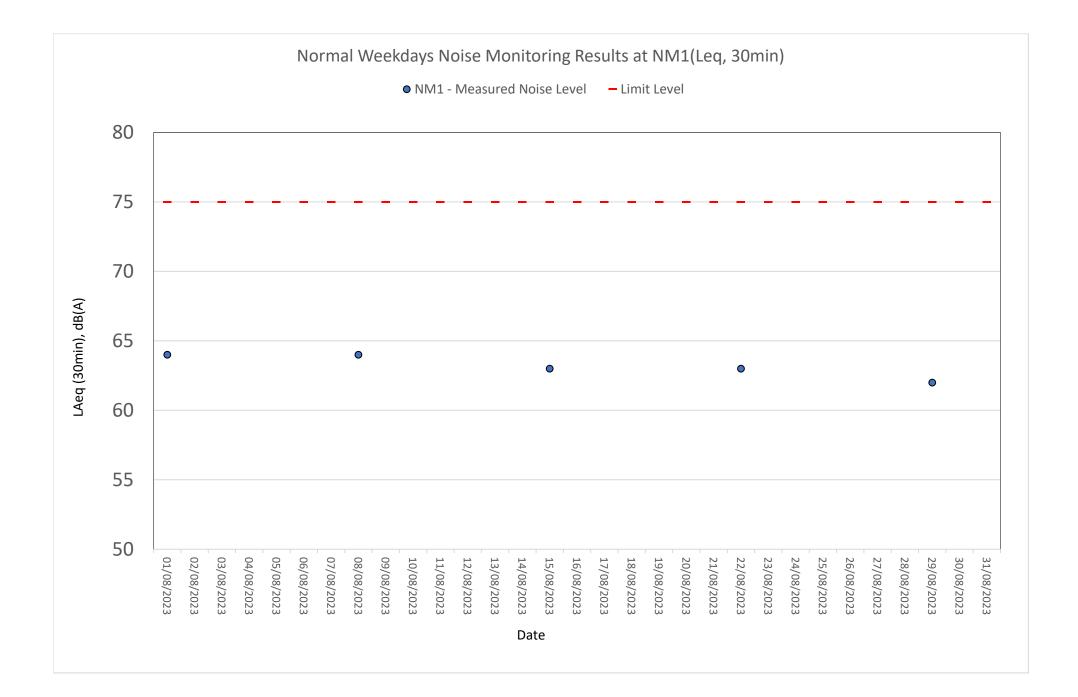
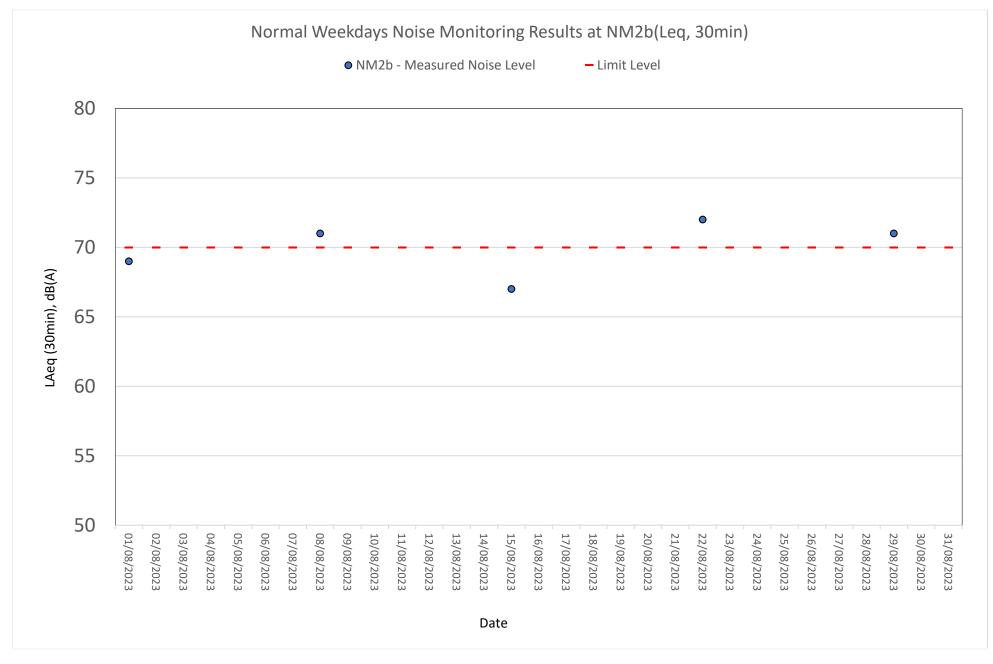
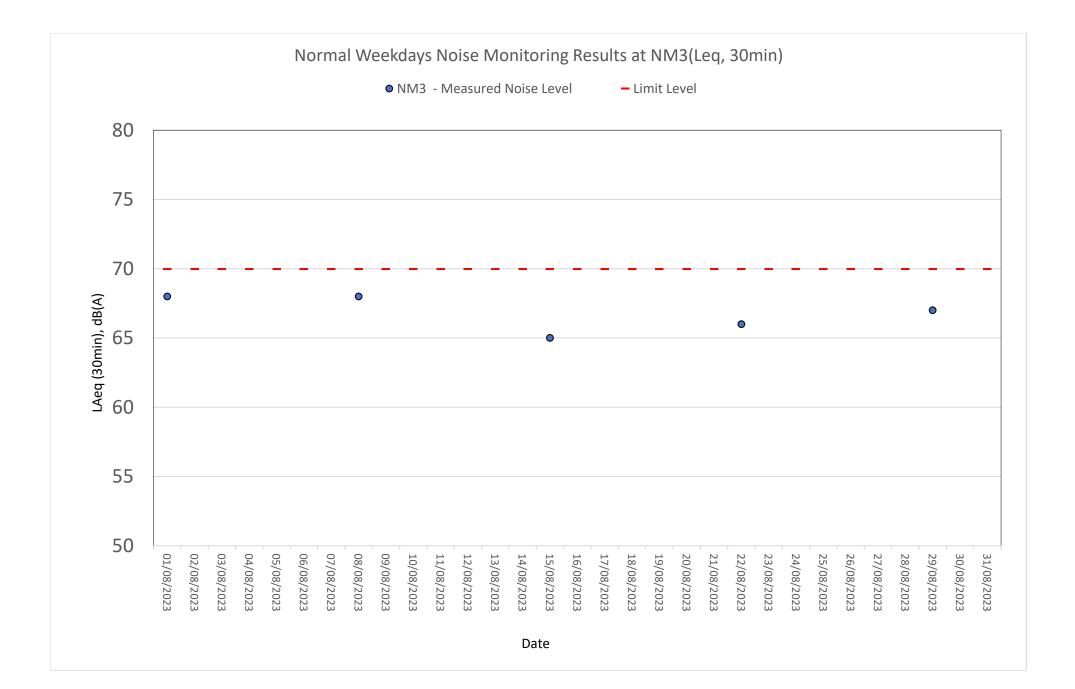
^On 08, 22 and 29 August 2023, the measured noise levels of NM2b exceeded the limit level of 70dB(A). However, they were lower than the baseline level of 73.4 dB(A). Therefore, they are not considered as an limit level exceedance.

On 08, 22 and 29 August 2023, the measured noise levels of NM2b exceeded the limit level of 70dB(A). However, they were lower than the baseline level of 73.4 dB(A). Therefore, they are not considered as an limit level exceedance.

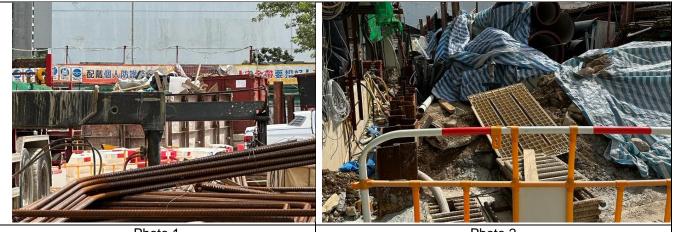
1. The Contractor has been reminded to cover the cements bag entirely. (Photo 3)

- 1. The Contractor has been reminded to schedule disposal of the non-inert waste when the waste skip is almost full.
- 2. The Contractor has been recommended to provide sandbag barriers surrounding the stockpile to prevent any washout into the channel.
- 3. Every stock of more than 20 bags of cement or dry pulverized fuel ash (PFA) shall be covered entirely by impervious sheeting or placed in an area sheltered on the top and 3 sides.

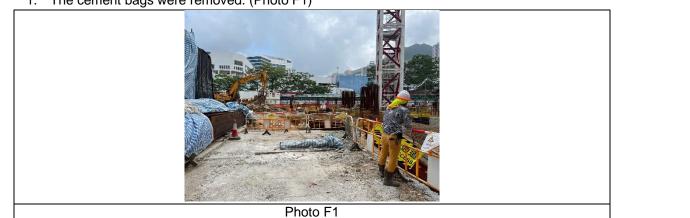
Follow up action for previous Site Inspection:1. The cement bags were removed. (Photo F1)

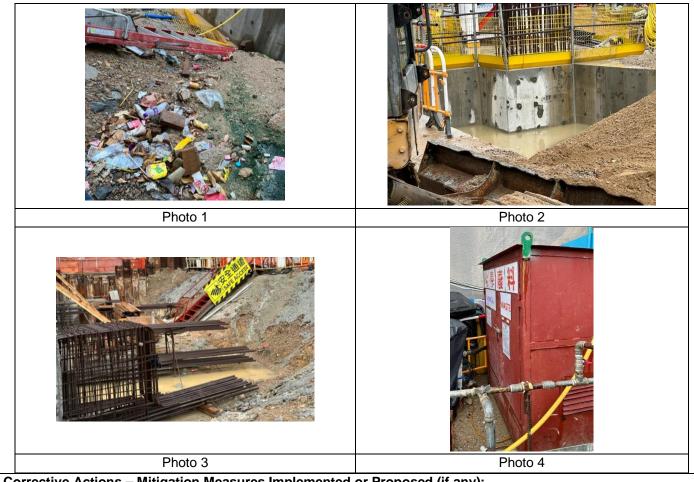
- 1. General waste is not properly disposed in enclosed bin. (Photo 1)
- 2. The stagnant water is found in low elevation in Zone C. (Photo 2 and 3)
- 3. The chemical waste cupboard is not locked. (Photo 4)

- 1. The Contractor has been reminded to properly segregate and stored general waste in enclosed bins or compaction units separately from the construction and chemical wastes.
- 2. The Contractor has reminded to divert the surface runoff to wastewater treatment facility.
- 3. The chemical waste cupboard should be locked.

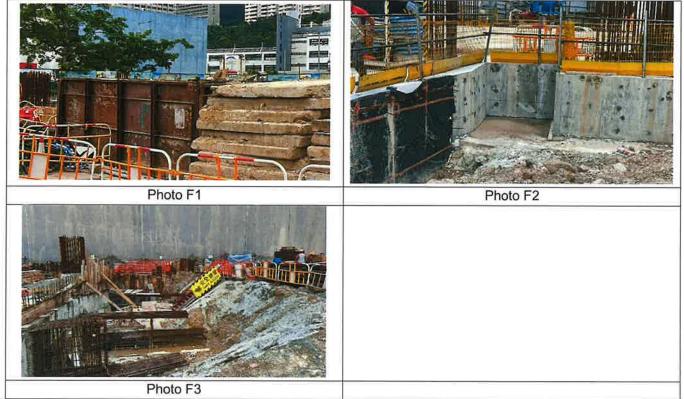
- 1. The accumulated non-inert waste was disposed. (Photo F1)
- 2. The stagnant water in the lower elevation was cleared off. (Photo F2 and Photo F3)

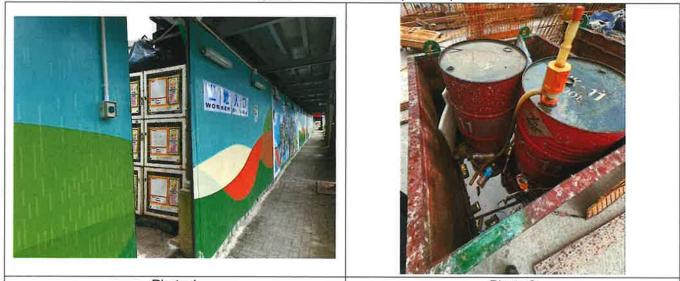
- 1. Environmental Permit and Construction Noise Permit are not displayed at the relocated site entrance. (Photo 1)
- 2. General refuse is found in the drip tray with chemical waste. (Photo 2)

- Environmental Permit and Construction Noise Permit were not displayed at the relocated site entrance. The Contractor was reminded to display EP and CNP at the relocated site entrance.
- General refuse was found in the drip tray with chemical waste. General waste should be stored in enclosed bins or compaction units separately from the construction and chemical wastes. The Contractor was reminded to clear the drip tray and dispose of as chemical waste.

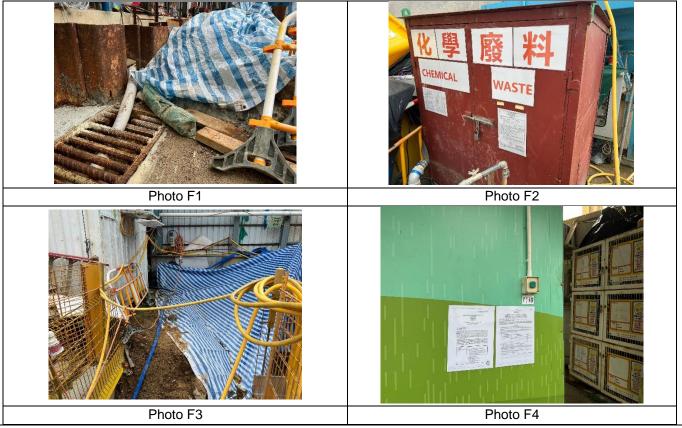
- 1. The Contractor has covered the dusty stockpile with impervious sheet and placed sandbag barrier to prevent the material entering in the channel. (Photo F1)
- 2. The chemical waste cupboard has been locked. (Photo F2)
- 3. The general refuse was removed. (Photo F3)
- 4. EP and CNP have been displayed at the relocated site entrance. (Photo F4)

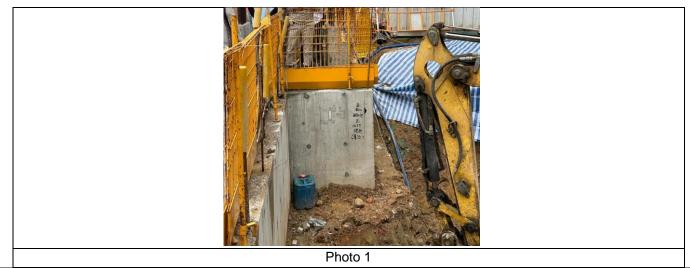
1. The chemical container is observed without drip tray and chemical label. (Photo 1)

1. The Contractor has been reminded to provide drip tray for all chemical container and to display chemical label.

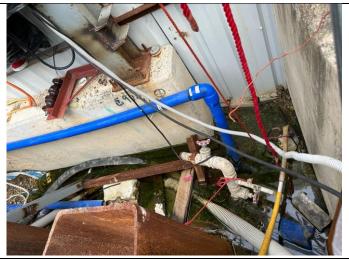
Photo 1

1. Stagnant water is found near the hoarding. (Photo 1)

<u>Corrective Actions – Mitigation Measures Implemented or Proposed (if any):</u> 1. The Contractor has been reminded to clear the stagnant water.
