# Environmetnal Team Services for Contract No. SS H504 Design and Construction of Chai Wan Government Complex and Vehicle Depot

25<sup>th</sup> Monthly EM&A Report (November 2023)

Contract No. SS H504 Design and Construction of Chai Wan Government Complex and Vehicle Depot

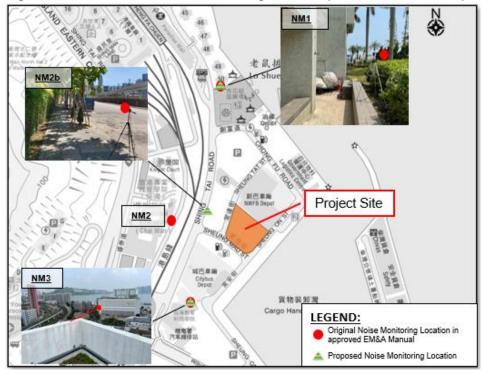
Figure 3-1 Location of Noise Monitoring Stations (NM1, NM2b and NM3)

To respond to the comment raised by EPD on monitoring location of NM2a by email dated 23 May 2022 and site meeting on 6 June 2022, the monitoring location of NM2a was adjusted to the pedestrian road at Shing Tai Road (NM2b) which is located between project site and original noise monitoring location, Hong Kong Institute of Vocational Education (Chai Wan) - Academic Block (NM2). Compared with NM2a, NM2b is far away from the traffic light and therefore should be able to minimise the traffic noise issue. This arrangement was started from 28 June 2022 and has been agreed by the Independent Environmental Checker (IEC). Noise measurement at NM2b will be considered as free-field and a correction of +3dB(A) would be made to the noise monitoring results.

Due to the adjustment of the location of NM2a to NM2b, the measured noise level at NM2b would represent the noise levels at NM2.

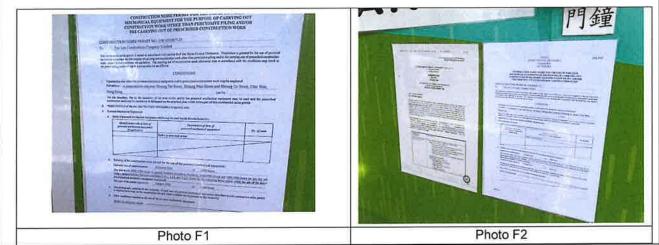
1. The updated CNP has been displayed at the site entrance. (Photo F1 and F2)

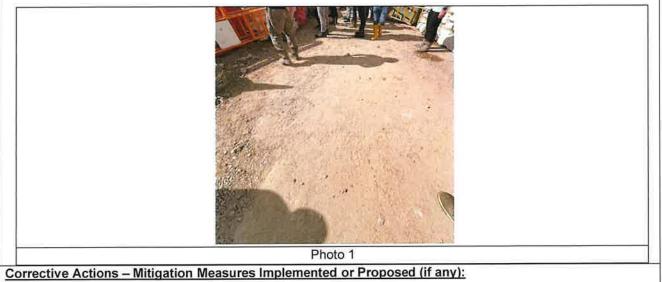
The unpaved road was dry and fugitive dust was observed. The contractor was reminded to schedule watering for the unpaved road to minimize dust dispersion.

1. The unpaved road is dry and fugitive dust is observed. (Photo 1)

1. The Contractor has been reminded to schedule watering for the unpaved road to minimize dust dispersion.

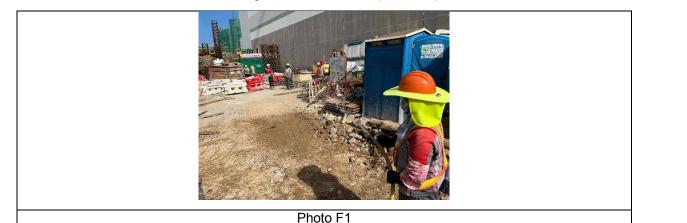
1. The Contractor scheduled watering for the work area. (Photo F1)

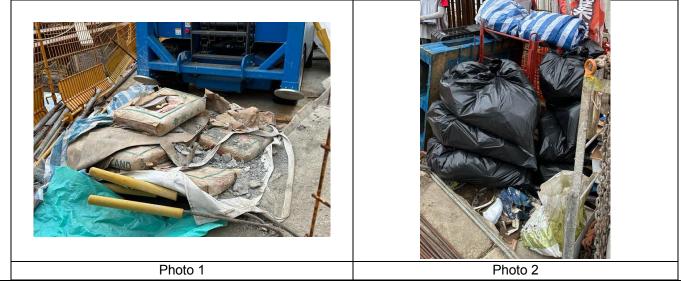
- 1. The used cement bags shall be covered with impervious sheet to minimize dust dispersion. (Photo 1)
- 2. The general waste shall be proper stored in compaction unit. (Photo 2)

- 1. The Contractor has been reminded to cover the cement bag with impervious sheet.
- 2. The Contractor has been suggested to transfer the general waste to the waste skip as early as possible after the lunch hour.

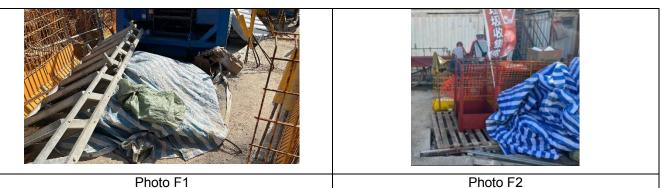
- 1. The cement bags have been covered with impervious sheets. (Photo F1)
- 2. The general refuse was removed. (Photo F2)

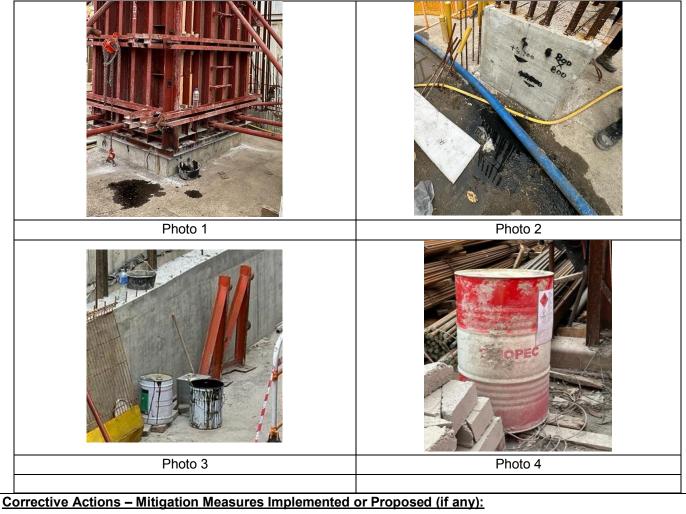
- The oil stains and mixture of oil were found in the work area. The contractor was reminded to clean the oil stain and dispose of as chemical waste.
- The potential spillage and leakage from paint container and oil drum shall be prevented. The contractor was reminded to provide drip try for oil drum and to place paint containers on impervious sheet for minimization of land contamination risk.

- 1. The oil stains and mixture of oil are found in the work area. (Photo 1)
- 2. The potential spillage and leakage from paint container and oil drum shall be prevented. (Photo 2)

- 1. The Contractor has been reminded to clear the oil stain and disposal of as chemical waste.
- 2. The Contractor has been reminded to provide drip try for oil drum and to place paint containers on impervious sheet for minimization of land contamination risk.

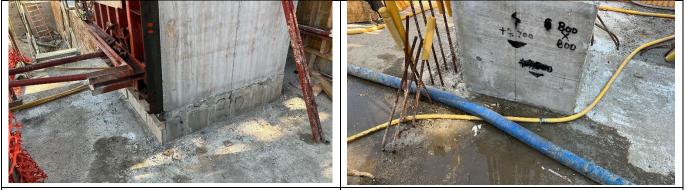
Photo F1

- 1. The oil stains and mixture of oil were cleaned and disposed of as chemical waste. (Photo F1-F2)
- 2. Owing to the site condition change, the chemical containers have been stored in chemical waste cabinet. (Photo F3)

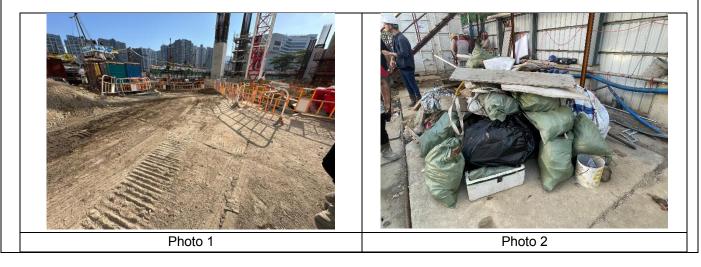
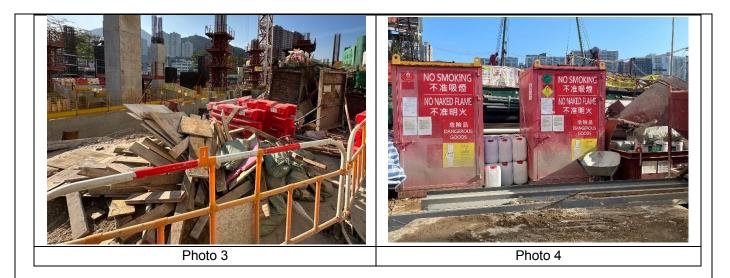
- The unpaved road was dry and fugitive dust was observed. The contractor was reminded to arrange to regular watering of the unpaved road for dust control.
- The waste skip was overloaded and accumulation of the C&D waste was observed in the open area. The contractor was advised to provide sufficient waste skip for waste storage and increase the frequency of waste disposal to avoid waste accumulation.
- The chemical containers shall be stored in the chemical storage area or drip trays to prevent chemical spillage. The contractor was reminded to provide drip tray for chemical container to minimize the risk of land contamination.

- 1. The unpaved road is dry and fugitive dust is observed. (Photo 1)
- 2. The waste skip is overloaded and accumulation of the C&D waste is observed in the open area (Photo 2 and Photo 3)
- 3. The chemical containers shall be stored in the chemical storage area or drip trays to prevent chemical spillage. (Photo 4)

- 1. The Contractor has been reminded to arrange for regular watering of the unpaved road for dust control.
- 2. The Contractor has been advised to provide sufficient waste skip for waste storage and increase the frequency of waste disposal to avoid waste accumulation.
- 3. The Contractor has been reminded to provide drip trays for chemical container to minimize the risk of land contamination.
