# Environmethal Team Services for Contract No. SS H504 Design and Construction of Chai Wan Government Complex and Vehicle Depot

27th Monthly EM&A Report (January 2024)

Contract No. SS H504
Design and
Construction of Chai
Wan Government
Complex and Vehicle
Depot

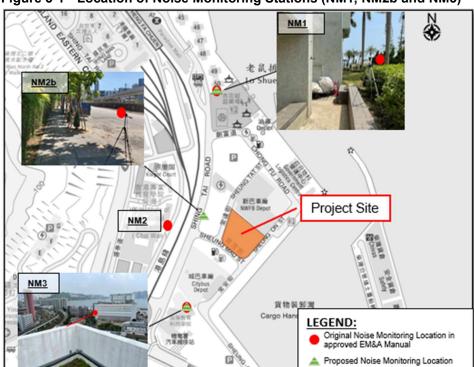
Figure 3-1 Location of Noise Monitoring Stations (NM1, NM2b and NM3)

Lamp Post no. 47447 at Sheung Mau Street (NM2a), which is located between project site and original noise monitoring location, Hong Kong Institute of Vocational Education (Chai Wan) - Academic Block (NM2), is found suitable and available to be an alternative noise monitoring location for NM2. Also, NM2a, which has a direct line of sight towards project site (where construction works will be carried out and likely to have noise impacts), is located closer to project site than NM2 and thus considered as a representative noise monitoring location. Monitoring position at NM2a is proposed at 2m above ground due to security concerns and minimize the road traffic noise contribution. Noise measurement at NM2a will be considered as free-field and a correction of +3dB(A) would be made to the noise monitoring results. The alternative location of NM2a, were therefore proposed and agreed by the Independent Environmental Checker (IEC).

To respond to the comment raised by EPD on monitoring location of NM2a by email dated 23 May 2022 and site meeting on 6 June 2022, the monitoring location of NM2a was adjusted to the pedestrian road at Shing Tai Road (NM2b) which is located between project site and original noise monitoring location, Hong Kong Institute of Vocational Education (Chai Wan) - Academic Block (NM2). Compared with NM2a, NM2b is far away from the traffic light and therefore should be able to minimise the traffic noise issue. This arrangement was started from 28 June 2022 and has been agreed by the Independent Environmental Checker (IEC). Noise measurement at NM2b will be considered as free-field and a correction of +3dB(A) would be made to the noise monitoring results.

Due to the adjustment of the location of NM2a to NM2b, the measured noise level at NM2b would represent the noise levels at NM2.

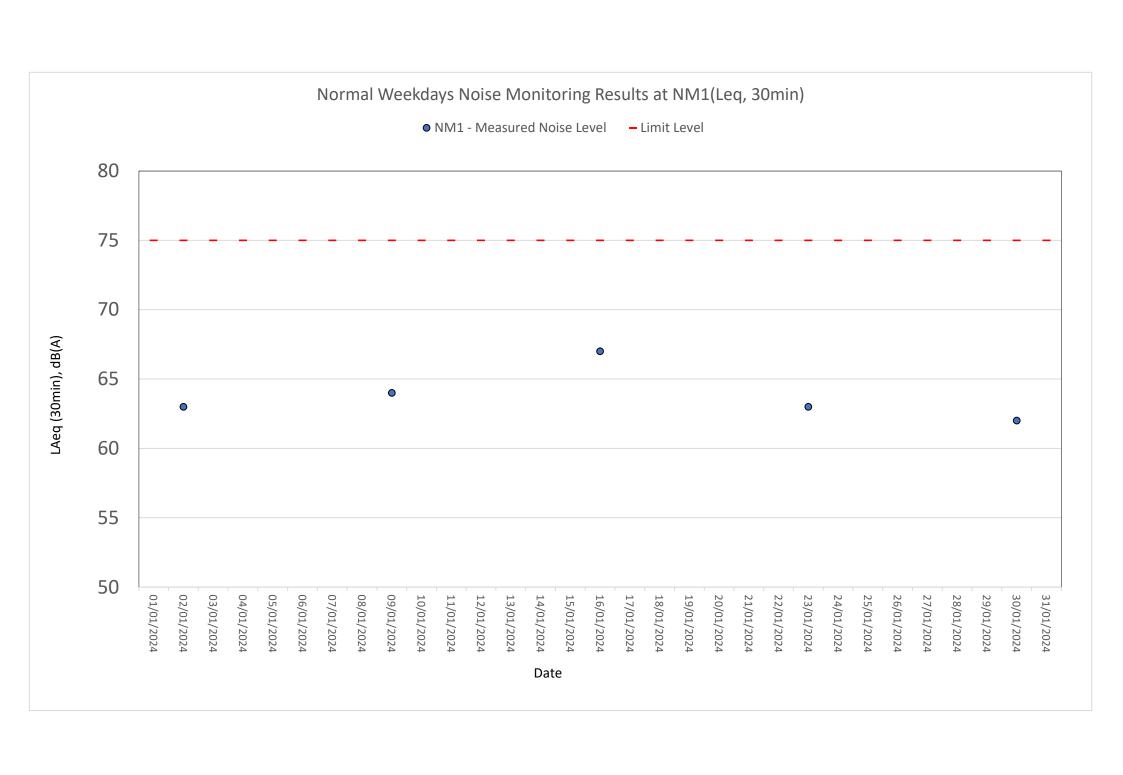
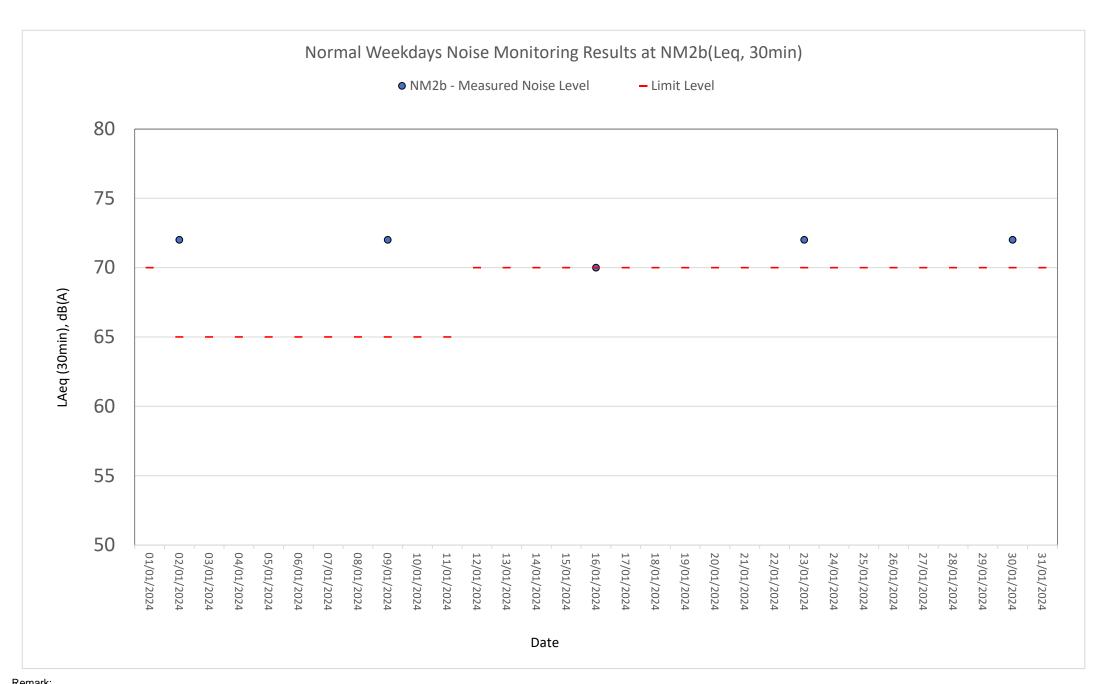
On 2 and 9 January 2024, the measured noise levels of NM2b exceeded the limit level of 65 dB(A) as they were within exam period. However, they were lower than the baseline level of 73.4 dB(A). Therefore, they are not considered as an limit level exceedance.

On 16, 23 and 30 January 2024, the measured noise levels of NM2b exceeded the limit level of 70dB(A). However, they are lower than the baseline level of 73.4 dB(A). Therefore, they are not considered as an limit level exceedance.

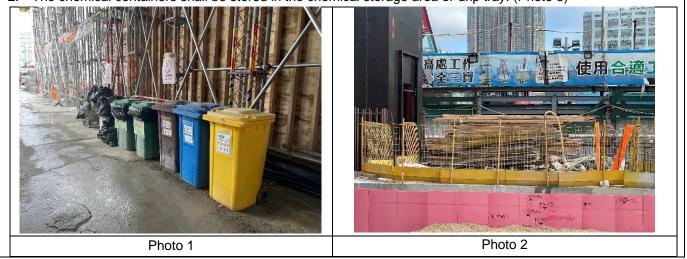
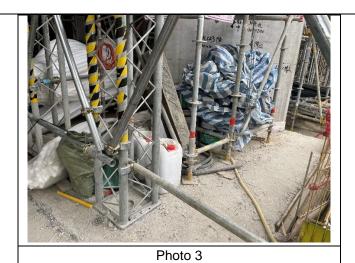
- The accumulation of general waste and C&D material were observed. The
  contractor has been advised that a sufficient waste skip for waste storage
  should be provided, and the frequency of waste disposal should be increased
  to prevent accumulation.
- The chemical containers shall be stored in the chemical storage area or drip tray. The contractor has been reminded to store the chemical containers in the chemical storage area or to provide sufficient drip trays for the chemical containers to minimize chemical leakage.

- 1. The accumulation of general waste and C&D material are observed. (Photo 1-2)
- 2. The chemical containers shall be stored in the chemical storage area or drip tray. (Photo 3)

- 1. The Contractor has been advised that a sufficient waste skip for waste storage should be provided, and the frequency of waste disposal should be increased to prevent waste accumulation.
- 2. The Contractor has been reminded to store the chemical containers in the chemical storage area or to provide sufficient drip trays for the chemical containers to minimize chemical leakage
