Contract No. DC/2018/08
Inter-reservoirs Transfer Scheme –
Water Tunnel between Kowloon Byewash Reservoir and Lower Shing Mun Reservoir
Revised Monthly Environmental Monitoring and Audit (EM&A) Report
(June 2021)

24th Monthly EM&A Report (Rev. 3)

- E2. This is the 24th Monthly Environmental Monitoring and Audit (EM&A) Report presents EM&A works undertaken in the period of 1 to 30 June 2021. EM&A works were performed in accordance with the approved EM&A Manual and conditions stipulated in the amended Environmental Permit EP-345/2009/A.

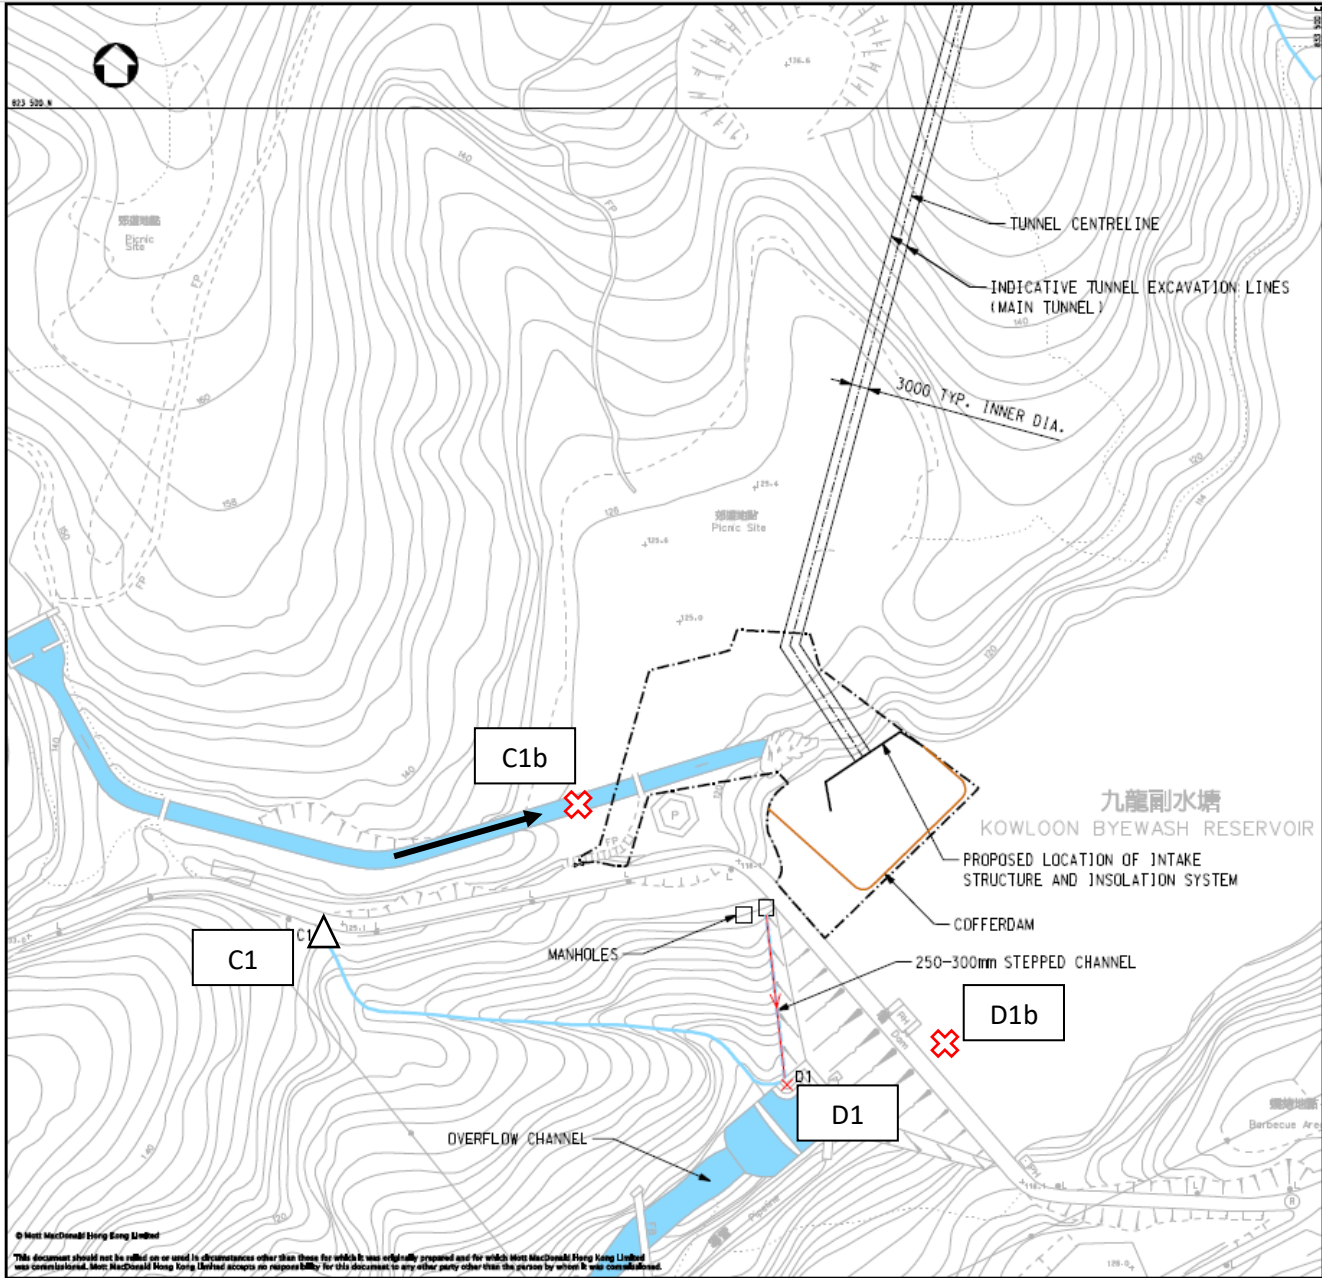
NOTE:
DESIGN DETAILS OF THE COFFERDAM WILL BE DETERMINED BY THE CONTRACTOR.

- LEGEND:
- WORKSITE AREA
 - WATERCOURSE
 - INDICATIVE LOCATION OF COFFERDAM
 - FLOW PATH OF TREATED EFFLUENT
 - × POINT OF EFFLUENT DISCHARGE / MONITORING STATION D1
 - △ CONTROL STATION AT INTAKE SITE
 - ⊠ Proposed Alternative Water Monitoring Station

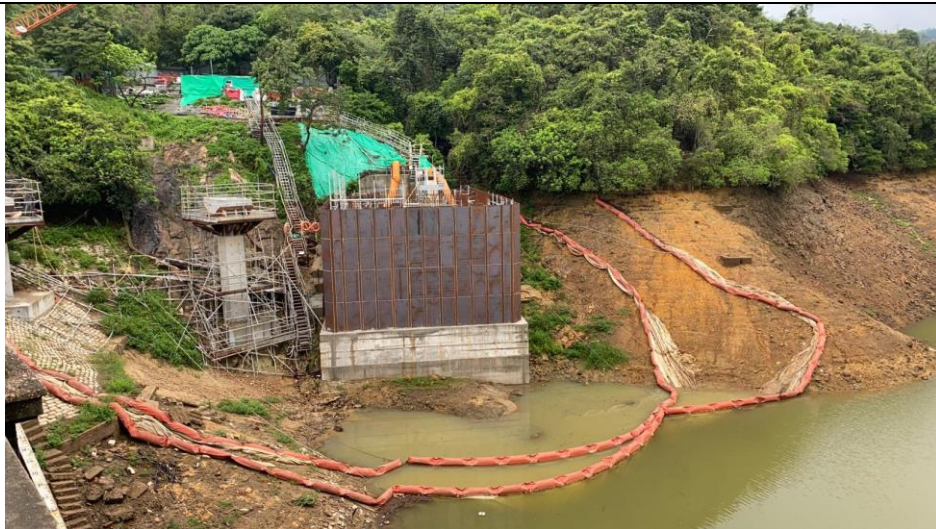
Our Ref.	IR024
Monitoring Date	24 June 2021
Time	09:07
Environmental Aspect	Water Quality
Monitoring Location	D1b
Parameter	Suspended Solids
Control Level	NA
Action Level	9.0
Limit Level	13.0
Measured Level	15.0
Exceedance	Limit Level
Site Observation	<p>According to the information collected, no earthwork was carried out under the IRTS project on 23 June 2021 and the Contractor confirmed that no works was conducted outside the cofferdam on the exceedance date (24 June 2021) as shown in Figure 1. The turbidity readings taken were 4.1 and 4.4 NTU.</p> <p>Amber Rainstorm Warning Signal was issued by the Hong Kong Observatory on 23 June 2021 from 14:10 to 15:30. Heavy rain was recorded at the KBR as suggested in the KBR rain gauge data graph (Figure 2). This may have deteriorated water quality of KBR by washing out the naturally exposed slopes as shown in Figure 3 (photo taken on 24 June 2021) and bringing the Suspended Solid content from the soil of country park to the reservoir.</p> <p>Despite the heavy rain, as shown in Figure 3, low water level was observed at the reservoir. Figure 4 shows that the Reservoir Water Level on 24 June 2021 did not reach the KBR cofferdam level (105.83 mPD) which suggests that the reservoir had no direct contact with the working area on that day.</p> <p>The Contractor is reminded to follow the Environmental Management Plan when carrying out construction procedures and all appropriate mitigation measures should be implemented during the construction works.</p>
